# Memo

<b>To:</b>	<b>Marie Gudopp</b>	<b>Job No:</b>	<b>1000057</b>
<b>From:</b>	<b>Emilia Stocks</b>	<b>Date:</b>	<b>27 July 2020</b>
<b>cc:</b>	<b>Dejan Kirbis (WCC), Andrew Kennedy (T+T)</b>		
<b>Subject:</b>	<b>Shelly Bay Shed 8 July 2020 Update</b>

## **Shed 8 Building, Shelly Bay, Wellington Geotechnical Completion Report - Temporary Repairs Works**

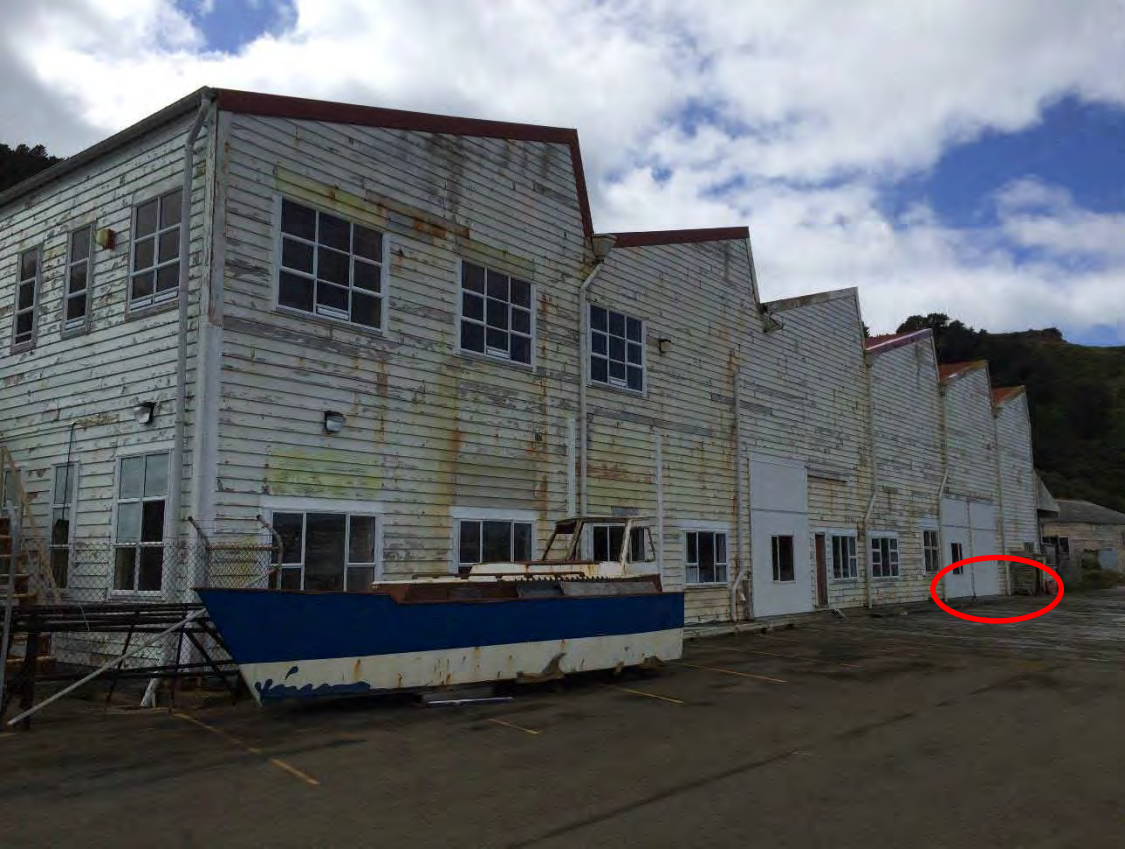
*Photo 1. Western side of Shed 8. Photo taken from wharf. Area with critical foundations marked in red.*

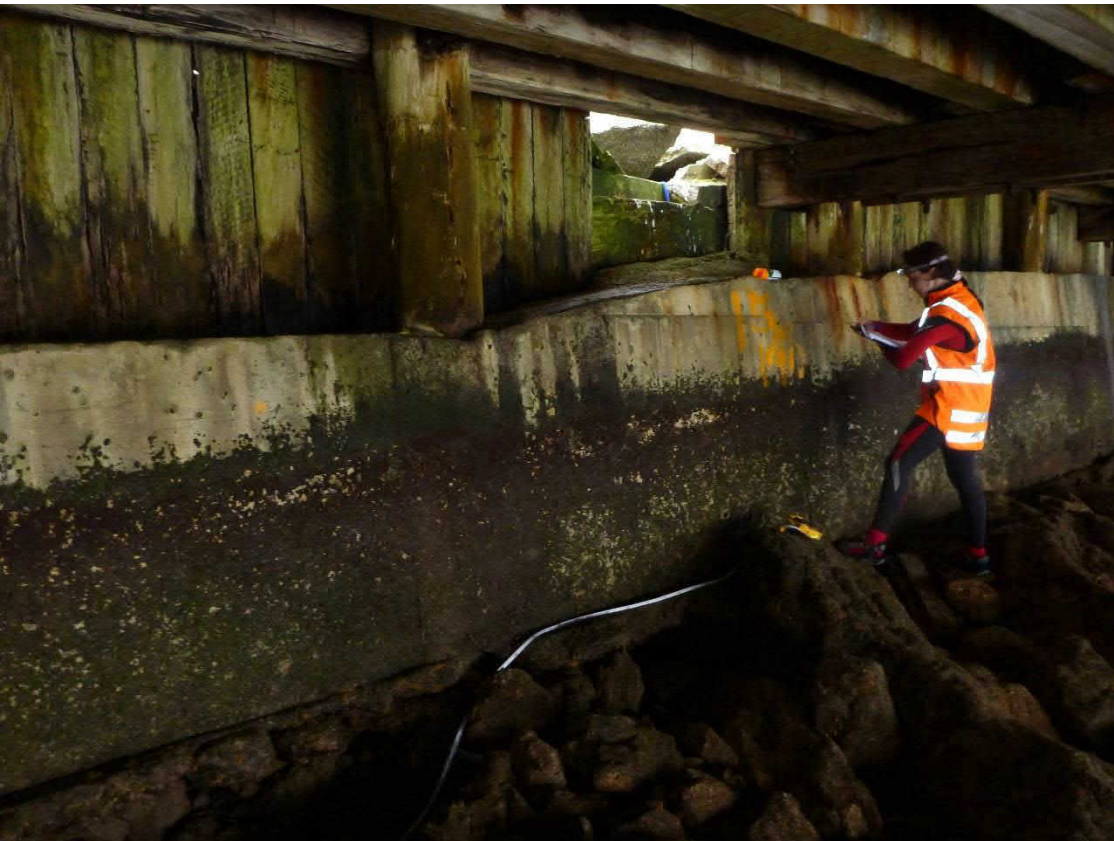
*Photo 2. Access to critical foundation No. 1 from water*

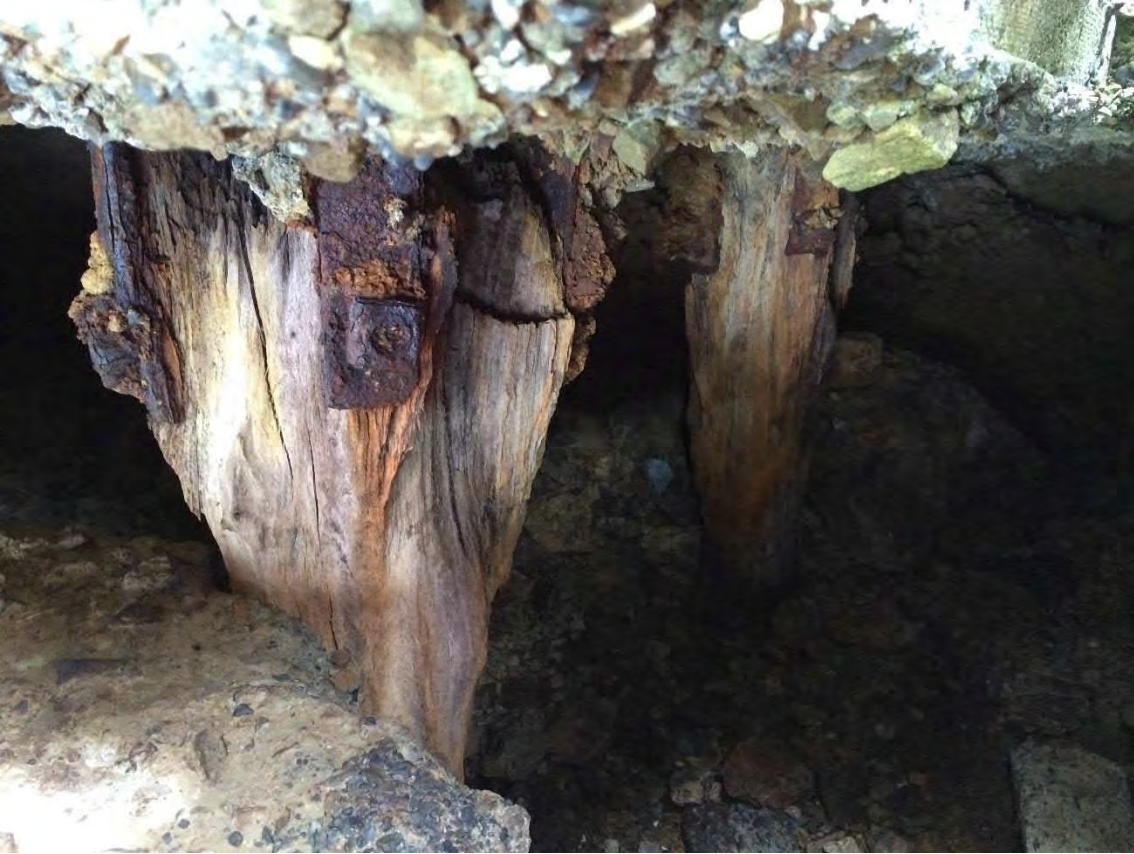
- Extensive undermining of pile caps and perimeter foundation beams over a large area along the building western edge (refer attached plan).
- The pile caps and beams appear to be in sound condition
- Many of the timber piles have either:
  - substantially degraded, pile diameter has reduced (necking effect) from approximately 300mm to 100-150mm and the ‘necked’ sections of the pile are significantly weakened (refer attached photo) or
  - were completely disconnected from the pile cap or missing.

*Photo 3. Damaged timber piles – critical foundation No. 1*

We propose to underpin the two critical pile caps with acro-props. Minimum three props to be installed under each pile cap. Refer detail below:

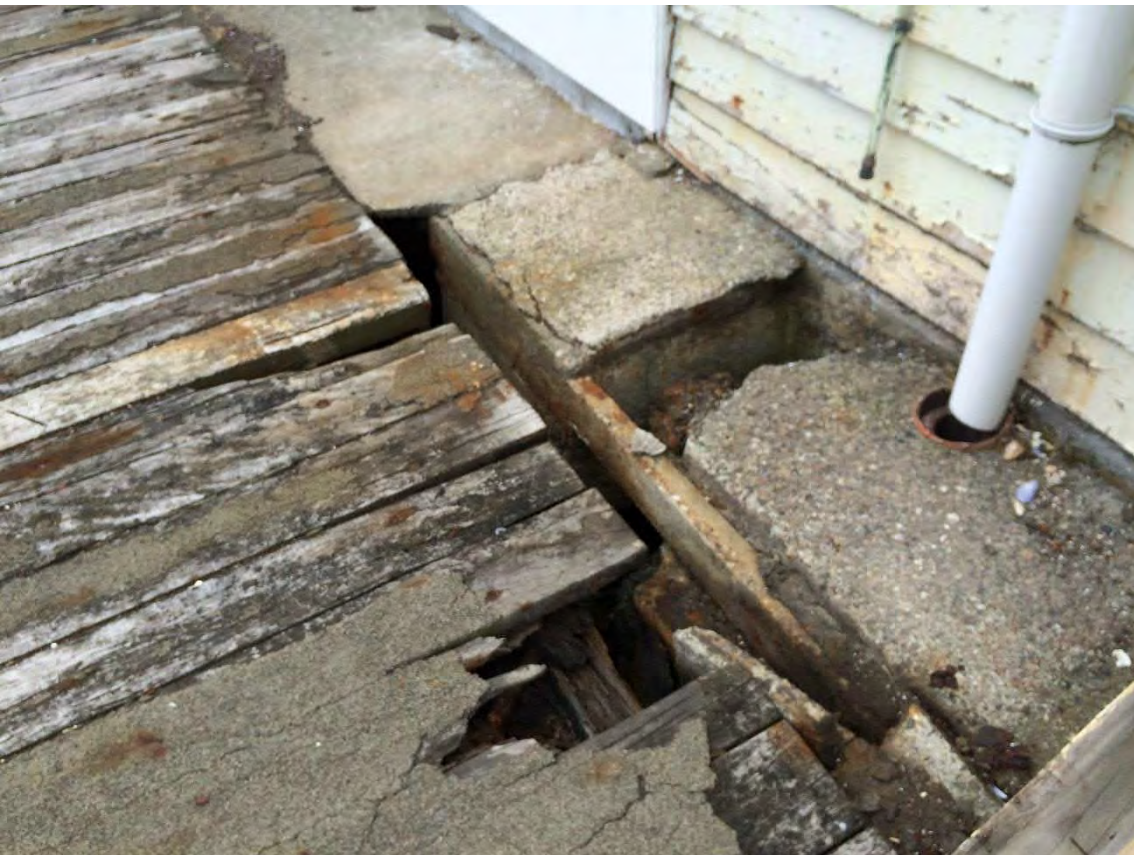
*Photo 4. Access to critical foundation No. 1.*

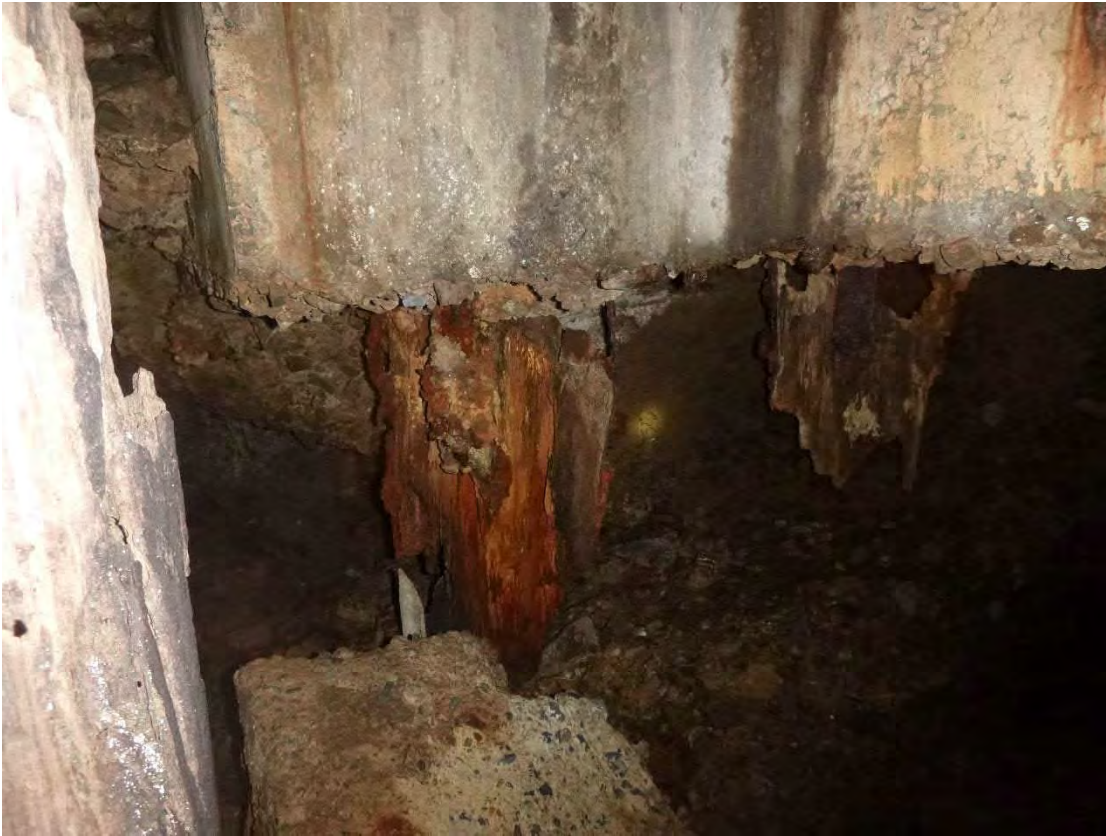
*Photo 5. Damaged timber piles – critical foundation No. 2.*

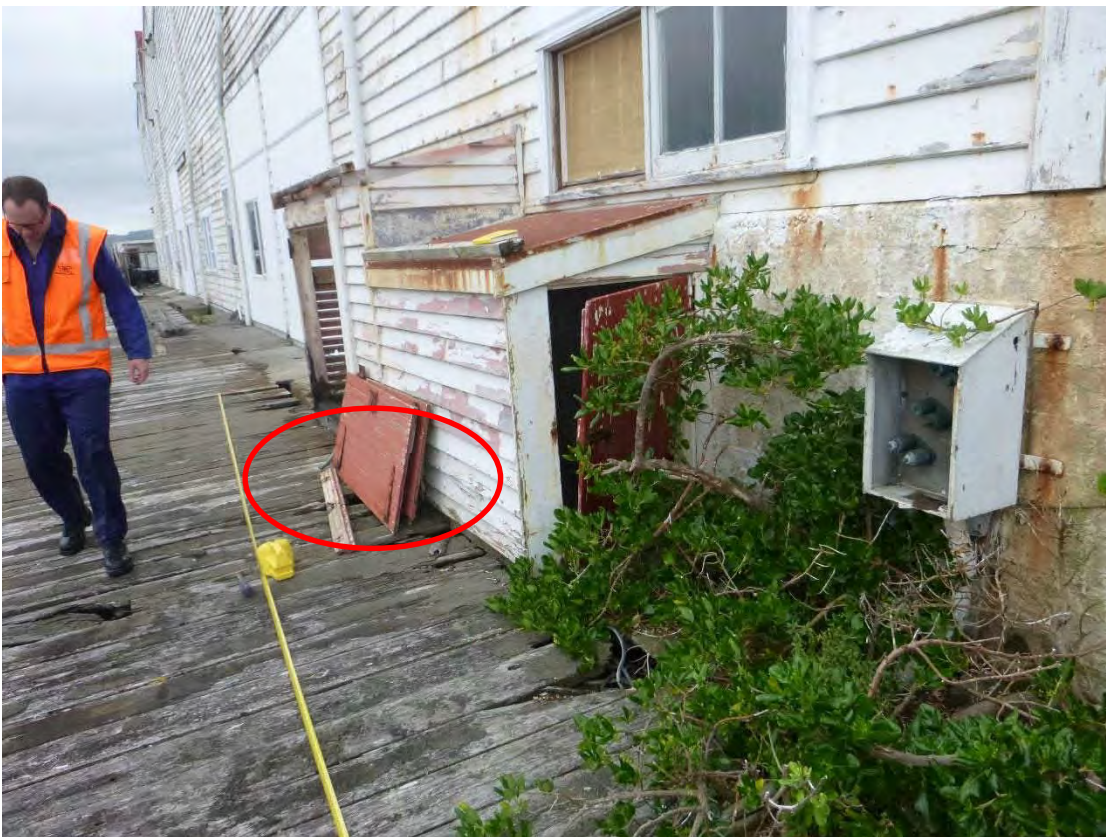
*Photo 6. Access to critical foundation No. 2.*

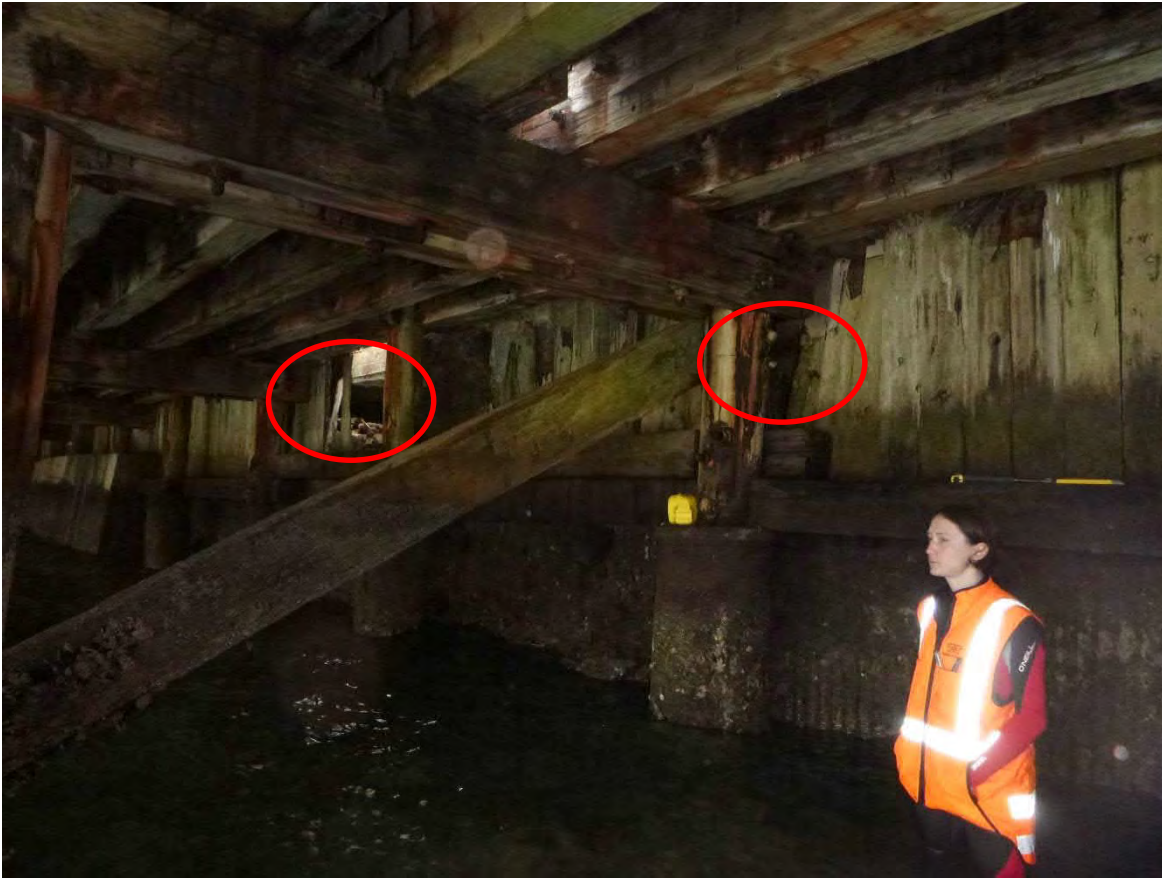
*Photo 7. General overview for access to critical foundations from water.*

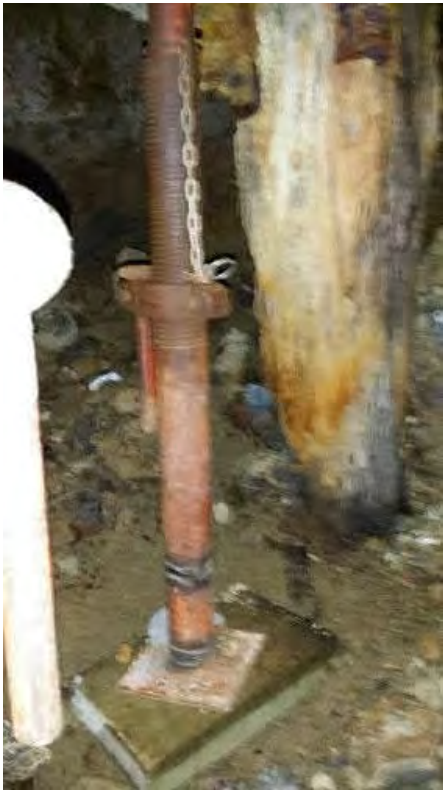
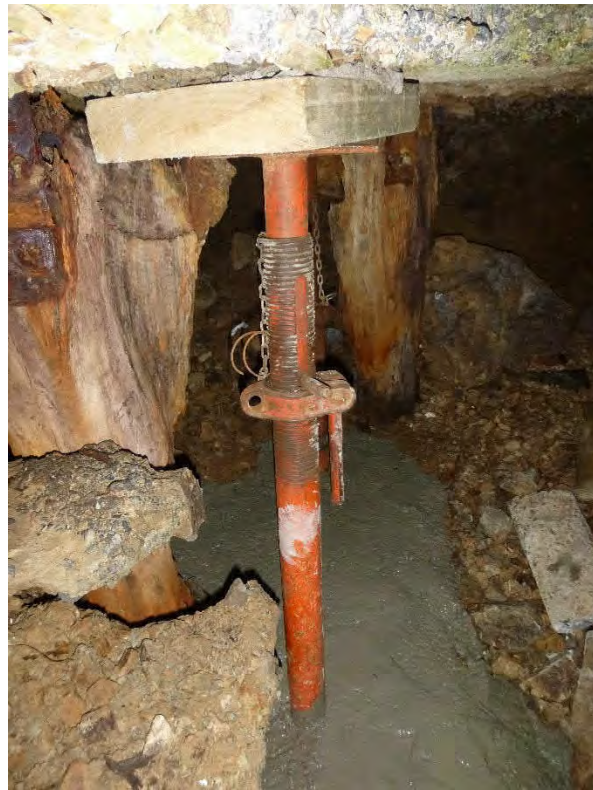
*Photos 1 and 2. Critical foundation 1 – stages of work*

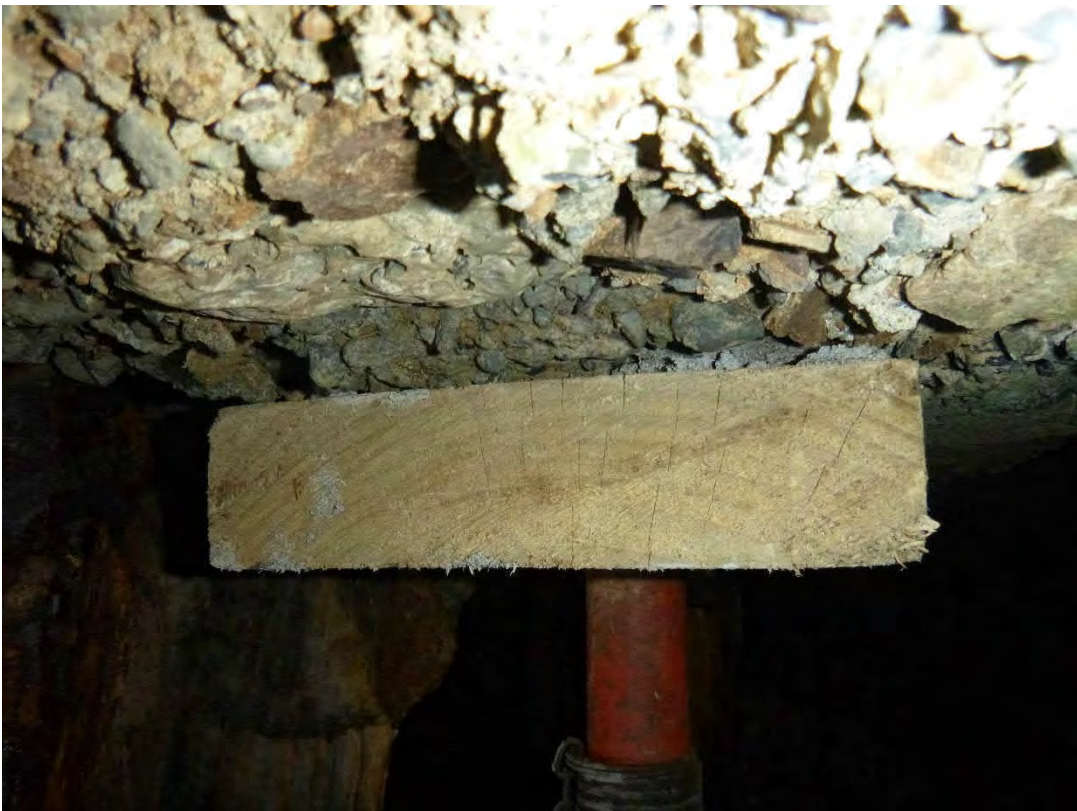
*Photo 3. Top of prop*

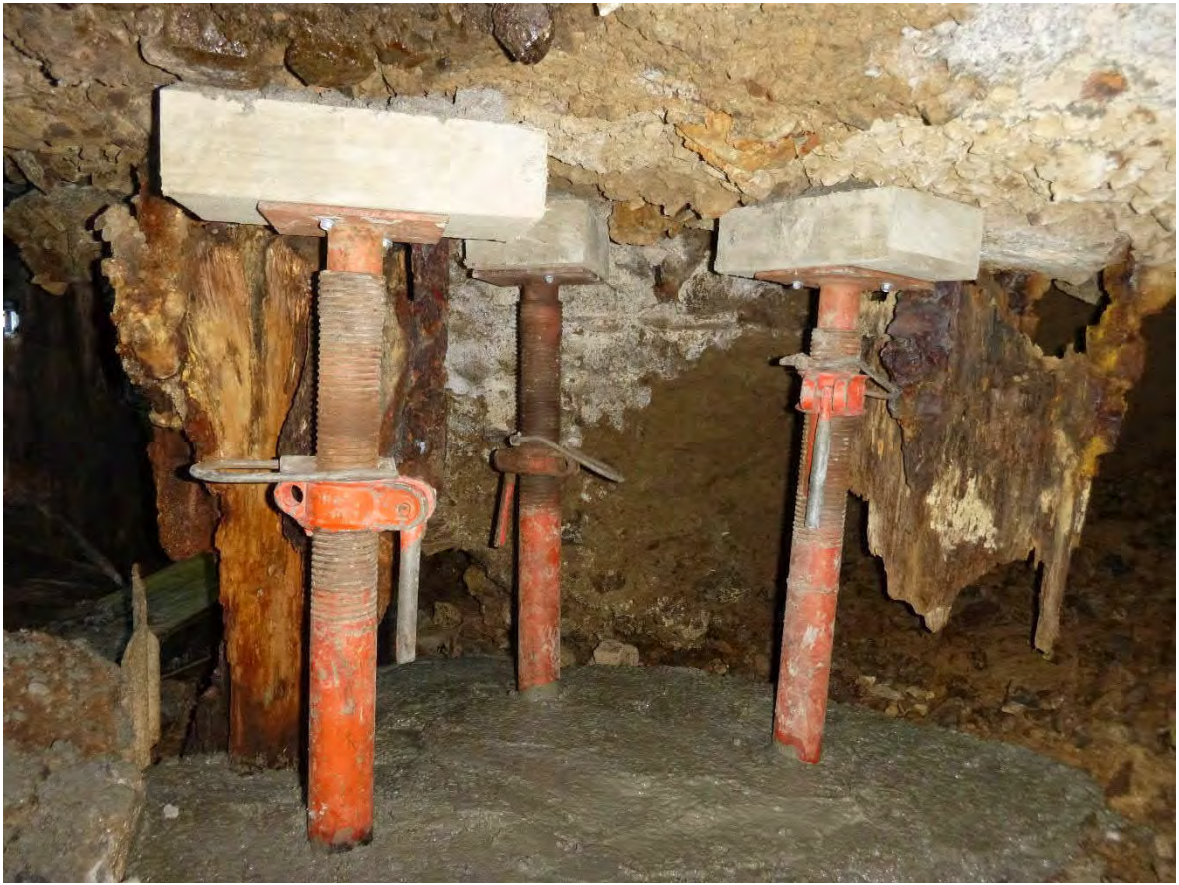
*Photo 4. Critical foundation 2.*

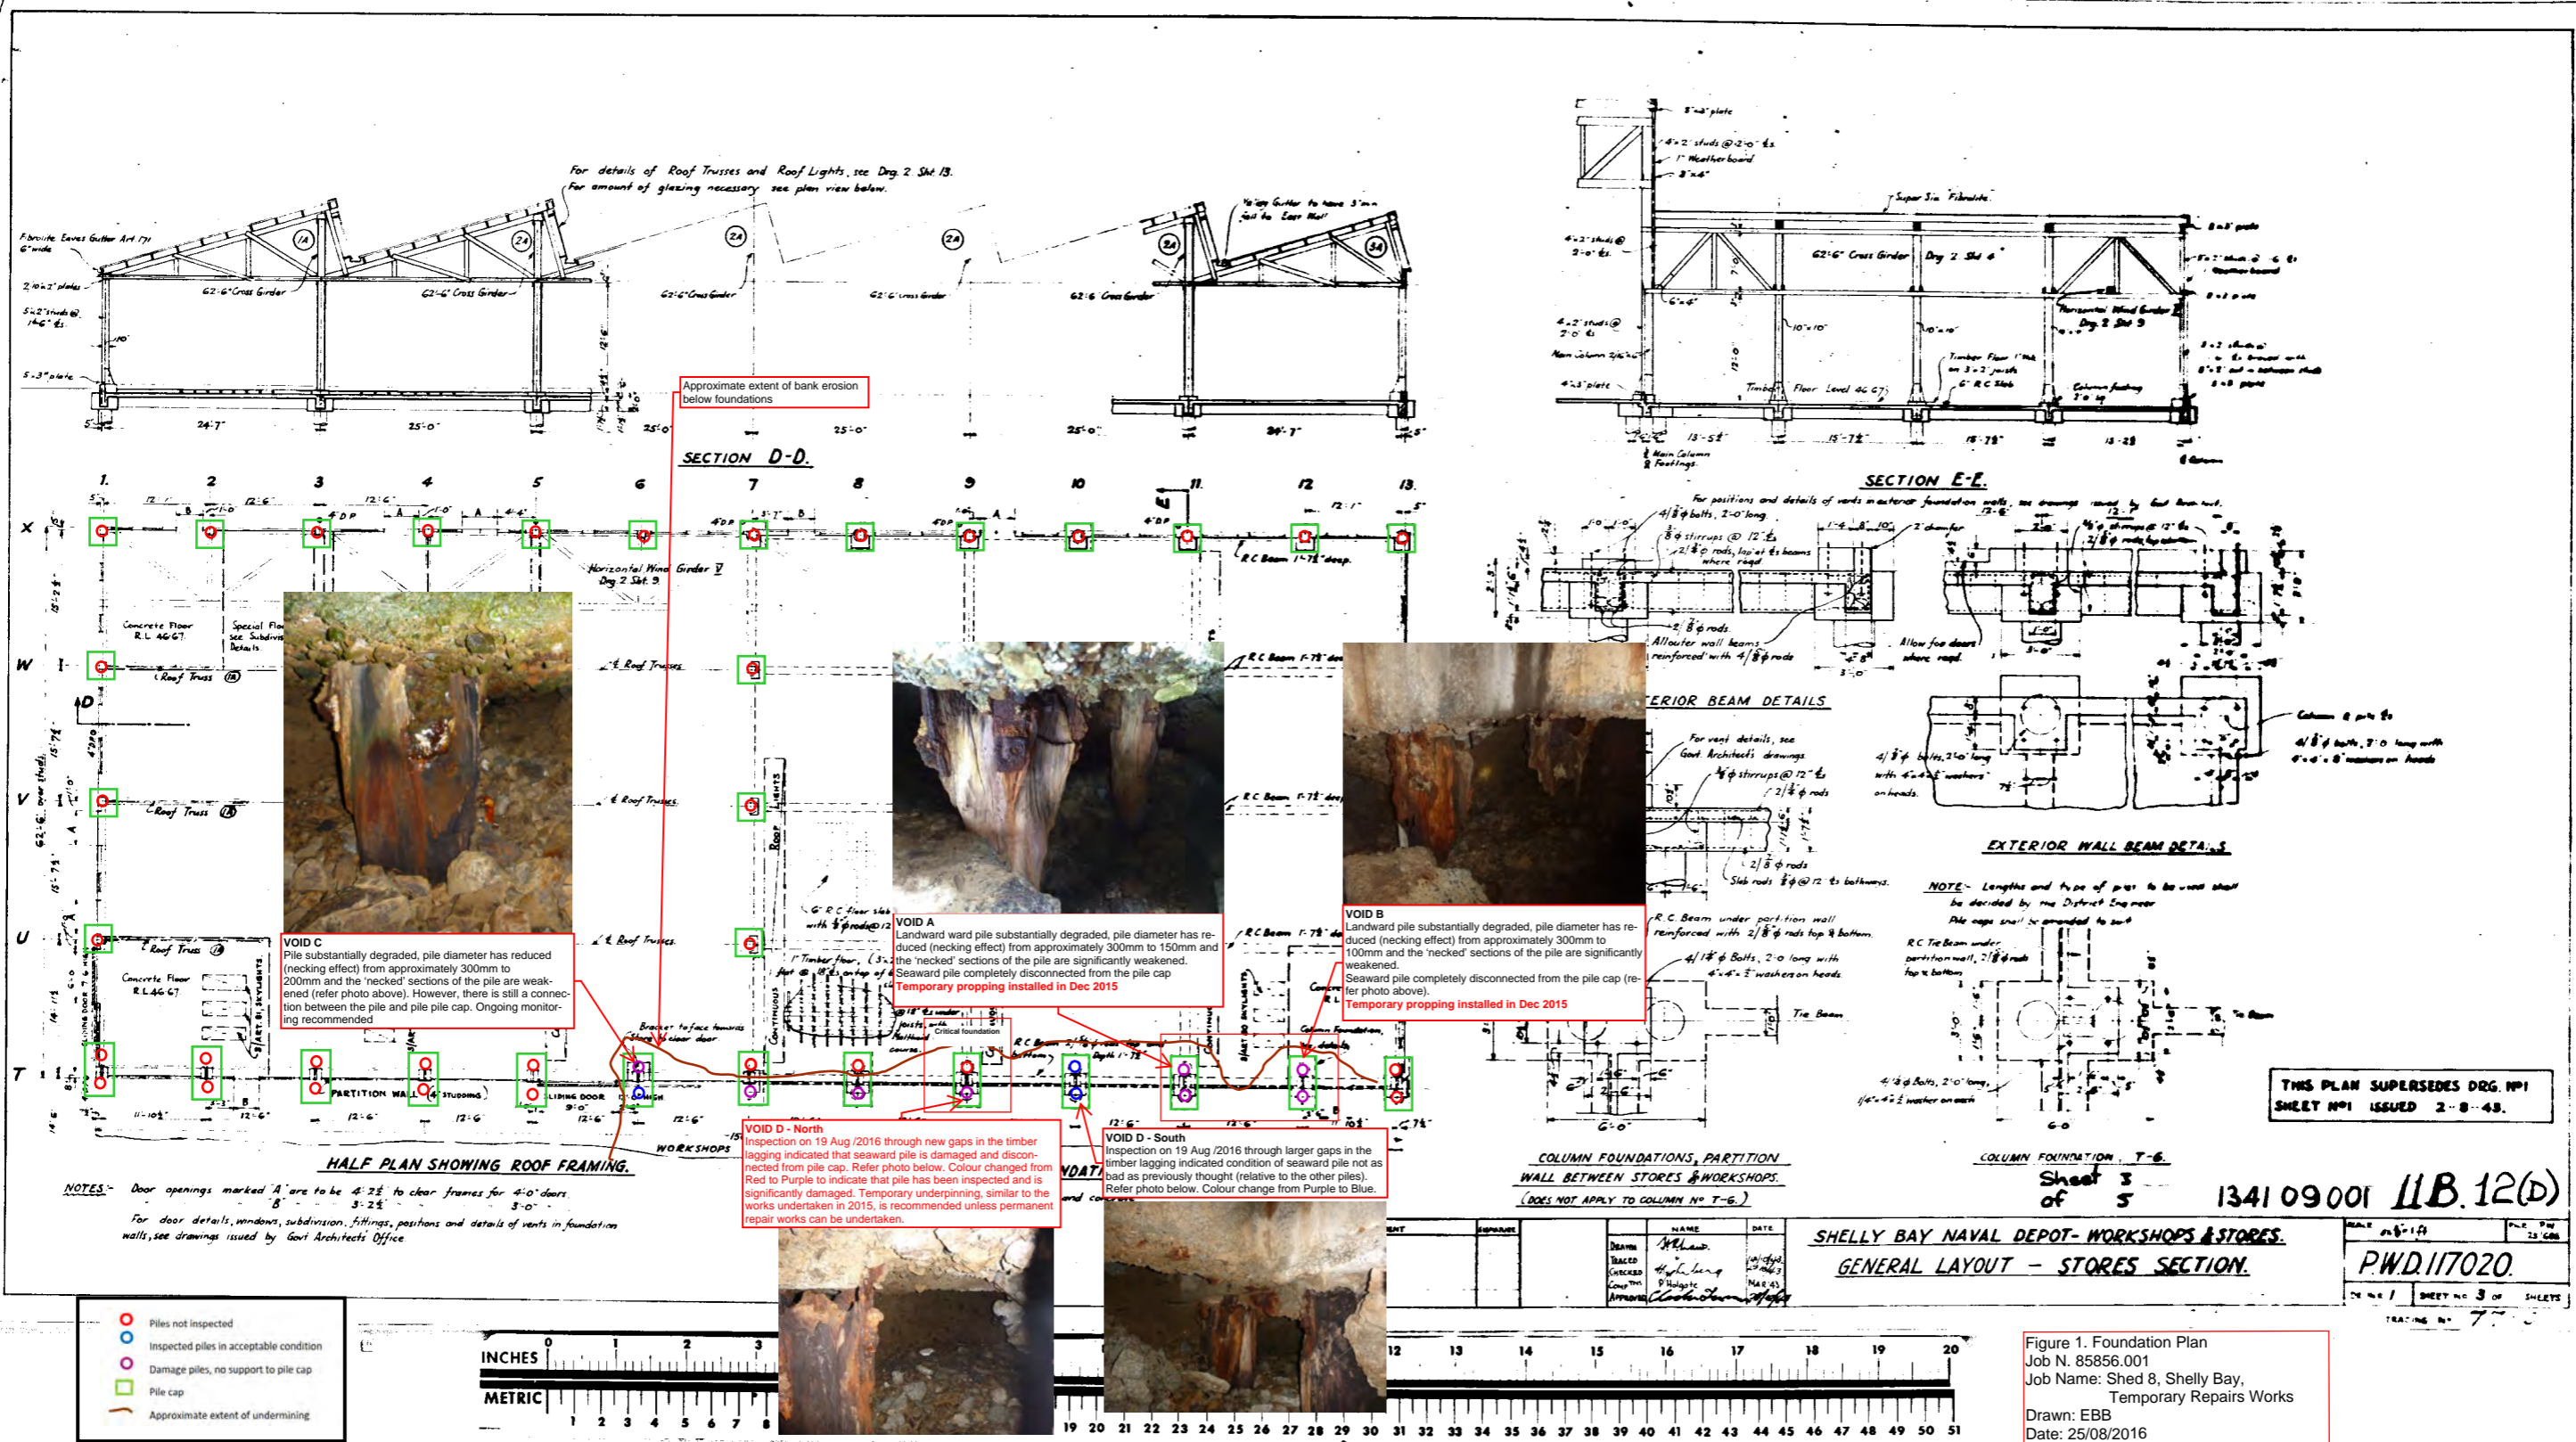
Figure 1: Foundation Plan  
 Job N. 85856.001  
 Job Name: Shed 8, Shelly Bay,  
 Temporary Repairs Works  
 Drawn: EBB  
 Date: 25/08/2016

- No evidence of any further undermining of the foundations except for damage observed in Void D as indicated in T+T Shelly Bay Shed 8, August 2016 Update and T+T Figure 1 Foundation Plan dated 25 August 2016 – both attached. New props were not installed by WCC and this recommendation should be considered by WCC depending on the timeframes to any repairs and on the proposed building use/ access.
