Slope Stability Review

Kiwi Point Quarry

Ngauranga Gorge

Wellington

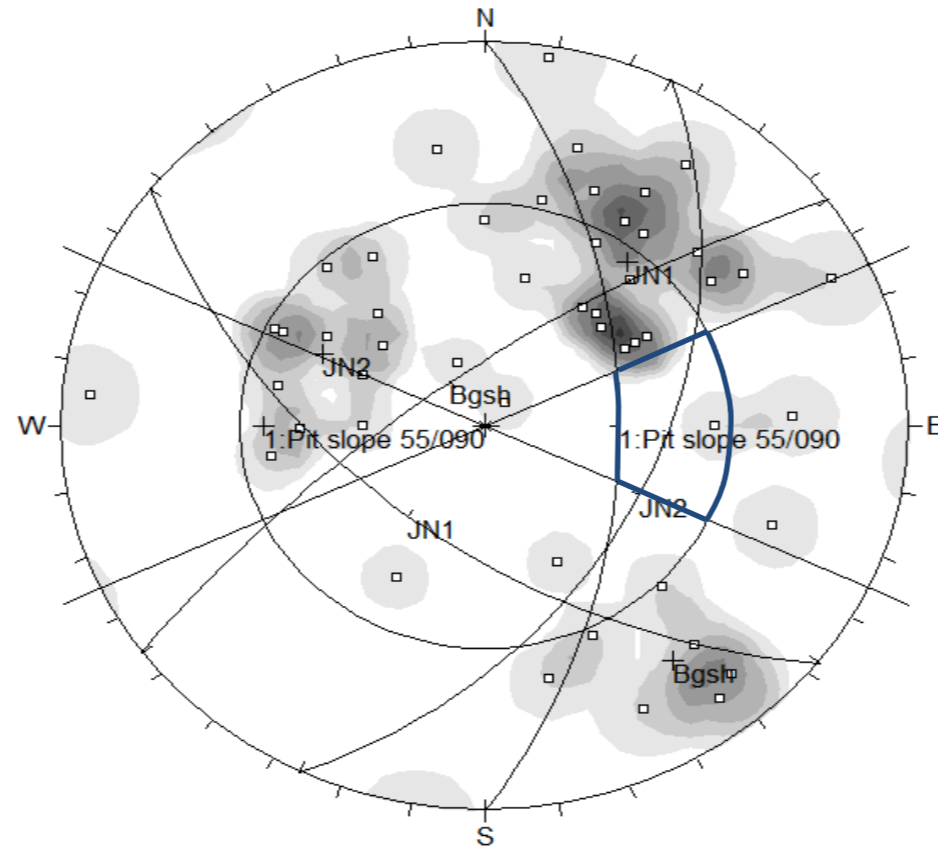
Control on Stability: High potential for planar failure for cut slopes with 55° batter angle and East orientation

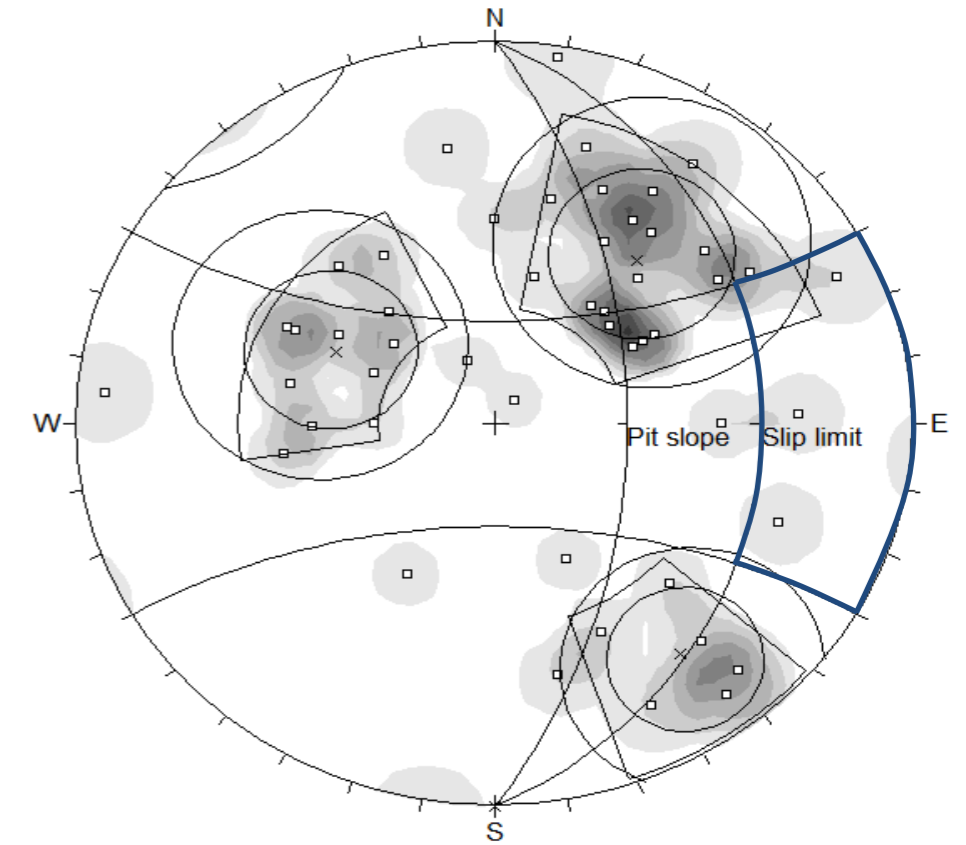
Control on Stability: Low potential for wedge failure for cut slopes with 55° batter angle and East orientation

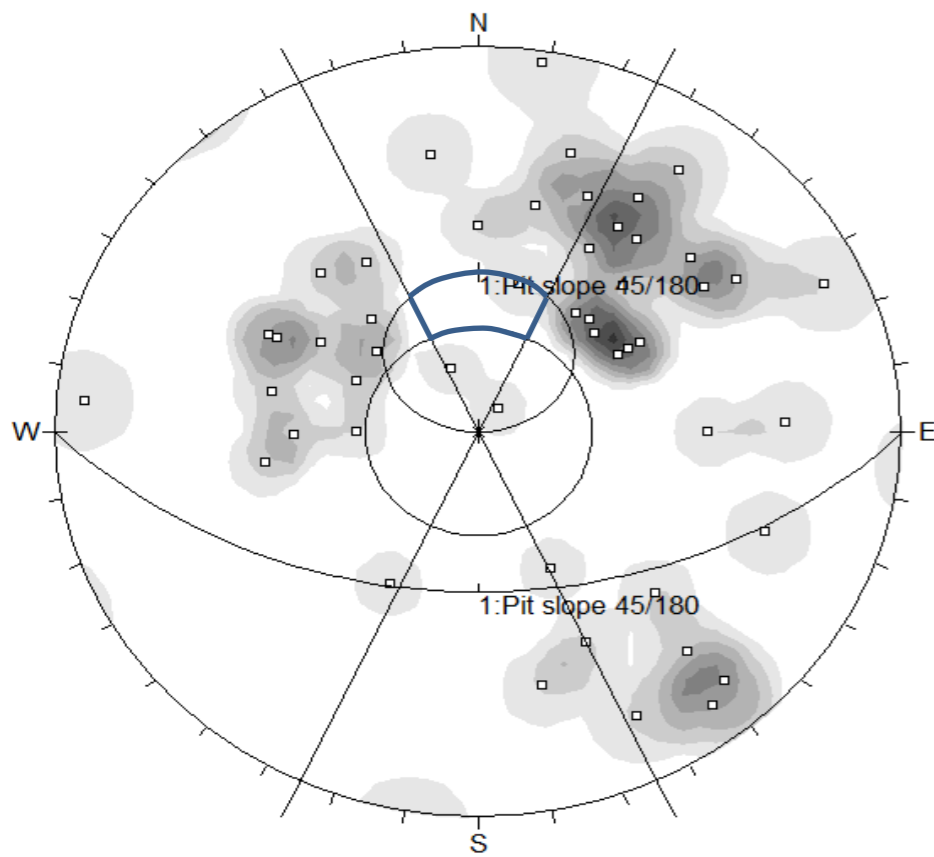
Control on Stability: Low potential for planar failure for cut slopes with 45° batter angle and South orientation

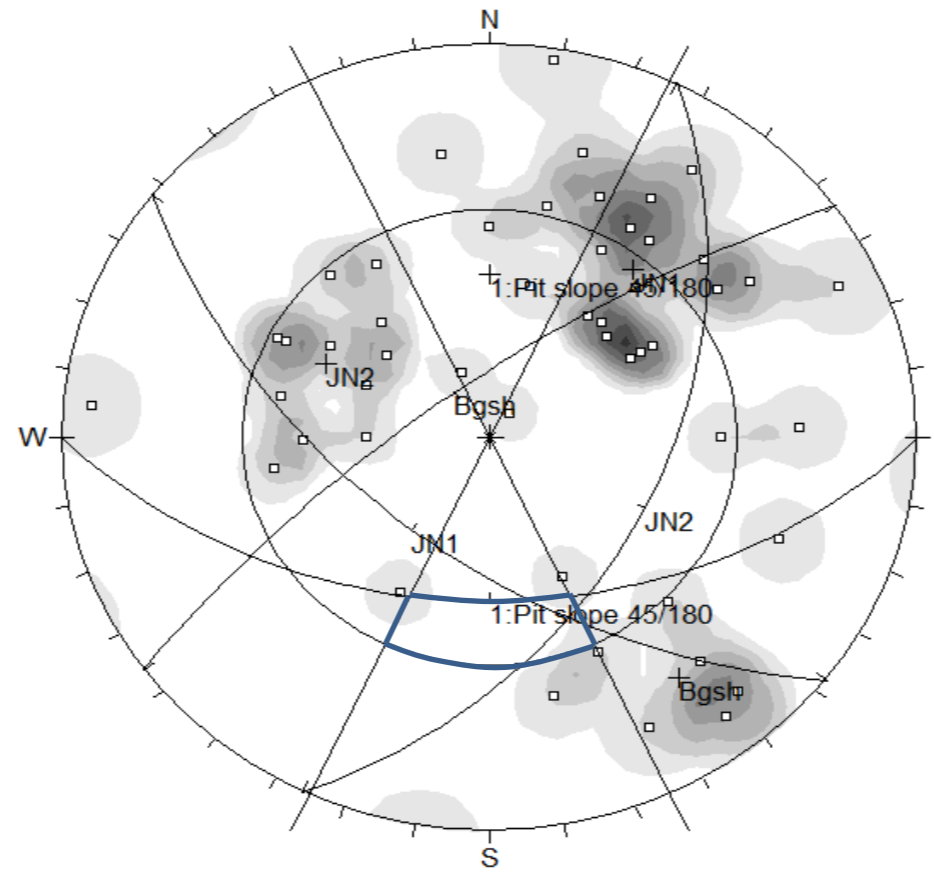
Control on Stability: High potential for wedge failure for on joint sets JN1 and JN2 for cut slopes with 45° batter angle and South orientation

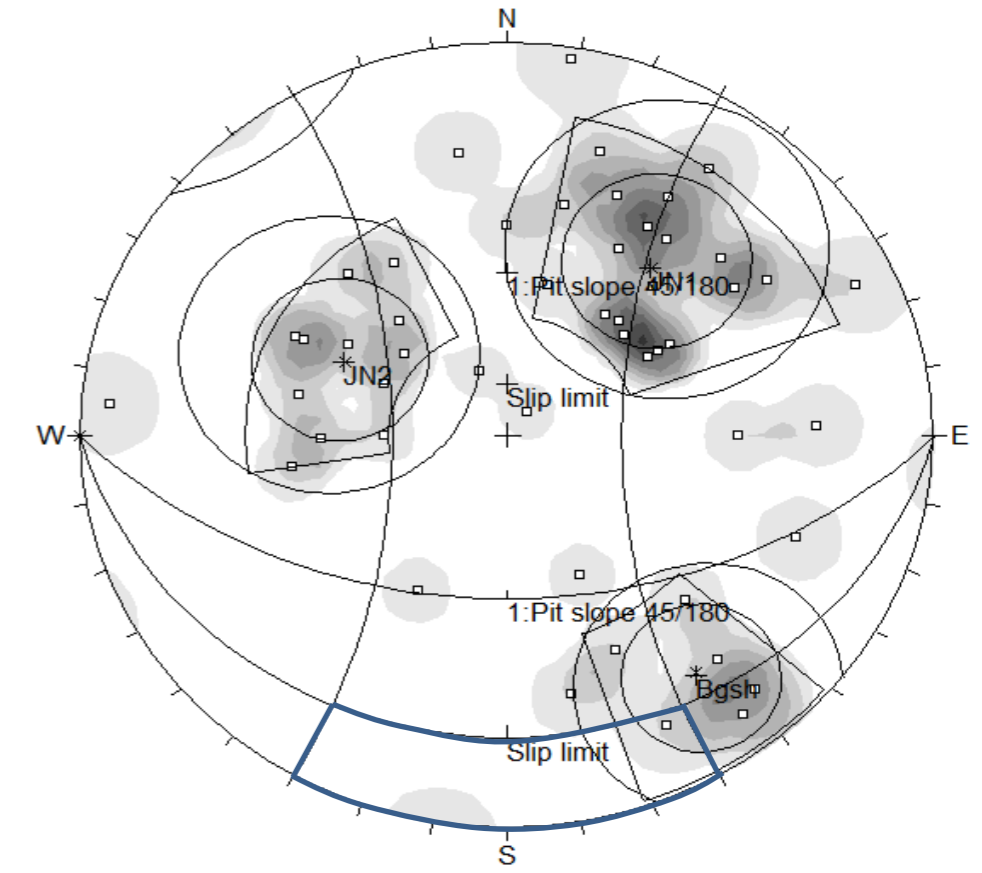
Control on Stability: Low potential for toppling failure for cut slopes with 45° batter angle and South orientation

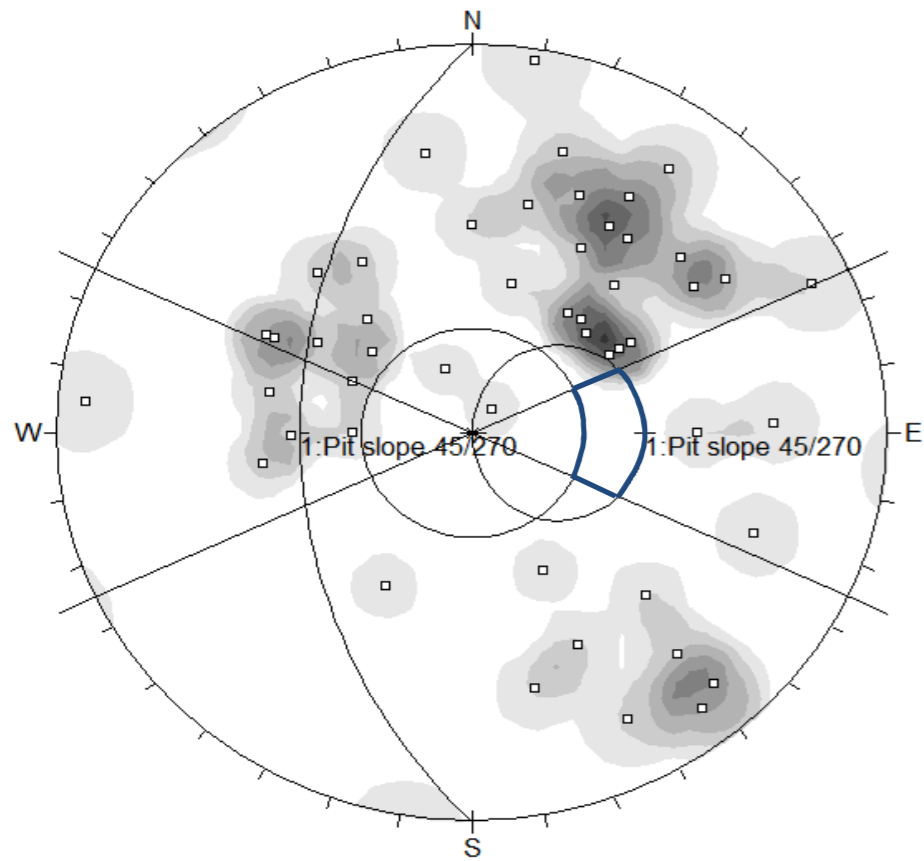
Control on Stability: Low potential for planar failure for cut slopes with 45° batter angle and West orientation

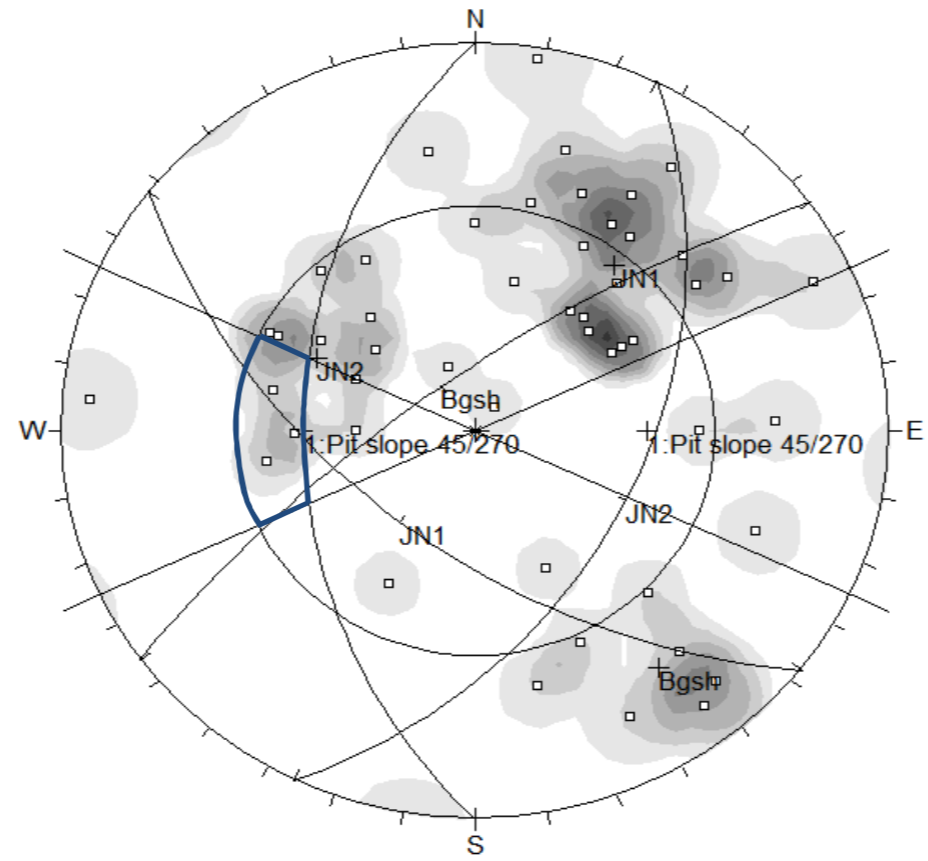
Control on Stability: Low potential for wedge failure for cut slopes with 45° batter angle and West orientation

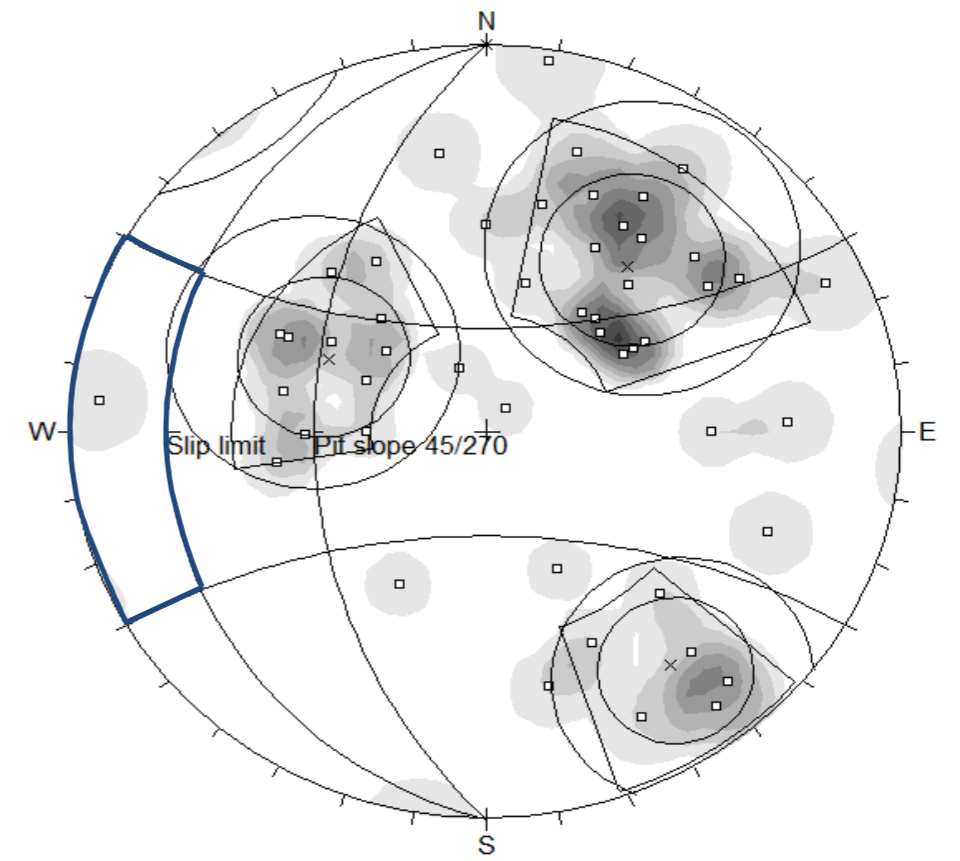
Control on Stability: Low potential for toppling failure for cut slopes with 45° batter angle and West orientation

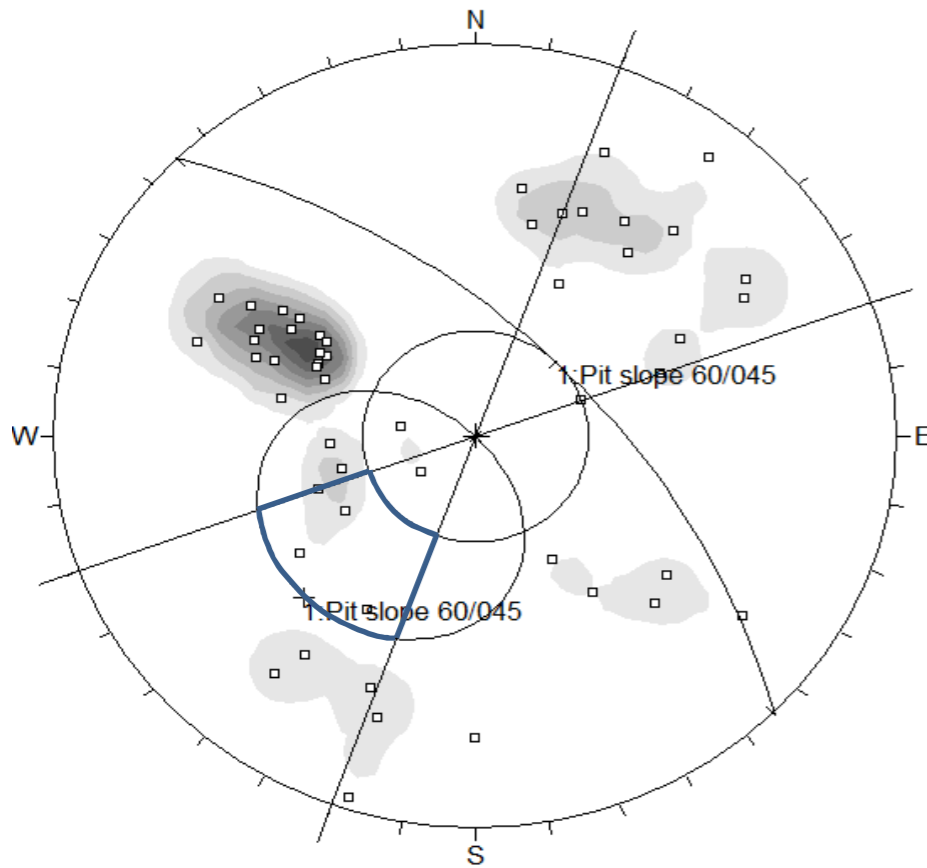
Control on Stability: Moderate potential for planar failure for cut slopes with 60° batter angle and North-East orientation

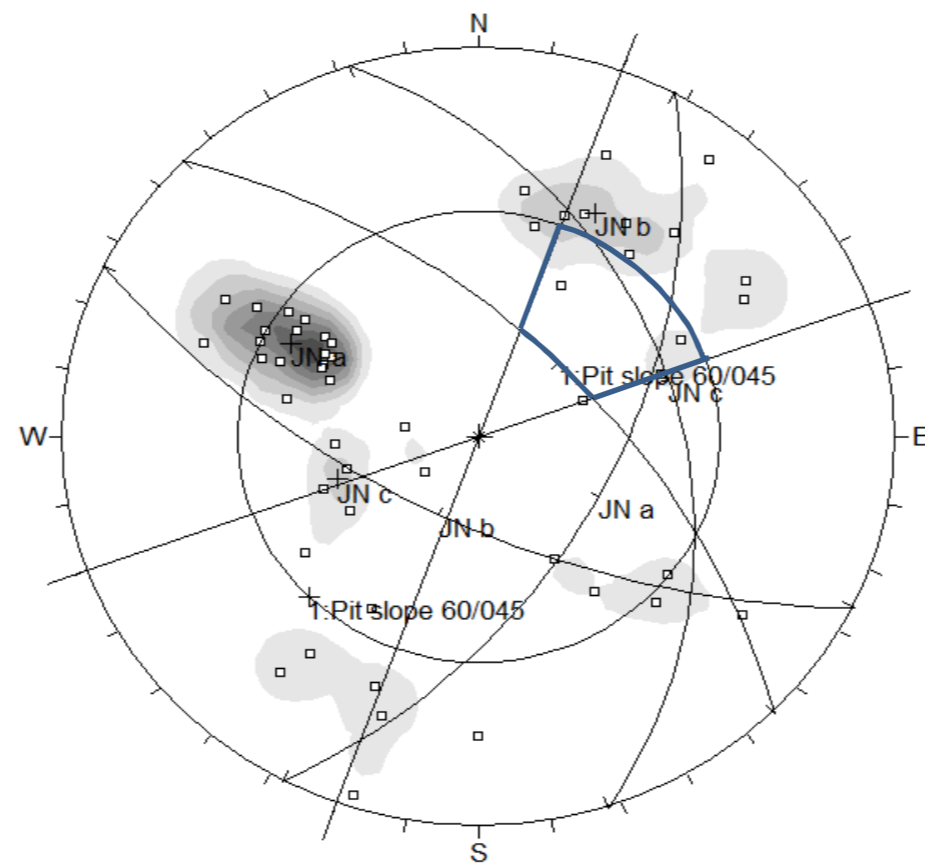
Control on Stability: High potential for wedge failure on joint sets on JNa and JNc for cut slopes with 60° batter angle and North-East orientation

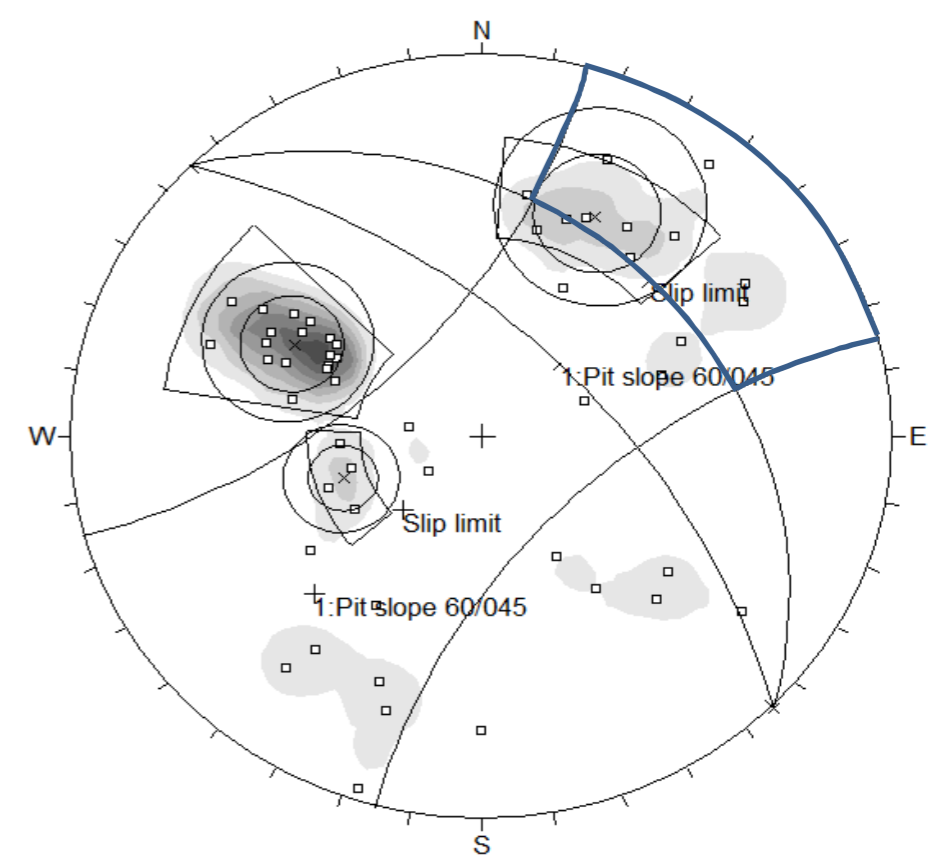
Control on Stability: High potential for toppling failure for cut slopes with 60° batter angle and North-East orientation

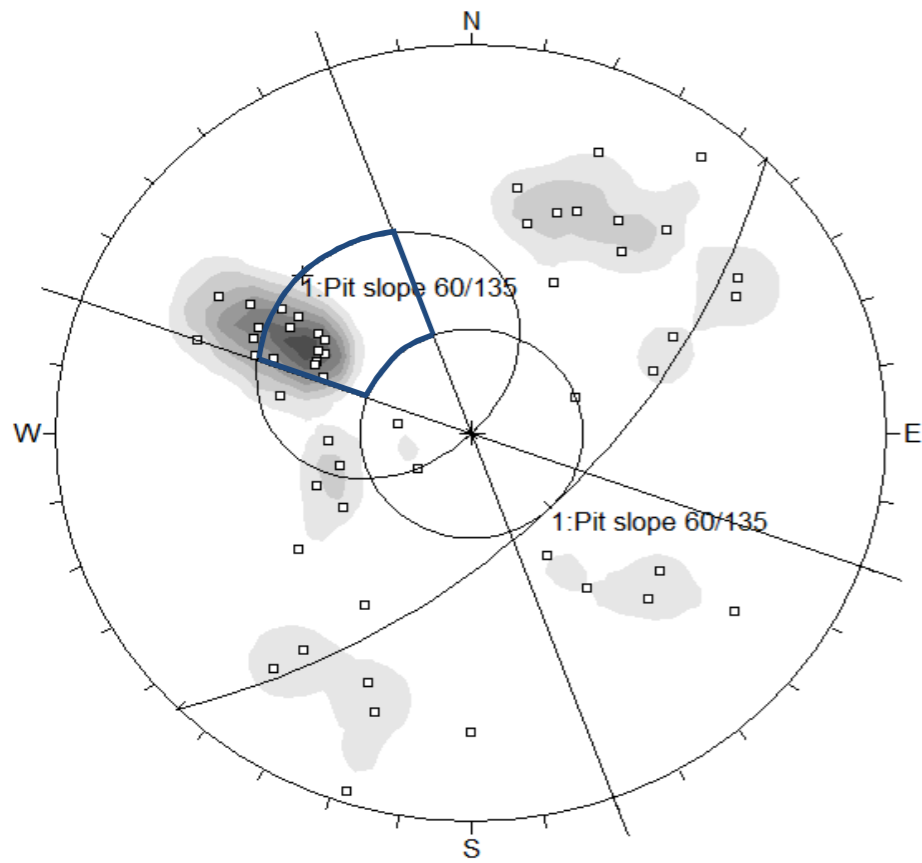
Control on Stability: High potential for planar failure for cut slopes with 60° batter angle and South-East orientation

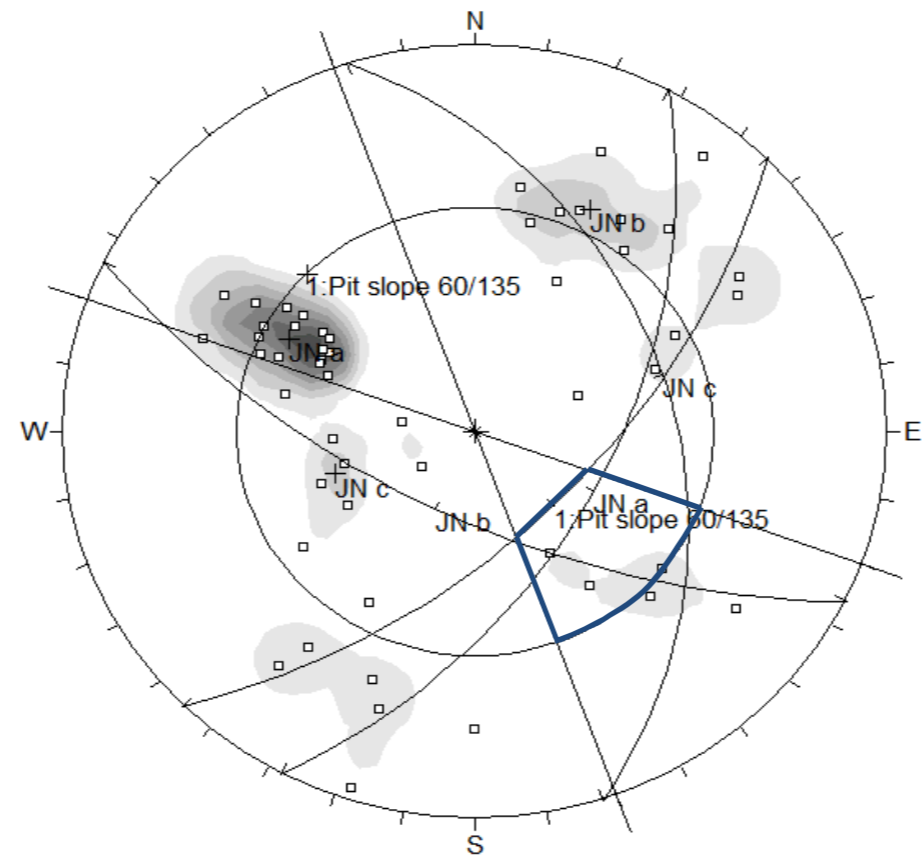
Control on Stability: High potential for wedge failure on joint sets JNa and JNb for cut slopes with 60° batter angle and South-East orientation

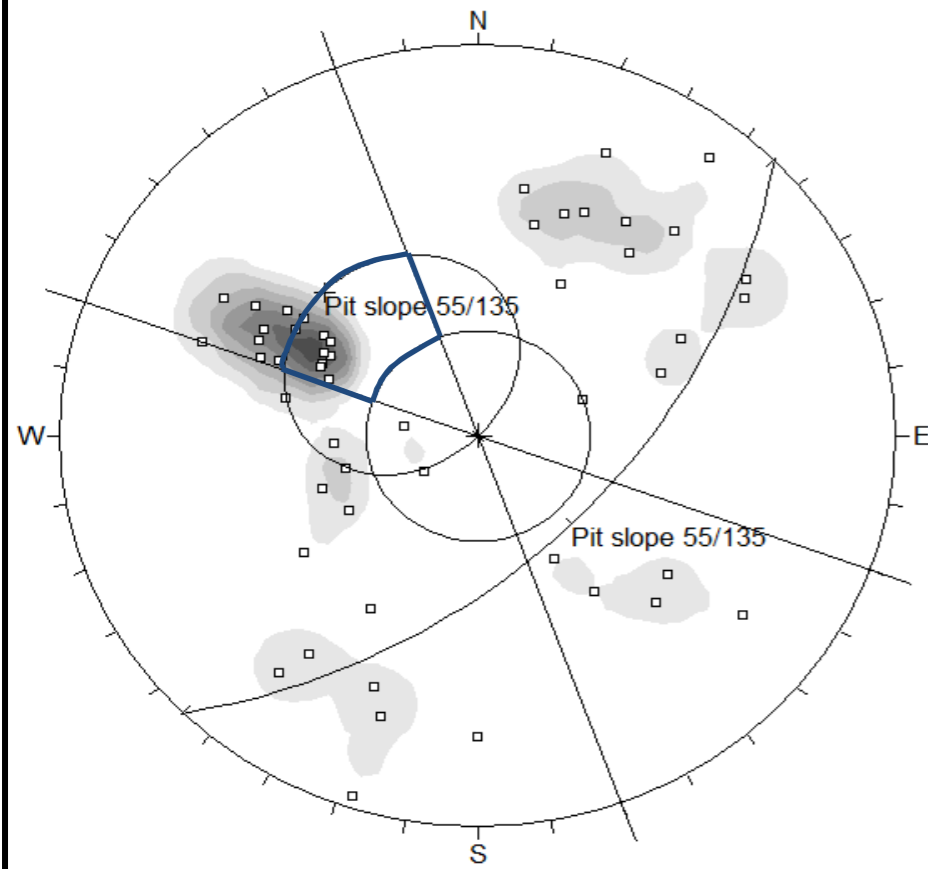
Control on Stability: High potential for planar failure for cut slopes with 55° batter angle and South-East orientation

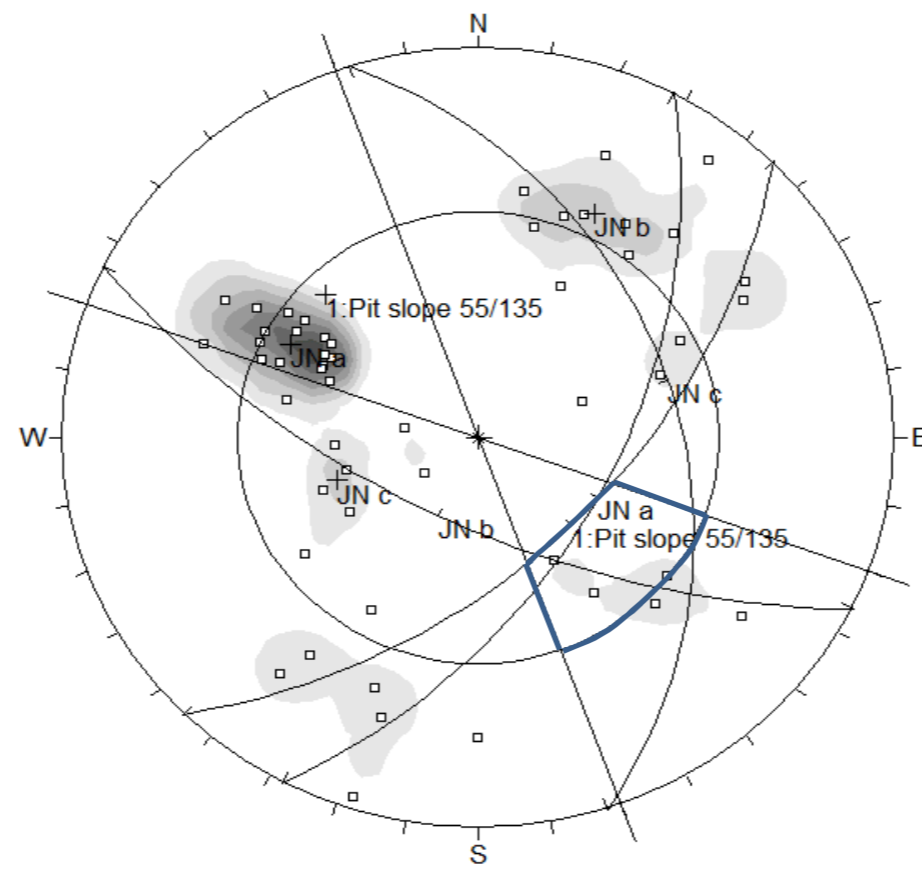
Control on Stability: High potential for wedge failure on joint sets JNa and JNb for cut slopes with 55° batter angle and South-East orientation

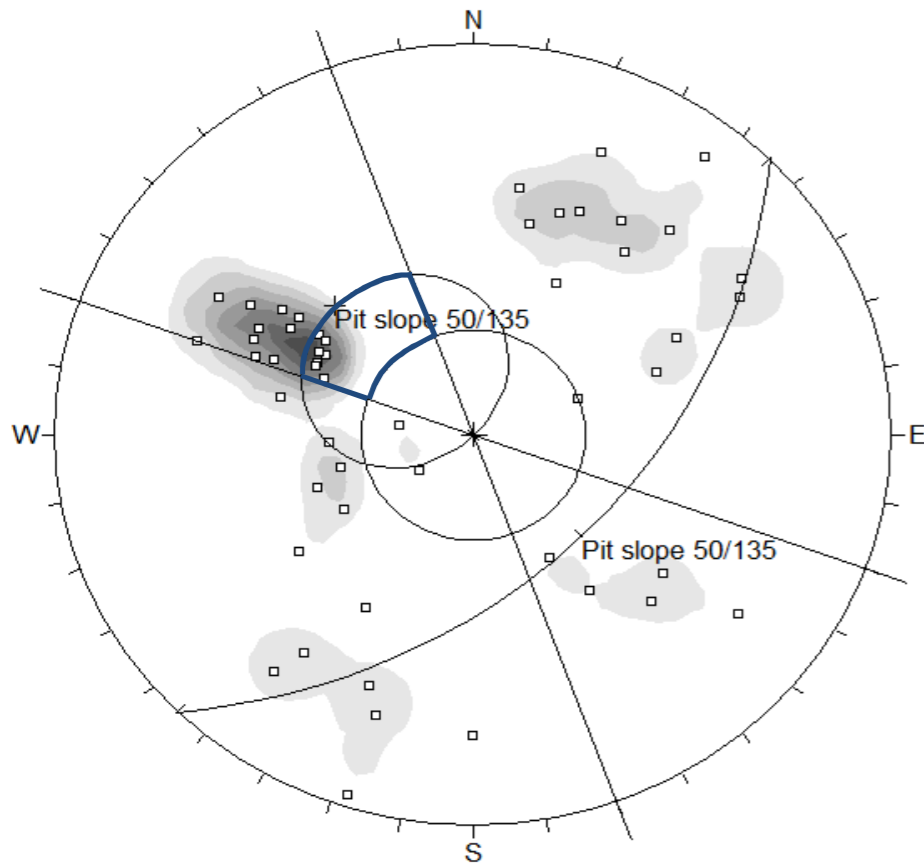
Control on Stability: High potential for planar failure for cut slopes with 50° batter angle and South-East orientation

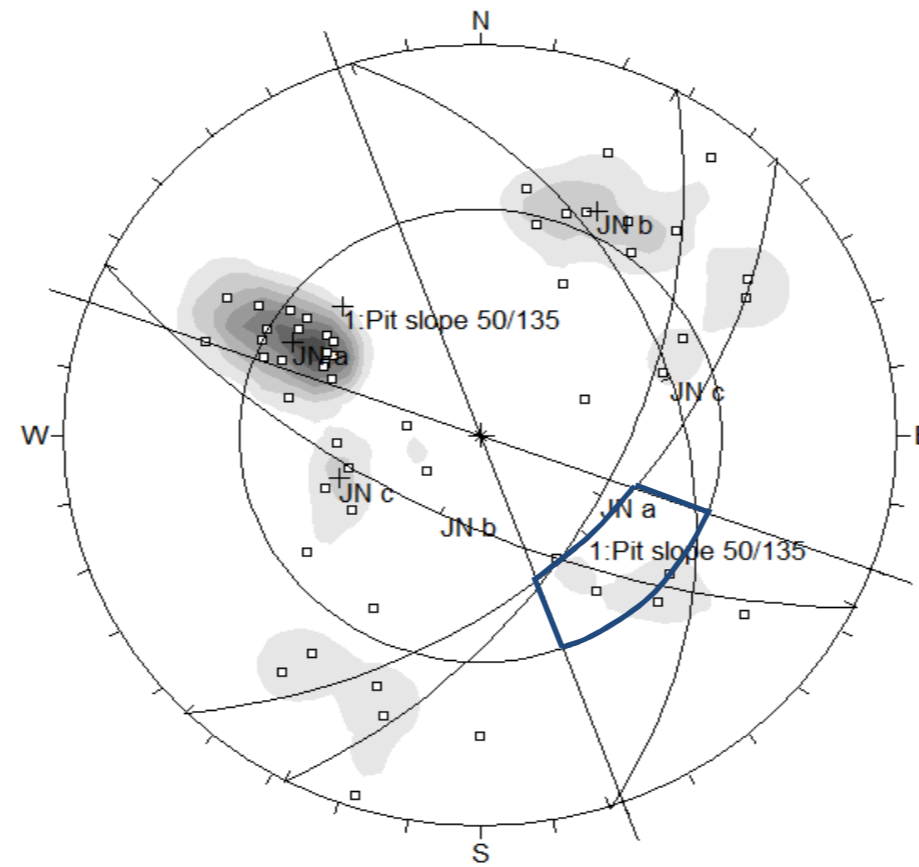
Control on Stability: Moderate potential for wedge failure on joint sets JNa and JNb for cut slopes with 50° batter angle and South-East orientation
