16 September 2022 File ref: IRC-3738

To get a copy of the report or whatever paperwork for 350 the Terrace retaining wall? Is it a council wall?

Wall Inspection:

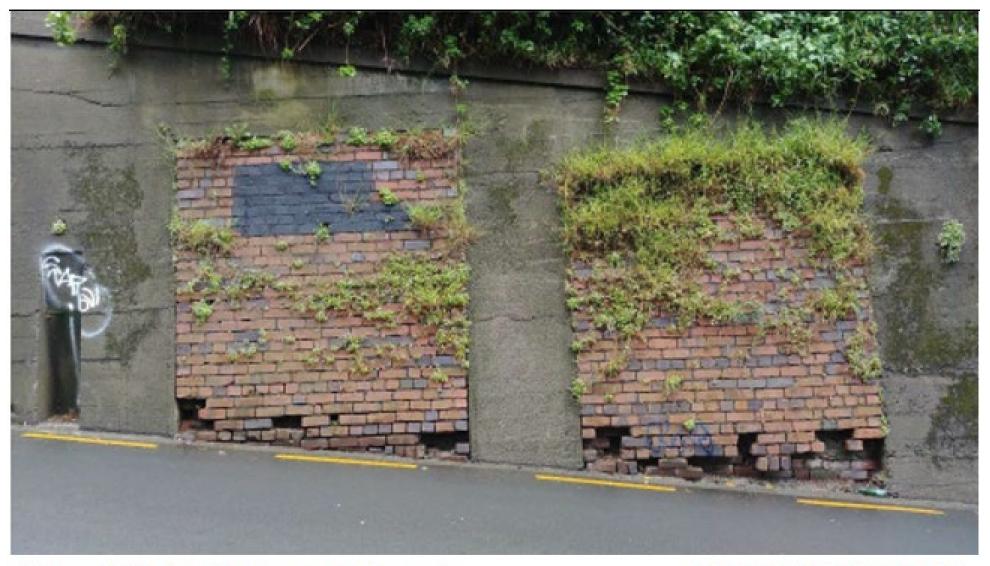
Address: THE TERRACE, OS 348

Asset I.D	Location	Wall Type	Defect	Component	Defect Condition Rating	Overall Condition Rating	Risk Rating	Max Height	Length	Remedial Option	Estimated Construction Costs	CPEng Engineer PS1 Required
647	THE TERRACE	Mass Gravity	Loss of Mortar	Facing	4	4	M	3.6	35	Remove brick facing and reinstate with engineered wall	TBC	Yes

Photograph 12 - Asset 647: Mass gravity, loss mortar
