314 The Terrace - Building Services Condition Assessment - Services

Prepared for Victoria University of Wellington

Prepared by Beca Ltd (Beca)

8 May 2015

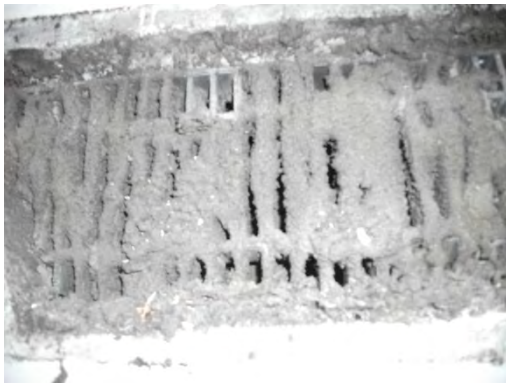
VENTIATION 04 – Condition of intumescent fire damper behind apartment bathroom extract grille

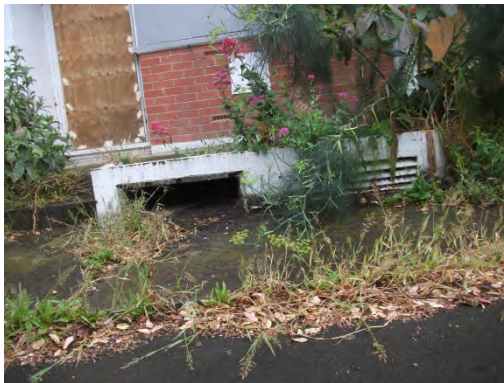
The ground level subfloor ventilation grilles are of metal construction and are in poor condition. These need to be replaced. Refer image VENTIALTION 10.

VENTIATION 10 – Subfloor ventilation openings

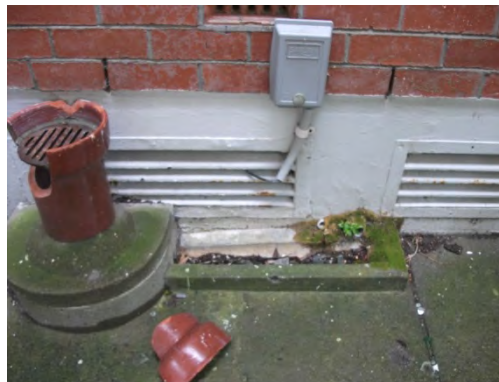
The current external gully traps are prone to damage and additional protection is needed. The associated drainage half channels need to be kept clear of debris to ensure correct operation. Refer image P&D 1

P & D 11 – West side gully trap and drainage channel

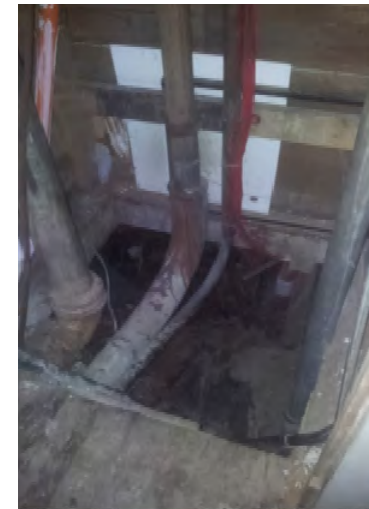
Cast iron drains are prone to corroding from the inside out and are unable to accommodate significant movement without fracturing. The existing cast iron soil stack should be replaced with modern materials. Refer image P & D 14.

P & D 14 – Typical; pipework at base of drainage stack

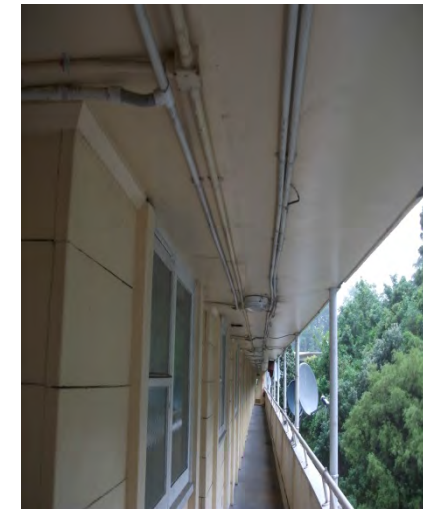
It is noted that the apartments on the south side of the building are feed by new PVC insulated sub-mains installed within surface mounted conduits installed along the ceiling of the walkway to each apartment. Refer image E 06.

E 06 – Typical power & communications distribution to apartments

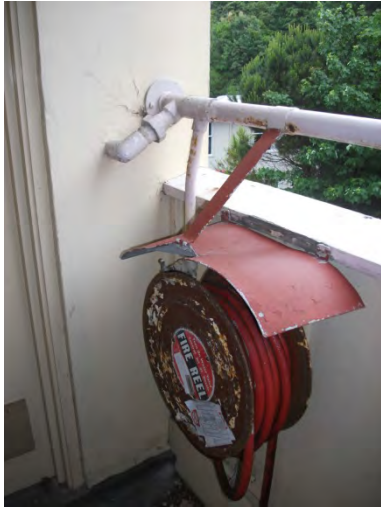
The FHR water supply system appears to have had some sections replaced with copper, indicating that the pipework has corroded internally. The entire FHR pipework reticulation should be replaced to avoid potential pipework failure in the future. Refer image FS 01.

Zinc plated mild steel hose reel assemblies are generally located outdoors; a good number of are in various states of damage due to corrosion. Refer image FS-01 in the appendix.

FS 01 – Highly corroded mild steel hose reel assembly, located within the balcony.

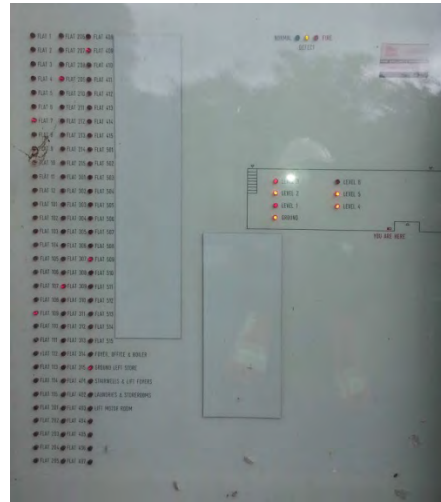
- Zone index (mimic) integrated with a Firetronix control unit (rear accessed), including automatic brigade call-out facility. We understand that the panel is now obsolete, without readily available replacement parts. During our visit, the mimic indicated various defect/alarm conditions (see image FS-02 in the appendix), which is not surprising, given the current condition of the system.

FS 02 - Fire alarm mimic panel, indicating various alarm/defect conditions

In consideration of the life-safety function of the system, its replacement would be prudent if the building is expected to be re-occupied at some later stage.

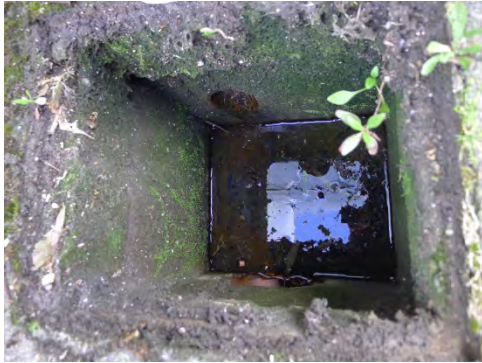
However, outside sumps that were readily accessible were inspected and were found to be not maintained and therefore were filled with leaf debris and plant growth. (Refer image CV 01).

CV 01 – Poorly maintained Stormwater Sump

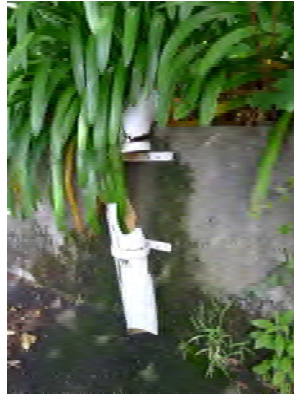
There are some areas of the storm water system that have above ground PVC pipes, many of these are broken and will need to be replaced (Refer image CV 02).

CV 02 – Broken PVC Stormwater pipe

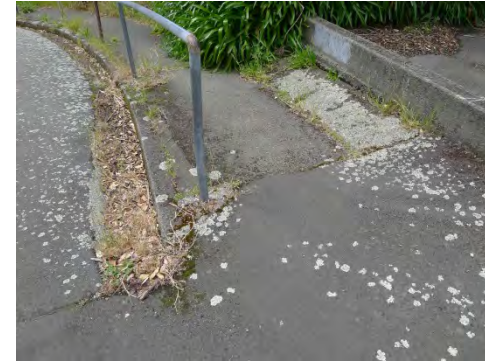
With so many wide joints in the pavement areas it is highly likely that the water has infiltrated and caused damage to the subgrade. It is therefore recommended that all asphalt areas be removed and replaced as well as any substandard subgrade areas be reconstructed.

CV 03 Uneven asphaltic pavement

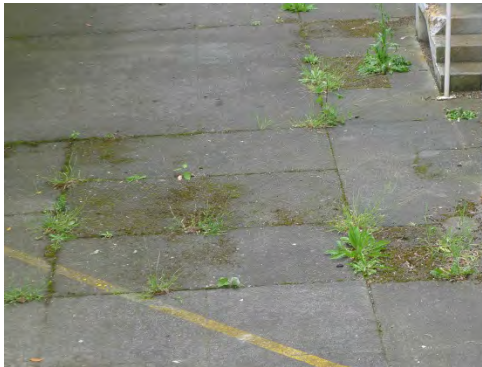
The concrete pavement needs to be replaced and likely the subgrade is in poor condition as a result of water infiltration through the joints.

CV 04 - Uneven concrete pavement

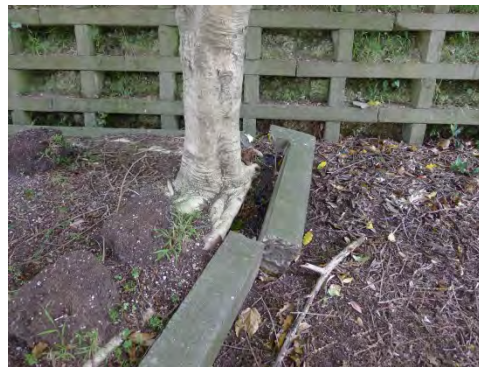
The kerbing within the site is also in a poor state. Much of the kerbing is covered with lichen and filled up with organic matter. Joints adjacent to the kerbing have opened up to allow for plant growth to occur and in some cases the kerbing is completely broken into separate sections, in particular the nib kerbs surrounding the landscaping areas. (Refer image CV 05).

CV 05 Broken kerbs

It is recommended that all kerbing be replaced.

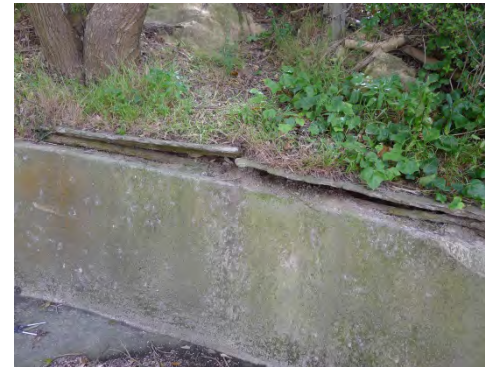
The retaining walls, particularly at the north end of the site have been damaged overtime by root growth of the adjacent trees. (Refer image CV 06).

CV 06 Damaged retaining walls

We recommend that they are replaced with new retaining walls. It would also be prudent to review the location of the walls with regard the trees to avoid root damage to the new walls in future.

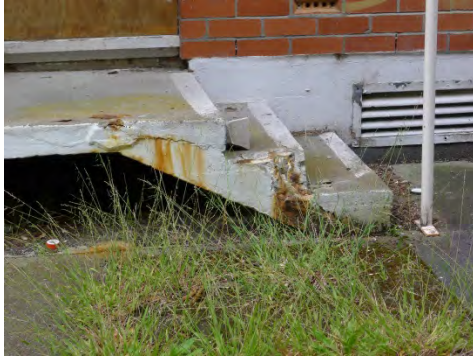
Steps are in a very poor condition with concrete spalling and reinforcing steel exposed. (Refer images CV 07 and CV 08).

CV 07 – Degraded steps

Rather than repair the steps and handrails it is recommended that they are completely replaced.

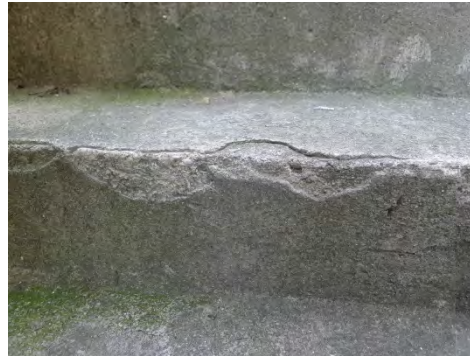
CV 08 – Spalling on steps

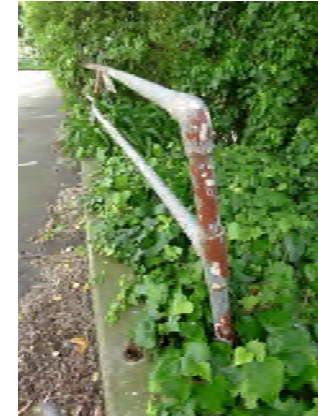
Many of the handrails are broken or completely missing. (Refer images CV 09).

CV 09 – Broken handrails
