Beca Infrastructure Ltd report on the Golden Mile Restoration Project - Stage 4 Post Construction Safety Audit and Wellington City Council response

14 July 2011

1 Introduction

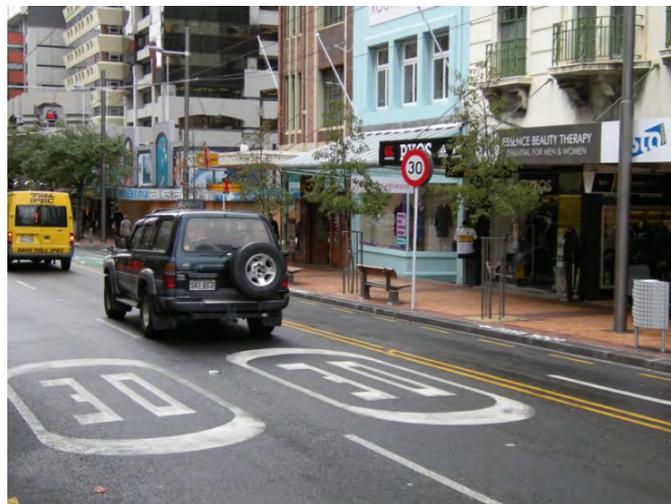
Photo 1

The posted speed limit changes between 30kmh and 50kmh at several places within the area of interest and the adjoining road network. On Willis Street the change occurred mid-block as shown in photo 1 below. The constantly changing speed limit does not appear to change at a point where there is any physical change in speed environment or that has any clear differentiation. These changes may appear random and unnecessary to drivers leading to unsafe and differential speeds in some areas.

A clear rationale for posted speed limits for the surrounding environment should be presented as an area-wide strategy and this should be clearly identified to road users through signage and gateway measures.

The full length of the Golden Mile from Lambton Quay to Courtenay Place has a speed limit of 30kmh. The change from 50kmh to 30kmh was introduced from the Mercer Street/Willis Street intersection to Courtenay Place as part of the Golden Mile improvement project. All thresholds to this restriction have 30kmh signs and red markings on the carriageway. The signs and markings identified in this Willis Street location are the old threshold markings denoting the extent of the previous speed limit restriction. These signs and markings have been kept to reinforce and repeat the new speed restriction introduced as part of the Golden Mile scheme. They will however be removed in time to provide a consistent treatment of cordon signs and markings at speed limit change points.

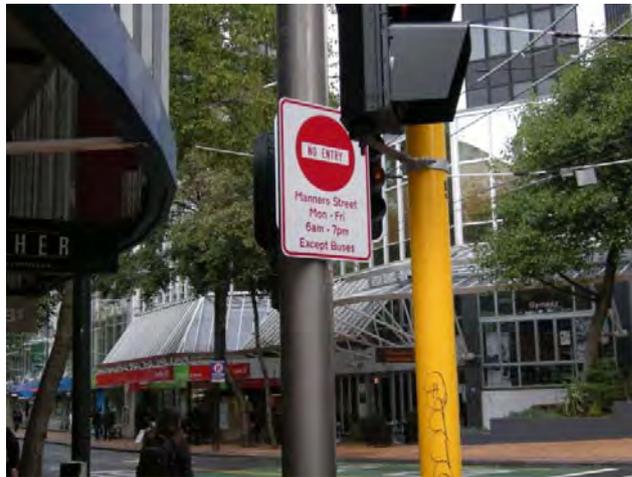
Photo 4

Operation of bus lanes normally allow for cyclists and motorcyclists to use them. The signs specifically state 'Buses Only' or 'Except Buses' as shown in photo 4, which excludes other users such as cyclists and motorcyclists. However, this could be open to misinterpretation and some cyclists may use these roads and put themselves in an environment that may be unsafe for them to operate.

Consider the provision of signage to advise cyclists and motorcyclists where they are not permitted.

Many of the bus lanes along the Golden Mile are 'Bus Only' and when they are operating exclude cyclists, motor cyclists and other vehicles. This is because of the high number of buses and safety concerns if others were to use these lanes, which are predominantly contra flow. Lanes marked as 'Bus Lane' are available for cyclists, motor cyclists and other special vehicles, such as on Lambton Quay. Signs to inform these users have only been used outside the central city at this stage. The situation will be monitored and, if appropriate in the future, signs will be erected to advise users.

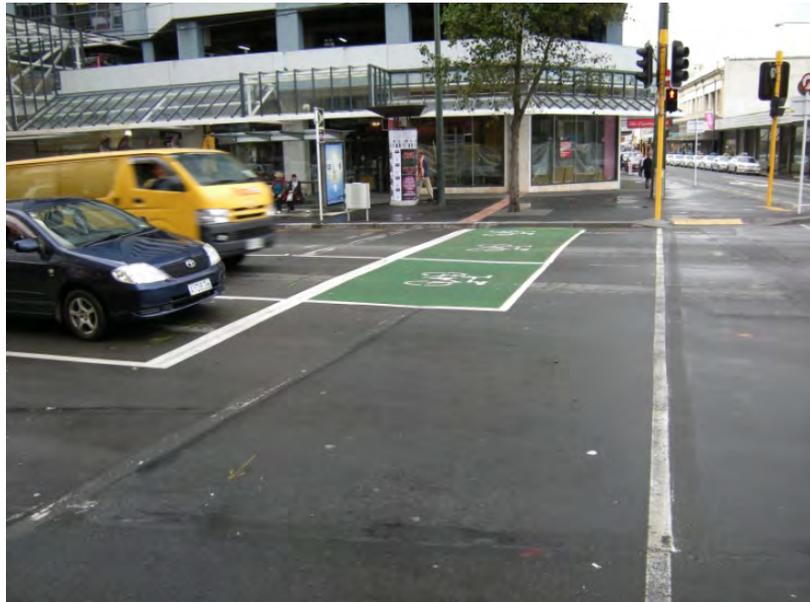
The use of cycle road markings is only provided at one location within the scheme. A general lack of cycle guidance was noted. The limited guidance provided does not give cyclists clear direction through the road network and may lead to inappropriate use. Photo 5 shows cycle markings provided.

Consider developing guidelines to provide a consistent level of cycle provision within the scheme and on the surrounding road network within the city.

Provision for cyclists, particularly in the form of cycle stop boxes, is provided on the fringe of the Golden Mile and in the wider road network, eg the location shown in photo 5. Because of the constraint caused by tight road geometry and dispersed nature of cycling on inner city streets, no on-road cycle facilities are provided. As this project is on the core Golden Mile route there are, by design, no special cycle facilities.

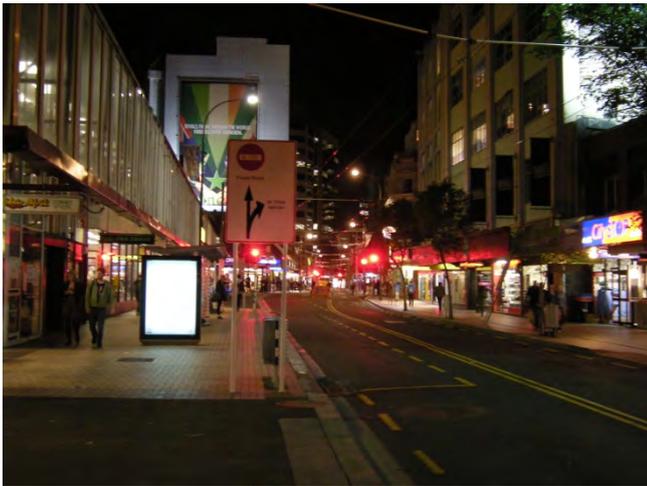
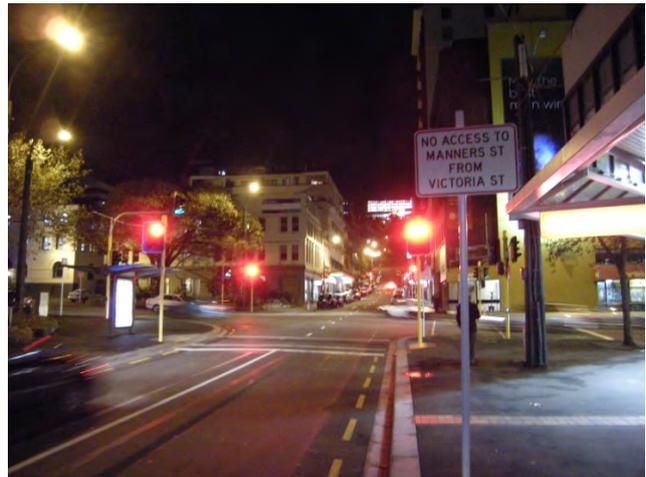
The night site visit revealed a number of signs that were not clearly visible in the dark, as indicated in photos 6 and 7. This was largely because they were not reflectorised. These included regulatory signs barring vehicles from bus lanes. This could lead to misuse of lanes and conflicts between buses and other vehicles.

Check signs and, where appropriate, signs and backing should be replaced with approved reflective material.

All signs installed have been manufactured with approved reflective material. Signs will be checked and, where there is poor ambient light, signs will be upgraded to a higher grade of reflectivity.

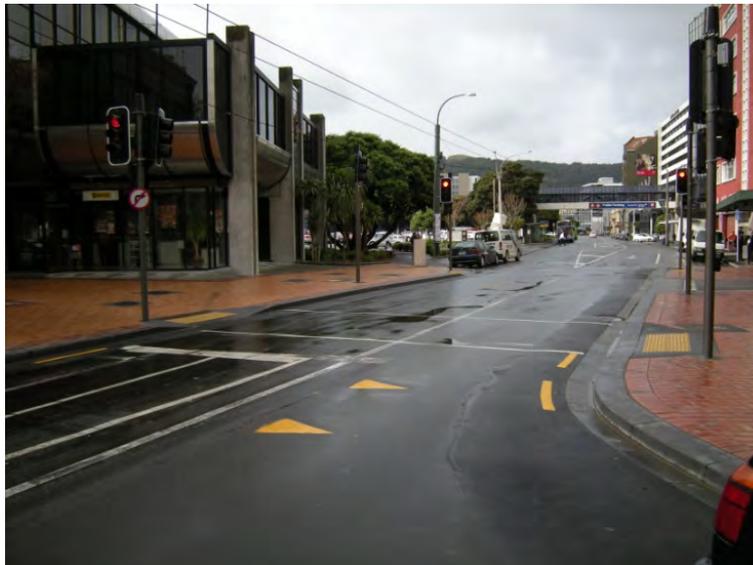
Photo 8

Part of the scheme has regulatory signs mounted on grey poles that detract from their visibility and could result in drivers not having sufficient time to observe, read and then act appropriately on the sign's message. The use of grey poles is shown in photo 8.

Regulatory signs could be mounted on appropriately coloured poles consistent with the adjacent road network. Typically regulatory signs are mounted on white poles and traffic signals on yellow poles, ie Dixon Street signs are mounted on yellow poles, which give the appearance of being more visible.

To reduce visual clutter all poles have been painted blast grey. We see poles as primarily a vehicle to support signs and other traffic infrastructure. Similarly with traffic signals, we believe the lanterns are the primary message for motorists.

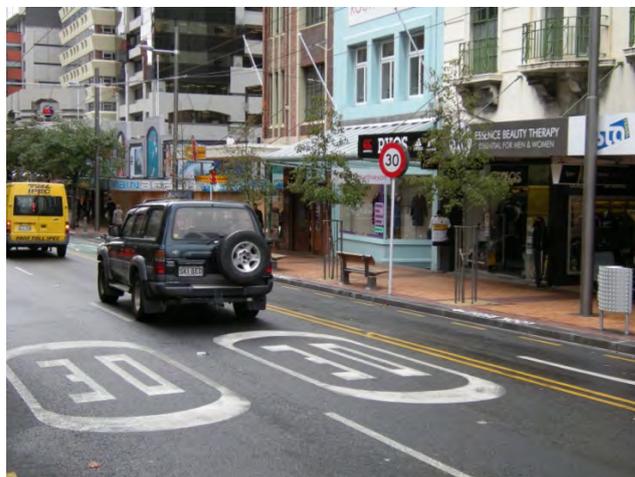
Photo 9

The 30kmh speed limit is reinforced with road markings. In some areas a red surfacing has also been used in conjunction with the speed limit marking. The use of two different marking styles makes it difficult for road users to easily recognise the environment in which they are travelling and may lead to some confusion. 30kmh road marking on Willis Street is shown in photo 9.

The road markings are a good way to reinforce the speed limit to road users. A consistent use of the style of marking is recommended to make it easier for road users to recognise the environment in which they are travelling and process and adapt to the information being presented.

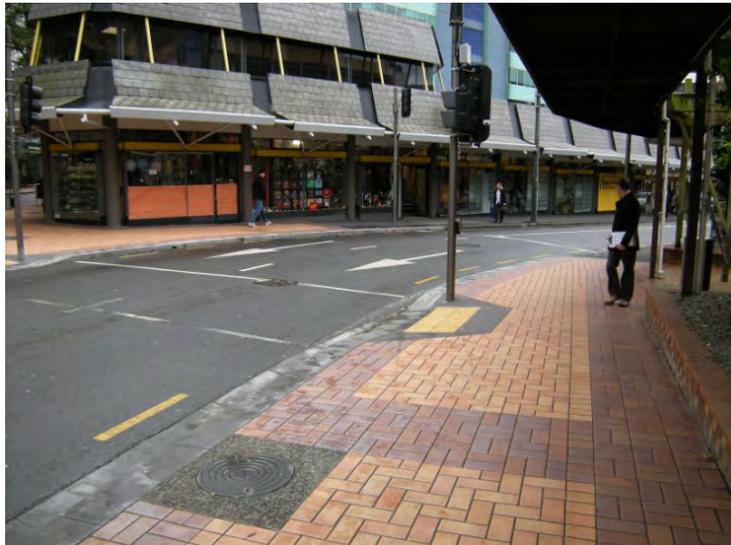
Photo 10

Victoria Street has wide traffic lanes which appear to be out of context with a 30kmh speed limit, see photo 10. Traffic was observed to be travelling at higher speeds, which matched the environment but not the speed limit.

The lanes should be narrowed with visual narrowing measures (such as narrower lane marking or threshold type signs) to provide an environment which matches the posted speed limit.

While in the past engineering works have been used to lower speed there is an increasing acceptance that speeds can be lowered using regulatory signage. This approach has been adopted by the Council as a more efficient means and, as such, threshold signs have been used on Victoria Street in advance of Manners Street to lower speeds through this intersection. This and other locations will be monitored to gauge the effectiveness of this approach over time.

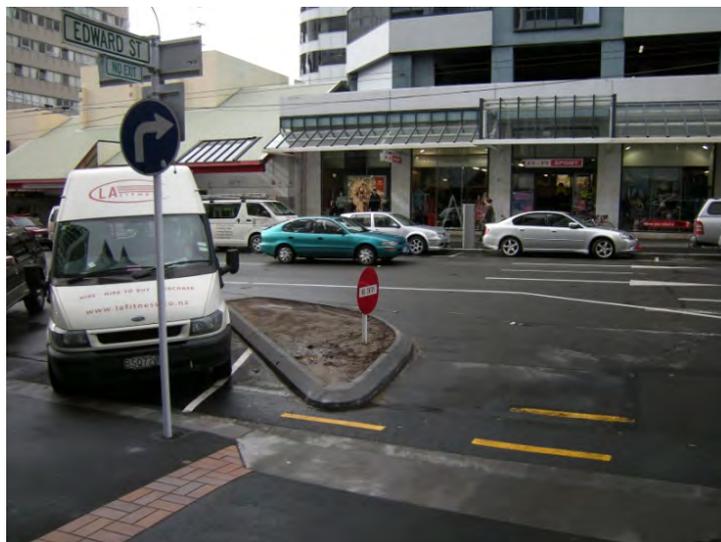
Photo 11

The exit from Edward Street onto Victoria Street is located adjacent to angle parking, where visibility to the left is obscured by parked vehicles, as shown in photo 11. The right-turn movement into the outside lane of oncoming vehicles is unsafe because of the lack of sight distance. In busy situations this observation would be more than minor, however, because of the low volume of traffic associated with the Edward Street exit. We consider this a minor issue.

Remove parking adjacent to the exit or convert to motorcycle parking which can be less visually obstructive.

We are confident the parking arrangement is workable being similar to other situations across the city. The situation will be monitored and, if the concern raised is material, then an alternative parking arrangement will be explored.

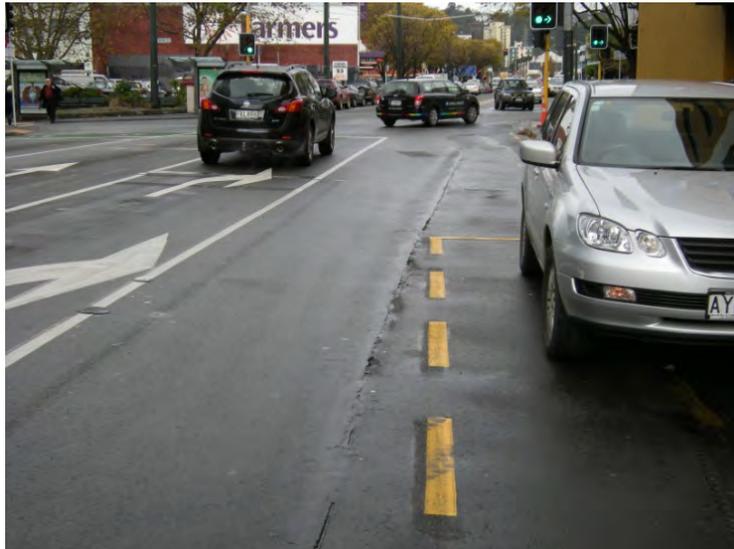
Photo 12

The northbound lane on Victoria Street, between Dixon Street and Edward Street, is not wide enough for traffic to pass a vehicle parked in the short-term parking spot located in front of the model shop, without traversing into the opposing traffic lane. See photo 12.

Remove parking area or adjust lane widths to provide minimum 2.8m clear lane width.

Road markings will be adjusted in this area to provide adequate clearance for all movements.

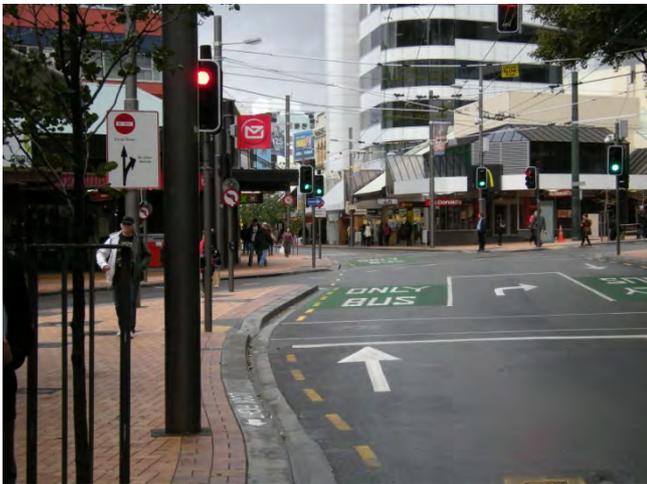
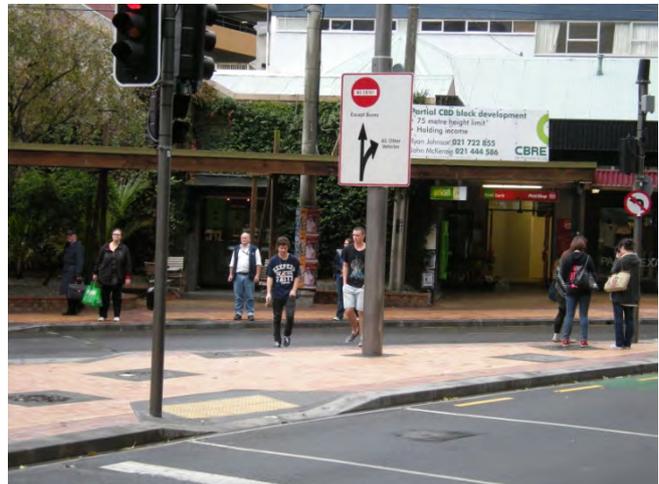
The no-left and no-right turn signs are not clearly visible because of their size and position as shown in photos 13 and 14.

The size of the signs should be increased to either 450 or 600mm and the new signs located where they are clearly visible to road users.

The signs have been positioned on existing poles to minimise clutter and reduced in size to minimise obstruction to pedestrians. The effectiveness of the signs will be monitored and, if necessary, will be repositioned or increased in size as appropriate.

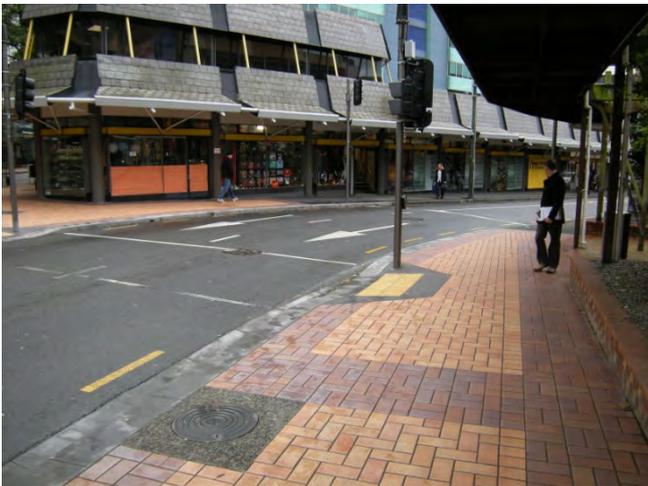
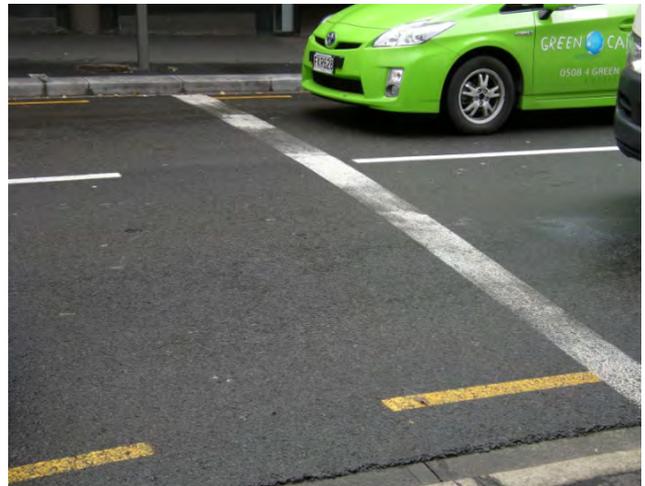
Continuity road marking lines and arrows pass through the pedestrian crosswalk area at the midblock signalised crosswalk adjacent to the intersection of Victoria and Manners streets. The limit line in advance of the pedestrian crossing is located away from the crossing point, see photos 16 and 17. The markings in this area were observed to cause some confusion as to where vehicles should queue and pedestrians cross.

Some blacked out continuity lines and walk lines have reappeared through this intersection. These will be permanently removed and existing markings refreshed or marked in thermoplastic to avoid confusion.

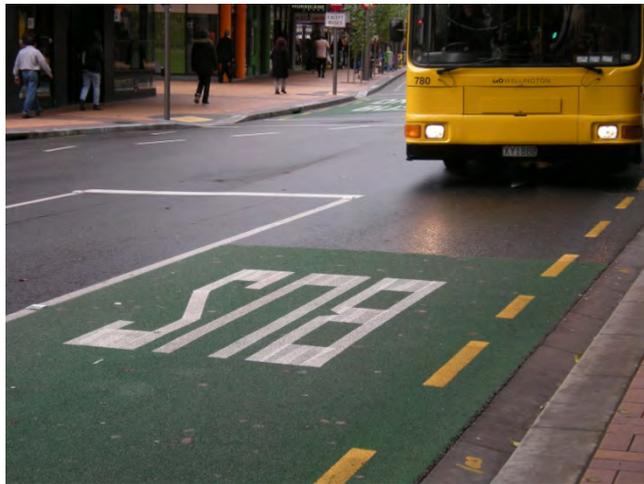
Photo 18

The Manners Street westbound traffic lane just immediately west of the Victoria Street intersection appears too narrow for buses. Buses were observed to track into the opposite lane as shown in photo 18. This could lead to head-on collisions. The lane width does not appear to match the 3.0m wide design indicated on drawing C116A.

The westbound bus lane is 3m wide through this area. The right-turn lane could be narrowed to achieve a wider westbound lane. This will be monitored and, if necessary, the lanes will be adjusted.

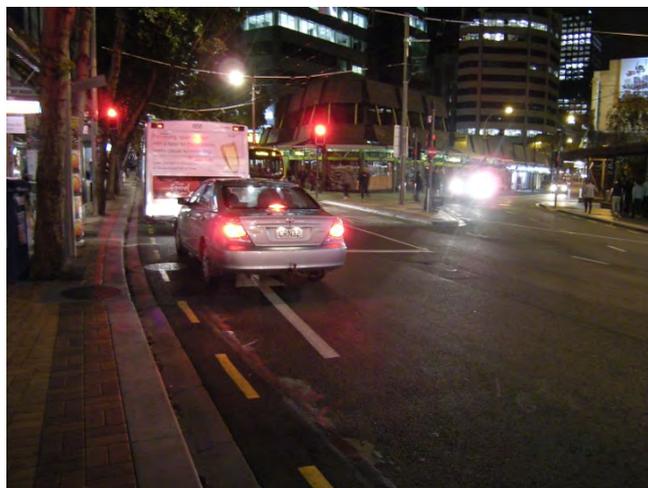
Photo 19

A number of occurrences were observed where buses on Manners Street, heading westbound from Victoria Street intersection, were found to block the pedestrian crossing on Manners Street on a green signal, making crossing hazardous, see photo 19.

Sufficient phase time is given for buses to clear the intersection. There are incidences where upstream buses loading at the bus stop cause queuing back through the intersection thus impeding progress through the intersection.

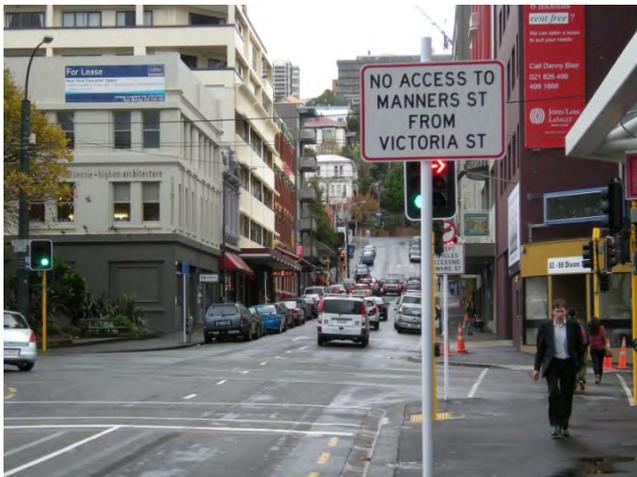
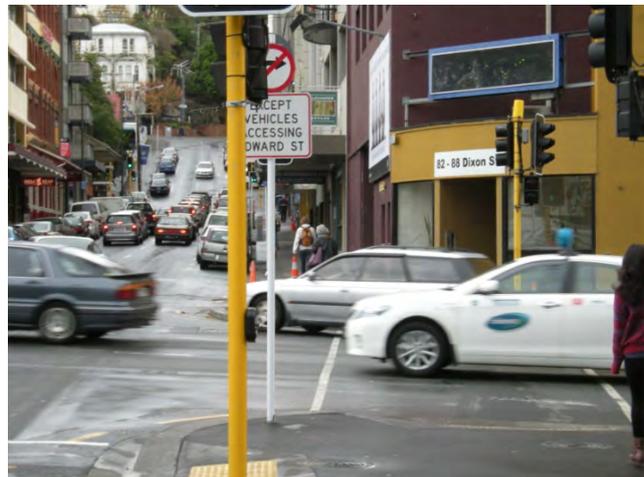
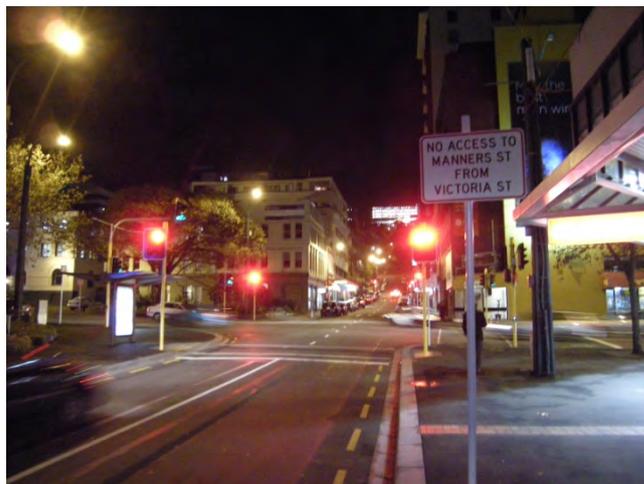
The no-right turn manoeuvre into Victoria Street, except for access to Edward Street, is not obvious to drivers and the wordy signs add to confusion. See photos 23–25. Some irregular vehicle movements were observed with late lane changes occurring. The situation is made worse in the dark when the signs are less visible, because they are not reflectorised.

The advance sign was designed to advise motorists who previously used the intersection of the change. This had some value during the transition but it is agreed that it can now be removed. This sign will be replaced by a repeat of the stop line sign and consideration given to increasing the reflectivity of it.

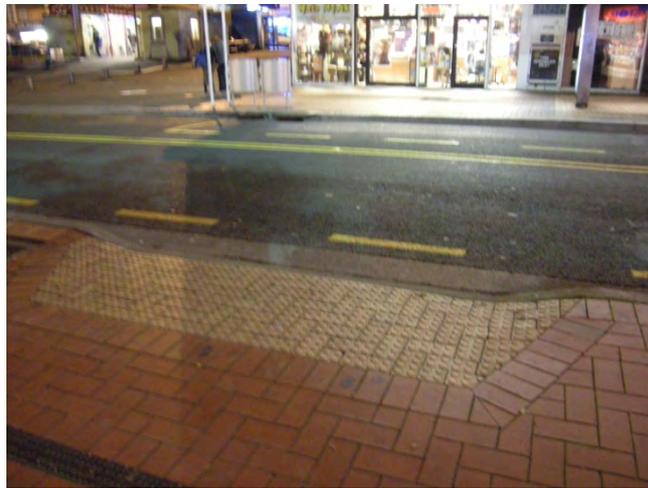
Photo 28

An uncontrolled drop kerb pedestrian crossing and tactile pavers was observed on north side of Manners Street at the east end with no corresponding crossing point on the opposite side of the road, see photo 28. The opposite side of the road is also located in a bus stop area, which may be blocked by buses. This crossing in this area may misguide some pedestrians and place them in danger, (particularly the visually impaired).

This is a redundant ramp that served mobility parking before the parking was removed as part of the scheme. Use of the ramp will be monitored and removed if it proves to be misleading to road users.

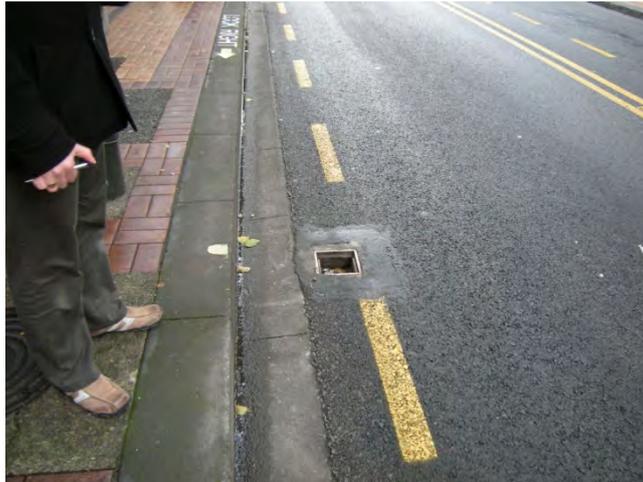
Photo 29

A service cover was observed to be missing from pit on west end of Manners Street. See photo 29. This situation is dangerous to pedestrians and road users who may trip in the area where there is live traffic.

Replace missing lid.

The missing service cover will be replaced as part of ongoing maintenance of the road network.

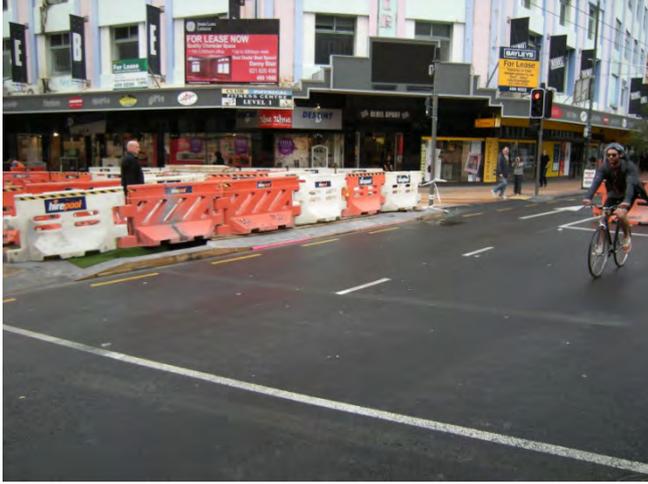
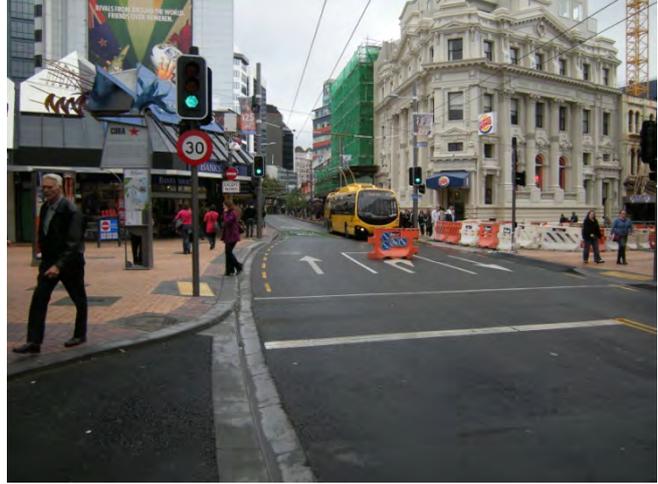
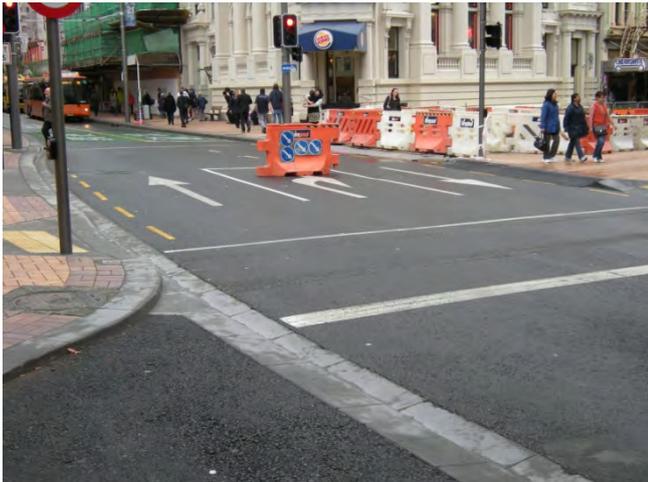
The right-turn bay and road markings are located in the middle of the intersection and are only long enough for one small vehicle. See photos 30–32. The purpose of the right-turn bay is to allow buses to pass on the left and avoid congestion while other traffic negotiates pedestrians. There is potential for a vehicle to get trapped in the intersection, obstruct pedestrians and make crossing hazardous.

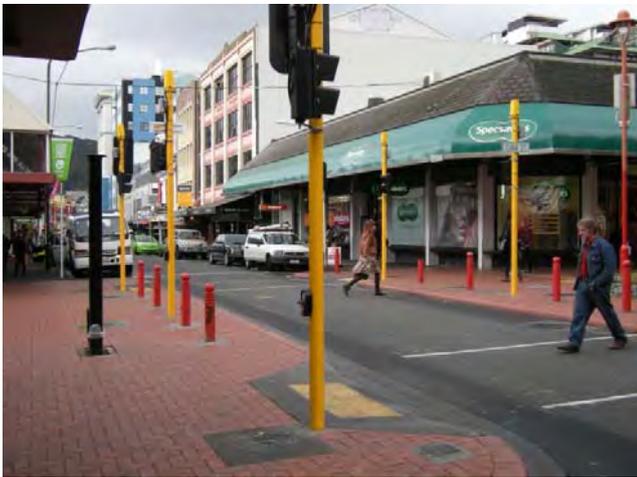
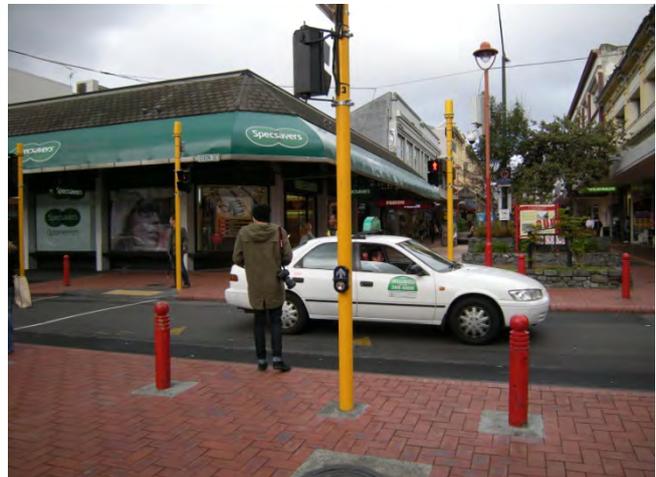
The pedestrian crossing has three call points, with the centre call point located in the middle of the intersection. This requires 6 poles for signals and adds to clutter at this location. See photo 35 and 36. The crossing furniture would appear excessive and may be hazardous to users.

The crossing facilities at this intersection reflect the fact that they service Cuba Mall. The third push-button facility was provided to increased pedestrian amenity. This reflects the desire and provides the convenience for pedestrian to cross from the full width of Cuba Street.

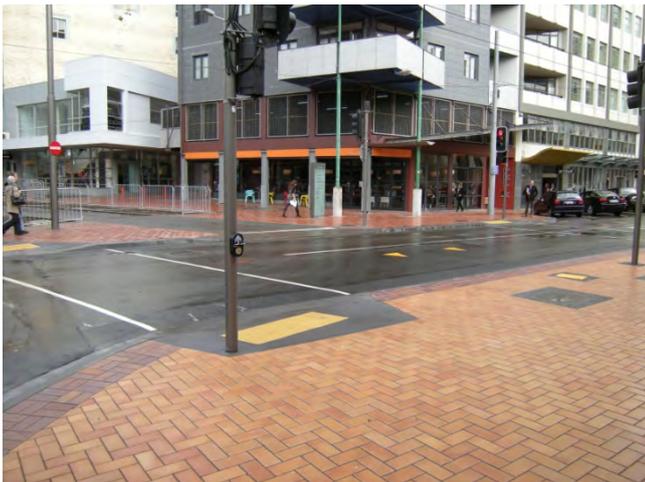
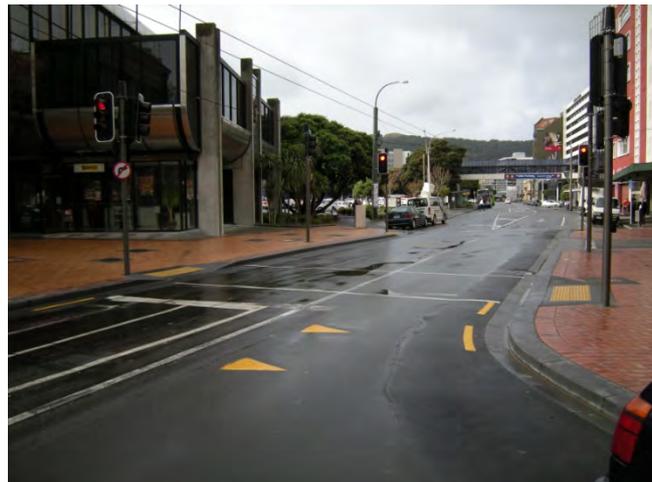
Concern is noted as minor at this stage but this could be raised if monitoring shows the layout to be unsafe.

It is proposed to monitor the intersection performance and consider a more conventional treatment if found to be unsafe.

Wakefield Street has been narrowed through the intersection to improve pedestrian amenity and to create a stronger pedestrian connection between Cuba Mall and the Civic Centre. Vehicles leaving Cuba Street do so under their own phase. There is therefore no problem if vehicles track wider when turning to leave the street. However the situation will be monitored and changes made if required.
