## Preliminary Environmental Site Investigation

90 Hanson Street

Newtown

Southern Cross Hospitals Limited

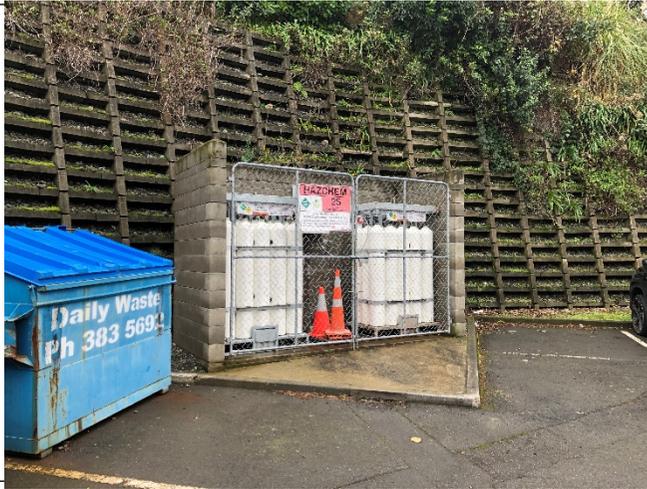
Site Conditions	Description
Visible signs of contamination	General household rubbish was noted on northern boundary of the property, adjacent to dwellings.
Presence of drums, wastes, and fill materials	Oxygen tanks were noted on hardstand in the northwest corner of the site. The tanks appeared to be in good condition.
Surface water appearance	No surface water observed during the site walkover.
Current surrounding land use	The surrounding area is a mixed-use residential / commercial area of Newtown. Hall Street and residential homes border the site to the south, Hanson Street and residential homes to the east, commercial development, including sports warehouses and parking, to the west, and commercial buildings to the north.
Local sensitive environments	No local sensitive environments observed.
Visible signs of plant stress	No visible signs of plant stress were noted during the walkover.
Ground Cover	Modern buildings and tar-seal roads cover the majority of the property.

Photograph 1: Oxygenate Tanks Located on Northwestern Corner of Property.

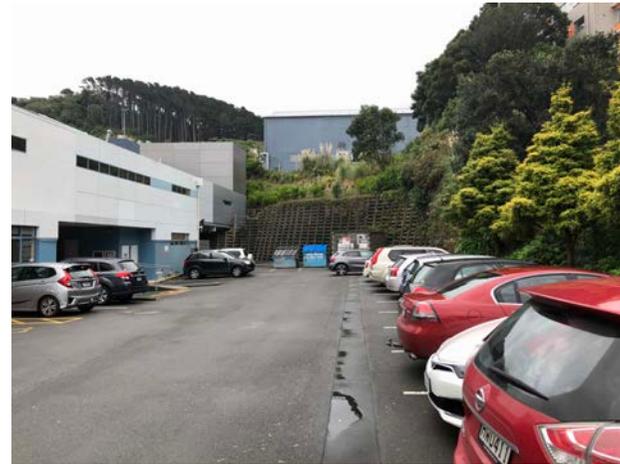
Photograph 2: View of Northern Carpark.

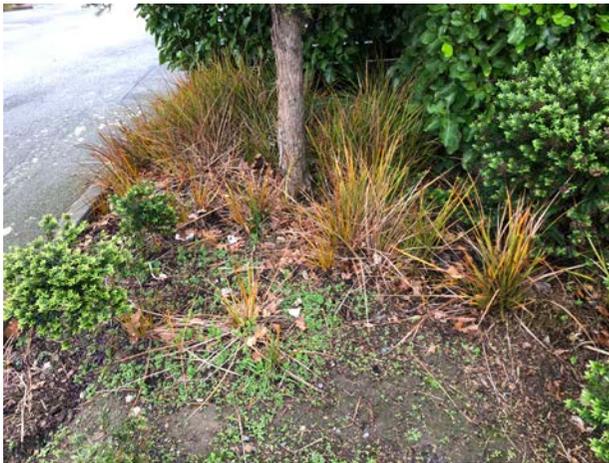
Additional Comments	<ul style="list-style-type: none"> <li>A gas junction was observed on the northeast corner for utility use</li> <li>A substation was located adjacent to the eastern boundary. No staining was noted.</li> <li>Paint chips were noted in the southeast garden that may possibly be of lead-based origin.</li> <li>A painted retaining wall was noted on the eastern boundary of the property. There is the potential for lead-based paints to have been used.</li> </ul>

Photograph 3: Minor Paint Chips Noted within Central Garden Area.

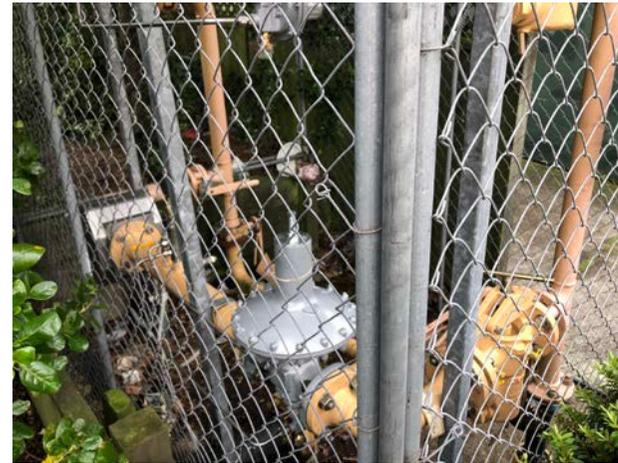
Photograph 4: Utility Gas Junction Located Adjacent to the Northeast Portion of the Property.

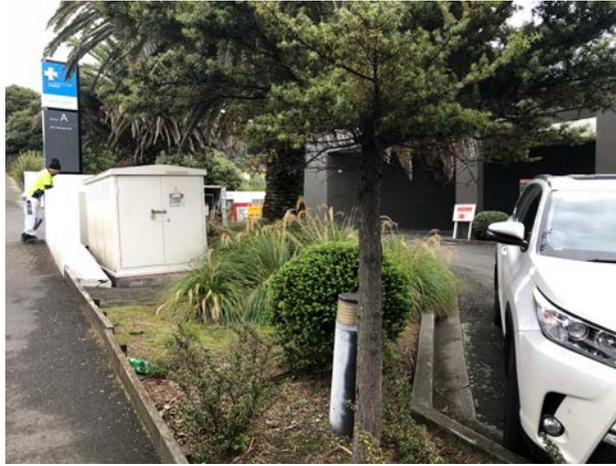
Photograph 5: Transformer Located Adjacent to the Property.

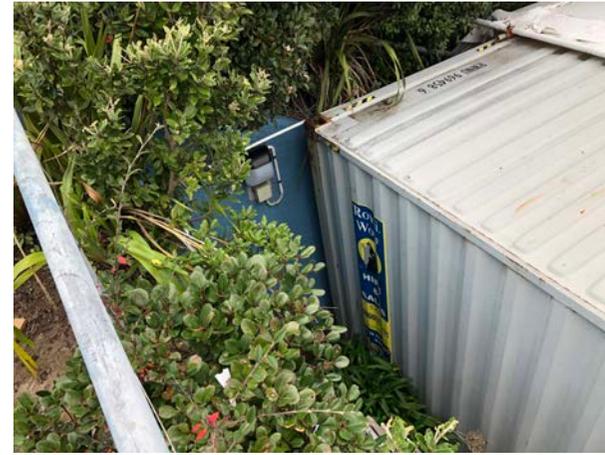
Photograph 6: Retaining Wall and Temporary Storage Containers Along Eastern Boundary.

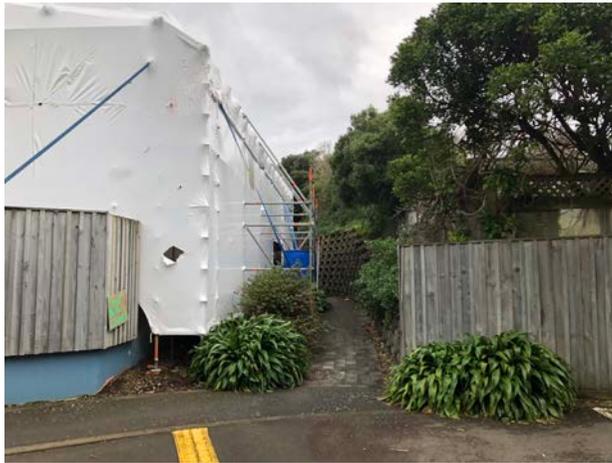
Photograph 7: Southern Carpark Facing East.

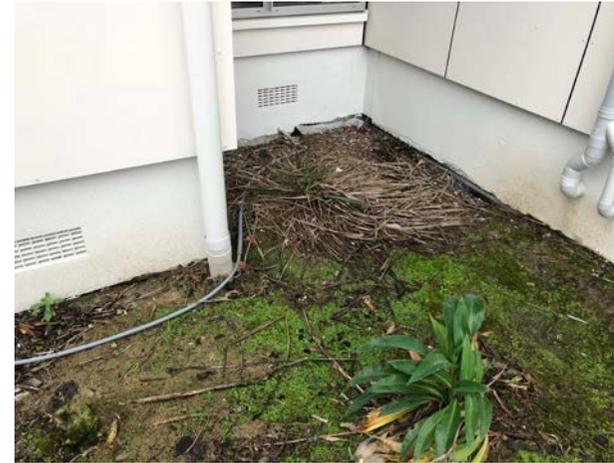
- HAIL ID E:1: *Asbestos products manufacture or disposal including sites with building containing asbestos products known to be in a deteriorated condition.* Given the former buildings on the site since at least the early 1900's in addition to the current building, constructed in 1990, there are the potential for asbestos based products. Further, there are the potential for lead-based paints within building products.

Photograph 8: Deteriorating Paint Along Base of Building.
