Wellington City Council Targeted Assessment Programme

following the
Kaikoura Earthquake of 14 November 2016

Technical Report

7 May 2017

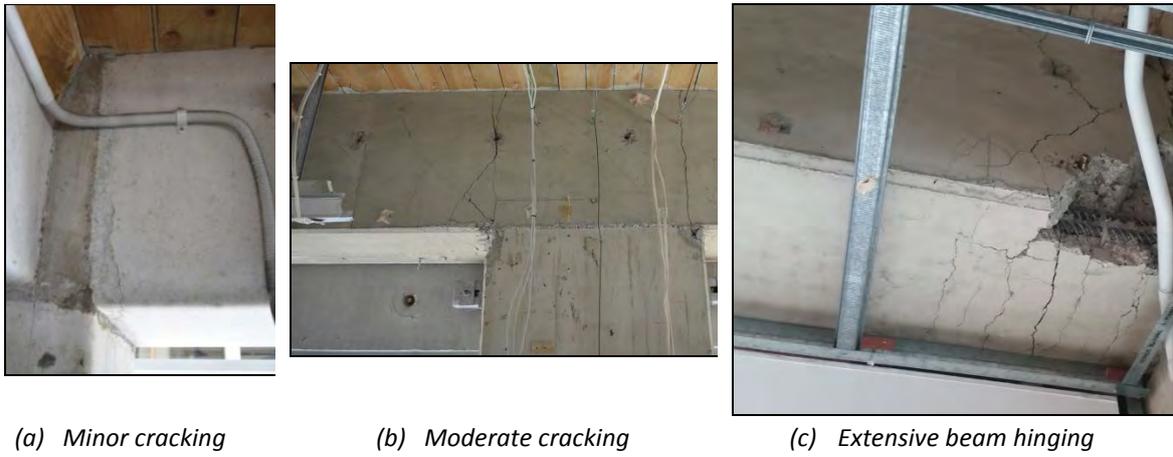
Only 25% of TDE buildings exhibited beam hinging exceeding the criteria set for CDS C1. With few exceptions, this occurred in 10 to 15 storey buildings. While diagonal cracking was observed in some plastic hinge regions, the predominant response of beams was flexural. Initial minor cracking often initiated at the cold joint between the precast beam and cast-in-place joint; however, further demands would typically lead to a distribution of cracks in the beam.

Figure 8: Examples of beam plastic hinging

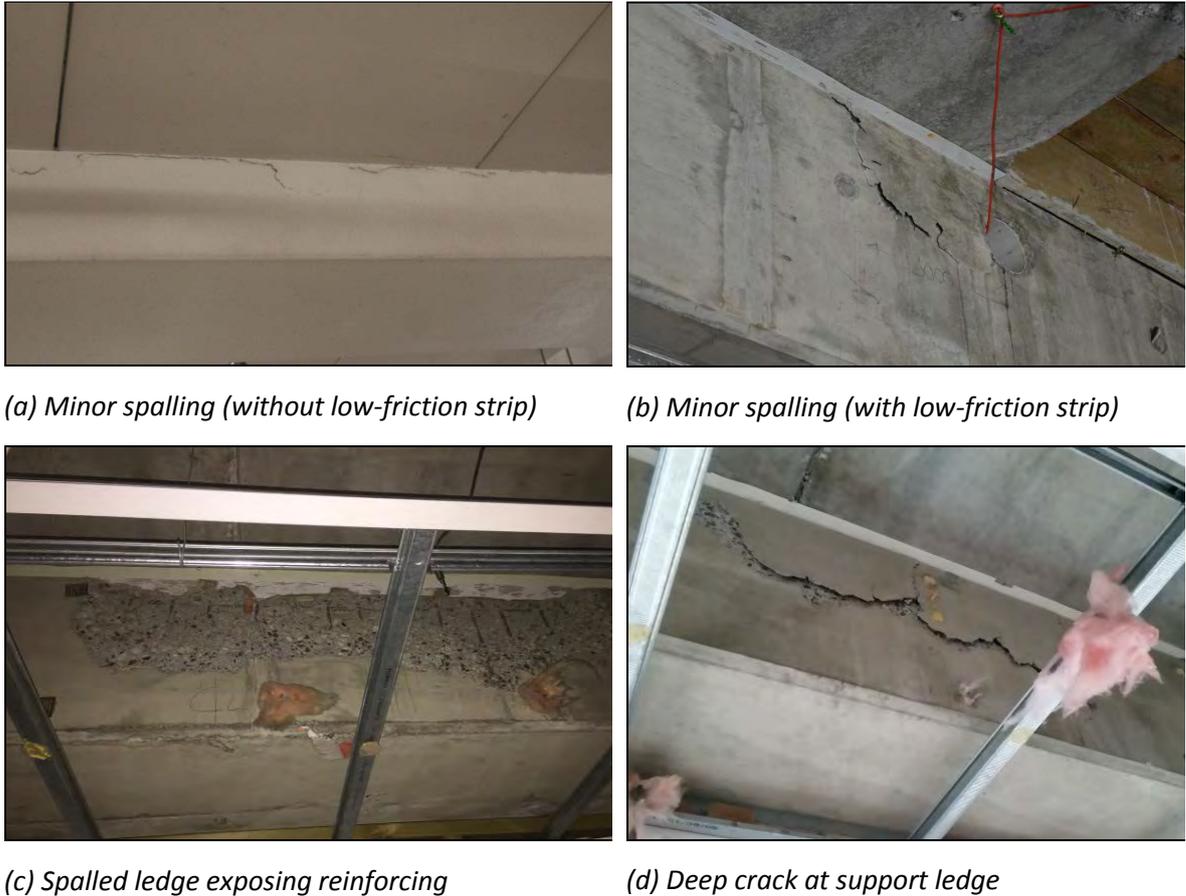
In addition to beam elongation, the building drift and associated rotation of the support beam can also lead to damage at the support. Minor spalling of the support ledge was observed in many buildings with hollowcore floor units seated directly on the support beam, as shown by the example in Figure 12a. The use of a bearing strip, as required by NZS 3101:2006 and used since the mid-2000s, can delay the onset of such minor spalling by allowing the unit to slide relative to the support beam. However, spalling of support ledges is still observed (e.g. Figure 12b) when the building is subjected to high drift demands with bearing stresses and prying effects increased. Examples of significant spalling of the support beam are shown in Figure 12c and d where the entire cover concrete has been lost. The seating length in this building was adequate to ensure that a residual bearing area was maintained to prevent complete loss of support and potential collapse of the floor units. Despite the extensive damage observed, Figure 12c highlights the importance of changes to design standard requirements in NZS 3101:2006 where seating lengths must be sufficient to accommodate demands due to both elongation and rotation, as well as the loss of bearing area due to spalling.

Figure 12: Examples of support ledge spalling

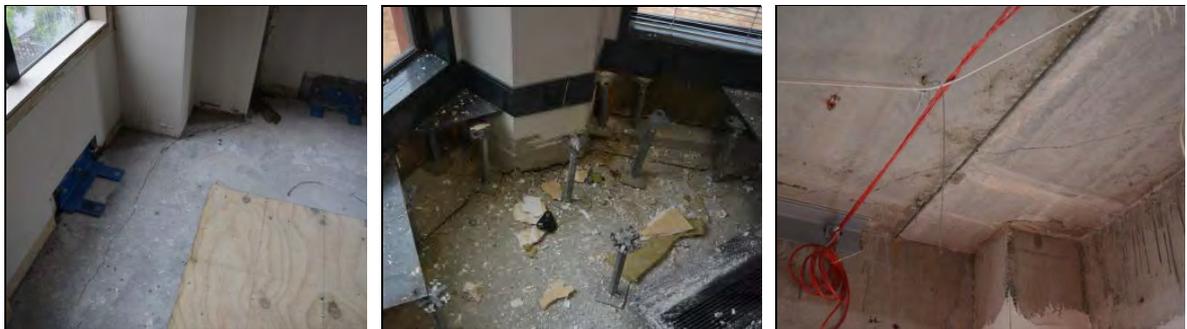
Figure 14: Damage in corners of floor plate – Single cracks

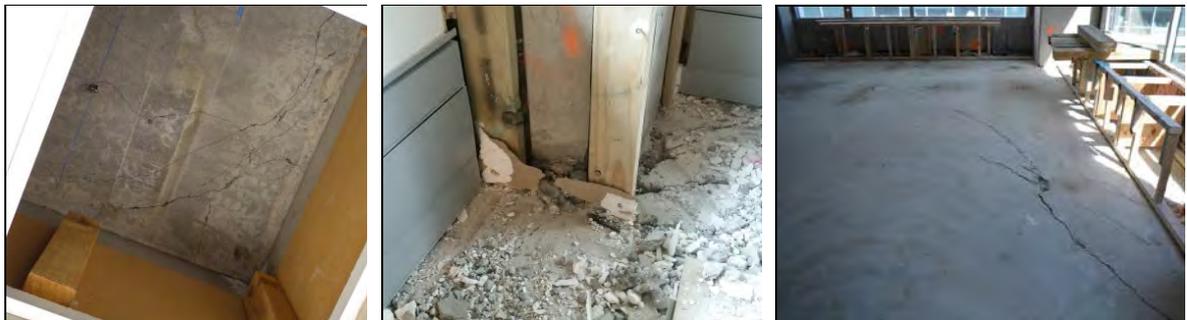
Figure 15: Damage in corners of floor plate – Significant cracking

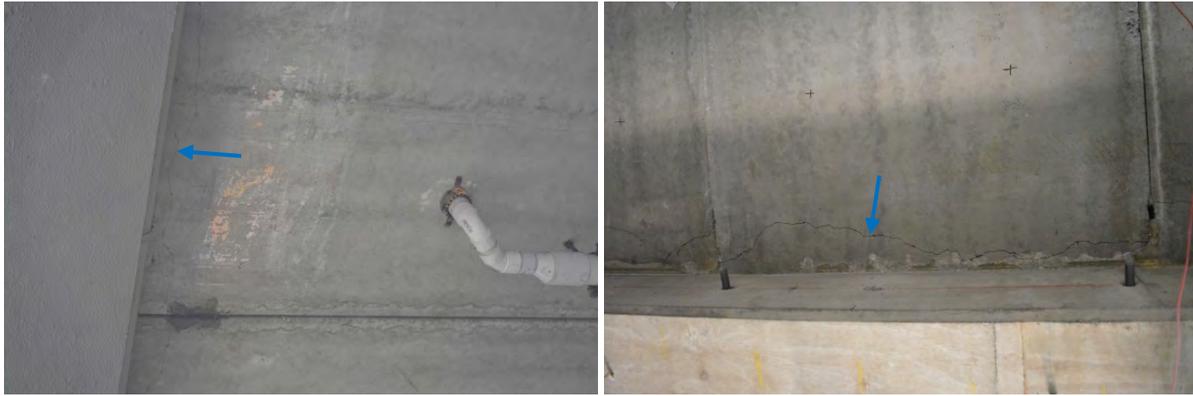
Figure 19 shows examples of transverse cracking within 100 mm of beam support, where prestress in the strand is unlikely to be significant. In addition, transverse crack at approximately 300 mm from the support were observed in some buildings, as shown in Figure 20. Typically the location of the cracks on top surface corresponded to the end of the starter bars, and in many cases the crack was found to extend vertically for the full depth of the unit. Given the distance of the transverse crack from the support, prestress strand bond is likely sufficient to sustain gravity loads, but further widening of the crack in aftershocks was still a concern. Further research is needed to understand the cause of this cracking pattern and the residual capacity when considering both gravity loading and demands in aftershocks.

Figure 19: Transverse cracking of hollowcore close to support

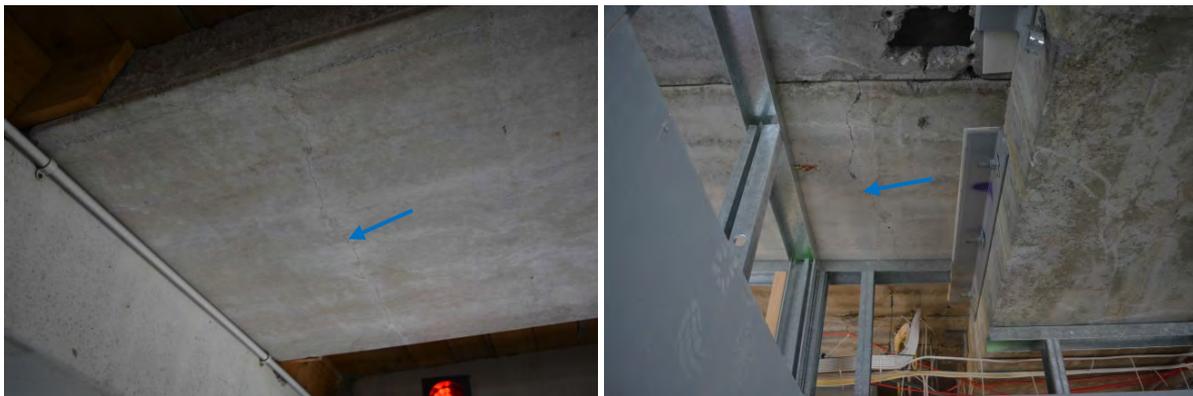
Figure 20: Transverse cracking of hollowcore away from support

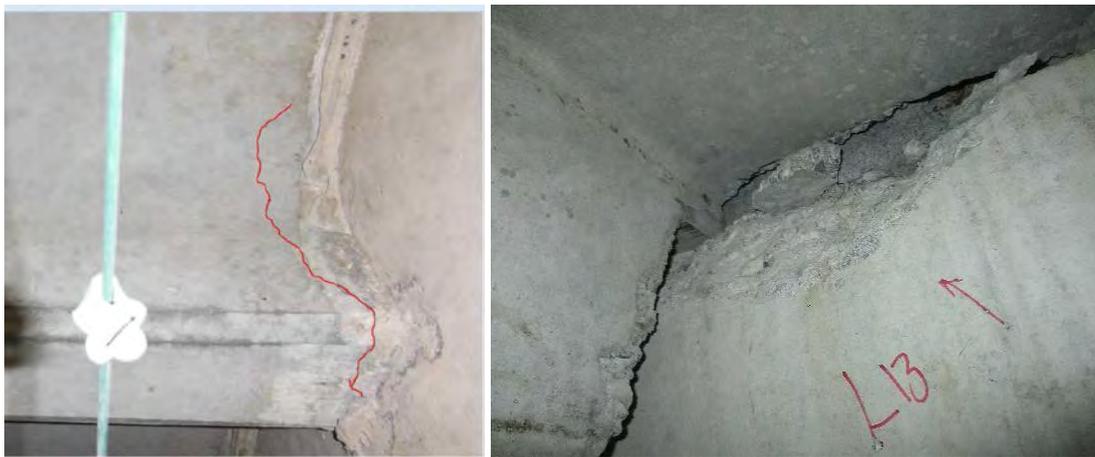
The beam hinging and frame dilation in the five TDE buildings with double tees was significantly less than that measured in Statistics House. Only minor spalling of ledges occurs, with no significant risk of loss of seating (see Figure 21b).

(a) Cracking of embedded tee rib
(crack drawn for clarity)

(b) Spalling of support ledge

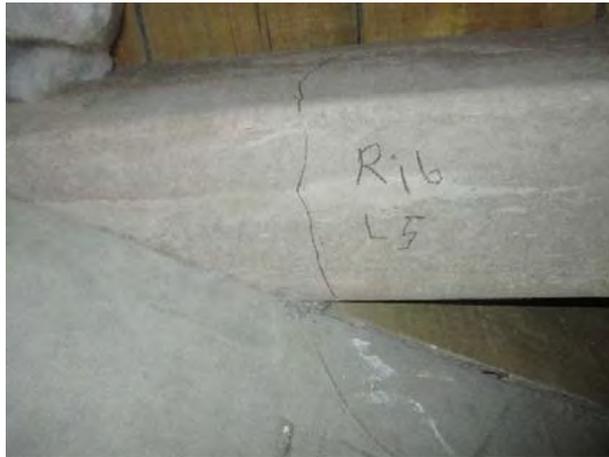
In general, the damage to buildings with rib and timber floors was less severe with only a few cases of damaged floors discovered. Of the 12 TDE buildings with rib and timber infill floors, only 4 were found to have critical damage states. Damage to precast ribs was discovered in two buildings. This damage consisted of transverse cracking through the ribs close to the support (see example in Figure 22). In one building this was an isolated case with just a single unit damaged, whereas in the other the damage occurred to multiple units in several floor levels. Transverse cracking in ribs typically results from the end of the rib being trapped in the support beam, causing flexural damage in the ribs when the building deforms. This transverse cracking can result in similar failure modes to hollowcore units, due to the lack of development of prestress at the cracked section close to the end of the rib. However, the cracks observed were almost all vertical and did not pose an immediate collapse risk. No cases of significant damage or spalling were observed at rib supports.

Figure 22: Transverse crack at end of rib (crack drawn for clarity)

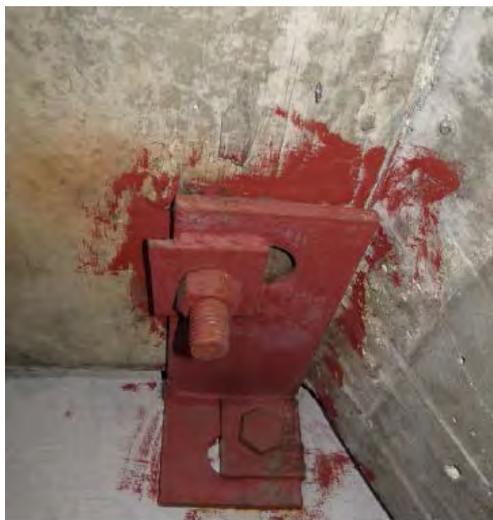
Figure 23: Precast cladding panel connection with limited movement capacity

Where these issues were identified, the engineers have recommended to owners that these connections should be reviewed and remediated where found necessary, and these recommendations should be actively followed up on by the owners.

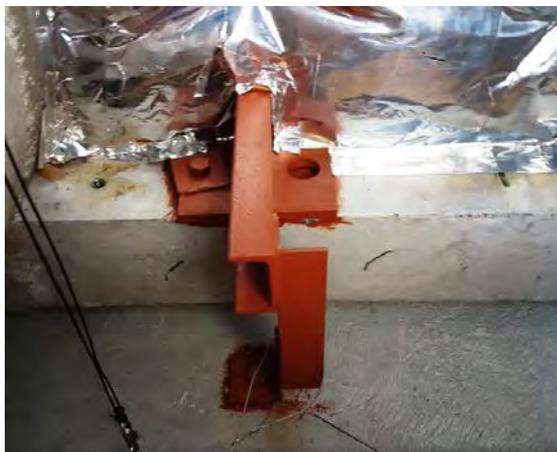
There were also some reports of loose bolt fixings to panels and bolts not being installed (refer Figure 24).

Figure 24: Precast cladding panel connection with fixing bolt not installed
