15 February 2016

## **Former Shelly Bay RNZAF Base, Shelly Bay Road, Wellington**

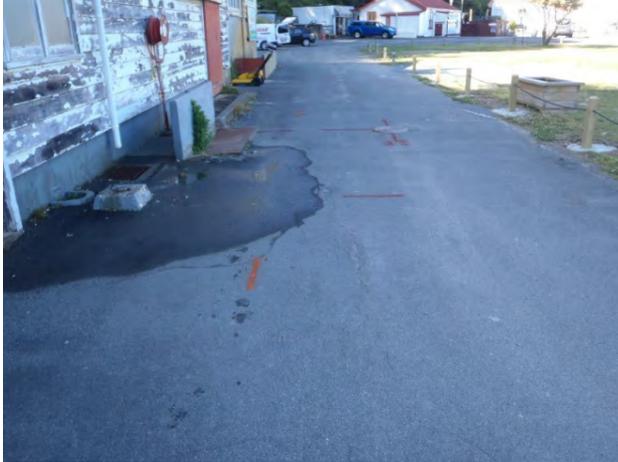
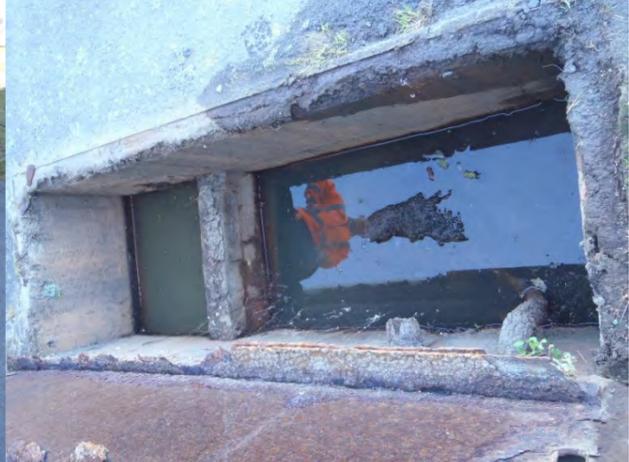
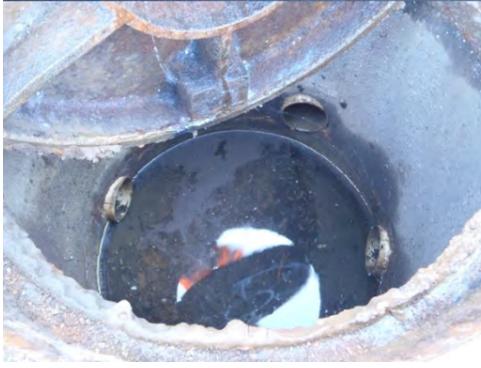
<i>Element</i>	<i>Source of Information</i>	<i>Comment</i>	<i>Photograph</i>
Stormwater	Site Walkover	<p>The boilerhouse condensate and blowdown previously entered the stormwater via an interceptor located adjacent to the boilerhouse facility.</p> <p>Photograph 1: Overview of the separator pit located adjacent to the boilerhouse. The stormwater manhole is noted in the middle of the picture.</p> <p>Photograph 2: Interceptor pit – no visual or olfactory evidence of impact of the water. Sediment in the interceptor may be impacted by metal contamination.</p> <p>Photograph 3: Inside the stormwater manhole located closest to the boiler house. No visual or olfactory evidence of impact noted on the water surface.</p> <p><b>Evaluation of potential for soil and groundwater impact:</b> No significant impact expected.</p>

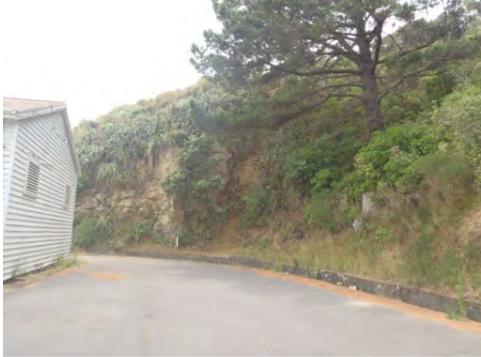
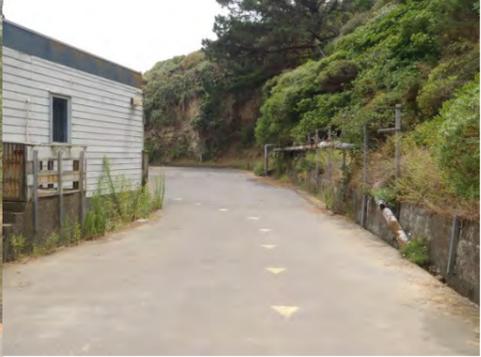
<p>Surface water run-off and small streams are evident on the hillside with all water draining from the slope collected in an interceptor channel at the foot of the slope.</p> <p>Photograph 4: Example of the interceptor channel at the base of the greywacke escarpment (North Bay). No visual or olfactory evidence of impact.</p> <p>Photograph 5: Example of the interceptor channel at the base of the greywacke escarpment (North Bay). No visual or olfactory evidence of impact.</p> <p><b>Evaluation of potential for soil and groundwater impact:</b> No significant impact expected.</p>

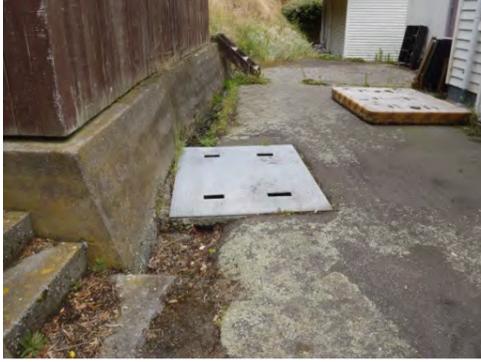
<p>Stormwater collection at the rear of the Officers Mess and Accommodation building (South Bay).</p> <p>Photograph 6: Stormwater grate.</p> <p><b>Evaluation of potential for soil and groundwater impact:</b> No significant impact expected.</p>

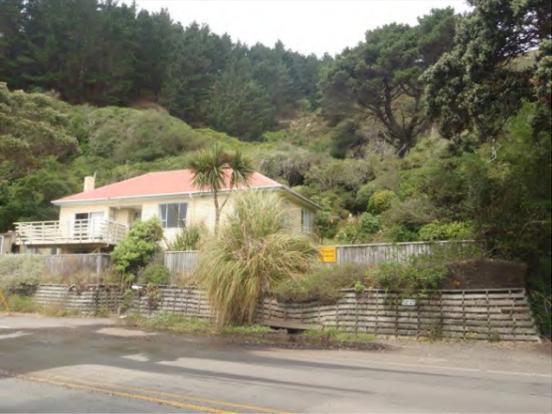
<p>Commanders House</p>	<p>Wellington Regional Council Selected Land Use Register</p>	<p>No evidence of current or historical hazardous activities.</p> <p>Photograph 7: Commanders House showing stormwater runoff from the hills above the site.</p> <p><i>Evaluation of potential for soil and groundwater impact:</i> No significant impact expected.</p>

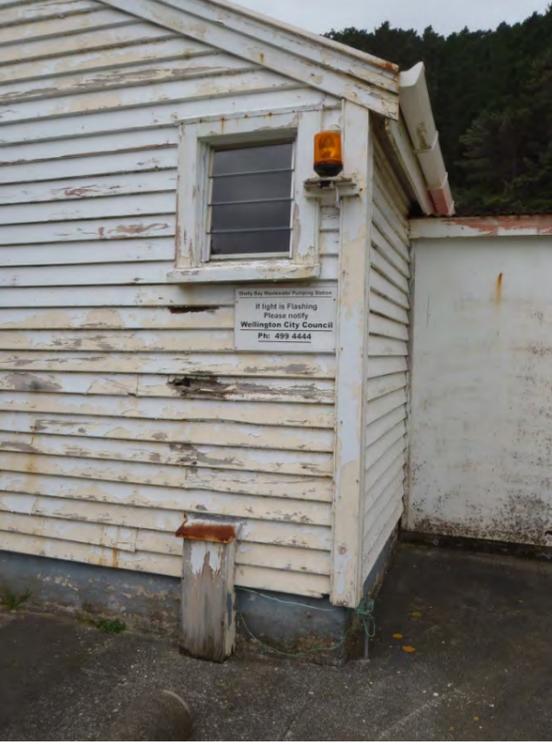
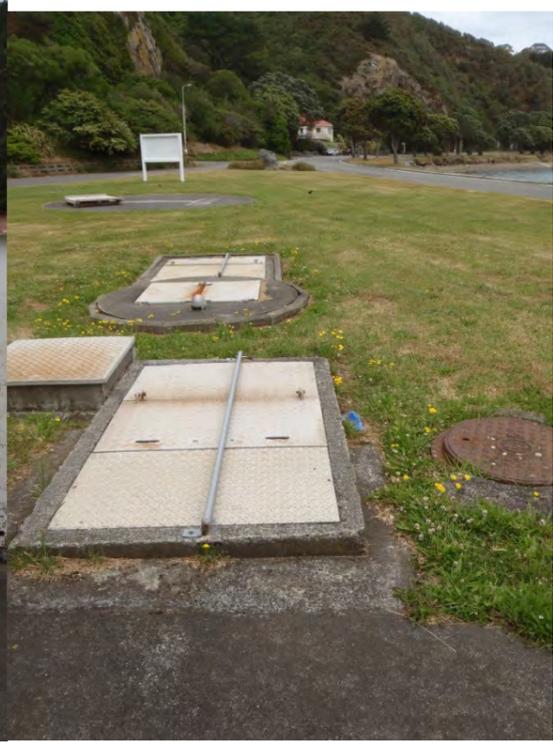
<p>Wastewater Pumping Station</p>	<p>Site walkover</p>	<p>A wastewater pumping station is a wooden building and associated underground structures operated by Wellington Water located at the south end of South Bay.</p> <p>Photograph 8: Building housing the pumping station equipment.</p> <p>Photograph 9: Wastewater retention structures. Access was unable to be made to the chambers present in the area to assess if biosolids were present.</p> <p><i>Evaluation of potential for soil and groundwater impact:</i> Biosolids may be present at the site and operational losses may have potential to create localised impact to soil and water in the vicinity of the plant.</p>

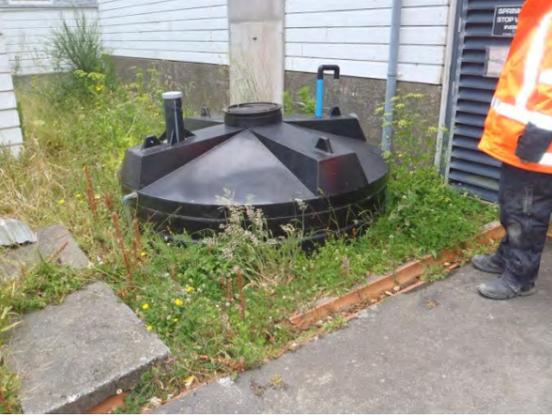
<p>Sewage/Septic</p>	<p>Opus January 2008</p>	<p>Opus January 2008 notes that wastewater from the Shipwrights Building drains to the Sea.</p> <p>Anecdotal evidence indicates that a disused septic tank is located at Building 6.</p> <p>A partially buried septic tank present adjacent to the Mess Building.</p> <p>Photograph 10: Septic tank located adjacent to the Mess Building.</p> <p><i>Evaluation of potential for soil and groundwater impact:</i> Considering the potential age and if maintenance of the facility is undertaken, significant impact to soil and groundwater is considered unlikely.</p>

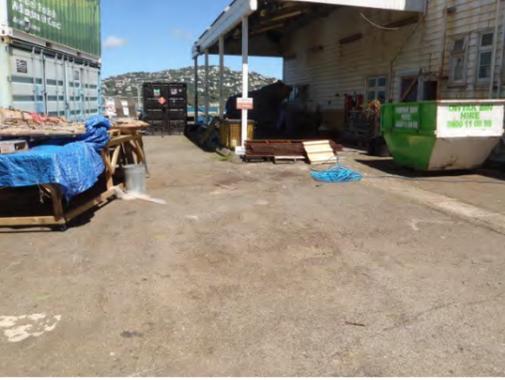
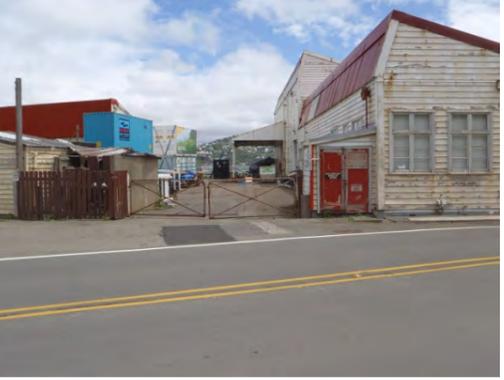
<p>Current Dangerous Goods Storage Container</p>	<p>Geotechnical Investigation</p>	<p>A dangerous goods storage container is present in the area between Building No. 8 and the Shipwrights Building.</p> <p>No information on the contents of the container was sought as part of this investigation.</p> <p>Photograph 11: Dangerous Goods Storage Container (black in the centre of the photograph)</p> <p>Photograph 12: Overview of the area containing the Dangerous Goods Storage Container.</p> <p><b>Evaluation of potential for soil and groundwater impact:</b> The photograph does not show any significant staining associated with the dangerous goods storage container. It is considered unlikely that significant impact to soil or groundwater would be related to the storage container.</p>

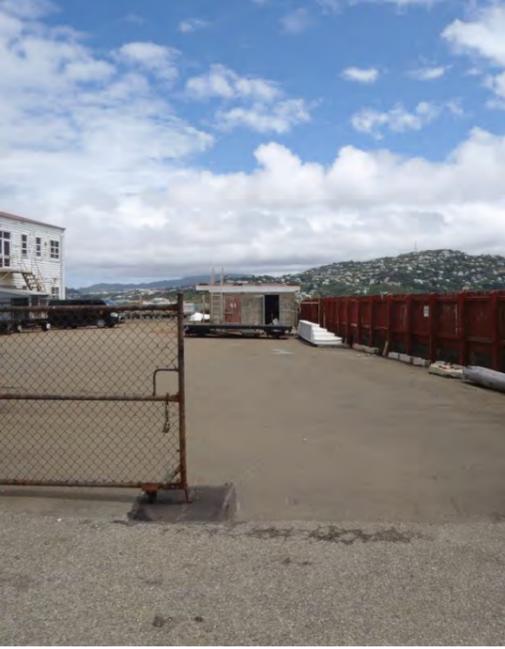
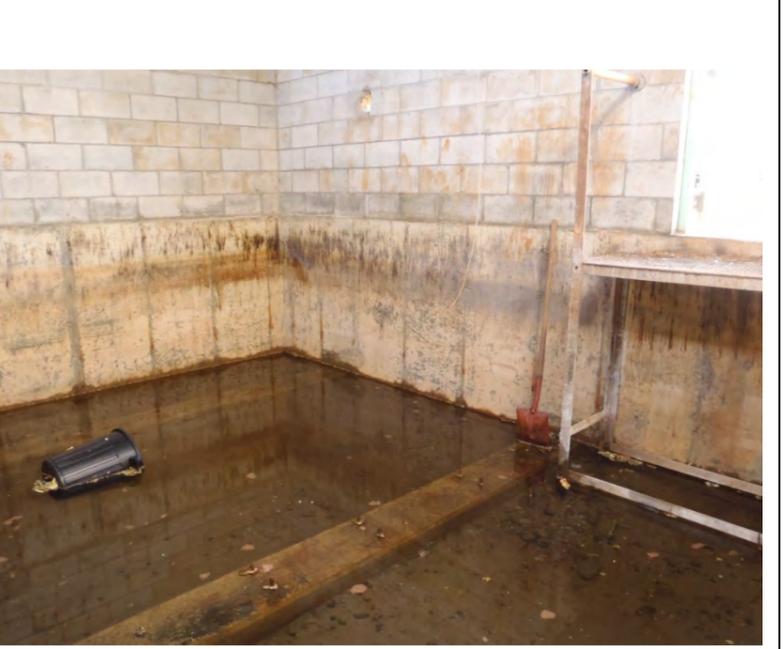
<p>Dangerous Goods Store/Fuel Storage</p>	<p>Geotechnical Investigation / Opus January 2008.</p>	<p>The facility was not observed as part of the PSI, however information provided during the geotechnical investigation showed that the dangerous goods store (referred to as the fuel supply building and paint store) is a concrete block structure adjacent to Building No. 8. The fuel supply building contained a diesel tank (an above ground tank located in shallow pit) which was removed in 1995 when the base closed.</p> <p>Photograph 13: Overview of the Dangerous Goods Store area taken from Shelly Bay Road.</p> <p>Photograph 14: Inside the Dangerous Goods Store.</p> <p><b>Evaluation of potential for soil and groundwater impact:</b> The photograph does not show significant staining inside the Dangerous Goods Store. As the building is retaining water it is considered unlikely that significant impact to soil and groundwater would be associated with this structure.</p>

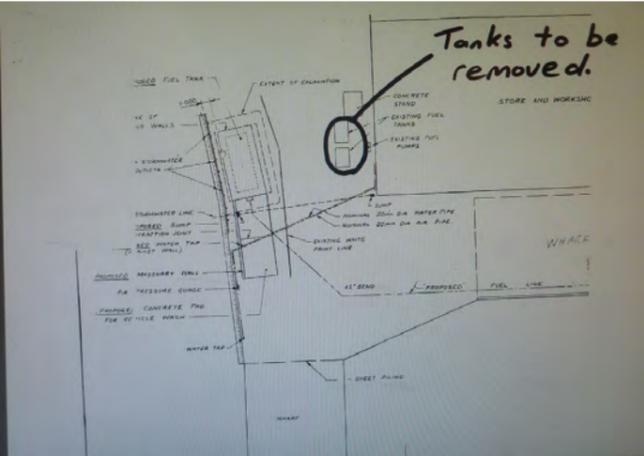
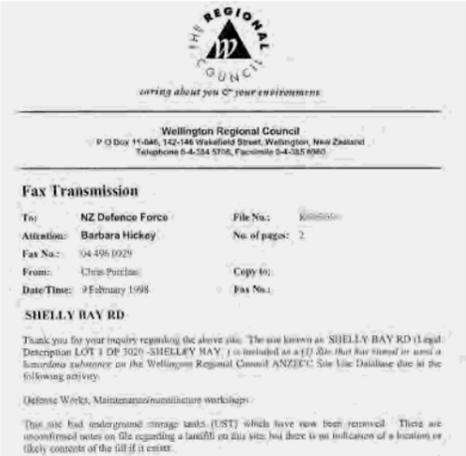
<p>Fuel Storage</p>	<p>Geotechnical Investigation</p> <p>Wellington City Council Archives Plan 0066_1_34.pdf (1993).</p> <p>Wellington Regional Council fax to New Zealand Defence Force – dated 9 February 1998. Reference K/9/5/59) – Contained in WRC SLUR search.</p>	<p>An above ground fuel storage tank was located inside the Dangerous Goods Store (details above).</p> <p>Photograph 15: Plan from Wellington City Archives file 0060:1:34 showing the location of the Dangerous Goods Store and “existing fuel tanks” it is not clear if the “existing tanks are below or above ground.</p> <p>No direct records are available to confirm if the removal of the “existing” tanks.</p> <p>A fax from Wellington Regional Council to the New Zealand Defence Force dated 9 February 1998 states that the site contained underground storage tanks which have now been removed. It is not clear if the tanks removed are related to these “existing tanks”.</p> <p><b>Evaluation of potential for soil and groundwater impact:</b> It is not known from the records reviewed if the tanks are above ground or underground. If the tanks were located underground, soil and groundwater may have been impacted due to operational losses.</p>	<p>As for above photographs and below.</p>

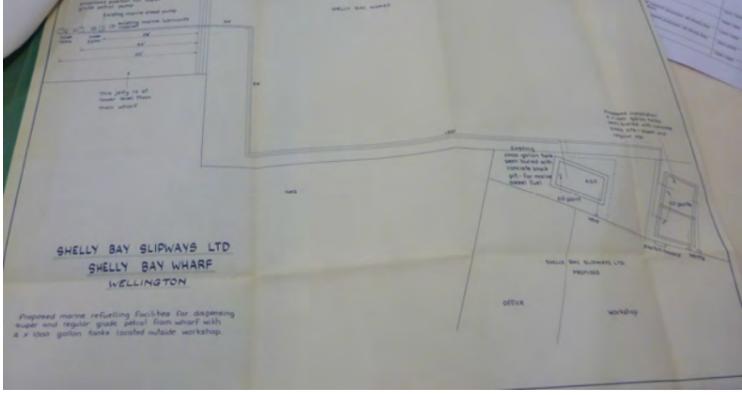
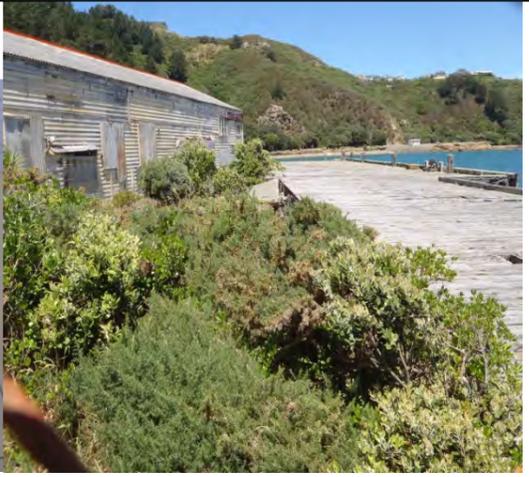
<p>Geotechnical Investigation (Photograph)</p> <p>Plan: Shelly Bay Slipways Limited Shelly Bay Wharf Wellington – Proposed marine refuelling facilities</p> <p>Letter from GI Cooper and WS Brambley Trustees for a Company being formed to be known as Shelly Bay Slipways Limited: Application for a Motors Spirits Retailers Licence Restricted to Marine Craft Only at Shelly Bay Wharf Wellington.</p>	<p>Wellington City Council records show the presence of an existing 2,000 gallon semi-buried diesel storage tank present in a concrete block bund. The document also includes an application dated 16 November 1971 for the installation of 2 semi-buried 1000 gallon super and regular motor spirits tanks.</p> <p>No direct records are available to confirm if the removal of the “existing” tank or whether the proposed tanks were installed.</p> <p>A fax from Wellington Regional Council to the New Zealand Defence Force dated 9 February 1998 states that the site contained underground storage tanks which have now been removed. It is not clear if the tanks removed are related to these tanks.</p> <p>Photograph 16: Plan from Wellington City Council archives of the location of the existing and proposed semi-buried tanks.</p> <p>Photograph 17: Photograph of the approximate area where the semi-buried tanks are/were thought to be located.</p> <p><b>Evaluation of potential for soil and groundwater impact:</b> soil and groundwater may have been impacted due to operational losses.</p>

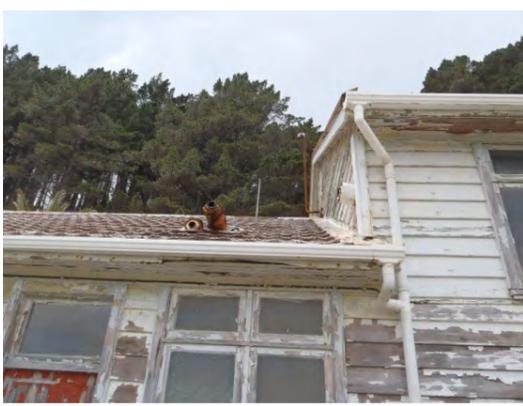
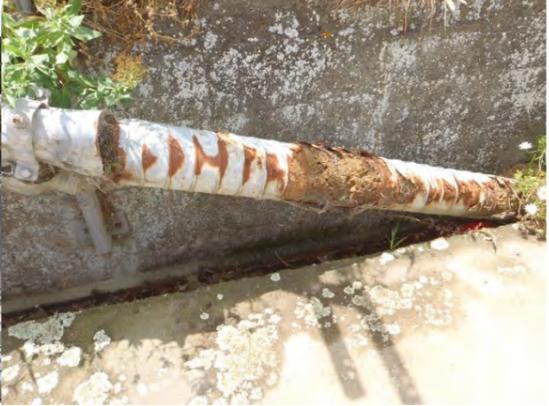
<p>Asbestos</p>	<p>Site Walkover</p>	<p>Asbestos lagging may have been used in piping that transferred heat from the boilerhouse to the buildings at the base. The piping remains present at the site with sections showing various stages of aging/decay exposing lagging.</p> <p>Testing of the lagging material and an asbestos survey have not been undertaken as part of these works.</p> <p>Photograph 18: Pipping and lagging exiting the boilerhouse roof.</p> <p>Photograph 19: Pipe lagging exposed at the base of the greywacke escarpment (North Bay).</p> <p><b>Evaluation of potential for soil and groundwater impact:</b> An asbestos survey has not been completed for the site. There is potential for the structures already demolished to impact soil if the asbestos was not removed appropriately. If structures or the lagging is to be removed at the site there is potential for soil to be impacted by asbestos if not undertaken correctly. Groundwater is unlikely to be affected by asbestos.</p>

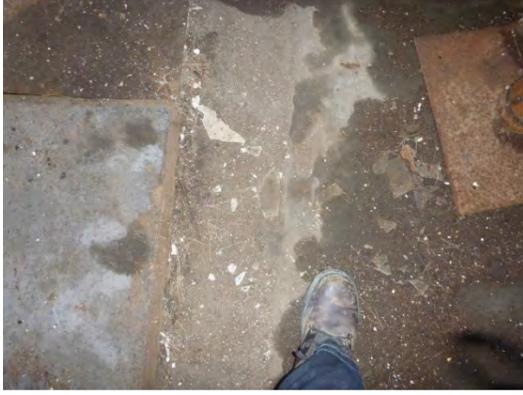
<p>Site Walkover</p>	<p>Possible asbestos containing material present on the floor of the boilerhouse.</p> <p>Photograph 20: Possible asbestos containing material noted on the floor of the boilerhouse.</p> <p><b>Evaluation of potential for soil and groundwater impact:</b> An asbestos survey has not been completed for the site. There is potential for the structures already demolished to impact soil if the asbestos was not removed appropriately. If structures are to be removed at the site there is potential for soil to be impacted by asbestos if not undertaken correctly. Groundwater is unlikely to be affected by asbestos.</p>

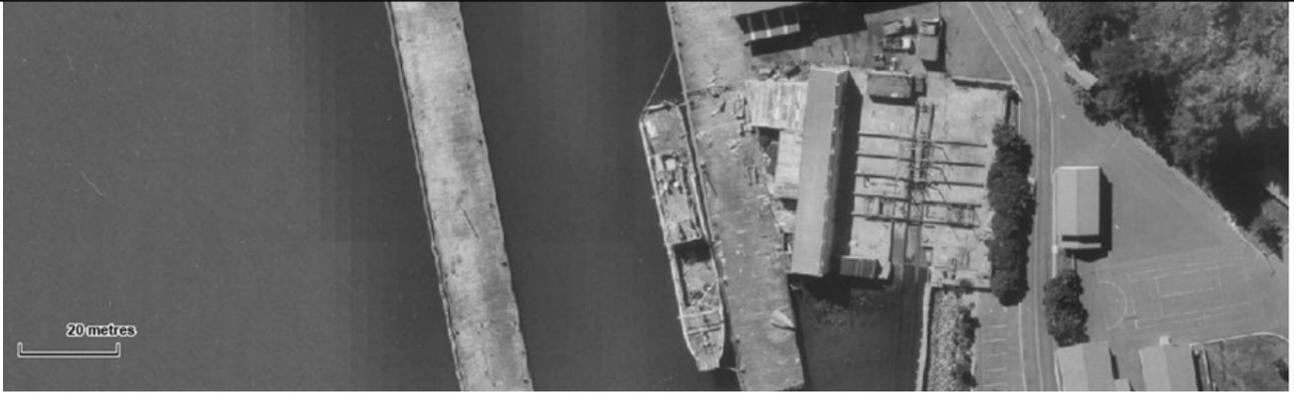
<p>Wellington City Archives</p> <p>Email to Wellington City Council from Unknown?: Shelly Bay Slipway Building Demolition of Lean-to Structures November 2001.</p> <p>1996 Aerial Photograph – Wellington City Council website  <a href="http://wellington.govt.nz/webmap/wcmap.html">http://wellington.govt.nz/webmap/wcmap.html</a></p>	<p>Council records from 2001 show that asbestos sheeting was present in unauthorised lean-to's in the area of the Slipway. These lean-to's were demolished as they were deemed unsafe in December 2001. The letter indicates that SERCO (the base maintenance operators) were to remove the asbestos appropriately and send material to the closest landfill.</p> <p>Photograph 21: Wellington City Council 1996 aerial photograph showing the presence of the lean-to structures adjacent to the Shipwrights Building.</p> <p><b>Evaluation of potential for soil and groundwater impact:</b> There is potential for the structures already demolished to impact soil if the asbestos was not removed appropriately. Groundwater is unlikely to be affected by asbestos.</p>

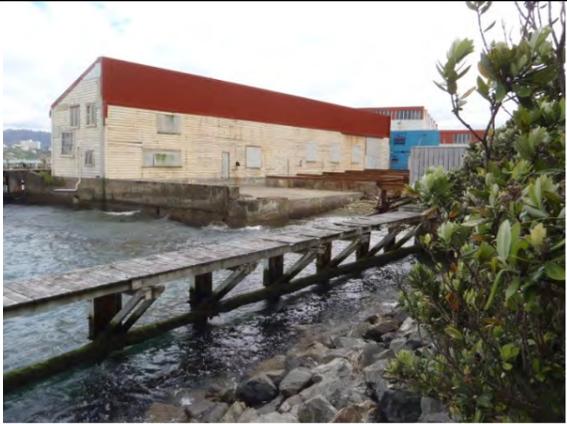
<p>Anecdotal Evidence</p>	<p>AECOM understands that during works undertaken by Tonkin and Taylor in relation to the sea wall in the area of Building No. 8 that asbestos was found in loose and asbestos containing material namely Chrysotile, Amosite and Crocidolite.</p> <p><b>Evaluation of potential for soil and groundwater impact:</b> There is potential for the asbestos to be present in soil adjacent to the seawall in the area of Building No. 8. Groundwater is unlikely to be affected by asbestos.</p>	<p>No photograph available.</p>
	<p>Opus January 2008</p>	<p>Opus report that the interior of Building No. 8/HQ Building and the Laundry Building (adjacent to the Boilerhouse) may have asbestos present in the interior of the building.</p> <p>Opus also report that Super 6 roofing (containing asbestos) may be present on the Shipwrights Building.</p> <p>Photograph 22: Shipwrights Building looking northwest across the Slipway area. It appears that the roof of the structure is newly painted/new. This may have occurred following the Opus January 2008 report.</p> <p><b>Evaluation of potential for soil and groundwater impact:</b> An asbestos survey has not been completed for the site. There is potential for the structures already demolished to impact soil if the asbestos was not removed appropriately. If structures are to be removed at the site there is potential for soil to be impacted by asbestos if not undertaken correctly. Groundwater is unlikely to be affected by asbestos.</p>

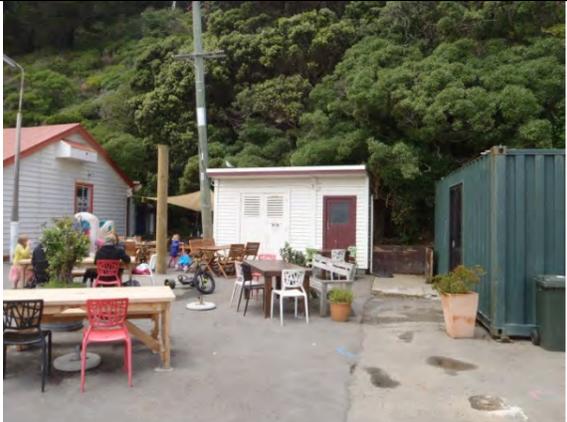
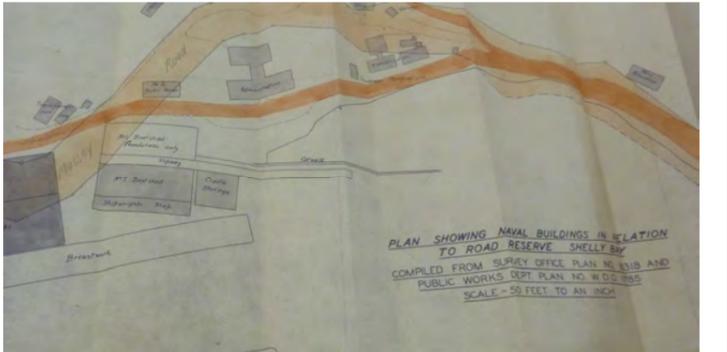
<p>Transformer/PCB's</p>	<p>Current Transformer Location: Site Walkover</p> <p>Historical Transformer Location: Plan Showing Naval Buildings in Relation to the Road Reserve Shelly Bay (Compiled from Survey Office Plan No. 18318 and Public Works Dept Plan No. W.D.O 1785). Pencil date</p>	<p>Two transformer locations were noted at the site, one historical transformer located to the east of the slipway adjacent to the library and one located adjacent to the current café.</p> <p>Photograph 23: Current transformer location in the area of the café.</p> <p>Photograph 24: Snapshot of the plan showing the historical transformer location.</p> <p><b>Evaluation of potential for soil and groundwater impact:</b> The transformers may have previously contained oils with polychlorinated biphenyls (PCB). No visual or olfactory evidence of staining was observed around the current transformer. There may be so localised impact around the transformer locations.</p>

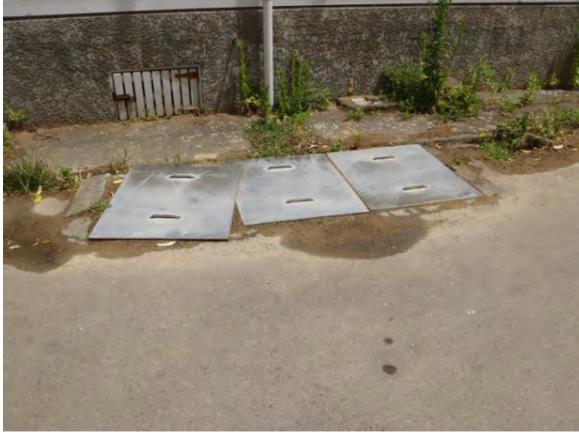
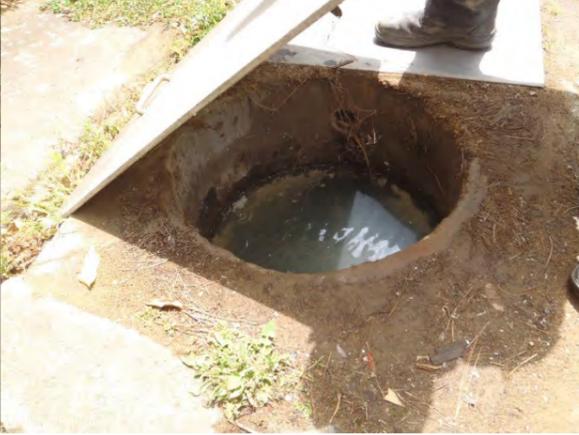
<p>Liquid Waste</p>	<p>Site Walkover Opus January 2008</p>	<p>A fat trap is present at the rear of the combined mess building.</p> <p>Photograph 25: Fat trap at the rear of the combined mess. Photograph 26: Last chamber of the fat trap. Some residual fat remains.</p> <p>Opus January 2008 reports that an area of liquid residue contamination was present on the concrete floor in southwest corner of the Shipwrights Building. Access to this building was restricted during the PSI. No photograph of the staining is available.</p> <p><b>Evaluation of potential for soil and groundwater impact:</b> Significant impact to soil or groundwater is not expected related to the fat trap. The origin of the liquid residue “contamination” noted in the Opus January 2008 report is unknown, therefore the impact on soil and groundwater is unable to be quantified.</p>

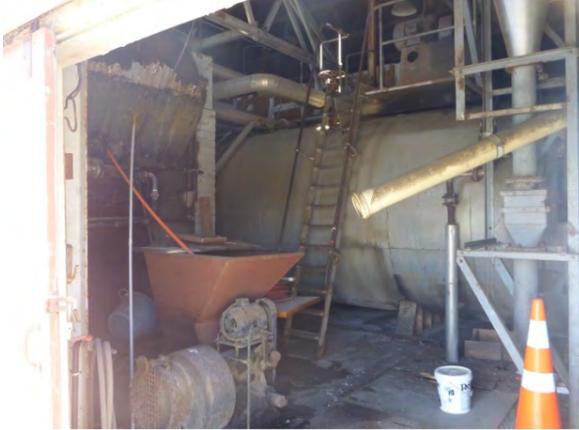
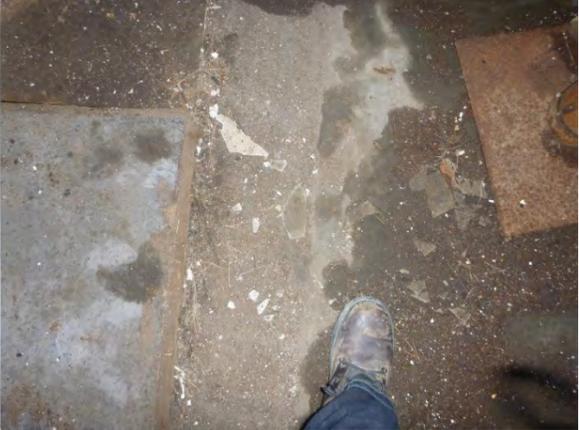
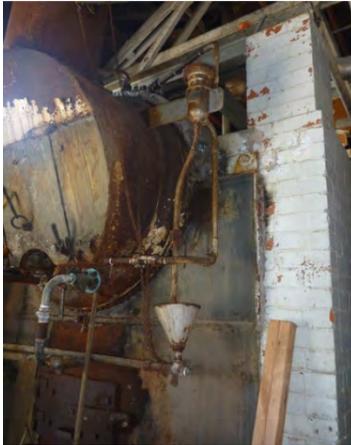
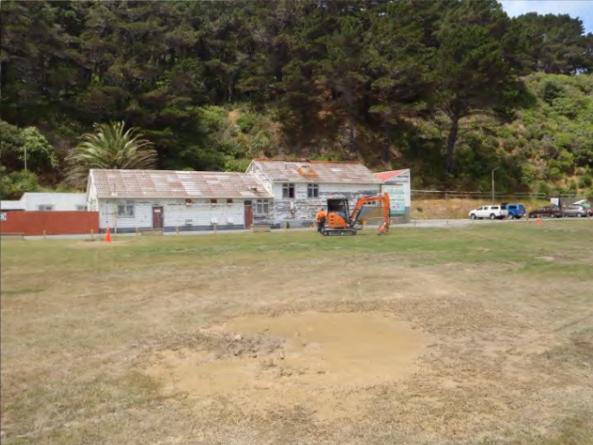
<p>Boilerhouse/Pumphouses</p>	<p>Site Walkover</p>	<p>A coal fired boilerhouse is present in the north bay. There was no evidence in either Wellington City Archives or during the Site Walkover of boiler ash at the site.</p> <p>Minor hydrocarbon staining noted on the floor of the main boilerhouse room.</p> <p>Photograph 27: Boilerhouse interior taken from the main door. Photograph 28: Hydrocarbon staining on the main boilerhouse room floor. Photograph 29: Boilerhouse fireplace. Photograph 30: Boilerhouse and Laundry looking east over the former Airman's accommodation.</p> <p><b>Evaluation of potential for soil and groundwater impact:</b> Soil and groundwater impact may be present related to the burning of coal to fire the boiler and hydrocarbon staining on the concrete. No evidence of ash burial was found in records relating to the site or during the site walkover. Significant impact related to the operation of the boilerhouse is considered unlikely.</p>

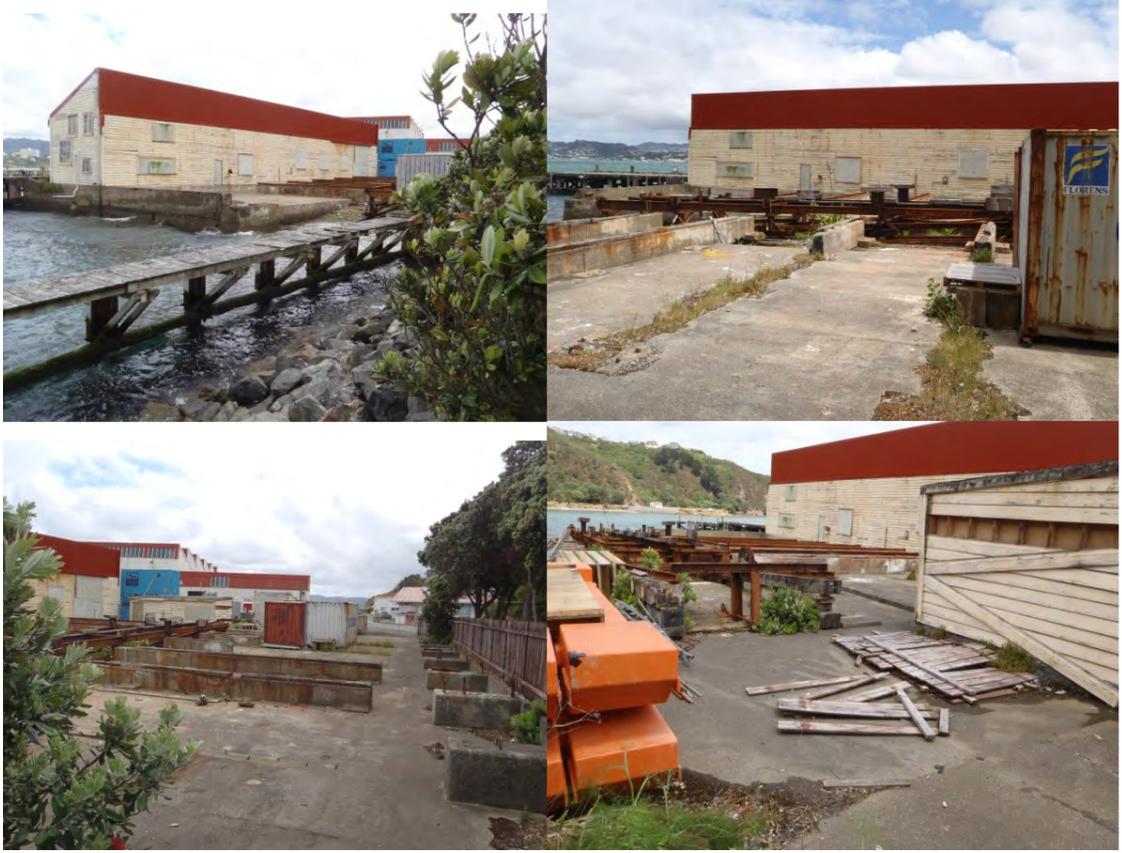
<p>Slipway</p>	<p>Site walkover</p> <p>Evening Post Article: the slipping of Shelly Bay.</p> <p>Opus January 2008</p>	<p>The facility was not observed as part of the PSI. Photographs were taken from outside the fenced area.</p> <p>Article notes: Ex-wartime launches used as civil aviation control craft for the flying boat base in Evans Bay and also finishing boats, pleasure craft and coasters that needed repairing were serviced at the Shelly Bay Slipway.</p> <p>Activities at the slipway have included the recovery of scrap metal, vehicle repair and trailer fabrication.</p> <p>Sediments may contain elevated levels of metals and hydrocarbons from industries undertaken in the area.</p> <p>Photograph 36: Slipway and finger pier taken from Shelly Bay Road.          Photograph 37: Slipway concrete area looking southwest taken from Shelly Bay Road.          Photograph 38: Slipway concrete area looking north taken from Shelly Bay Road.          Photograph 39: Slipway cradle area looking south taken from Shelly Bay Road.</p> <p><b>Evaluation of potential for soil and groundwater impact:</b> Based on aerial photographs it appears that the working areas of the slipway have been concreted. It is therefore considered that localised impact to soil and groundwater may have occurred in localised area (such as the crane hydraulic fluids (if used)).</p> <p>If dredging of the slipway area is required for the development, sediment may be impacted and require specialist disposal.</p>

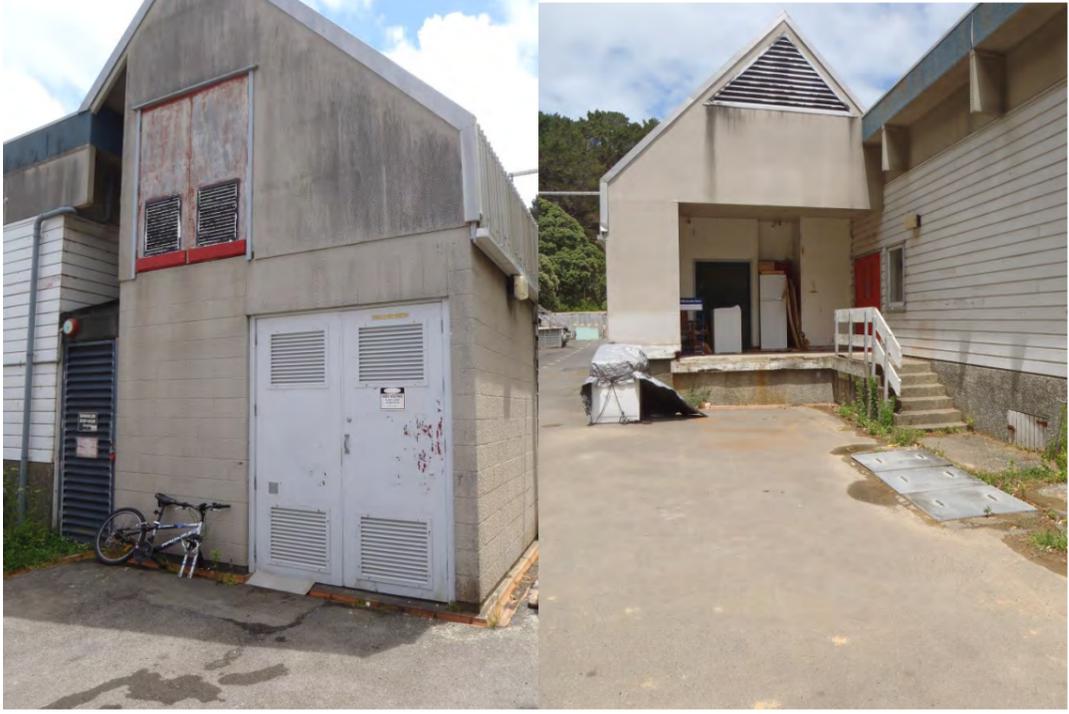
<p>Generator/Refrigeration?</p>	<p>Site Walkover</p>	<p>Generator/Refrigerator present at the rear (east) of the mess facility in North Bay.</p> <p>Photograph 40: Southern exposure of the gas/refrigeration plant at the mess facility.          Photograph 41: Northern exposure of the gas/refrigeration plant at the mess facility.</p> <p><b>Evaluation of potential for soil and groundwater impact:</b> No significant impact expected.</p>

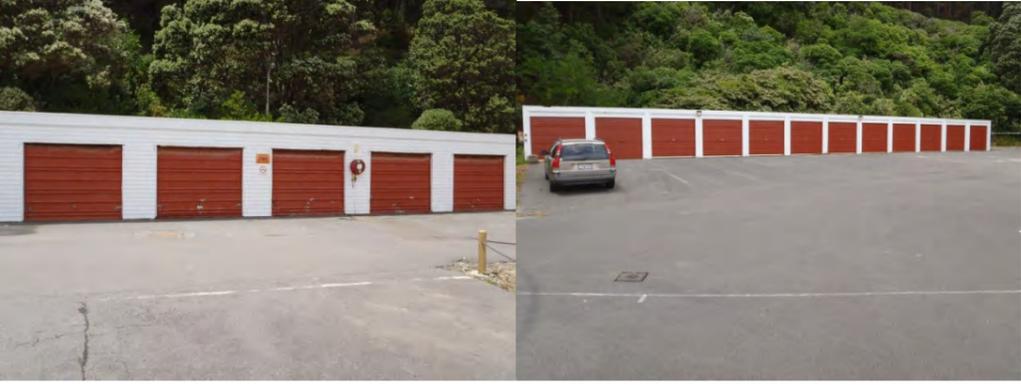
<p>Garaging</p>	<p>Site Walkover</p>	<p>Vehicle garages are located on the eastern boundary of North Bay and the northeast boundary of South Bay.</p> <p>Photograph 42: North Bay garaging. Photograph 43: South Bay garaging</p> <p><i>Evaluation of potential for soil and groundwater impact:</i> No significant impact expected.</p>

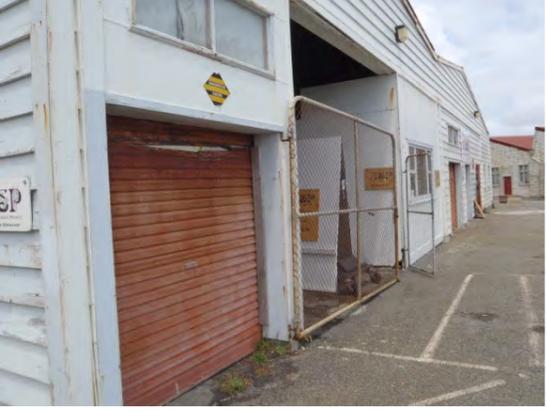
<p>Serco Paint Store</p>	<p>Site Walkover</p>	<p>The Serco Paint Store and Workshop is located directly to the east of Building 8.</p> <p>The facility was not inspected as part of the PSI, however it is expected that vehicle maintenance and the storage of paint was undertaken in this building.</p> <p>Photograph 44: Serco workshop facility.</p> <p><i>Evaluation of potential for soil and groundwater impact:</i> No significant impact expected.</p>
