# Thorndon Connections cycleway audit – safety and accessibility

30% design audit

November 2022

90% design audit

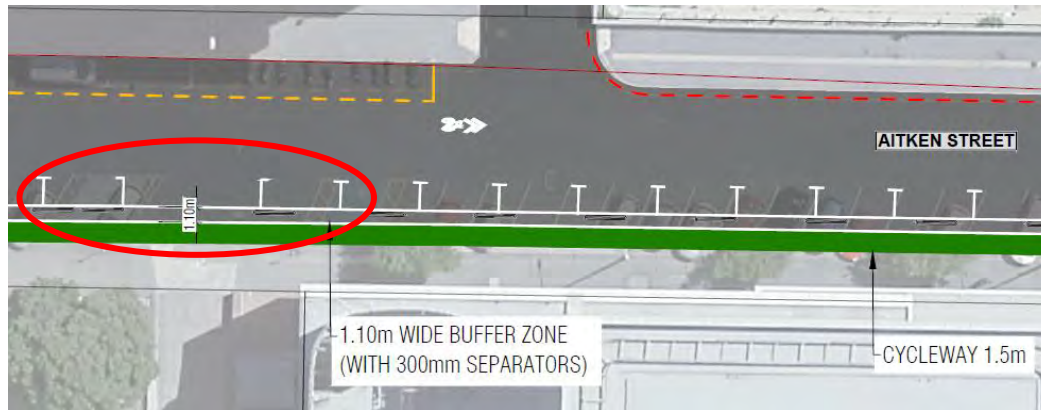
Figure 4-1: Aitken St driveway

The crash type expected is conflict between a motor vehicle entering the driveway and a cyclist on the cycleway, due to the driver’s view of the cyclist being blocked by parked cars. The risk factors are the high parking occupancy along Aitken St and the assumedly high turning volumes into the driveways.

The relevant guideline is Waka Kotahi’s cycling network guidance (CNG) [Technical Note on separated cycleways at side roads and driveways](#), which states that when there are more than four parking spaces on the approach to the driveway, the closest parking space should be set back 8 m from the driveway. On the downstream side a minimum setback of 3 m is recommended. The CNG [High-use Driveway Treatment for Cycle Paths and Shared Paths Design Guidance note](#) gives extra information for treatments at high-use driveways.

Probability of crash occurring	Likely
Expected crash severity	Minor injury
<b>Primary treatment recommendations:</b>	
4.3.1	Increase parking setbacks to driveway to comply with CNG <a href="#">Technical Note on separated cycleways at side roads and driveways</a>
<b>Supporting treatment recommendations:</b>

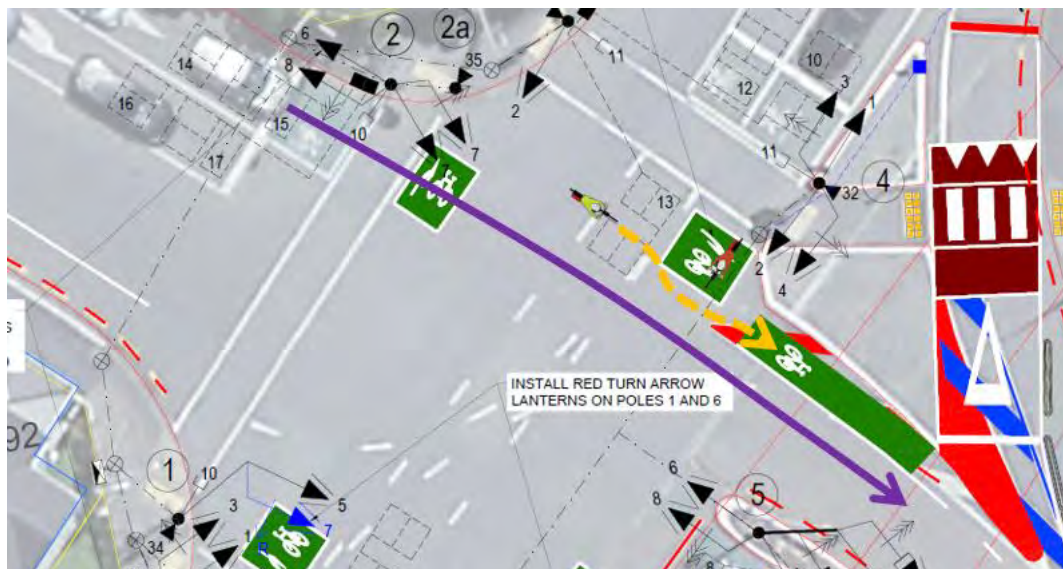
The safety issue is the hook turn box in the north-east quadrant of the intersection sits partially in front of the departure cycle lane on Molesworth St. Therefore, cyclists waiting in the hook turn box could block the path of travel of cyclists heading through from Park St or the hook turn box in the north-west quadrant, forcing them to cut into the general traffic lane (see Figure 4-2).

**Figure 4-2: Through-cyclist deviating to avoid cyclist waiting in hook turn box**

The crash type expected is motor vehicle vs cyclist.

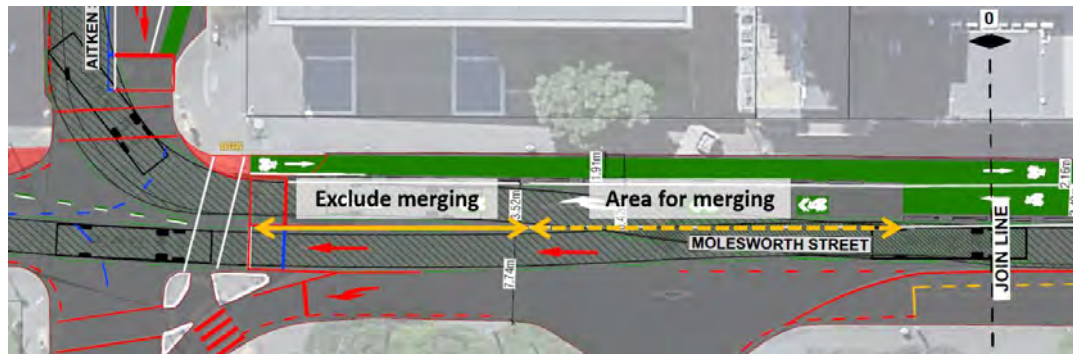
There is currently little available NZ guidance on the design of mixing lanes, however ViaStrada are currently working on a technical note for Waka Kotahi on the subject. It is expected that cyclist volumes will be high in these locations, as are traffic volumes; given also that mixing lanes are not common in Wellington, the probability of a crash occurring is likely. Given that motor vehicles are expected to be travelling around 30 km/h, crashes that do occur would likely result in serious injury.

Figure 4-3: Areas of mixing lane where merging is allowed vs excluded, based on vehicle tracking

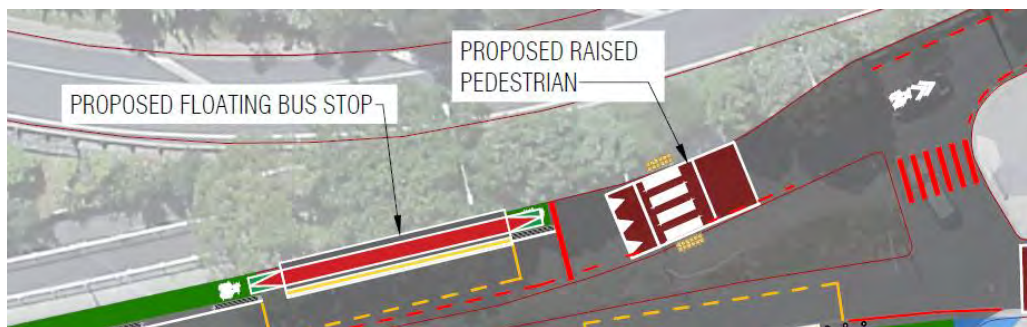
The safety issue is southbound cyclists on Murphy St transitioning from the cycleway to mixed traffic immediately after the floating bus stop (see issue 4.7) and immediately before the new raised pedestrian crossing.

**Figure 4-4: cycleway transition to mixed traffic between bus stop and pedestrian crossing**

The crash type expected is conflict between a cyclist and a motor vehicle. The risk factors include the proximity of the three conflict points, which increases the cognitive load on drivers and cyclists, the lack of sharrows at the merge location (it is not possible to provide these due to the bus stop and the pedestrian crossing) and the potential for drivers to be distracted looking for pedestrians at the crossing rather than cyclists at the merge point. There are no specific standards relating to this issue. Best practice would be sharrows at and just prior to the merge location, but it is not possible to provide these due to the bus stop and the pedestrian crossing. It is anticipated that cyclists will keep left approaching and crossing the pedestrian crossing, so crashes will be unlikely. The raised platform on the pedestrian crossing will slow motor vehicles, so crashes that do occur should only result in minor injury.

Probability of crash occurring	Unlikely
Expected crash severity	Minor injury
<b>Primary treatment recommendations:</b>	
4.8.1	Shift the bus stop northwards, so a merge can be established prior to the pedestrian crossing (this may also help addressing issue 4.7).
4.8.2	OR continue the cycleway past the pedestrian crossing and merge downstream.
<b>Supporting treatment recommendations:</b>	
4.8.3	As well as providing sharrows at the merge location, provide sharrows just prior to the merge, to alert drivers.
4.8.4	Put sharrows in green boxes, to emphasise the merge to mixed traffic.

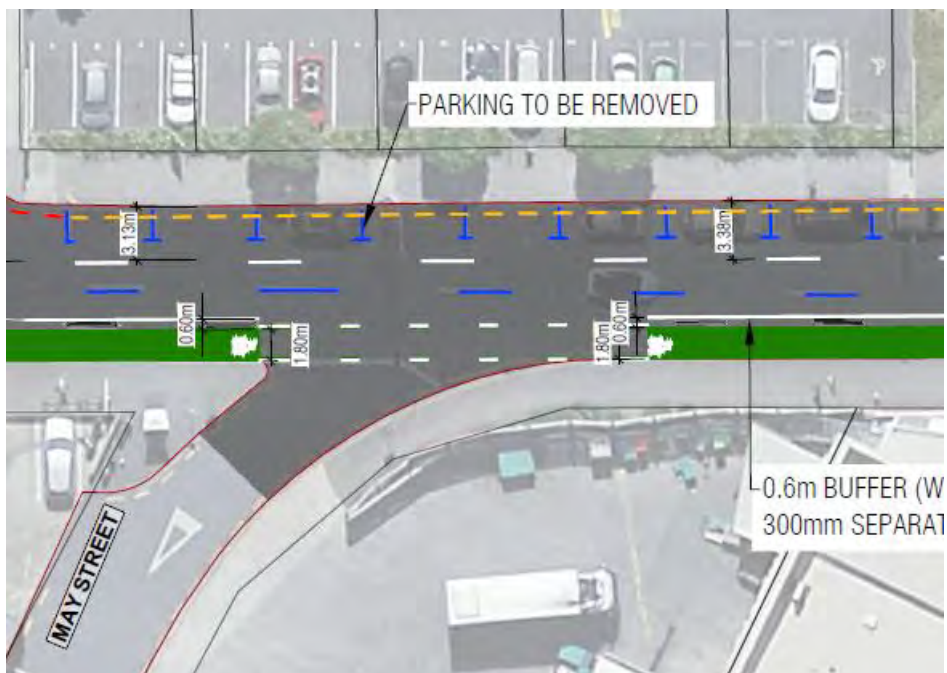
The safety issue is the low angle between the direction May St drivers are heading, and the direction they must look back over their shoulder to see cyclists approaching on the cycleway. Figure 4-5 shows the site location.

The crash type expected is motor vehicle vs. cyclist.

Probability of crash occurring	Unlikely
Expected crash severity	Serious injury
<b>Primary treatment recommendations:</b>	
4.9.1	Cycleway (and pedestrian) raised platform across May St.
4.9.2	Painted island or mountable kerb extension to square up May St approach and reduce vehicle speeds, while still accommodating tracking of heavy vehicles
<b>Supporting treatment recommendations:</b>	
4.9.3	A more conspicuous marking treatment of the cycleway across the side road.
4.9.4	Note the existing limit line needs to be relocated.

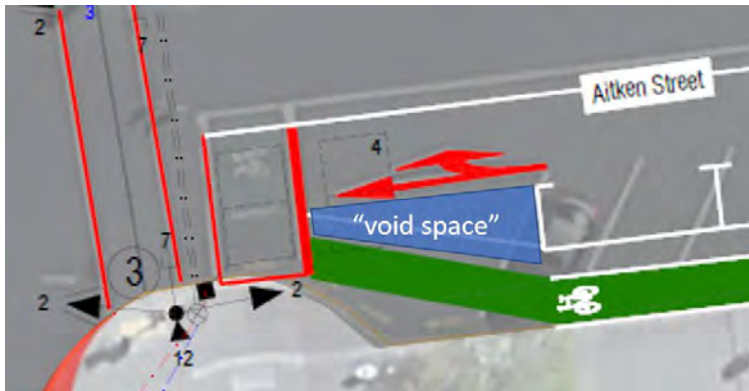
The risk factors for the Aitken St approach include right-turning cyclists having to get past the parallel through-traffic, as they are originating from a kerbside cycle lane. This is complicated by the taper on the cycle lane after the termination of the parking – drivers may use the “void space” (see Figure 4-6) to form two queues. Also, right-turning cyclists will want to wait a shorter distance into the intersection than right-turning drivers, because the cycle lane on Molesworth St is on the right-hand side.

**Figure 4-6: void space on Aitken St approach**

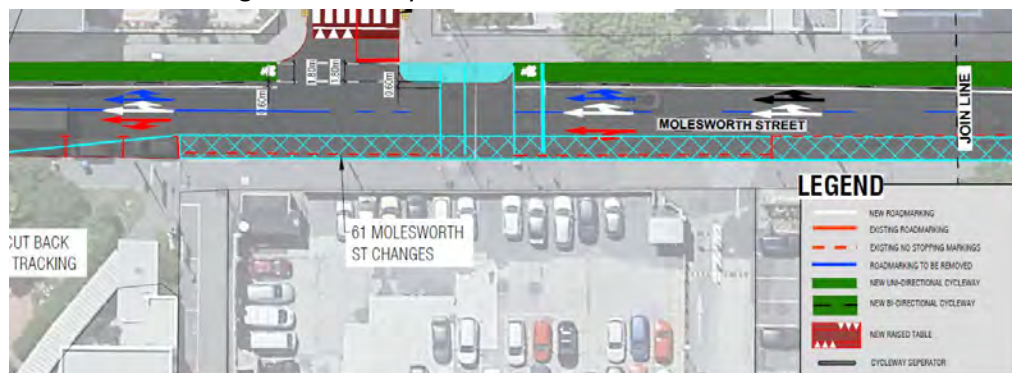
The design colour coding suggests existing shared through / left-turn lane to be retained, and through / right-turn lane to be shifted over, however this does not properly reflect the intention of there being one lane only in this section.

Figure 5-1: Lane markings at 61 Molesworth area

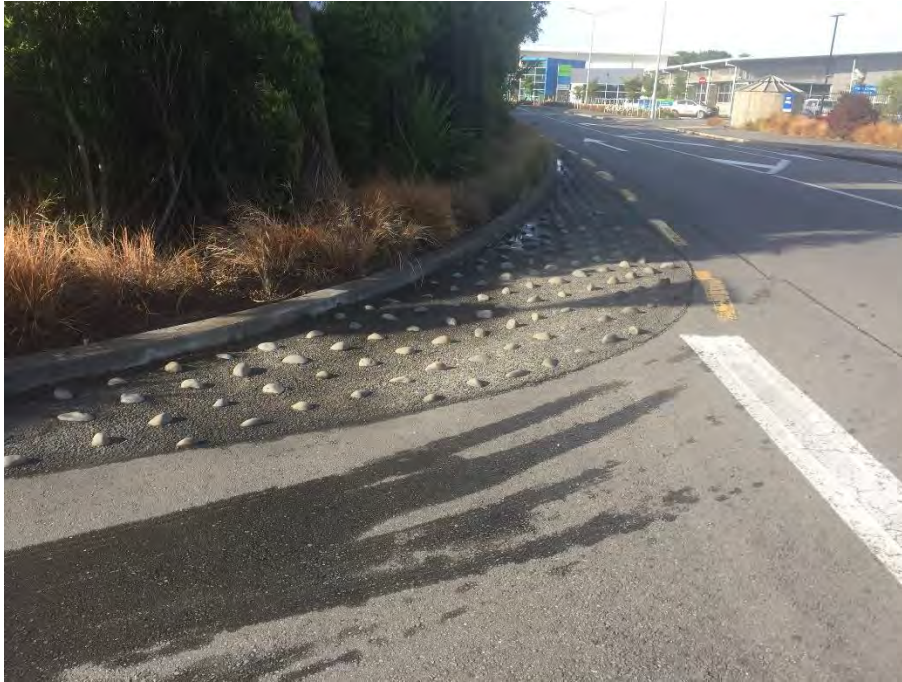
**Figure 4-1: River stones on Sisson Drive**

Probability of crash occurring		Unlikely
Expected crash severity		Serious injury
<b>Primary treatment recommendations:</b>		
4.1.1	<p>Rather than a painted edge line, the area could be filled with river stones set in concrete (similar to the <a href="#">Northlands Mall approach to Sisson Drive</a> in Christchurch – see Figure 4-1). This would be traversable by heavy trucks, but avoided by car drivers.</p> <p>Consider whether the area of the river stone island can be increased above that of the painted edge line currently proposed (based on light vehicle tracking).</p> <p>Ensure a flat pedestrian path through the stony area is included.</p>	
<b>Supporting treatment recommendations:</b>		
4.1.2	N/A

<b>Responses:</b>	
<b>Designer</b>	Agree that the Hill St pedestrian crossing distance is longer than desired and that a traversable kerb buildout could be of use to slow left turning vehicles. However, the use of riverstone material is not in keeping with a transitional approach as this feature cannot be easily changed once installed. The use of low rubber speed humps for buildout would be preferred.
<b>Safety Engineer</b>	Agree with Designer - preference for low rubber speed humps in buildout area.
<b>Proposed action</b>	Agree with above low rubber speed hump treatment more applicable and raised pedestrian crossing and reduced speed limits will reduce risk here also.
<b>Client decision</b>	Agree with Proposed Action
<b>Action taken</b>	Add low rubber speed hump to design.

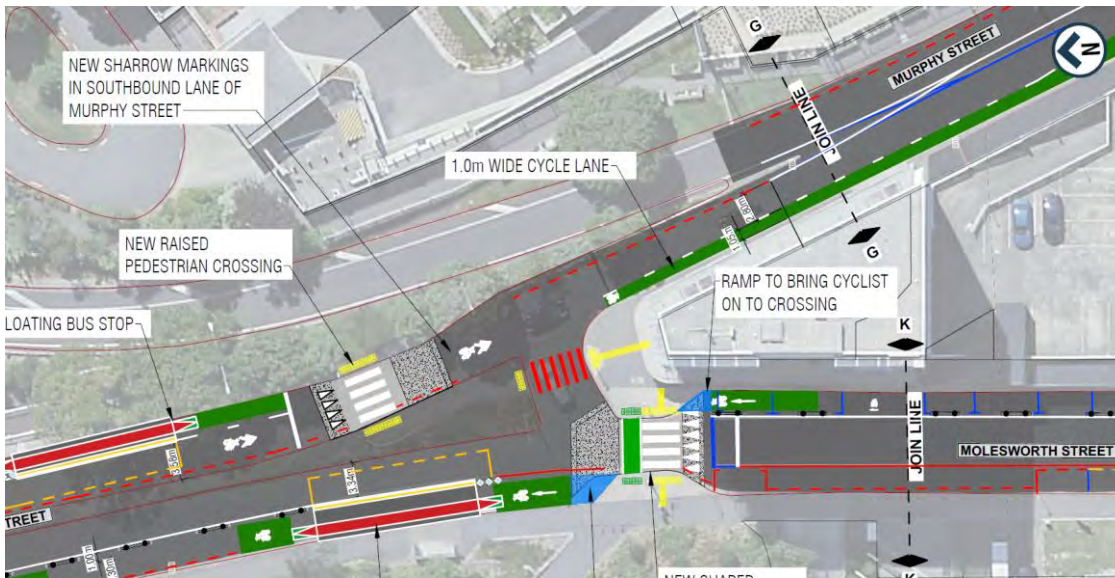
The safety issue is that the merge point for cyclists and motorists appears to be on the pedestrian crossing platform; this could cause confusion for cyclists or motorists and could ultimately result in motorists failing to merge correctly with cyclists or give way to pedestrians on the crossing.

Figure 4-2: cycleway transition in vicinity of bus stop and pedestrian crossing

Firstly, shifting the bus stop back has improved the distance available for cyclists and motorists to merge.

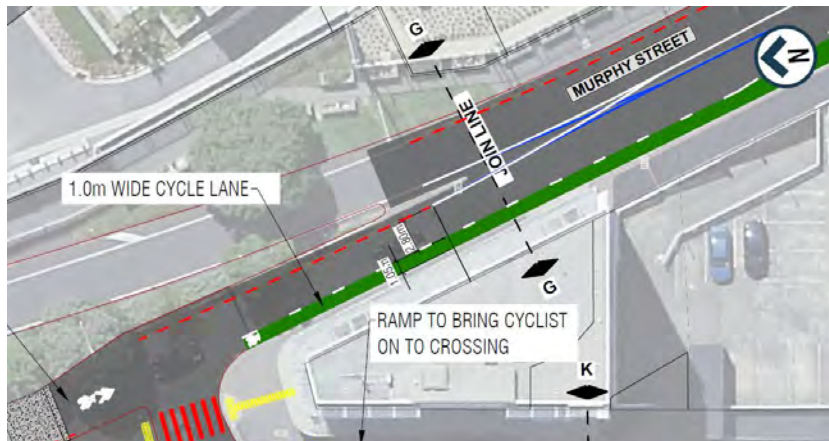
The safety issue is the cycle lane on Murphy Street after the pedestrian crossing (see Figure 4-3) is too narrow.

Figure 4-3: narrow cycle lane on Murphy Street

The crash type expected is cyclist vs motorist.

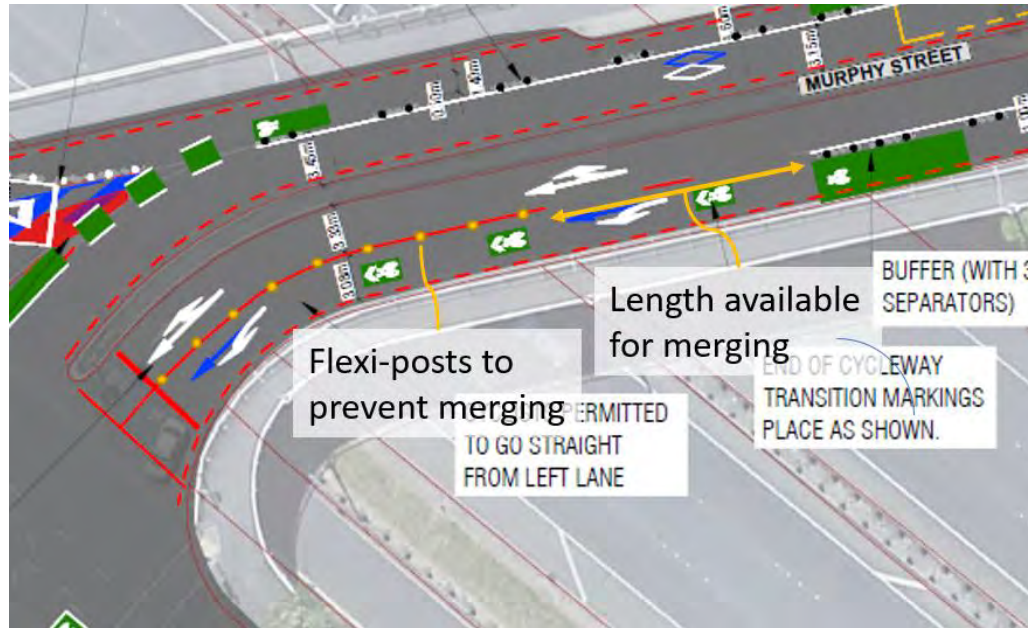
reduce the size of the zone of potential conflict and increase predictability.

Figure 4-4: Mixing lane with defined merging length

<b>Responses:</b>	
<b>Designer</b>	Agree with CAT, to restrict length available for merging
<b>Safety Engineer</b>	Agree with CAT and Designer.
<b>Proposed action</b>	Update plans
<b>Client decision</b>	Agree with Proposed Action
<b>Action taken</b>	Plans updated

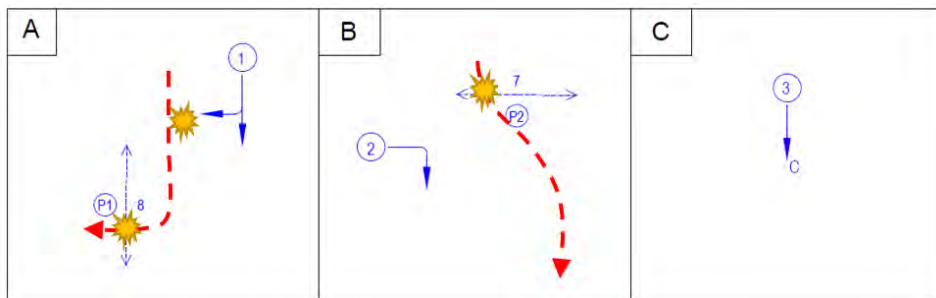
The problem is that, in either the A or B phase, there will be cyclists waiting at the limit line believing that they could progress safely, and some cyclists will choose to run a red light to improve their efficiency – these are illustrated in Figure 4-5. In the B phase, cyclists travelling along Mulgrave Street would be safe to cross on a sharp diagonal, provided they do not conflict with any pedestrians crossing Mulgrave Street. In the A phase, cyclists turning right might do so, but they would risk conflict with any pedestrians crossing Aitken Street and, of greater concern, they would be at risk of being hit by vehicles turning right into Aitken Street.

**Figure 4-5: Likely cyclist non-compliant manoeuvres and resulting conflicts**

Furthermore, whilst one cyclist may be able to judge a safe manoeuvre, subsequent cyclists may follow along without adequately judging the situation. For example, a confident right turning cyclist may move in the B phase, knowing they can make it before an approaching right turning vehicle, but the cyclist behind them may not notice the vehicle or judge the

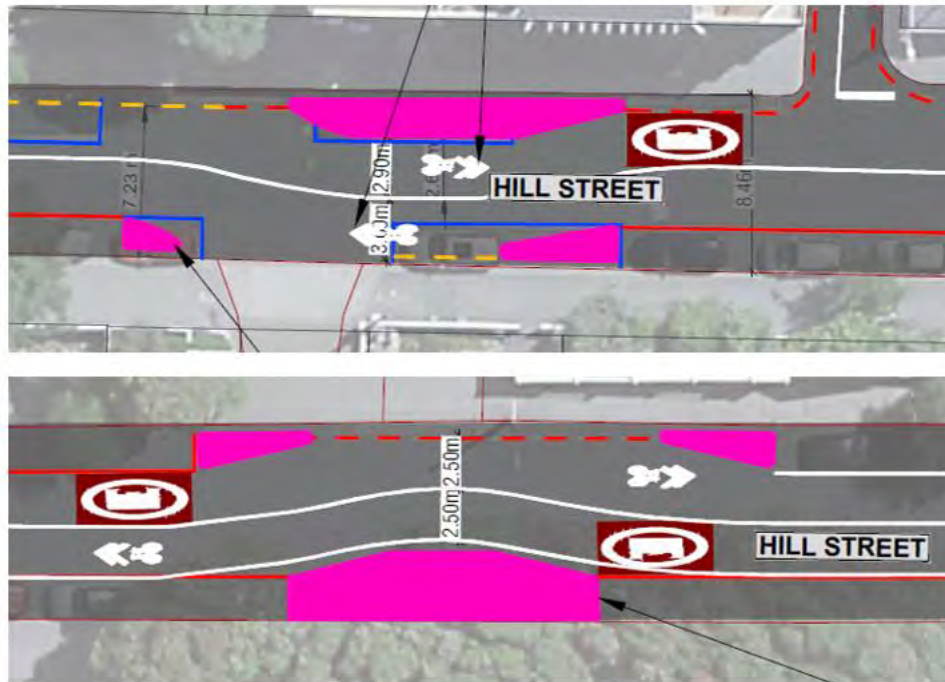
The two chicanes on Hill Street employ different marking layouts regarding the use of the 30 and sharrows markings (Figure 5-1). It would be preferable to have a consistent design.

**Figure 5-1: Different chicane designs on Hill Street**

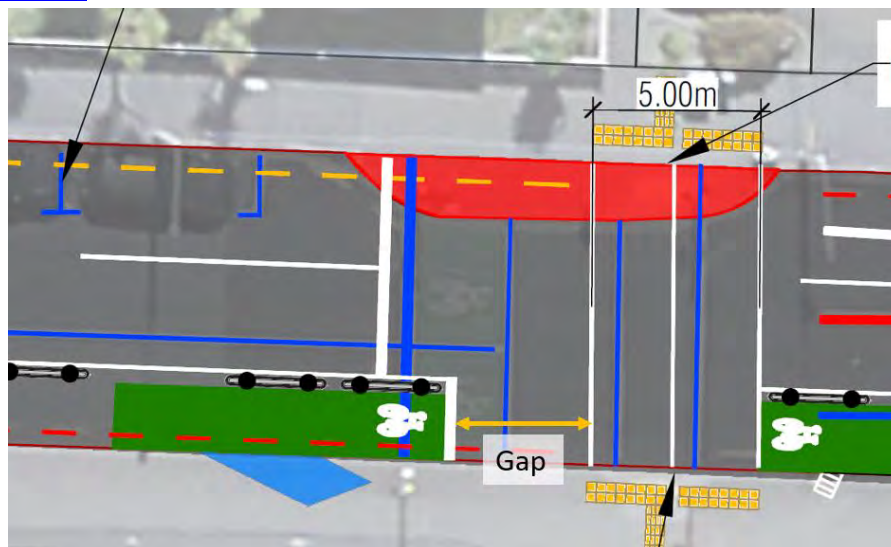
There is a large gap between the advanced stop line and the pedestrian / cycle midblock crossing line; this is only required to be 200mm – see CNG section on [cyclist waiting facilities at intersections](#).

Figure 5-2: Gap between limit line and pedestrian crosswalk
