WCC Housing Detailed Seismic Assessments

Berkeley Dallard – Detailed Seismic Assessment

Wellington City Council

Reference: 523020

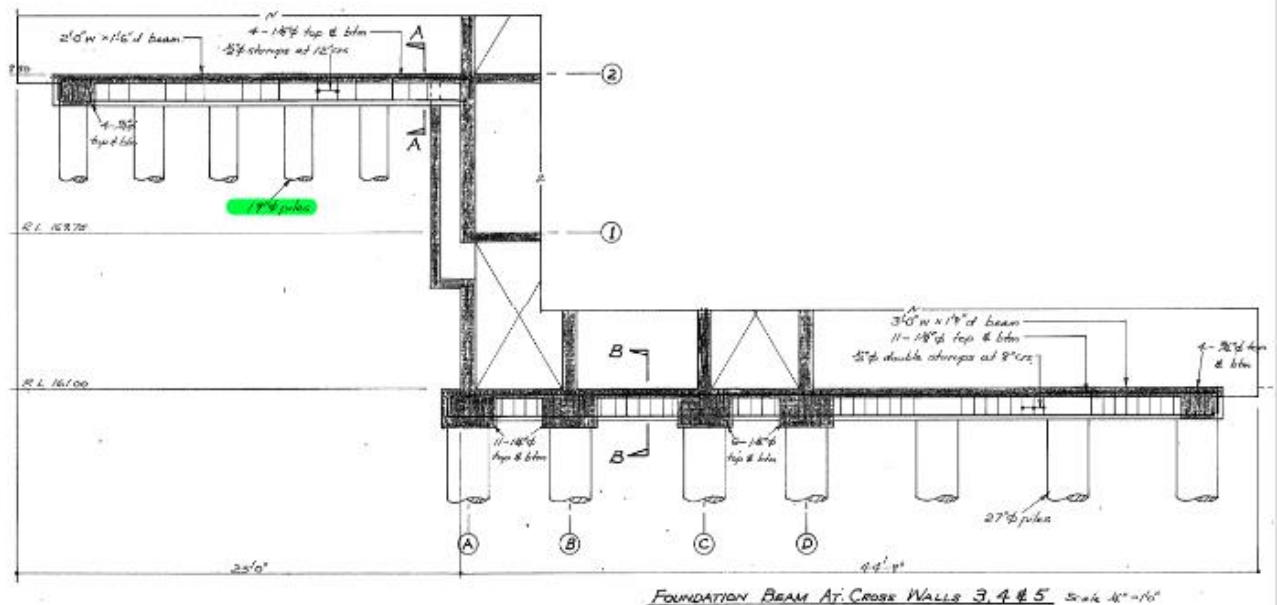
Figure 4-3, Typical Soil Retaining Structure

Also, the passive pressure from the soil retaining structures is not relied on. As shown in **Figure 4-3** the general construction method was to build a temporary soil retaining structure and then build the shear walls of the building with a gap behind the temporary retaining structure. Therefore, even when the piles fail and the building starts to slide, the passive pressure of the soil retaining structure will not provide immediate resistance until the sliding exceeds the gap width. Therefore, this mechanism is not considered to be reliable to resist the lateral loads.

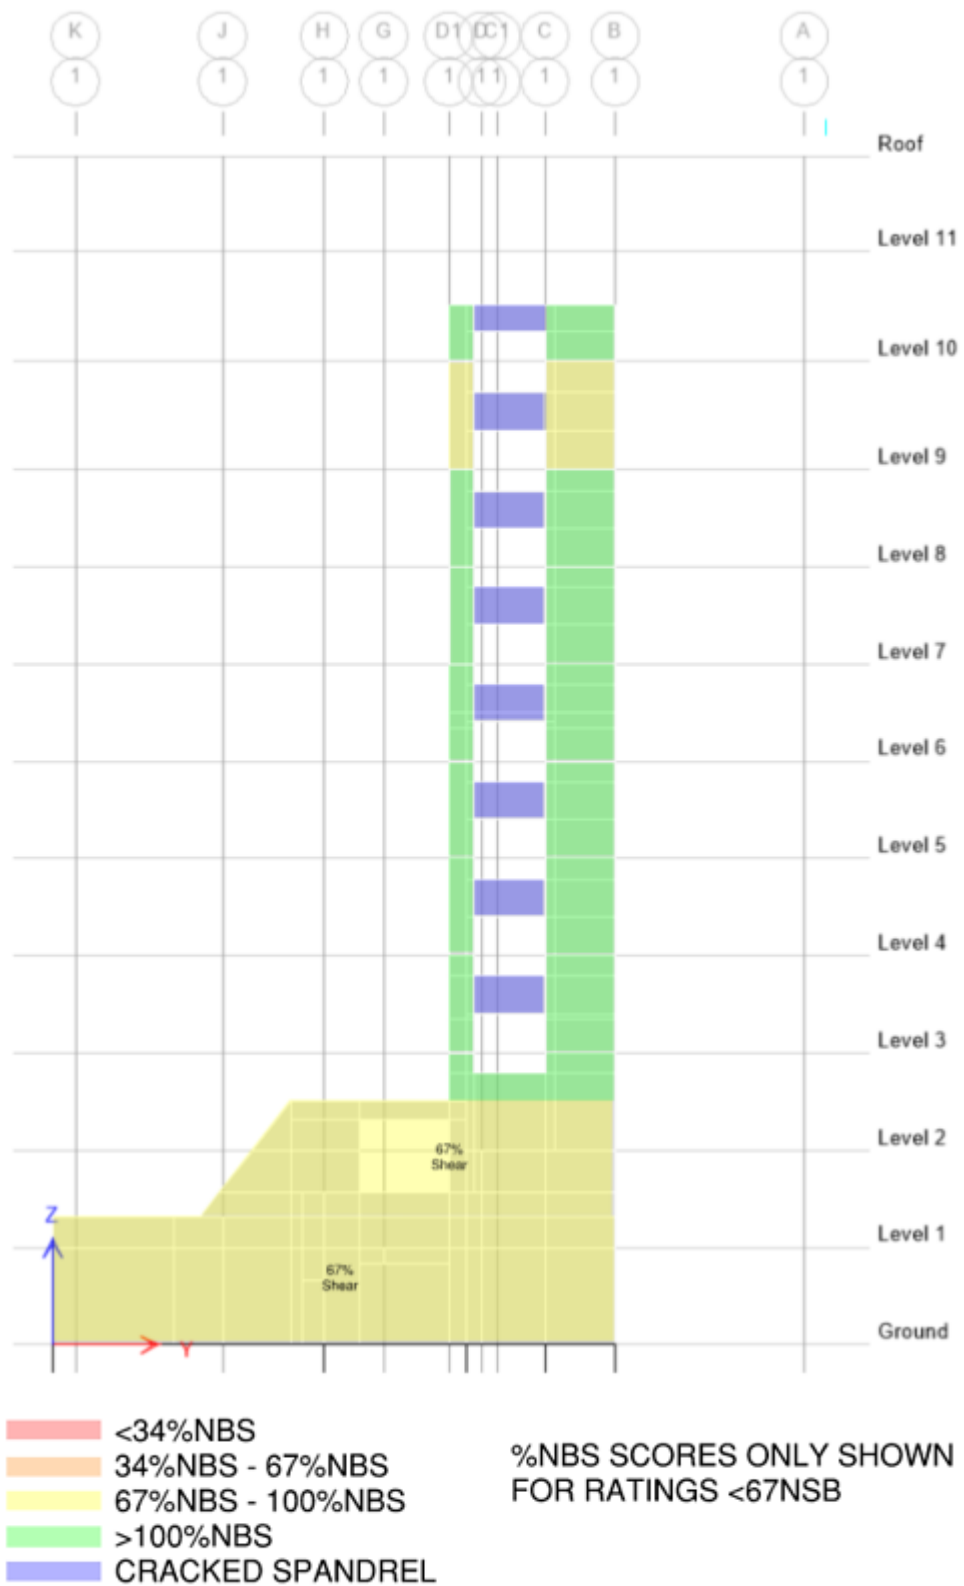
Figure 5-3, Critical Transverse Direction Wall – North Structure

Refer to **Figure 5-3, Critical Transverse Direction Wall – North Structure** and **Figure 5-4, Critical Longitudinal Direction Wall – North Structure** for the critical gridline ratings in the longitudinal and transverse walls in the North Building and **Figure 5-5, Critical Transverse Direction Wall – South Structure** and **Figure 5-6** for the critical longitudinal and transverse walls in the South structure. All critical walls with their scoring are shown in **Appendix H**.

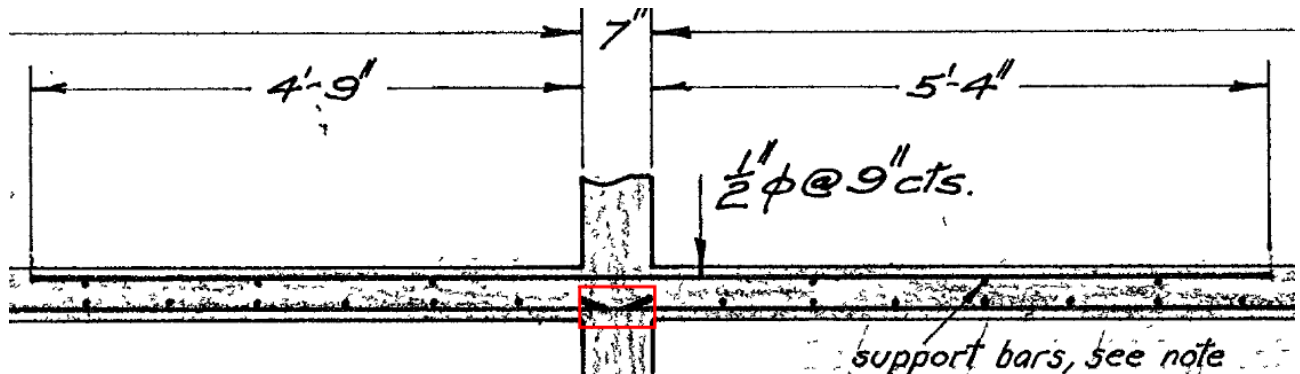
Figure 5-7, Typical bottom reinforcement lap detail in walls

In our analysis, since the diaphragm was reinforced with the ductile deformed bars, we allowed for the force redistribution. It is noted that the capacity of the bottom layer reinforcement at wall locations are ignored as the lap length for the bottom layer of the reinforcement is significantly less than what is required. This was due to having a poor lap splice detail. **Figure 5-7** shows the typical detail of the bottom layer lap splice that lacks evidence on the lap length or how the bottom bars are lapped. This was understood as an unreliable load path, and given the uncertainty, we ignored the contribution.

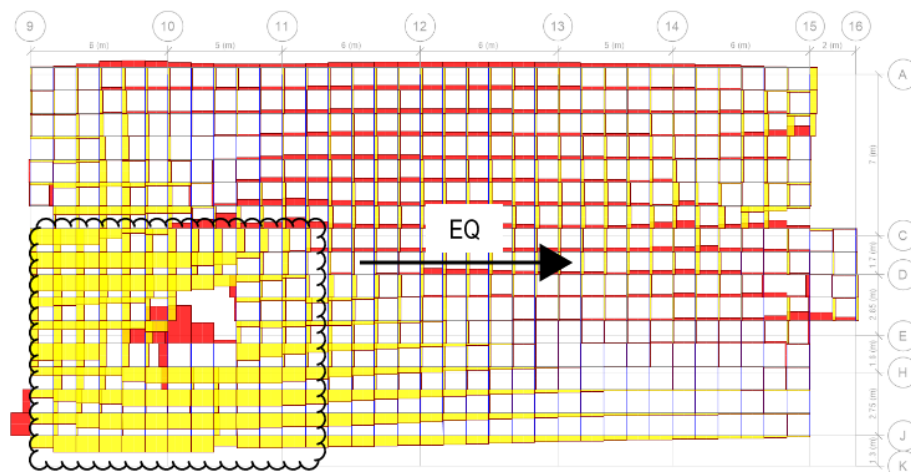
Figure 5-8, Expected Localized Damage around Corner Walls in the South building
(Diagonal Members not Shown for Clarity)

The diaphragms in the longitudinal direction have insufficient capacity to reliably transfer 100% ULS inertia loads and therefore, was identified as a Structural Weakness. Localised damage around the longitudinal shear walls located in the corners is expected in a severe earthquake. Refer to **Figure 5-8** for the expected localized damage for the positive earthquake loading in the longitudinal direction. Comparable localized damage is expected for the North building as indicated in **Figure 5-9**.

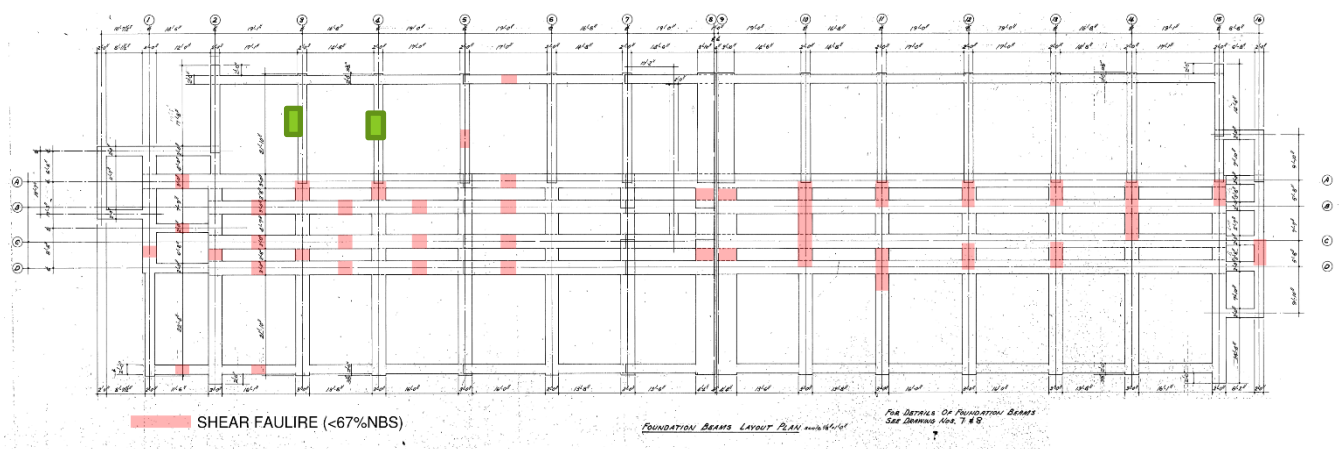
Figure 5-10, Ground Beams with Highlighted Shear Failure Locations (Left: North Building, Right: South Building)

A shear failure is a brittle mechanism which prohibits load redistribution among the foundation elements and where there's no other viable load path, it acts as a fuse, not letting certain piles to contribute to lateral load. Accordingly, shear governed ground beams are eliminated as a viable load path and a redistribution of load was considered. Refer to **Figure 5-10** for the locations where the ground beams which are expected to have a shear failure mechanism.
