HUP2-T0-Seismic Assessments

144 Daniell Street - DANH– Detailed Seismic Assessment

Wellington City Council

Reference 525885

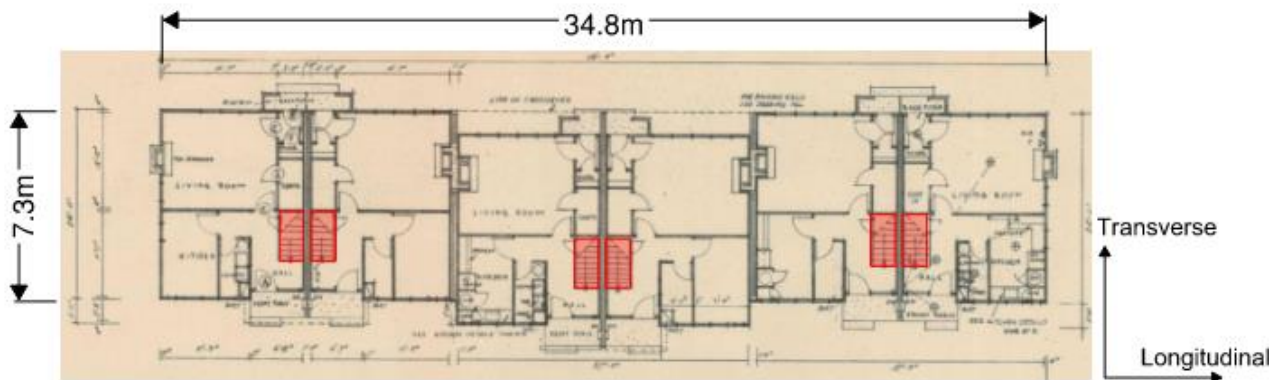
Figure 3-1. Stair Locations

The stairs are timber-framed boxed stairs. The existing structural drawings do not contain sufficient information to seismically assess the stairs.

However, according to the Guidelines, internal stairs constructed of timber are unlikely to lead to a significant life safety hazard due to loss of egress. Refer to Figure 3-1 that shows the locations of the stairs.

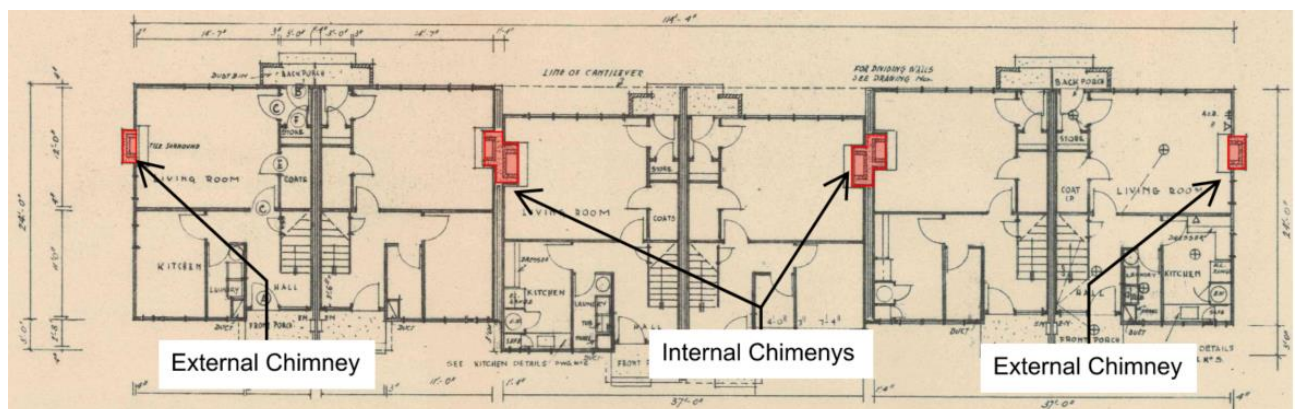
Figure 3-2. Chimney Locations

The internal RC chimneys have sufficient capacity to resist out-of-plane seismic loading. The existing drawings indicate that the original internal RC chimneys are positively connected to the RC party walls with reinforced bars.

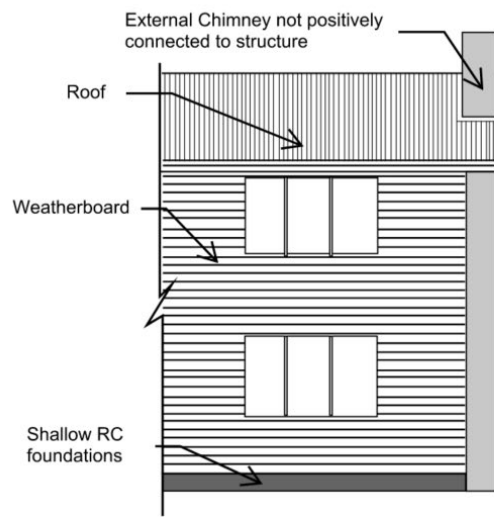
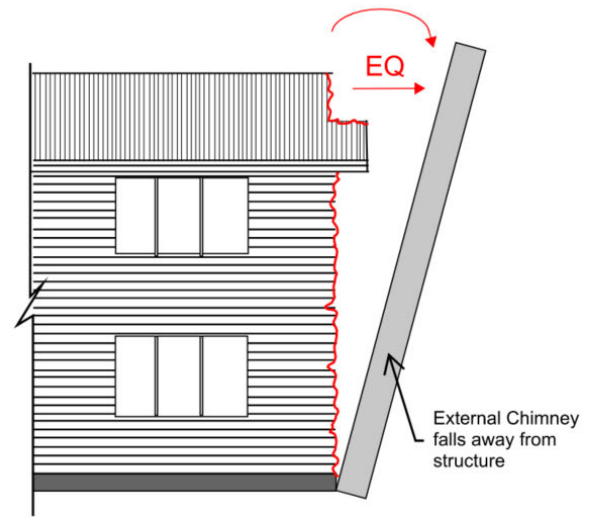
Figure 3-3 External Chimney Failure Mode

The perimeter external reinforcement concrete chimney overturning capacity to resist out-of-plane parts seismic loading. The chimney is anticipated to fall away from the building, potentially posing a hazard to pedestrians during a design-level earthquake. However, the chimney is not expected to be a hazard for people inside the building during such an event. The external chimney failure mode is shown in Figure 3-3.

- Removing the external chimney.
