HUP2-T0-Seismic Assessments

WCC Housing Detailed Seismic Assessments

146 Daniell Street – DANI– Detailed Seismic Assessment

Wellington City Council

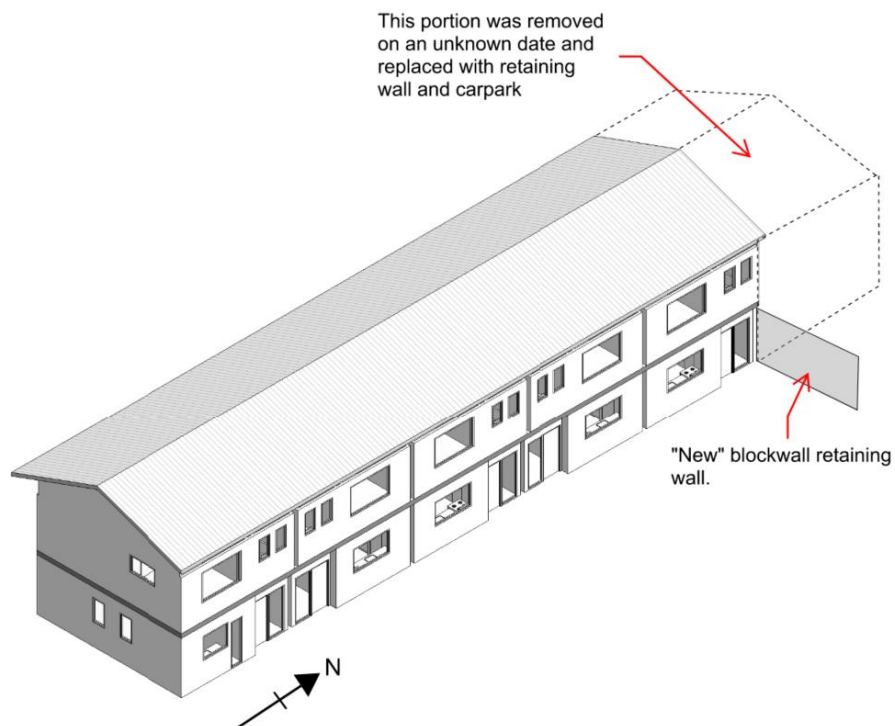
Figure 1-3. 3D View of Building

On an unknown date, the northern unit of the building was removed and replaced with a car park and retaining wall (Figure 1-3). For this DSA, we assumed that the structure and retaining wall are not positively connected and that the structure does not resist any soil loading. Further investigations are required to confirm this assumption.

Finally, we recommend undertaking onsite investigations to confirm that the structure and the northern retaining wall are not positively connected.

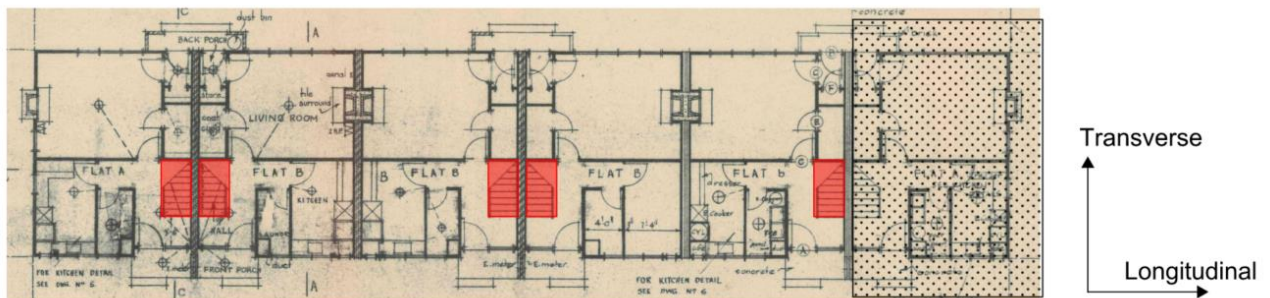
Figure 3-1. Stair Locations

The stairs are timber-framed boxed stairs. The existing structural drawings do not contain sufficient information to seismically assess the stairs.

However, according to the Guidelines, internal stairs constructed of timber are unlikely to lead to a significant life safety hazard due to loss of egress. Refer to Figure 3-1 that shows the locations of the stairs.

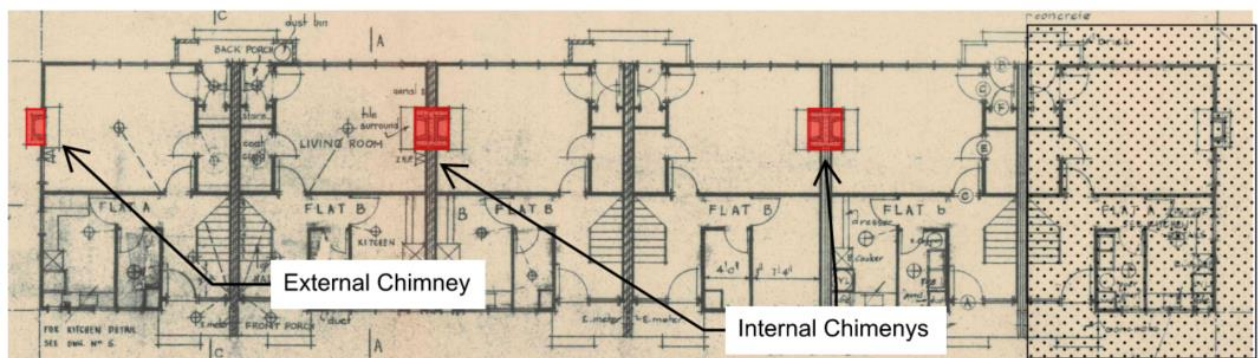
Figure 3-2. Chimney Locations

The perimeter external reinforcement concrete chimney overturning capacity to resist out-of-plane parts seismic loading. The perimeter chimney is not positively connected to the main structure. The chimney is anticipated to fall away from the building, potentially posing a hazard to pedestrians during a design-level earthquake. However, the chimney is not expected to be a hazard for people inside the building during such an event. The chimney is not positively tied back to the timber structure and functions as a stand-alone structure. The external chimney failure mode is shown in Figure 3-3.

The internal RC chimneys have sufficient capacity to resist out-of-plane seismic loading. The internal chimneys are expected to bear on the timber joists and diaphragm to transfer their load.

We recommend retrofitting the building to achieve a minimum seismic rating greater than 34%NBS (IL2). Our review indicates that seismic strengthening, to attain a rating exceeding 34%NBS (IL2), would involve, removing the external chimney.
