# **HUP2-T0-Seismic Assessments**

## **WCC Housing Detailed Seismic Assessments**

148 Daniell Street - DANJ– Detailed Seismic Assessment

**Wellington City Council**

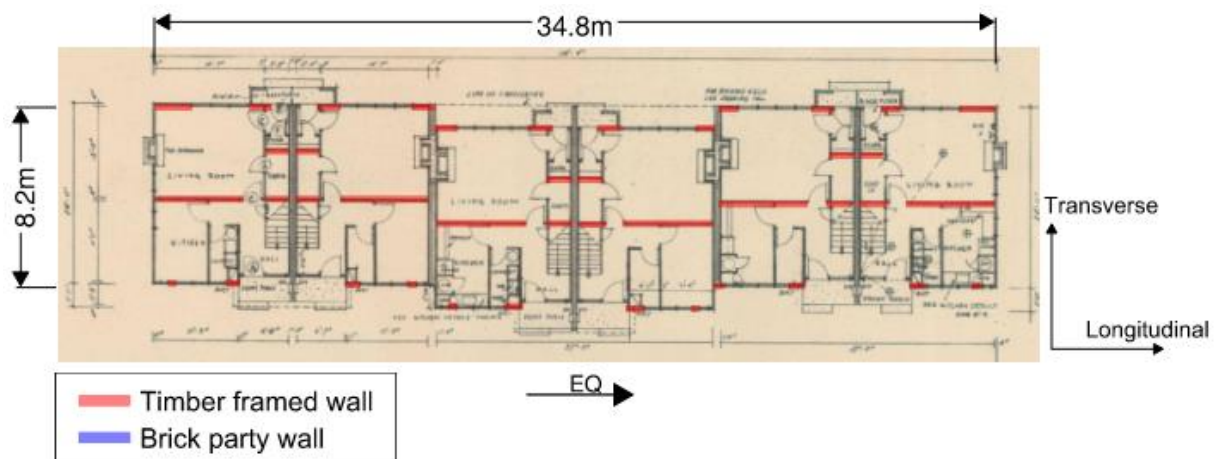
Figure 1-4. Lateral Load Resisting Elements in the Longitudinal Direction

Element:	%NBS(IL2):	Commentary:
Timber framed brace walls with plasterboard sheathing – Longitudinal Direction	35-55%	<ul style="list-style-type: none"><li>■ The timber framed walls have insufficient in-plane capacity in the longitudinal direction at the ground level. The bracing was assessed using a ductility of 3.5 and <math>S_p=0.5</math>. The range of %NBS is due to the unknown plasterboard fixing spacing. The lower bound range is derived by assuming the plasterboard fixing at 300mm centres and the resistance from external weatherboard, and the upper bound %NBS is determined based on the plasterboard fixing at 150mm centres and external weatherboard.</li><li>■ The out-of-plane seismic load from the unreinforced block party walls must be resisted by the walls in the longitudinal direction. And the total length of timber framed brace wall in the longitudinal direction is relatively short compared to the walls in the transverse direction.</li><li>■ The timber framed walls in the longitudinal direction at the first level scores at 100%NBS(IL2).</li></ul>

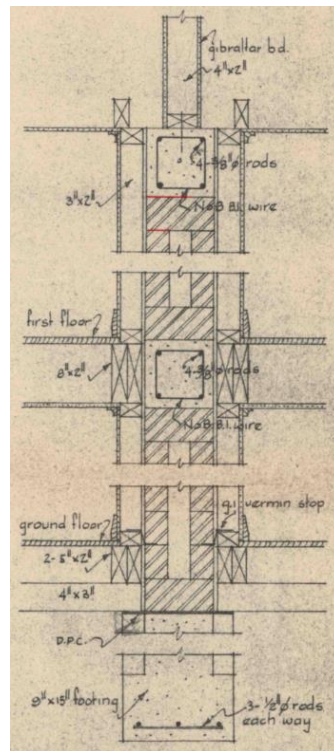
**Figure 1-6 RC Party Wall Elevation**

Unreinforced Block Party Wall	60%	<ul style="list-style-type: none"> <li>■ The unreinforced block party wall lacks the capacity to resist out-of-plane seismic loading. However, the timber studs on either side of the walls can vertically span between levels, preventing the walls from falling out-of-plane. The timber studs achieve a 60%NBS score based on their flexural capacity.</li> <li>■ Additionally, we observe, based on the existing drawings, that there is no apparent positive connection from the party walls to the diaphragm. Instead, the walls are expected to bear on the timber joists and diaphragm to transfer their load.</li> <li>■ The unreinforced block party walls are governed by toe crushing when subjected to in-plane loading and achieve a score of 100%NBS.</li> </ul>
RC Chimneys	15%	<ul style="list-style-type: none"> <li>■ The perimeter external reinforcement concrete (RC) chimney overturning capacity to resist out-of-plane parts seismic loading.</li> <li>■ The chimney is expected to overturn away from the building, potentially posing a hazard to pedestrians during a design-level earthquake. However, it is not anticipated to be a hazard for individuals inside the building during such an event. The chimney is not positively tied back to the timber structure and functions as a stand-alone structure.</li> <li>■ The internal RC chimneys have sufficient capacity to resist out-of-plane seismic loading. The existing drawings indicate that the original internal RC chimneys are positively connected to the party walls with reinforced bars. The internal chimneys are expected to bear on the timber joists and diaphragm to transfer their load.</li> </ul>

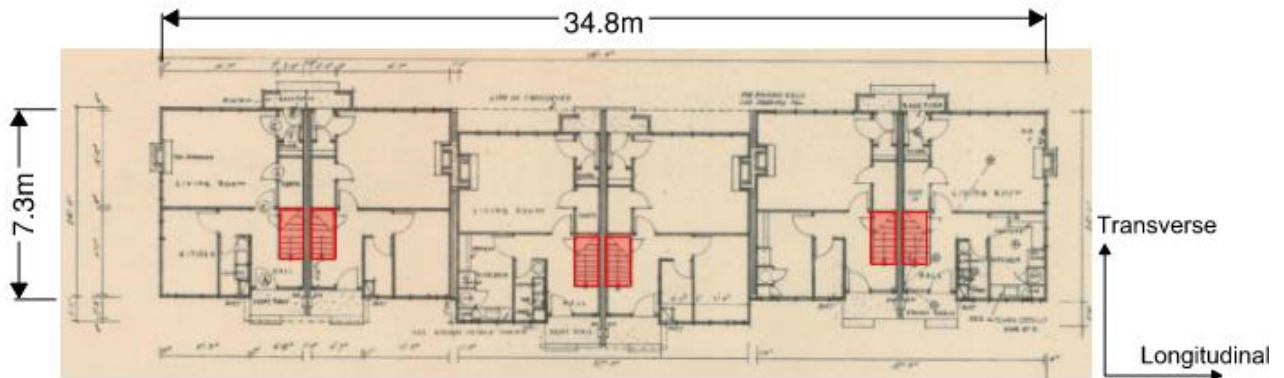
Figure 3-1. Stair Locations

The stairs are timber-framed boxed stairs. The existing structural drawings do not contain sufficient information to seismically assess the stairs.

However, according to the Guidelines, internal stairs constructed of timber are unlikely to lead to a significant life safety hazard due to loss of egress. Refer to Figure 3-1 that shows the locations of the stairs.
