WHAA Detailed Seismic Assessment

16 Glenmore Street

Document Number:
N0541-RBG-WHA-XX-RP-ST-00001

Prepared for Wellington City Council

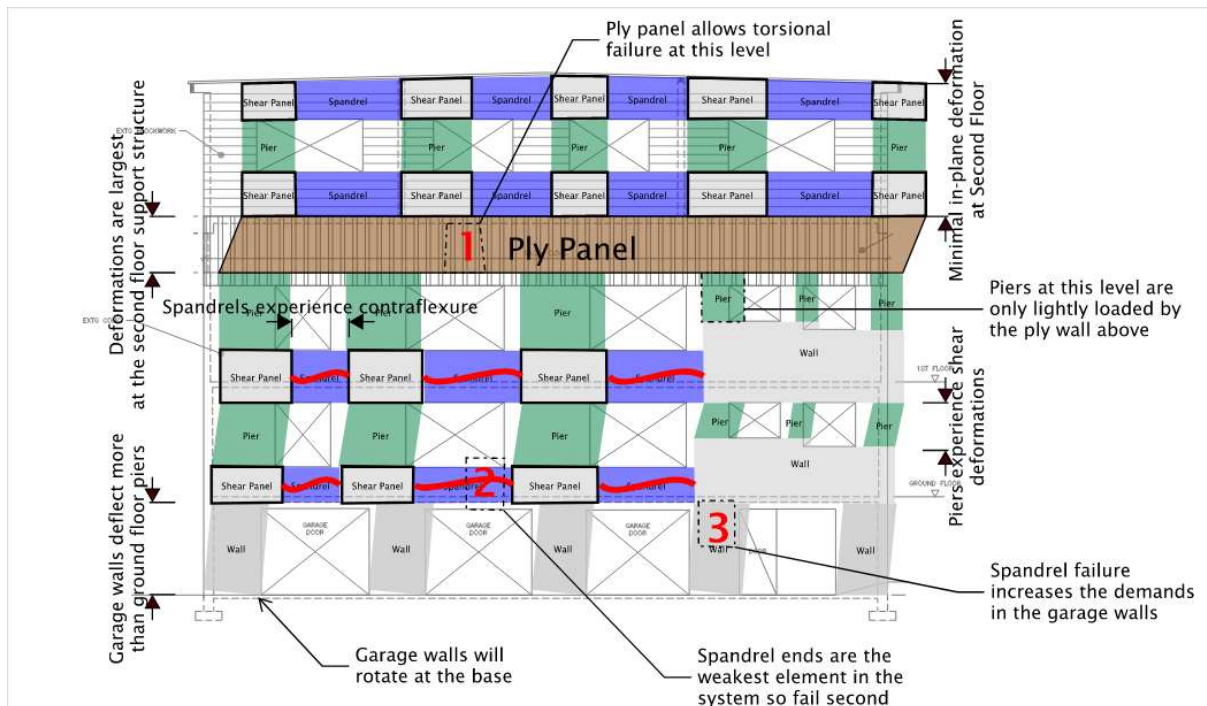
Figure 10: Qualitative results summary

The ETABS modelling shows that the inherently torsional response at the second-floor support structure limits the performance of the system. The plywood allows relatively large displacements at the front of the building, in turn inducing second-order buckling in the wall stitching the 1950 building to the 1975 extension. A failure of this type in this location could be catastrophic, because the kinetic loads from the upper storey landing on the first floor will be very high.

The next-weakest elements in the system are the spandrel panels. These panels experience contraflexure as the structure tries to rotate. The spandrel panels try to restrain the rotation of the joints and the piers. Since there is no fixity in the walls at the bottom of the garage, once the spandrels fail there is nothing to restrain movement in the front wall. In a more typical building, where the base of the cantilever walls were fixed, the failure of a spandrel panel transfers load into those fixed bases, but here that is not possible.

Because they are not fixed against rotation at the base, and because they are shorter than the piers above, the garage walls are far more flexible than the structure above. They are supported against lateral movement

by the concrete floor above the garages, but the garage concrete construction is also a torsional “C” shape. Once the garage walls begin to experience damage or significant rotation, they also begin to lose their ability to carry vertical loads, which would be potentially catastrophic..

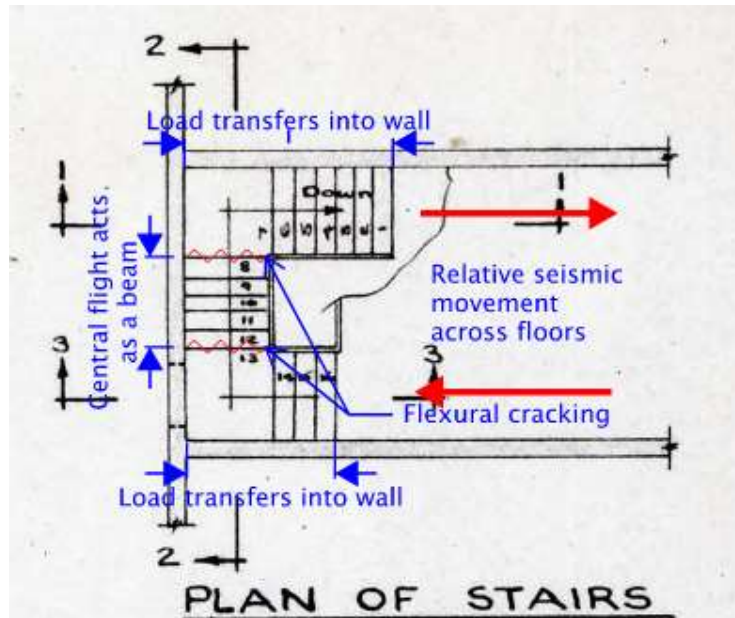
Figure 12: Stair load paths

The internal stairs from Ground to First are formed from in-situ concrete with no apparent seismic detailing for movement, but they also contain a landing at mid height that prevents an efficient strut forming between the storeys. The stairs are built into the walls on one side, and the connection is detailed showing a hooked bar which will allow them to transfer loads into the stairs. This is illustrated in the diagram below:

This flexural cracking could make the stairs inoperable at higher levels of shaking, but is not likely to prevent use of the stairs at the levels of shaking which would cause primary structural damage. Due to the stiff connections to surrounding walls even high levels of shaking are unlikely to lead to the kind of buckling collapse that a direct stair flight could experience.

The concrete stairs represent a hazard to the occupants because once they are damaged it may make it difficult to evacuate the building. However, they are likely to perform adequately above levels of shaking that will cause one of the primary systems to fail, as described elsewhere in this report.

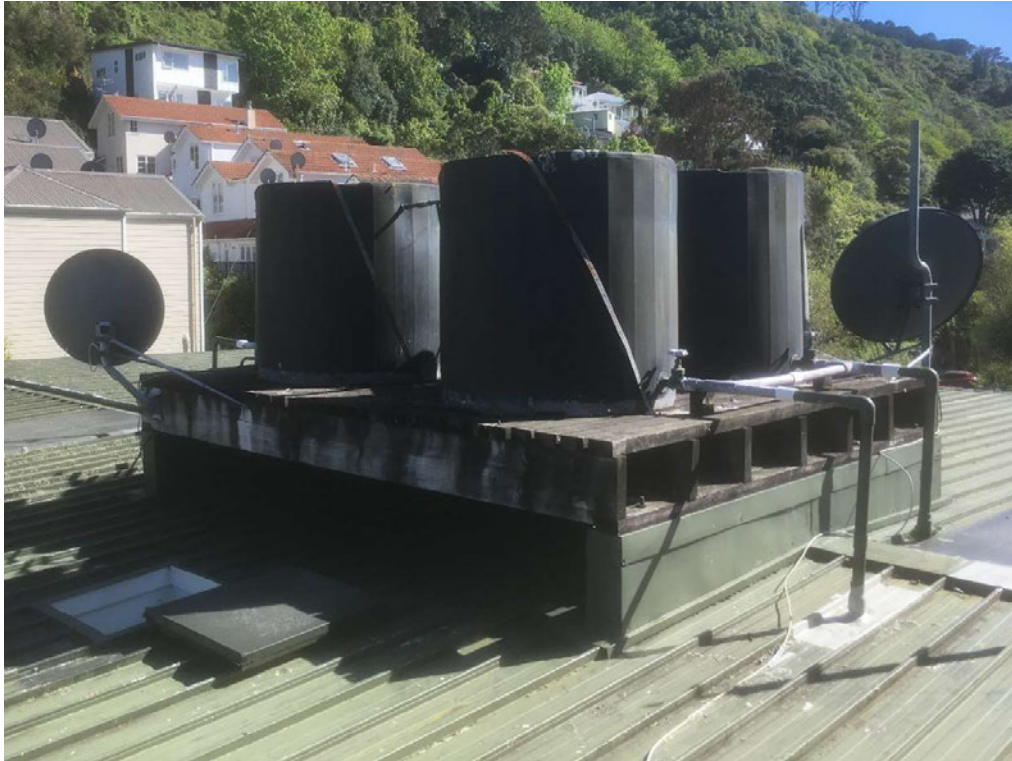
Figure 13: Roof tank support structure

There are four tanks of 750l each. In the 1974 drawings, they were intended to be supported on a substantial platform with an enclosure, but in reality they appear to be supported by two timber walls built above the 1974 block walls supporting a timber platform, refer to the photo below.

From the photos provided, there is a notional seismic restraint to the tanks on top of the platform, but this is likely to be inadequate for all but the lowest of seismic loads. The bolts connecting the platform to the support walls appear nominal, so the platform could become detached, and the joists for the platform appear to be unrestrained from rotation so can suffer rolling shear failures.

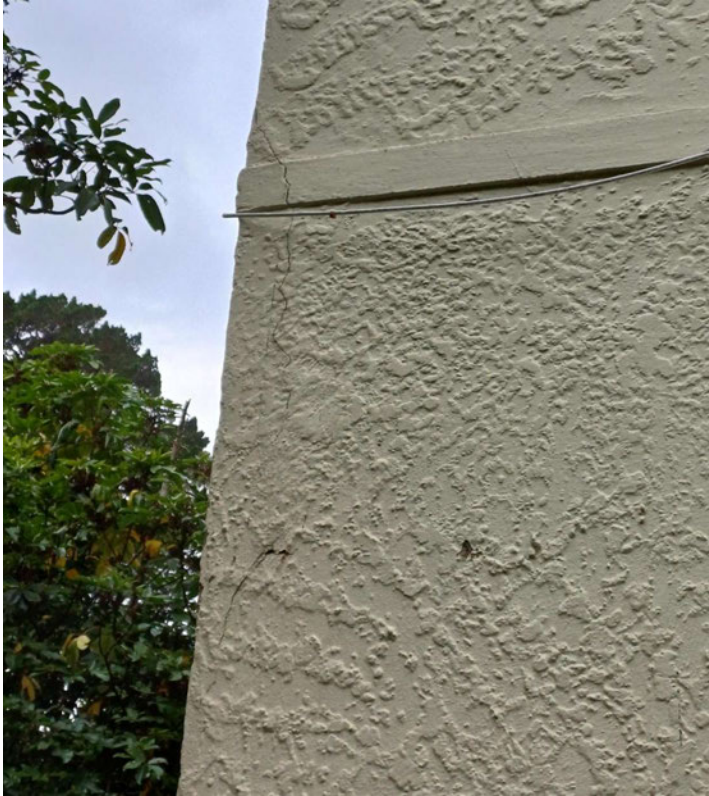
Cracks have been observed in the exterior of the building. The location of the cracks does not correspond well with cracking that might arise from previous earthquakes, so we infer that these cracks are due to corrosion of the steel. The building has exceeded its notional design life, so it is possible for corrosion to have happened. This can only be determined by further investigation, including breaking out areas with large cracks to examine the steel directly. Refer to annotations in Inspection Photographs.

Cracking at Glenmore/Driveway Corner (Grid F/5 intersection)

This may indicate advanced corrosion in the original reinforcing steel.

BREAK OUT CONCRETE AT CRACKS TO DETERMINE REINFORCING CONDITION

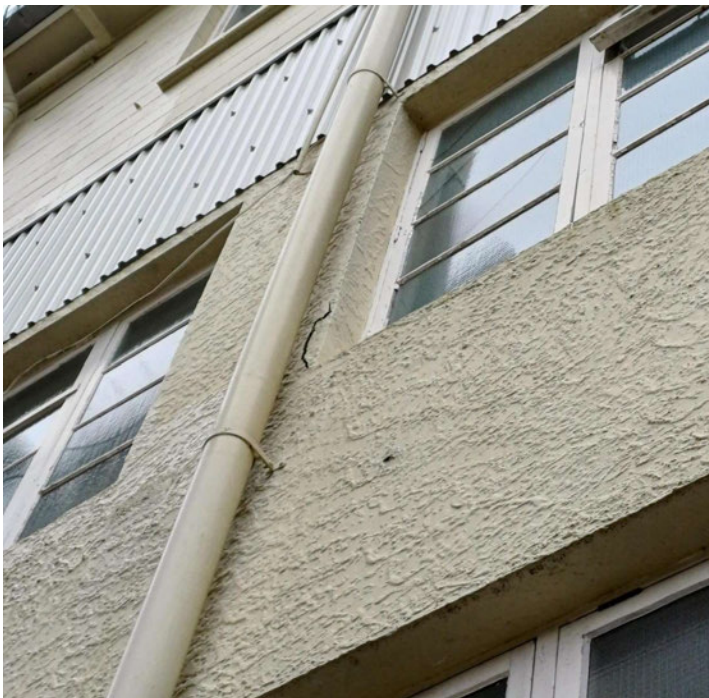
Cracking on Grid 1 pier.

This may indicate advanced corrosion in the original reinforcing steel.

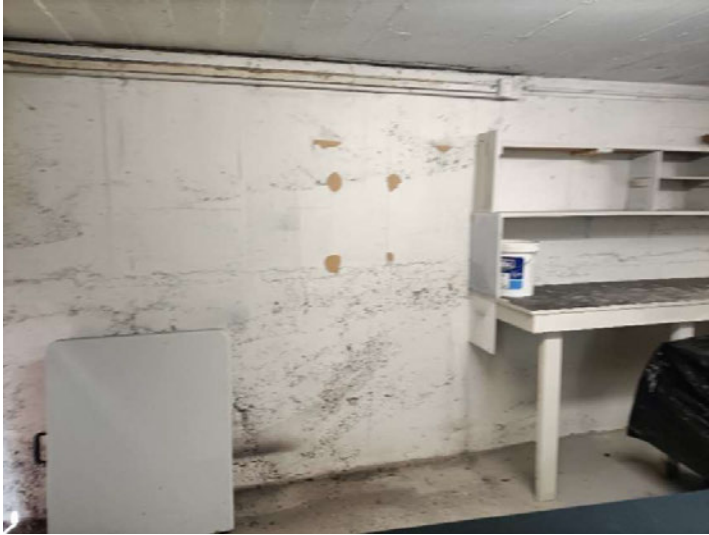
Typical condition of visible interior concrete at garage level.

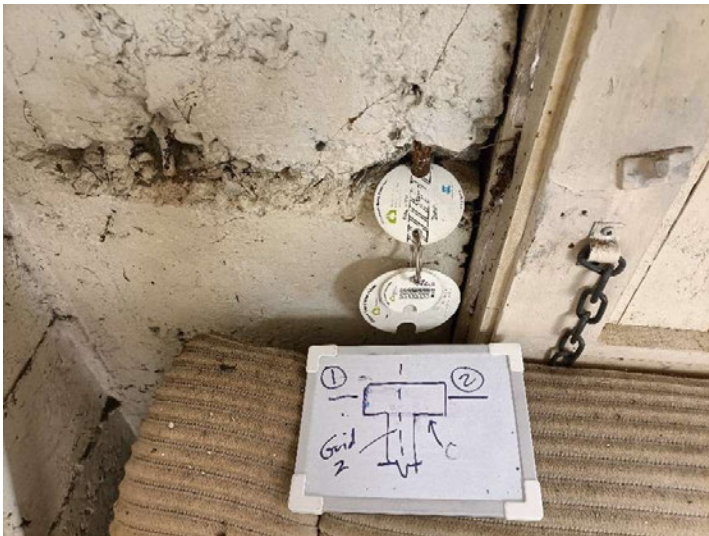
Condition of the garage wall piers

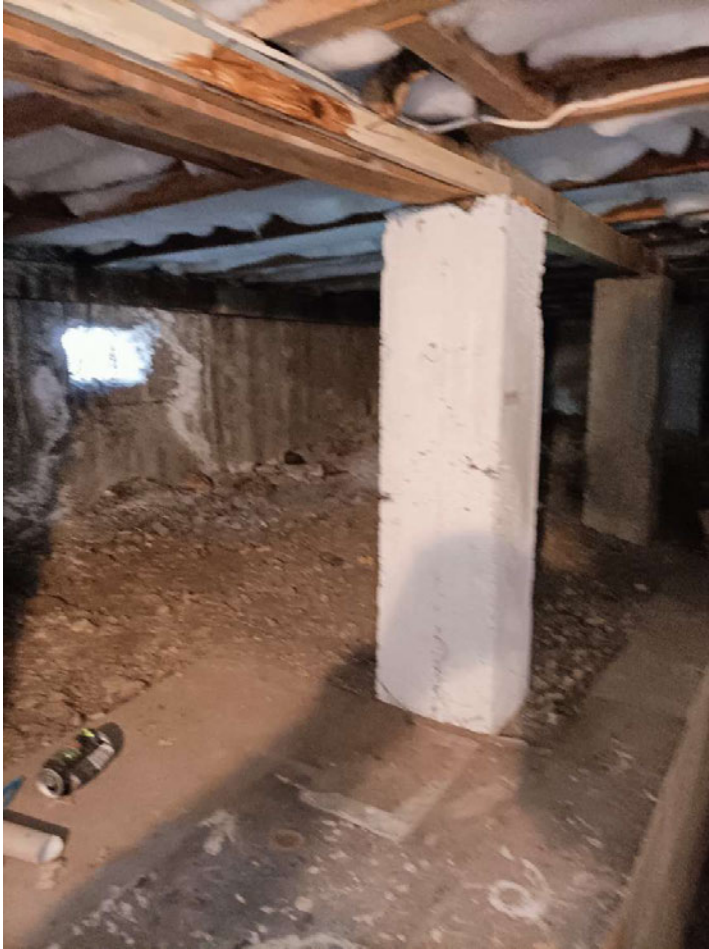
Typical interior pile and general view of rear foundation wall

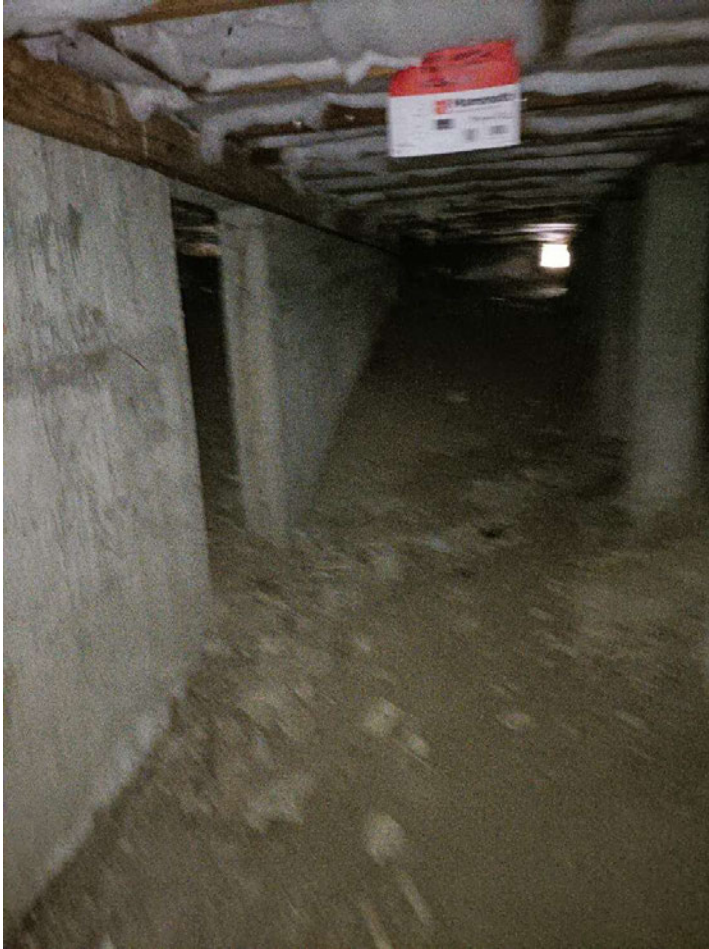
Typical interior concrete foundation wall

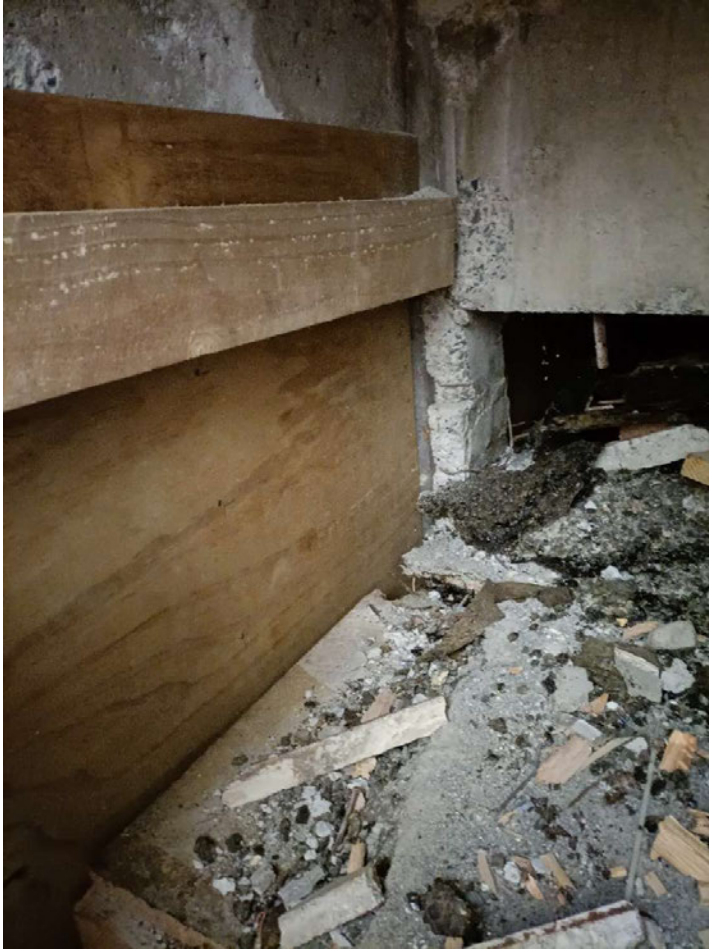
Interior of plywood wall on Glenmore Street elevation and cast-in steel beam

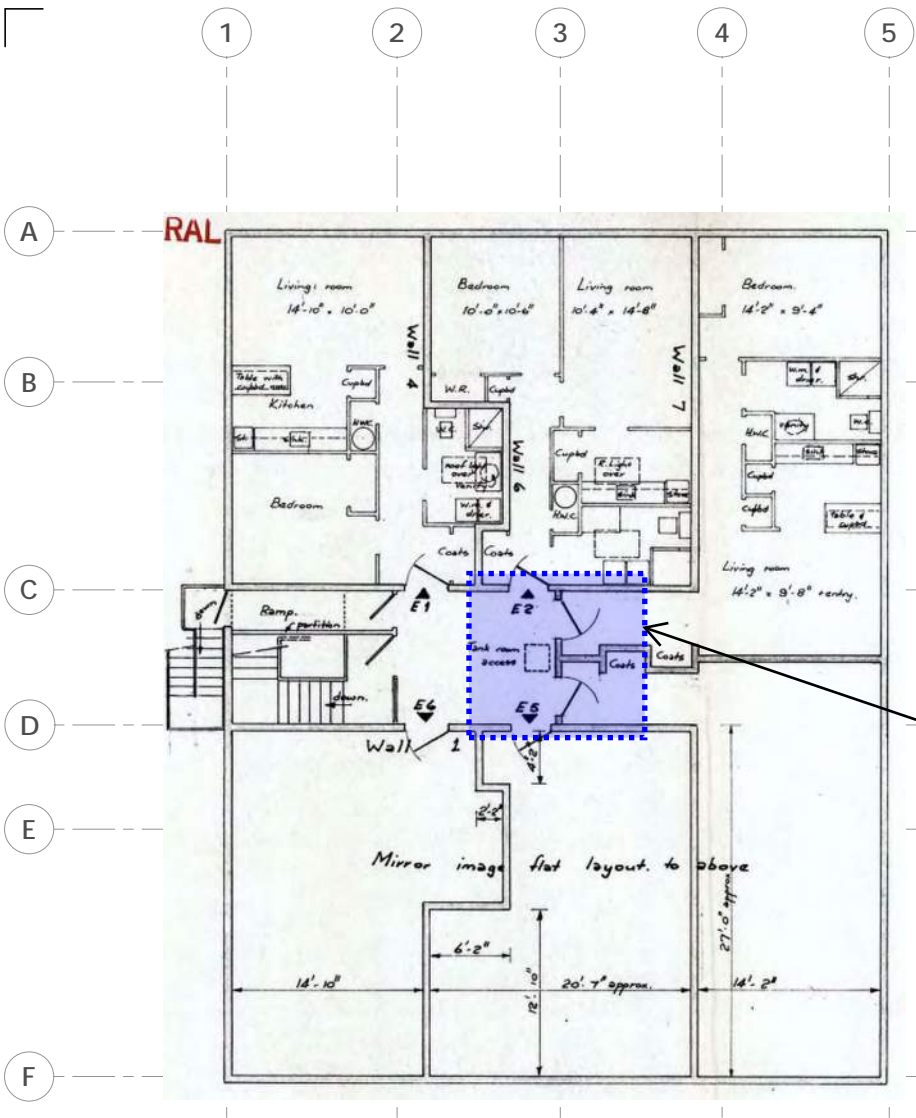
Sufficient investigation has been conducted to confirm that the existing tanks are inadequately supported and restrained.
