Report

314 The Terrace - Building Structure Condition & Detailed Seismic Assessment

Prepared for Victoria University of Wellington

Prepared by Beca Ltd (Beca)

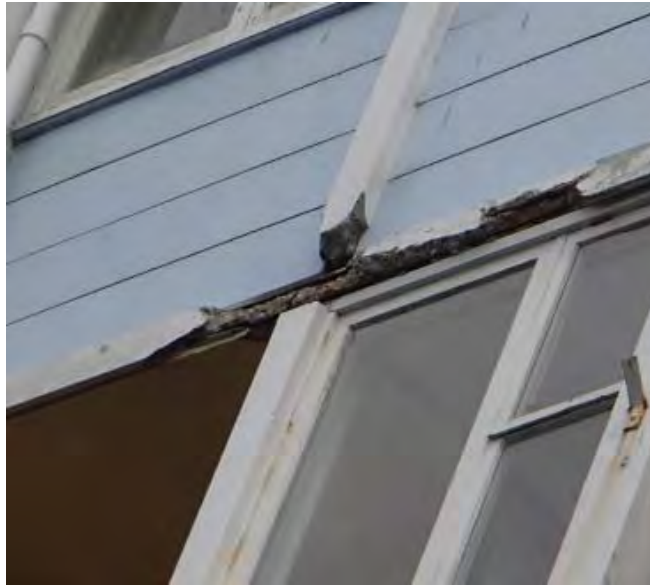
Figure 5: Façade deterioration

The façade consists mainly of windows and precast reinforced concrete planks as cladding. These are supported by precast reinforced concrete posts that span between the floors. As discussed in the condition assessment, the façade has significantly deteriorated since the building was constructed. Figure 5 shows a typical area of deterioration of the precast post connection to the slab.

The seismic capacity of the façade elements has been significantly reduced below “as-new” by the deterioration that has occurred. The rating of the façade is assessed to be less than 34%NBS and limits the rating of the building as a whole.

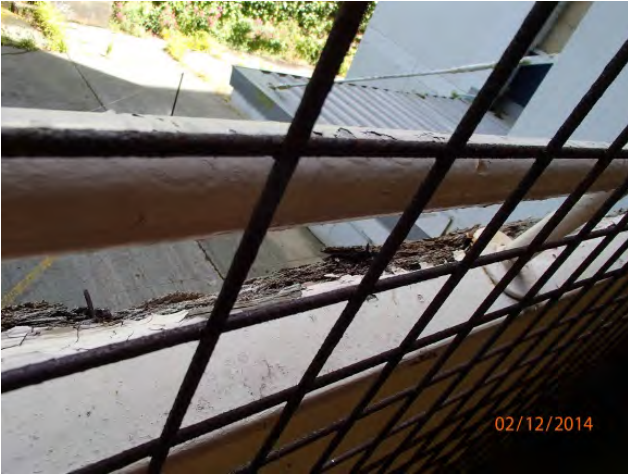
STRUC 01

Balustrades to the rear walkways feature steel handrails and in a number of locations throughout the building have corroded (refer image STRUC 01). Further the timber sills to the balustrades are rotting and deteriorating. Generally it appears the timber construction of these balustrades is in very poor condition and rotting in a number of locations (refer images STRUC 02, STRUC 03).

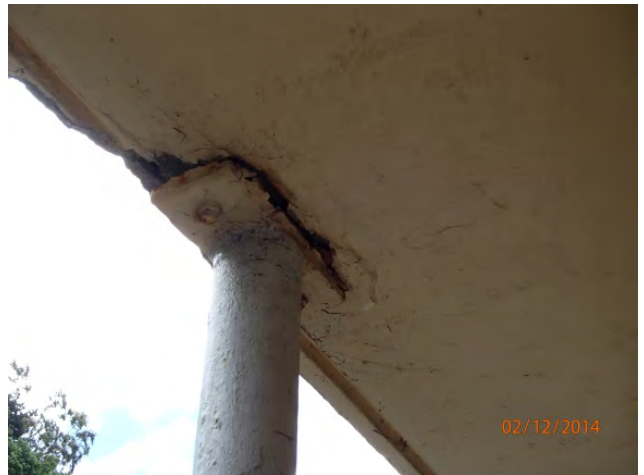
STRUC 04

At a number of locations the top fixings of the steel column to the concrete slab edge have corroded. Significant concrete spalling to the slab edge at these locations can also be seen. In some locations, it appears that the top fixing is no longer positively fixed to the concrete and the column can be moved with modest pressure (refer image STRUC 04).

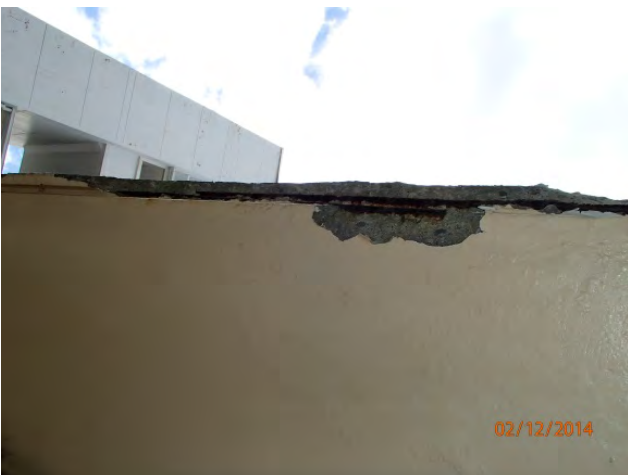
STRUC 05

The slab edge soffit features a narrow drip detail. Concrete cover was often noted as missing at this location and reinforcing bars are exposed (refer image STRUC 05).

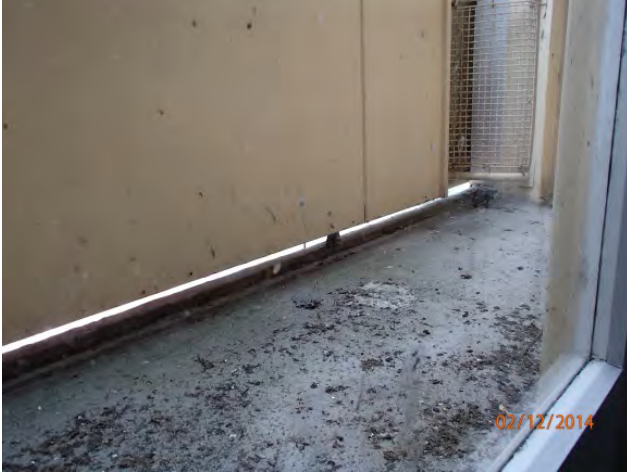
STRUC 07

Fixings of the timber panels to the concrete slabs were generally in very poor condition and in a number of locations the fixings had completely corroded away. Restraint for the horizontal steel handrails had also been compromised in several locations (refer image STRUC 07).

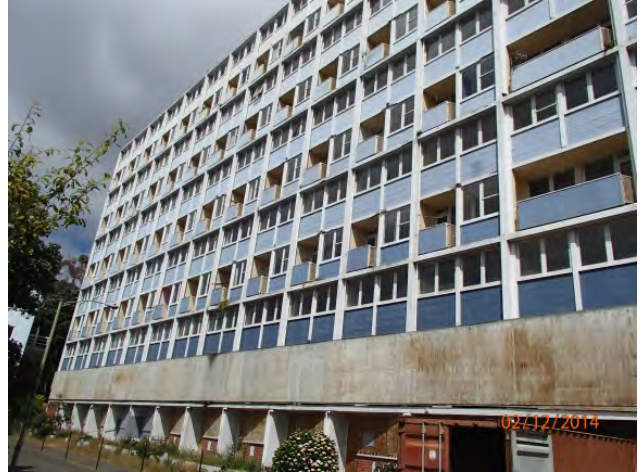
STRUC 08

Generally the facades are in very poor condition. Significant spalling of concrete and corrosion of the reinforcement can be seen in the majority of slab edge and wall/column junctions (refer image STRUC 08).

The concrete spalling is extensive in some places exposing corroded reinforcement to the base of the façade columns and offering very little residual strength against imposed wind and seismic forces. Further, the infill timber panels are connected to the concrete slab edges and columns and will be affected by the performance and fixing integrity of the concrete frame.

- Full replacement of the façade or significant repair and reinstatement of the existing.
- In addition to the façade replacement, we recommend that defective and/or carbonated concrete is removed and reinforcement that is found to be corroded or missing should be cleaned and/or replaced as appropriate. New concrete repairs are recommended to all affected areas. To assess the extent of works required for the concrete repairs, carbonation testing (likely to be by full scaffold access) of the façade will be required.
