# CONDITION SURVEY REPORT WELLINGTON CITY COUNCIL

August 2023

THIS REPORT HAS BEEN COMMISSIONED BY WELLINGTON CITY COUNCIL (WCC). THE OBJECTIVE OF THE REPORT IS TO RECORD THE CONDITION OF THE PROPERTY INCLUDING DRAINS AND SERVICES, ASSESSES THE GLAZED CLADDING SYSTEM INSTALLED ON THE GREENHOUSE/CAFÉ, AND IDENTIFY REMEDIAL OPTIONS ALL IN ACCORDANCE WITH THE WCC SCOPE OF WORKS.

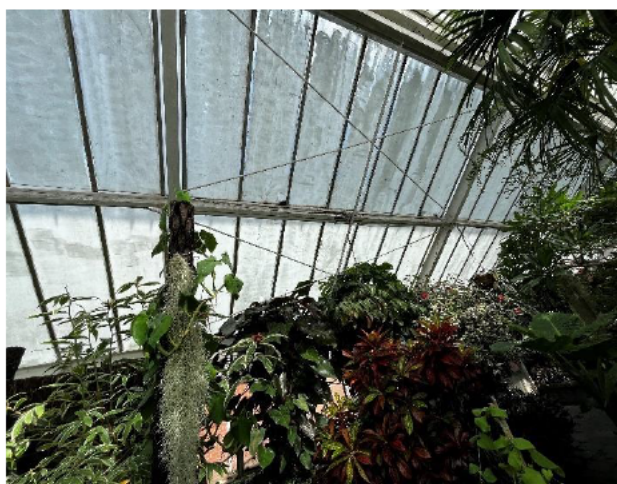
1.1 View from inside the tropical zone showing the steel portal frame, roof purlins and the lantern skylight

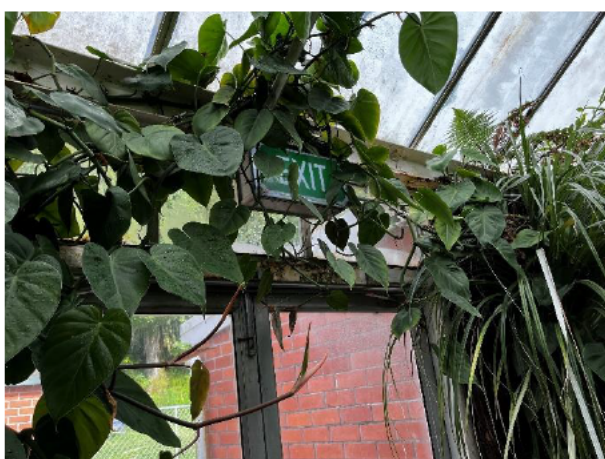
1.4 Corroded beam and damaged painted finish

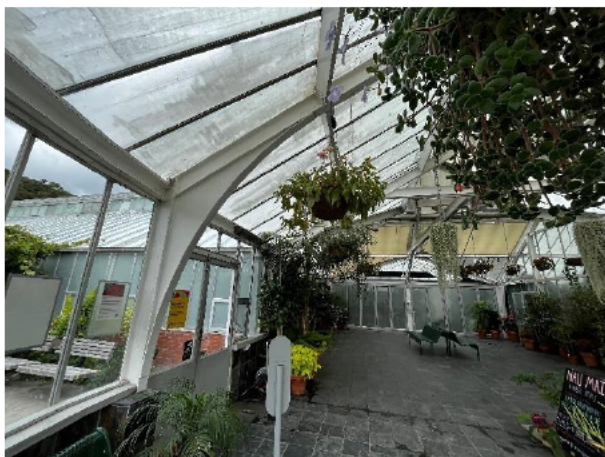
1.6 Advanced corrosion in a perimeter beam

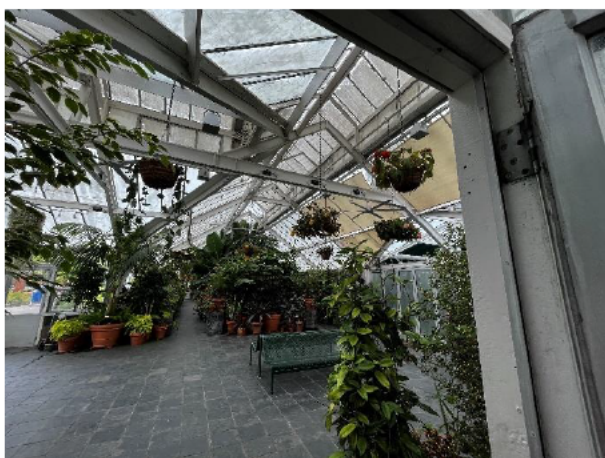
1.8 Advanced corrosion in a knee joints as detailed in photo 6 of the structural engineer's report

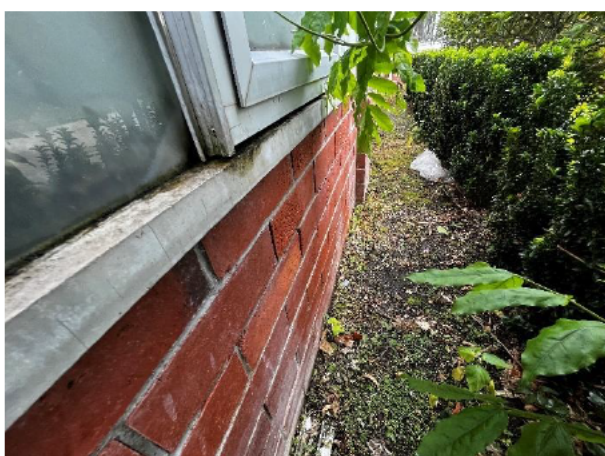
1.16 Cracking in the mortar joints located on the west elevation

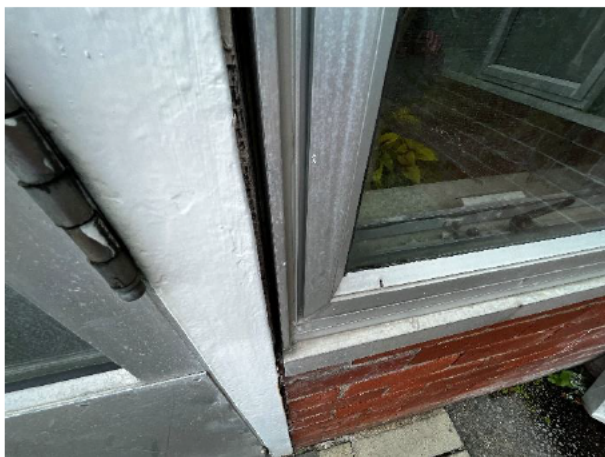
1.18 Damaged bricks located on the west elevation next to the door on the central annex

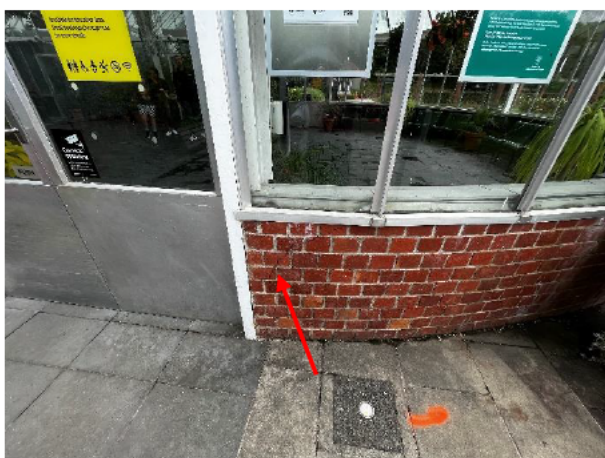
1.20 Spalled brick in the central annex wall

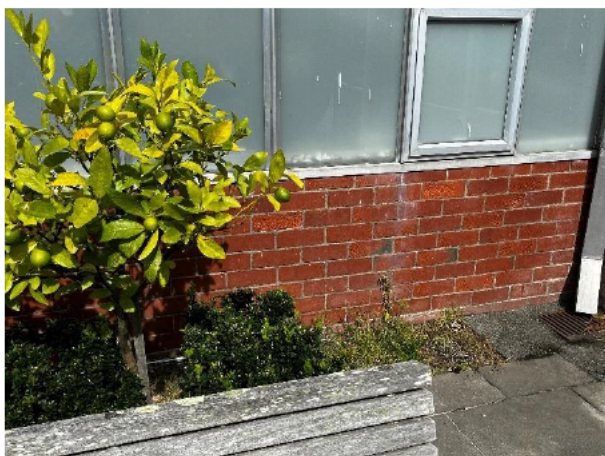
1.22 Close up view of the cracked veneer

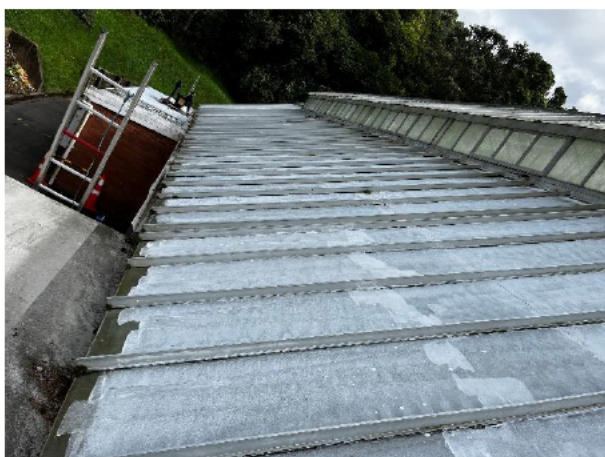
1.36 Corner junction is leaking into the roof frame below

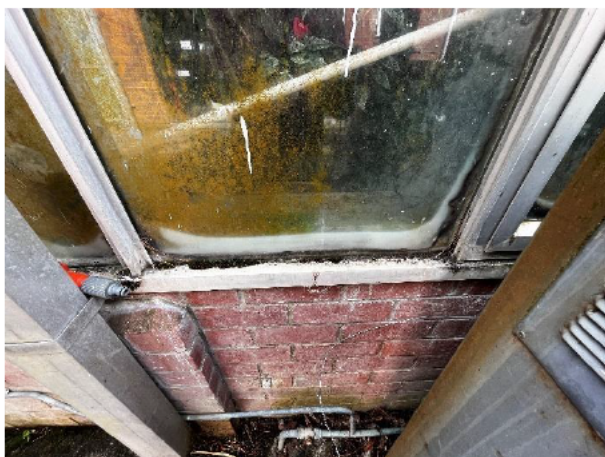
1.50 Aluminium, glazing bead is split and dislodged

4.1.6	Glazing system	All	The aluminium glazing beads are in poor condition with separation, splitting and some missing. The frame is poorly flashed resulting in water and air leakage. The frame is poorly sealed at wall junctions resulting in water ingress	Replace the frame with a new system	1.35-1.69	4

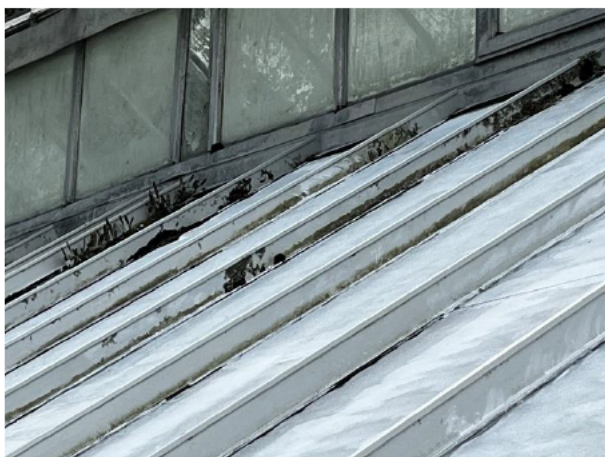
1.52 Missing glazing bead

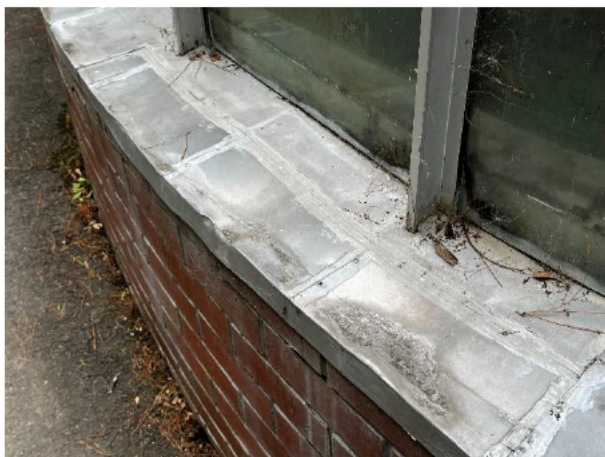
1.54 Plants growing through between the glass and frame

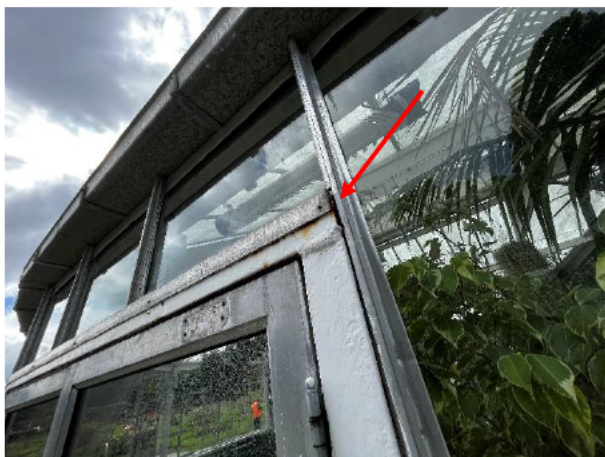
1.60 Loose glazing Bead

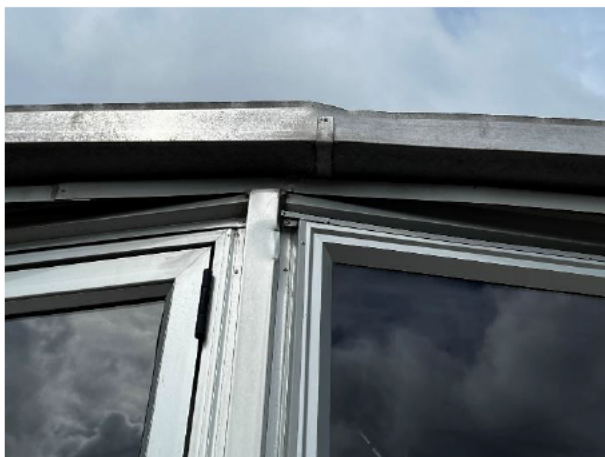
1.66 Poorly sealed junction between the wall and glazing system creating a moisture ingress route

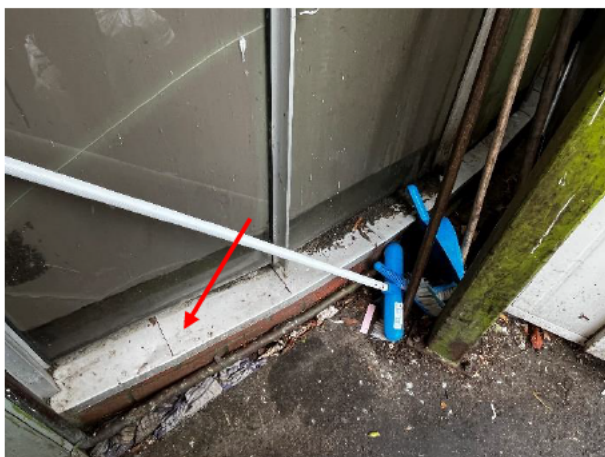
1.68 Open and damaged mitre joint both sides

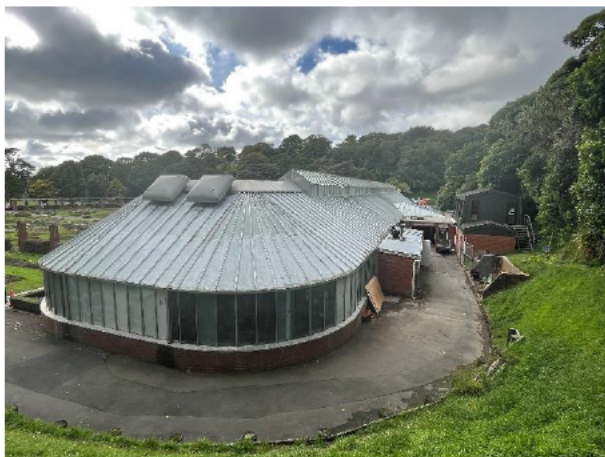
1.70 Glazing joint sealant has failed resulting in damage to the kitchen ceiling

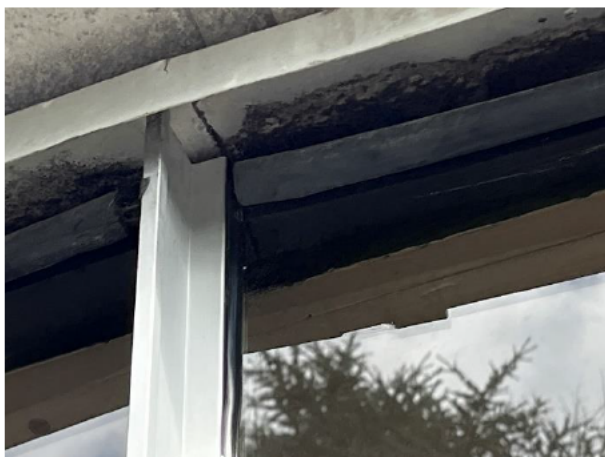
1.78 Gasket missing to base of glazing pane

4.1.8	Glazing system	All	The rubber gaskets were shrunk, loose or missing resulting in water and air leakage	Replace the glazing gaskets	1.78-1.86	4
<b>Ancillary Building Roofs</b>

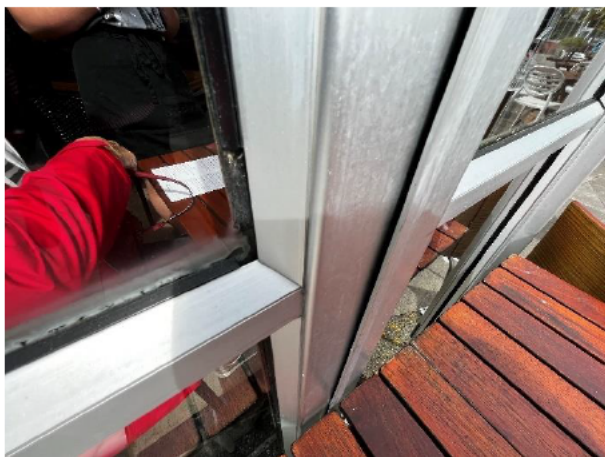
1.80 Gaskets have worked loose

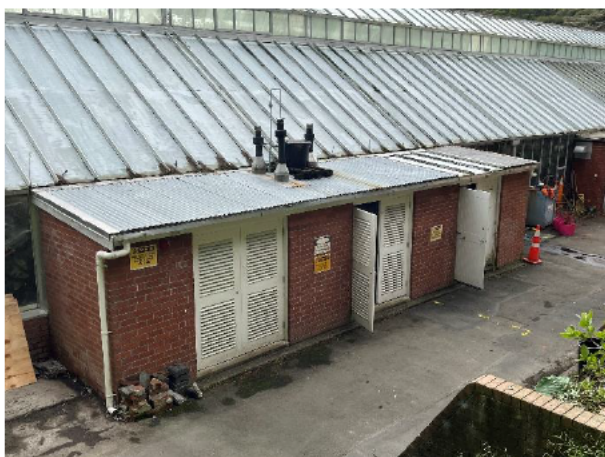
1.87 Boiler room and potting shed

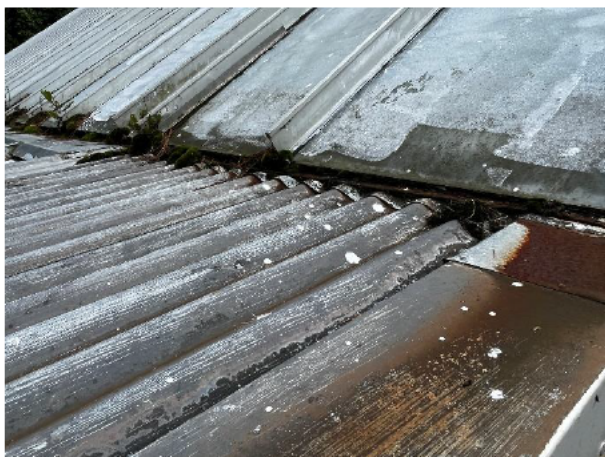
1.89 Corroding edges to roof sheets and vegetation growth

4.1.9	Corrugated metal roof cladding	Toilet block, boiler room and store to South	The corrugated roof sheets are corroded and have reached the end of their economic design life. The skylights are leaking at the eaves due to a lack of flashings and there is an incorrect flashing where the roof abuts directly onto the glasshouse with no stepdown to create a moisture barrier.	Replace all corrugated roof cladding, flashings and water storage tank.	1.87-1.95	4
<b>External Joinery</b>

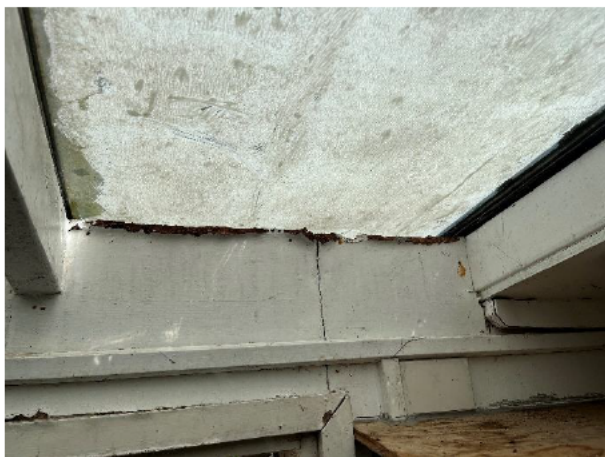
1.91 Internal damage to the potting shed skylight walls

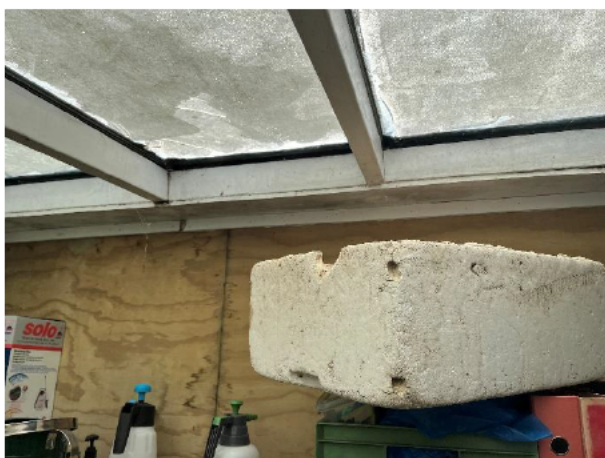
1.93 Moisture staining along the plywood joint

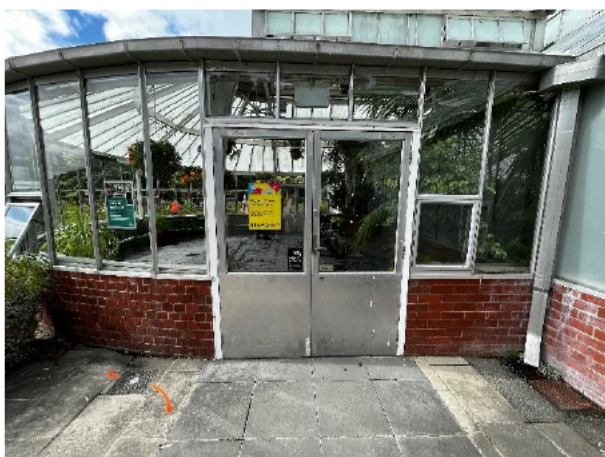
1.98 Defective and damaged doors with corrosion in the steel frame

4.1.10	Glazed aluminium framed double door units	Glass house	Holes in door mullions and transoms where ironmongery removed, door leaf's have slipped and are out of alignment, beads are missing, steel sub frames are corroding.	Replace the doors and frames (5no). Note while doors are of varying ages, all require replacement as they form part of the glazing system which is to be replaced in its entirety.	1.96-1.98	4

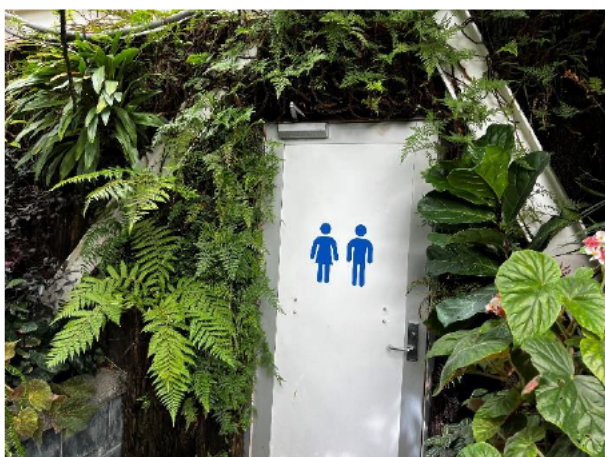
1.100 Door to the toilet block from the Glasshouse is in good condition

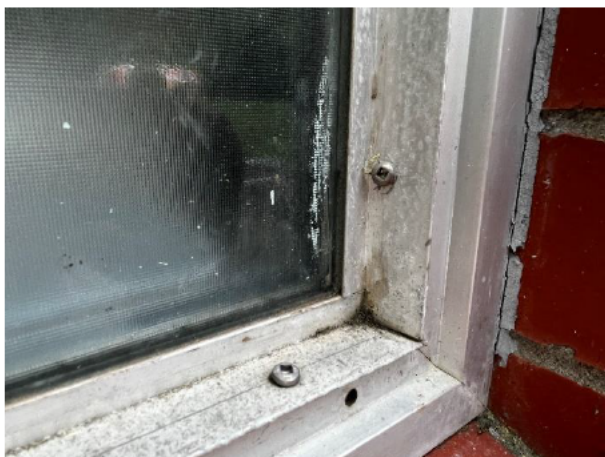
1.102 Windows are fastened shut and the perimeter sealant has failed

4.1.12	Aluminium windows 1988	Toilets & kitchen	Open mitre joints, shrunk gaskets and temporary replacement beads screw fixed into frames.	Replace the windows	1.101-1.102	4
<b>Internal Walls and Ceilings</b>

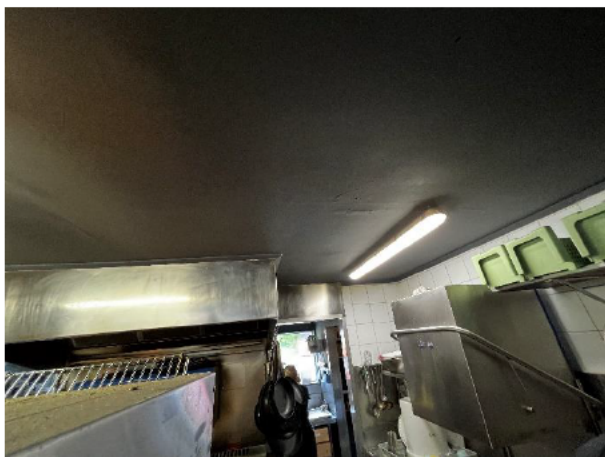
1.103 Water related damage to kitchen ceiling

4.1.13	Timber frame and plasterboard or particleboard lining	Kitchen	The kitchen ceiling is damaged from water leaks from the glass roof above. Wear and tear damage to painted surfaces and wall linings.	The wall and ceiling bulkhead linings are worn, dirty and moisture damaged and require replacement.	1.103	3

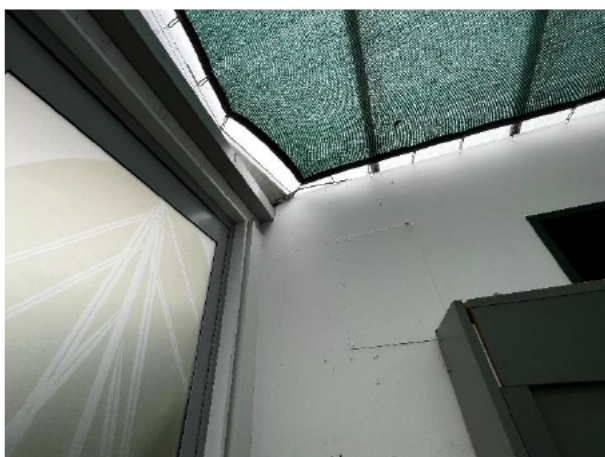
1.105 Moisture ingress and cracking to wall lining

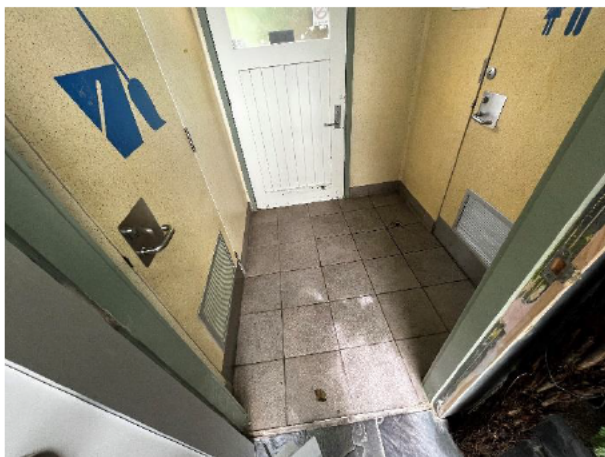
1.107 The toilet entrance wall, floor and ceiling linings and tiles are beyond economic life

4.1.15	Plastic coated plasterboard wall linings	Toilets	Plastic coated plasterboard wall linings are cracked and exceeded their economic design life	Replace the toilet wall and ceiling linings and investigate the wall framing for moisture damage. The works will as a consequence require removal of the fixtures and fittings. Refer to 4.1.32	1.107-1.112	4
<b>Floor</b>

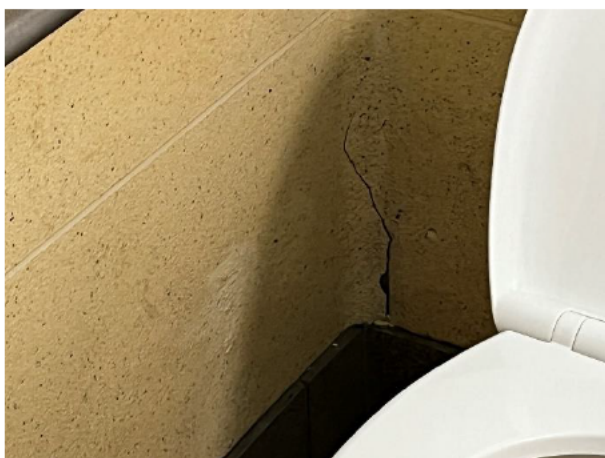
1.109 Cracked and delaminating wall lining finish

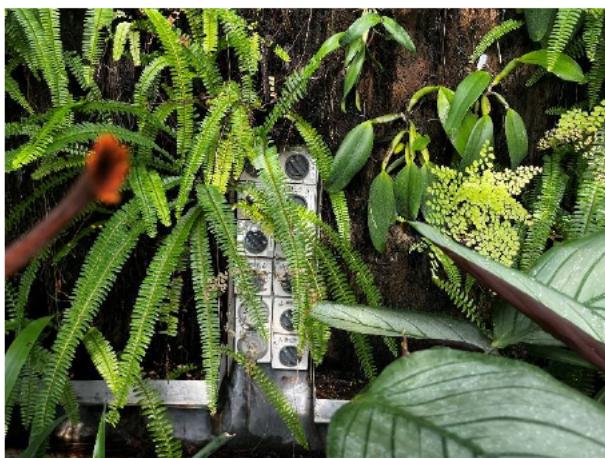
1.121 Electric switch array is constantly wet?

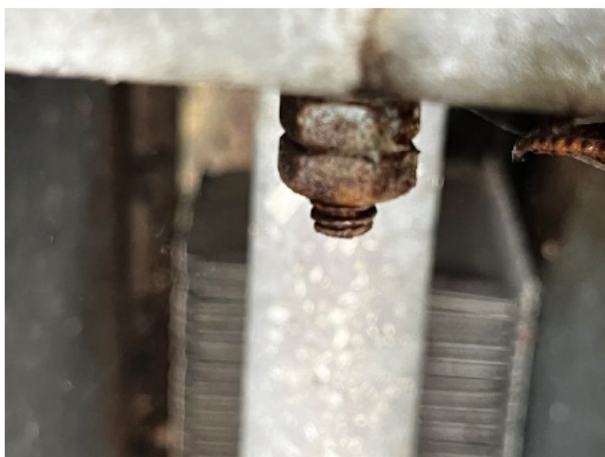
1.133 Corroded nuts and bolts from the radiator cover

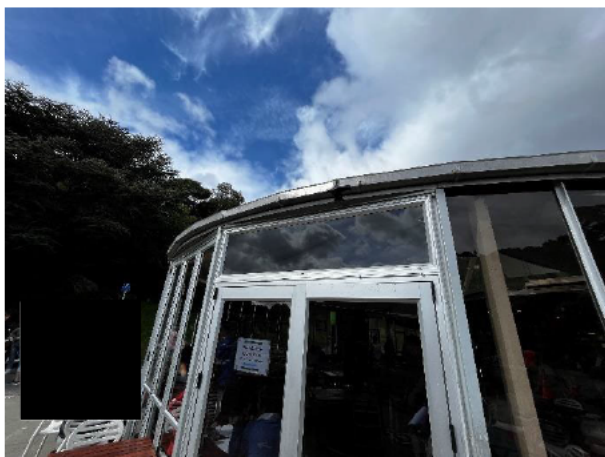
1.155 Defective gutter joints

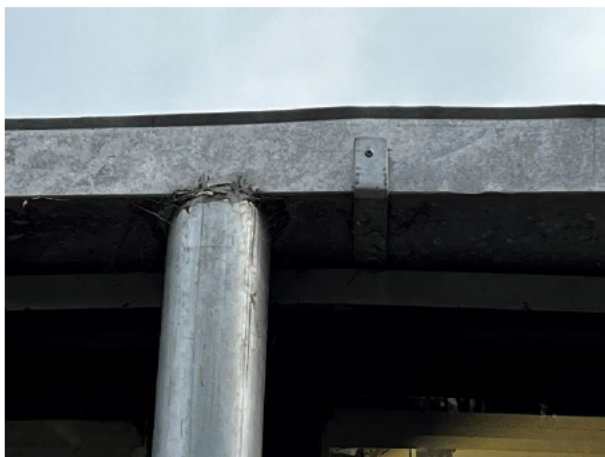
1.157 Corroded outlet

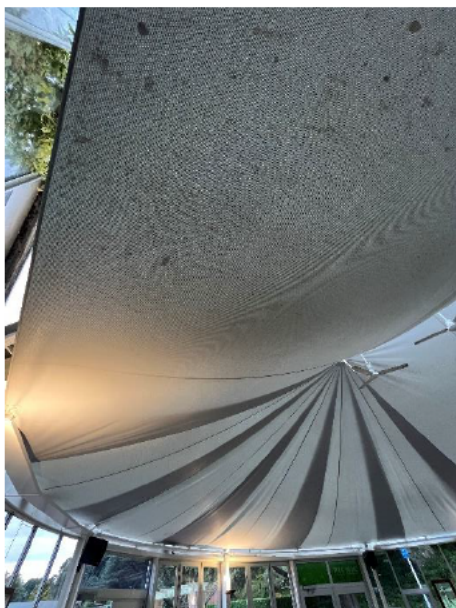
1.160 Internal shade sails with dirt and bird droppings on sails

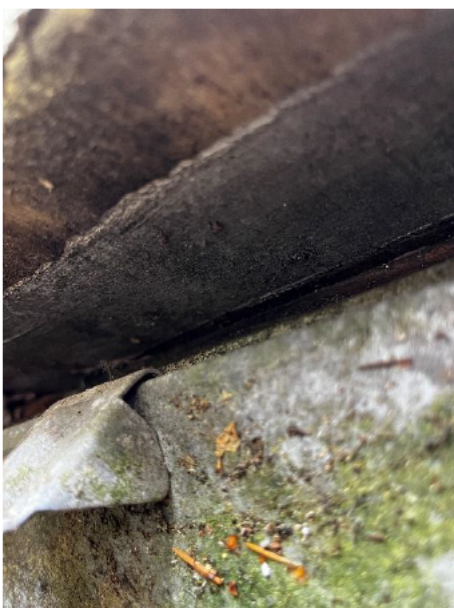
2.11 Roof framing has darkened and appears decayed

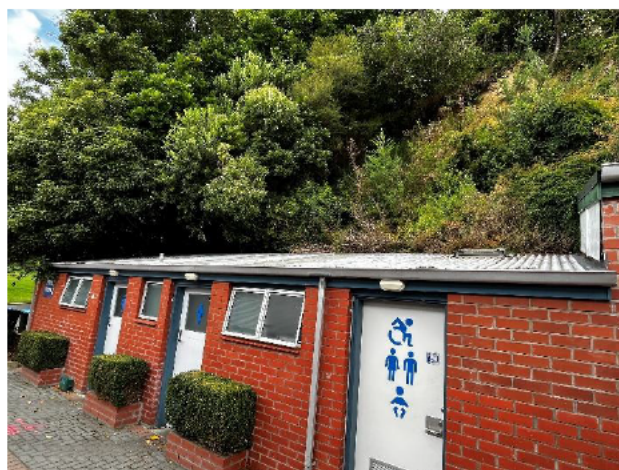
2.22 Toilet block roof cladding has attained the end of its design life and is recommended for replacement

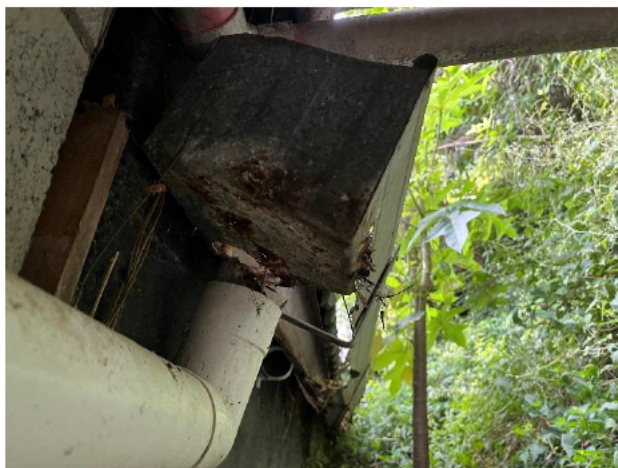
2.24 Rear gutters are corroded

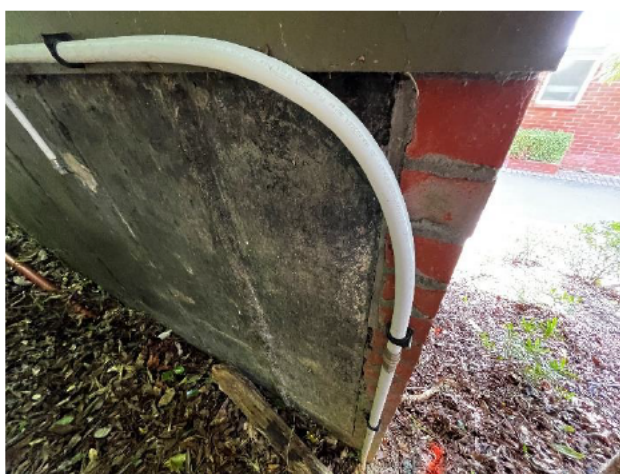
2.43 The gable to rear wall junction is missing mortar and appears to have been incorrectly waterproofed creating a moisture ingress route into the wall frame

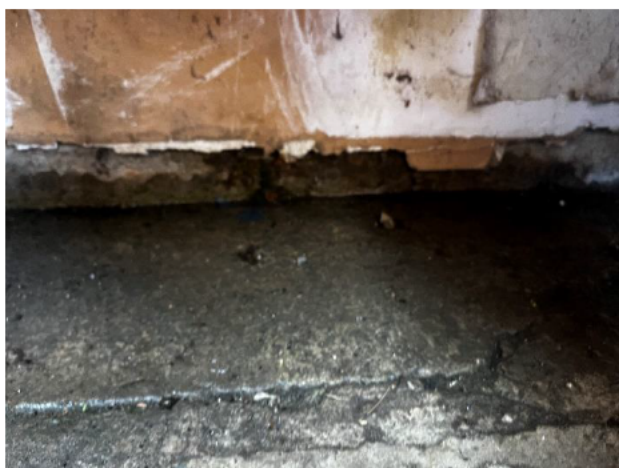
2.47 The dry room floor is saturated from external moisture engrossing into the dry side of the wall

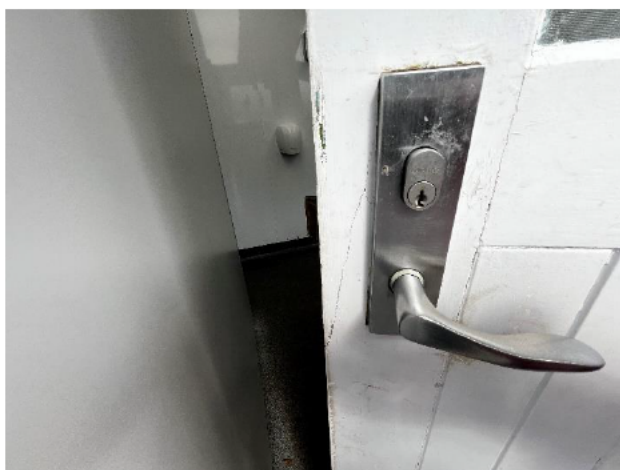
2.57 Male toilet door is showing signs of wear and tear

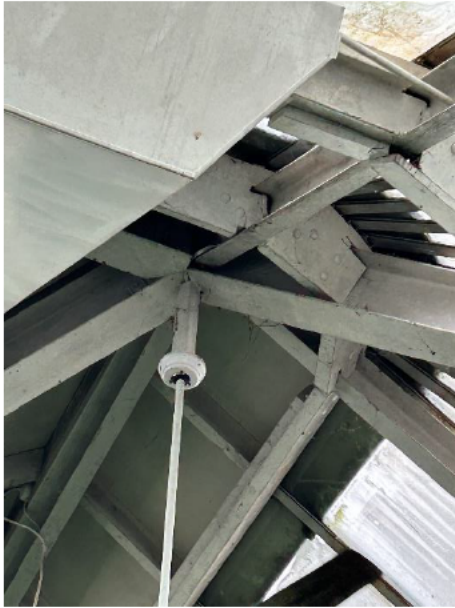
**Photo 2**

Hips in end bay over pool area showing signs of surface rust

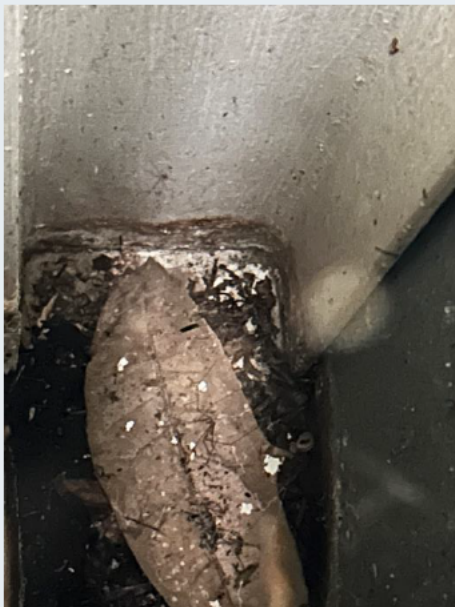
**Photo 3**

Some of the portal legs have soil built up against them and they are showing signs of rusting

Not all of the portal legs could be seen due to planting and no access

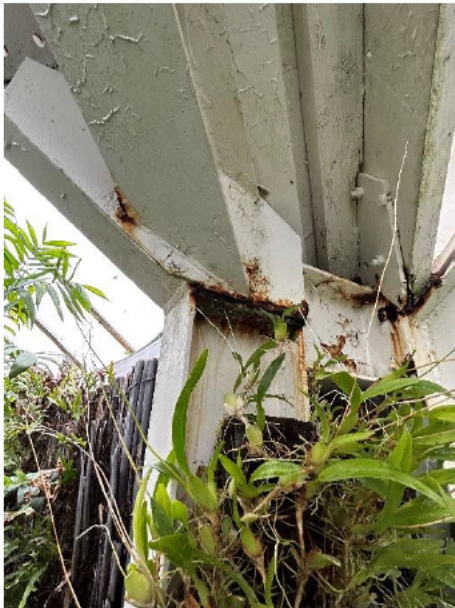
**Photo 6**

Extreme rusting to portal knee joint in the Pool area, stiffener plates are rusting and are showing signs of delamination

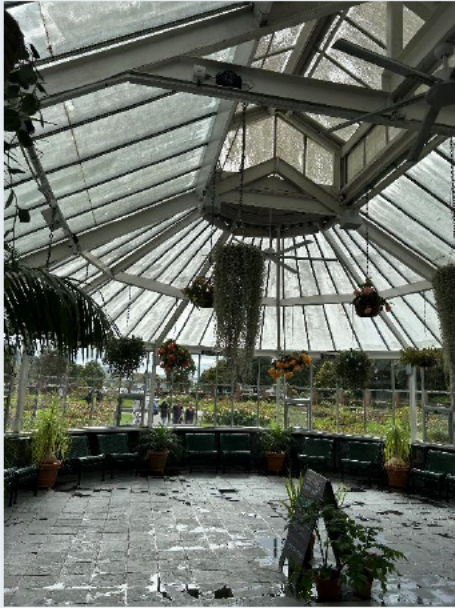
**Photo 11**

Centre area of the buildings roof structure small areas of surface rusting

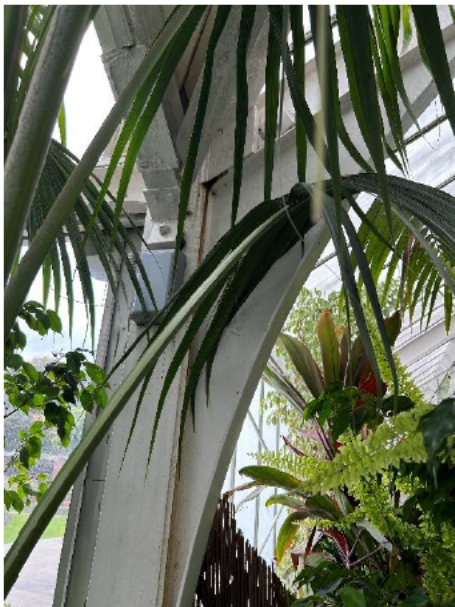
**Photo 12**

Knee joint with stiffener plates and edge beam signs of surface rusting

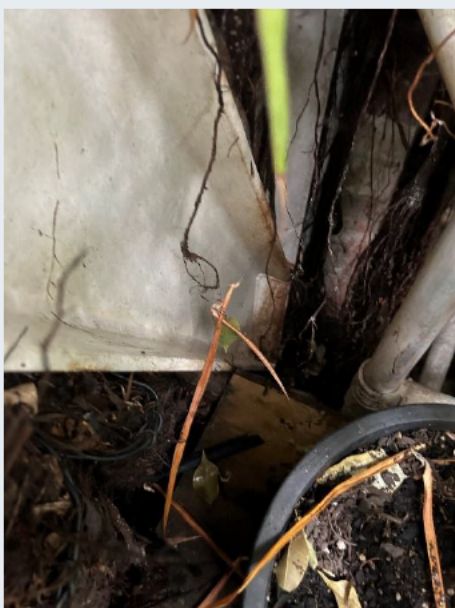
**Photo 13**

K-Frame bracing base signs of surface rusting

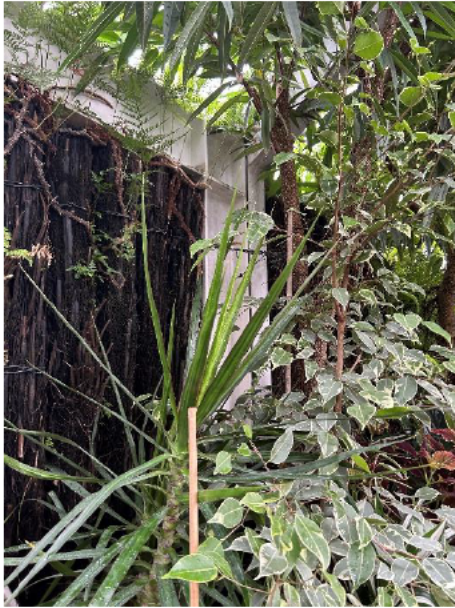
**Photo 14**

K-Frame knee joint as detailed, no signs of rusting but the paint is flaking

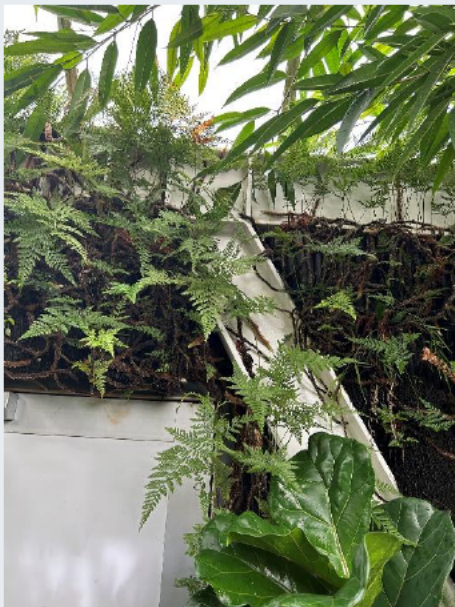
**Photo 15**

K-Frame middle brace and stiffener plates as detailed no signs of rusting, but paint is flaking

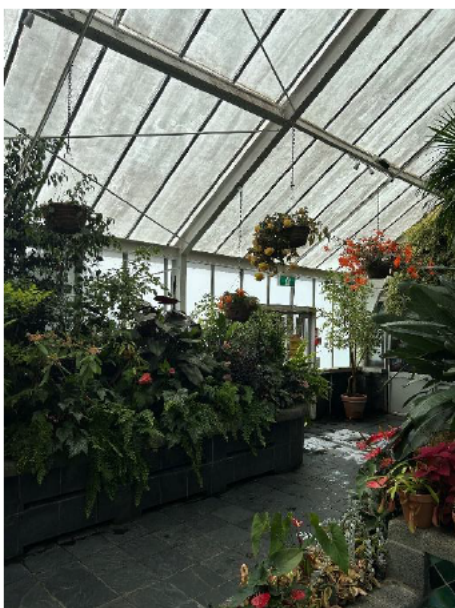
**Photo 16**

Roof bracing bay where the purlins are sagging

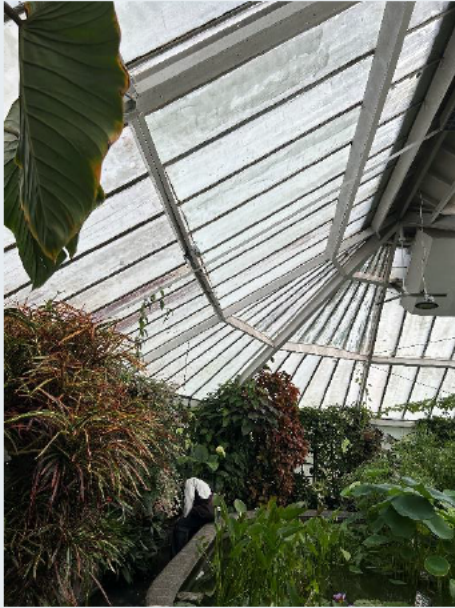
**Photo 17**

Sagging purlins in roof area over the pool and some of the purlins are showing signs of rot

4.1.2	Structural frame	Southwest tropical plants	Two roof purlins are deflected	Replace or strengthen the two purlins. Allow for steel elements to be painted as above.	1.12	3

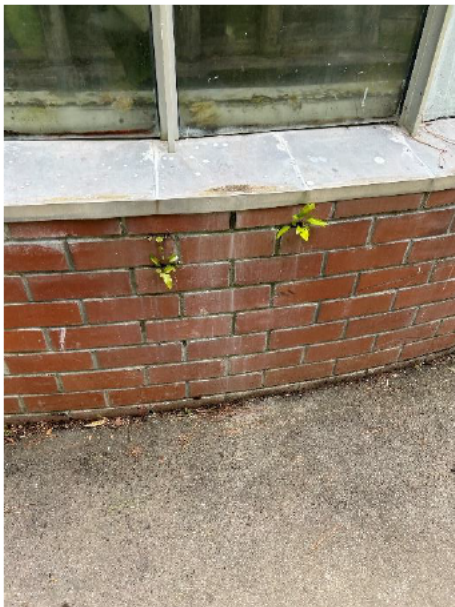
**Photo 18**

Mortar joint cracking in the lower brick walls

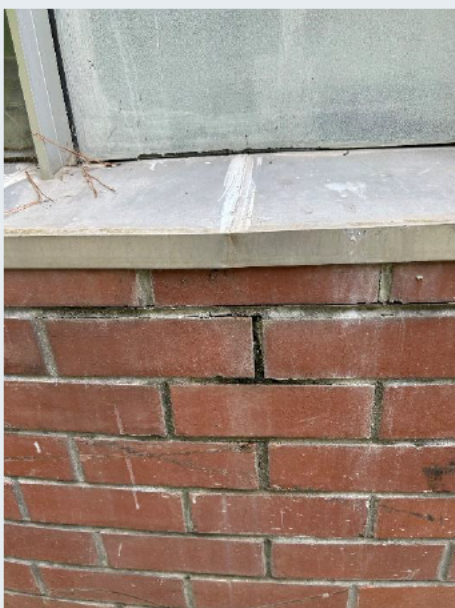
**Photo 19**

Mortar joint cracking

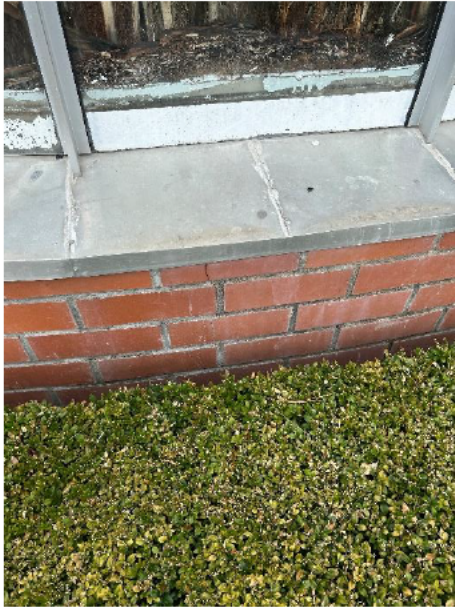
**Photo 20**

Mortar joint cracking where some repairs have been carried out

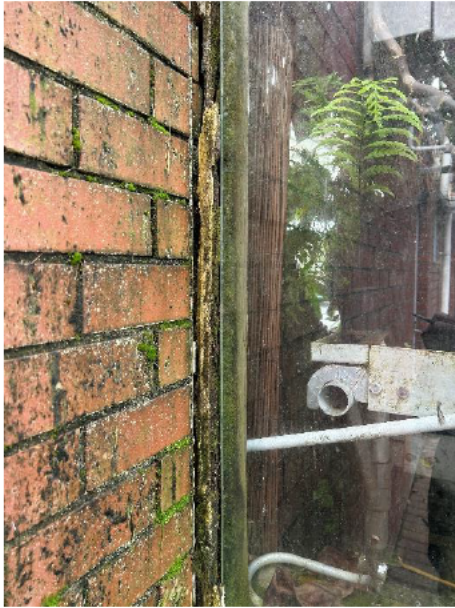
**Photo 26**

Rotten timber around some window frames

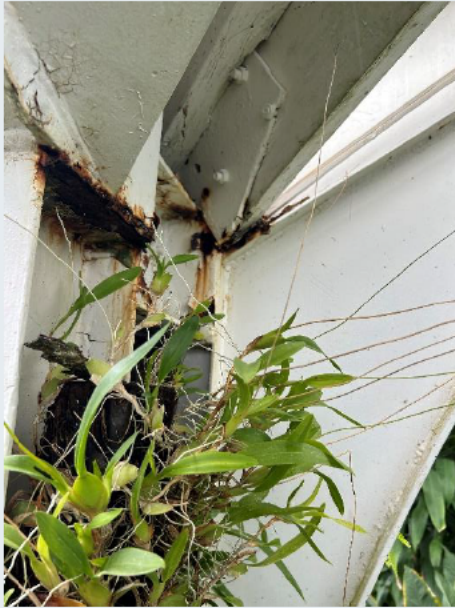
**Photo 29**

Extreme portal knee joint rusting as per photo 6

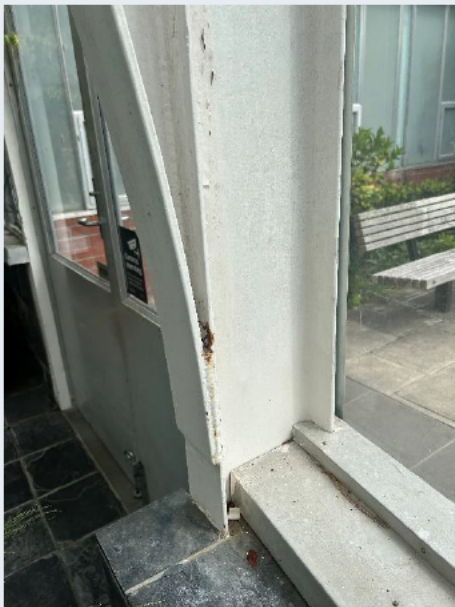
**Photo 33**

Surface rusting at stiffener plate

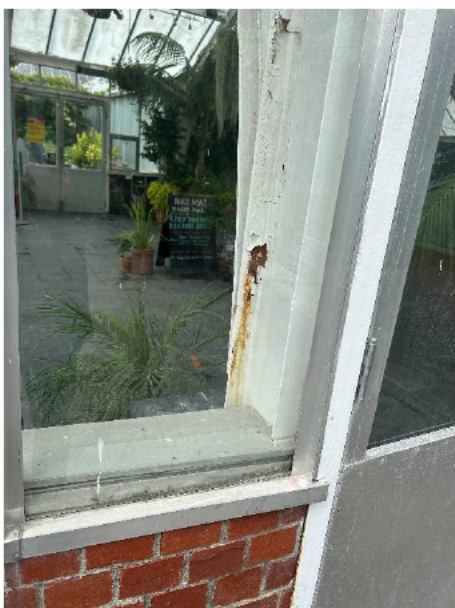
**Photo 34**

Surface rusting on the portal leg
