# Central Library

Hollowcore Seismic Assessment

**Wellington City Council**

Reference: 253267

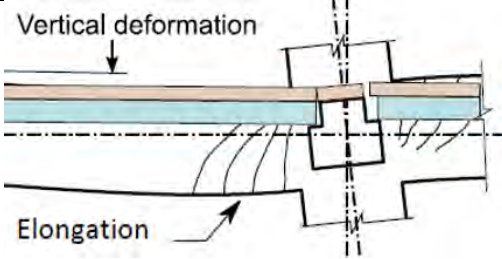
Potential Mechanism	%NBS (IL2)	Failure Mechanism <sup>1)</sup>
1. Loss of Seating	20

<p>Vertical deformation</p> <p>Elongation</p>
2. Positive Moment Failure	55

The most critical mechanism of failure has been assessed to be the potential loss of seating/support to the hollowcore units. The existing structural drawings indicate that the seating as specified typically ranges between 50 and 60mm. It is on this basis when allowance has been made for construction tolerances, and creep and shrinkage effects, that the hollowcore precast floor system at IL2 achieves a score of **20%NBS** as assessed by the MBIE guidelines for assessing existing buildings. There are a large number of parameters included in the calculations to determine the score. A sensitivity study of those factors indicates that this range could potentially extend from **15% - 25%NBS (IL2)**.

The low score based on the potential loss of seating of the hollowcore units presents a significant hazard and potential risk to building occupants following a significant earthquake event.

The available hollowcore seating at this stage has solely been determined based on our review of the existing structural drawings. It is recommended that a comprehensive on-site measurement of the as-built seating dimensions is completed in line with the methodology described in the MBIE assessment guidelines.

It is recommended that on-site investigations be completed to verify the as-built condition of the existing seating dimensions, and starter and saddle bar reinforcing. It is possible some variation exists which could increase or decrease the desktop results presented in this report.

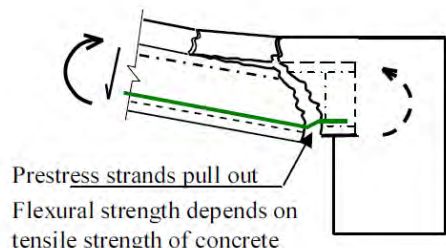
<p>Prestress strands pull out</p> <p>Flexural strength depends on tensile strength of concrete</p>
3. Negative Moment Failure	100

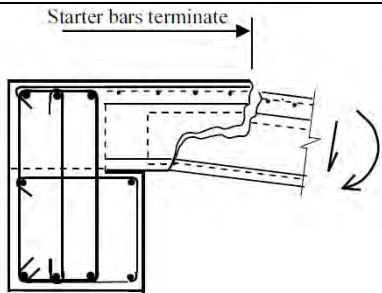
<p>Starter bars terminate</p>
4. Web-Cracking	25

It is noted that the high score for the mechanism of Negative Moment Failure is based on the presence of exceptionally long starter and saddle bars as detailed in the existing structural drawings. It is recommended that on-site investigations be performed to verify the as-built detailing of these bars.

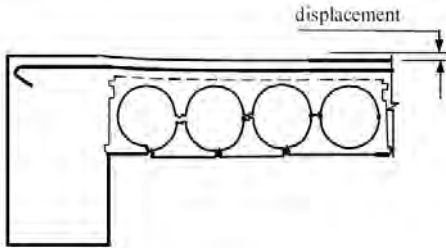
<p>displacement</p>
5. Torsion	100

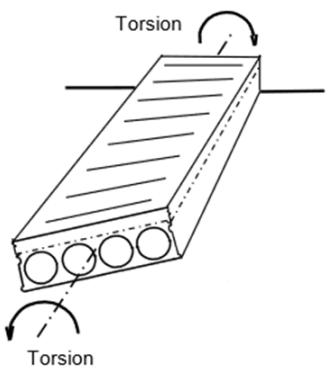
<p>Torsion</p> <p>Torsion</p>
