Shelly Bay Slipway Building

Building Condition Report

Wellington City Council

Date: 7 March 2013
Reference: 5-C2432.00 Slipway
Status: Version 1

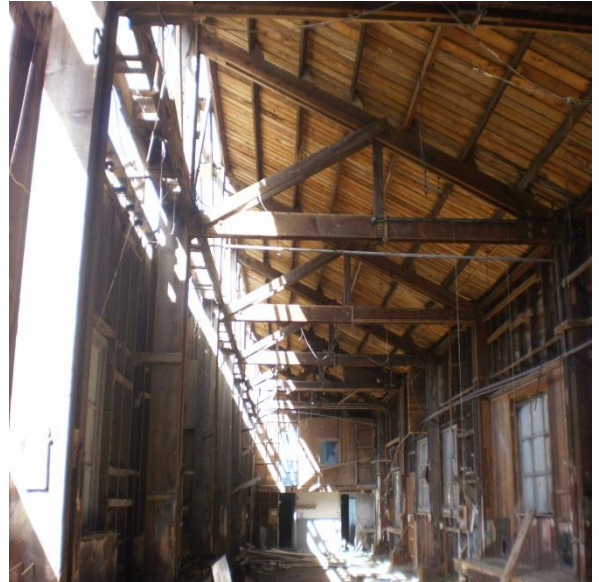
Figure 1: Internal view of building

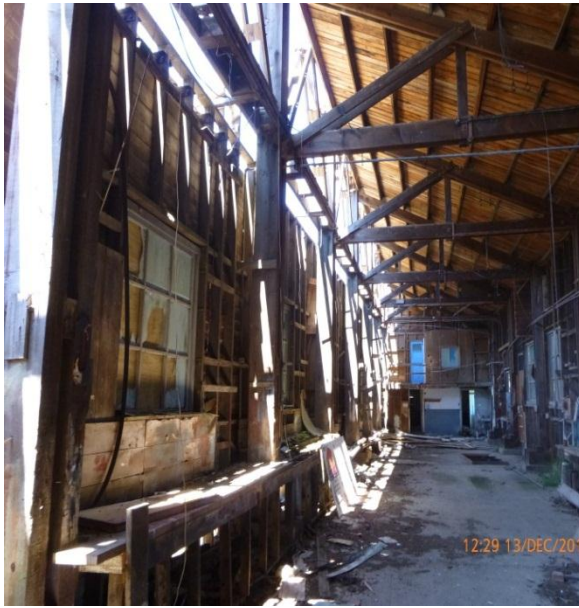
Figure 2: Timber framed external wall

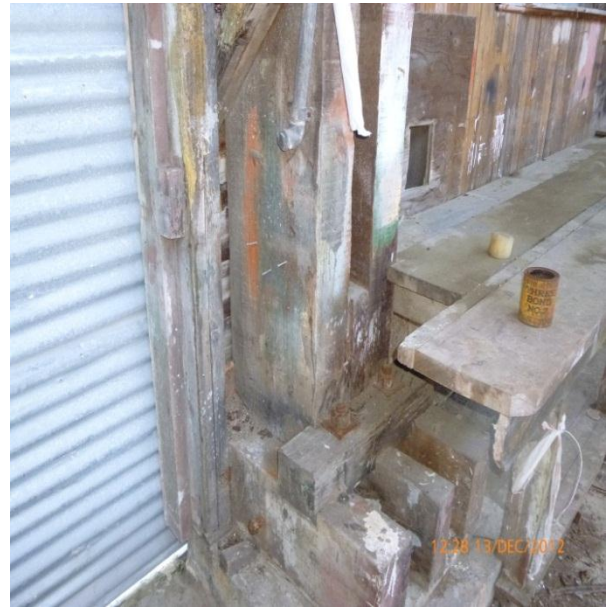
Figure 3: Timber portal column base

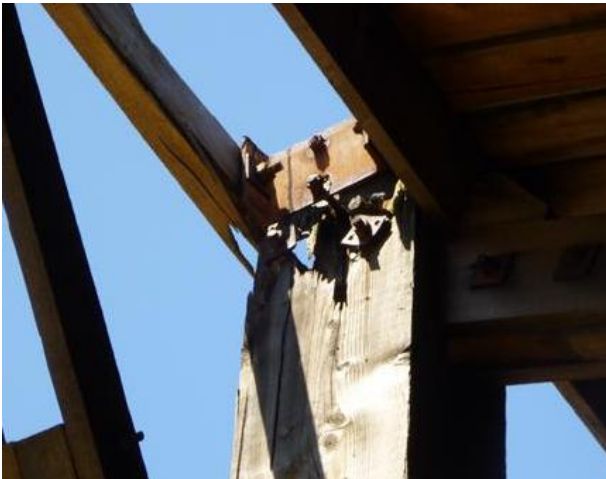
The condition of the timber truss supporting the eastern (high) side of the roof is extremely poor. The original cladding adjacent to the truss has been either purposefully removed or has been dislodged by the elements. This exposure has resulted in the bolted truss showing significant signs of rot and rust. As seen in the photos below, this means in places the top chord of the truss is missing and the bolted connections are so badly rotted and rusted they are only just holding together. This deterioration means the roof is unstable in high winds or in a seismic event inducing loads in the longitudinal direction as the fixity of the roof to the structure is compromised.

Figure 4: Deteriorated Connection

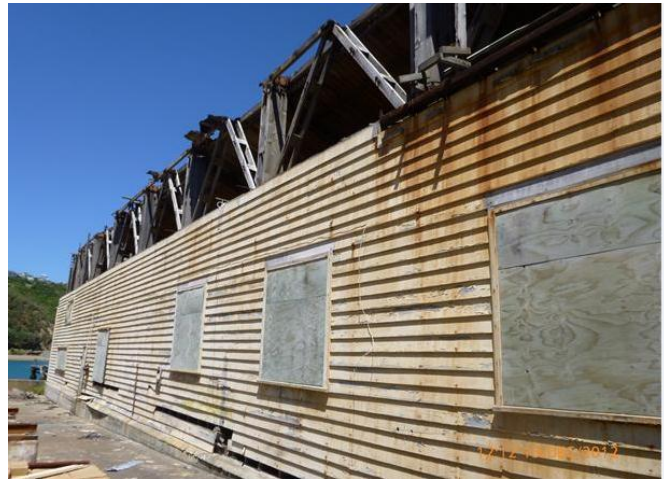
Figure 5: Truss missing top chord members

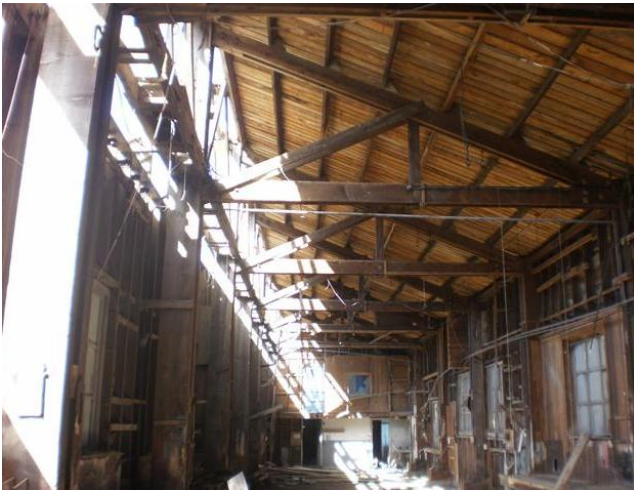
Figure 6: Timber frames with half truss

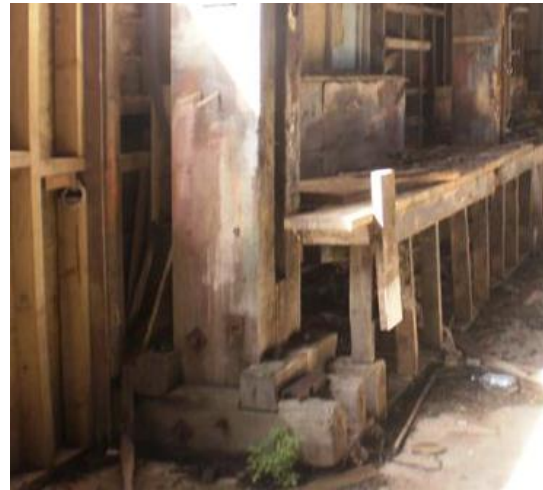
Figure 7: Timber frame base detail

The timber portal frames are largely intact despite their exposure to the weather. However, given the deterioration in the external cladding which has occurred the frames could be expected to deteriorate quickly in a similar manner to the east wall truss. Already there are early signs of rot in the timber members and rust in the bolted connections which will affect their ability to resist lateral loads.

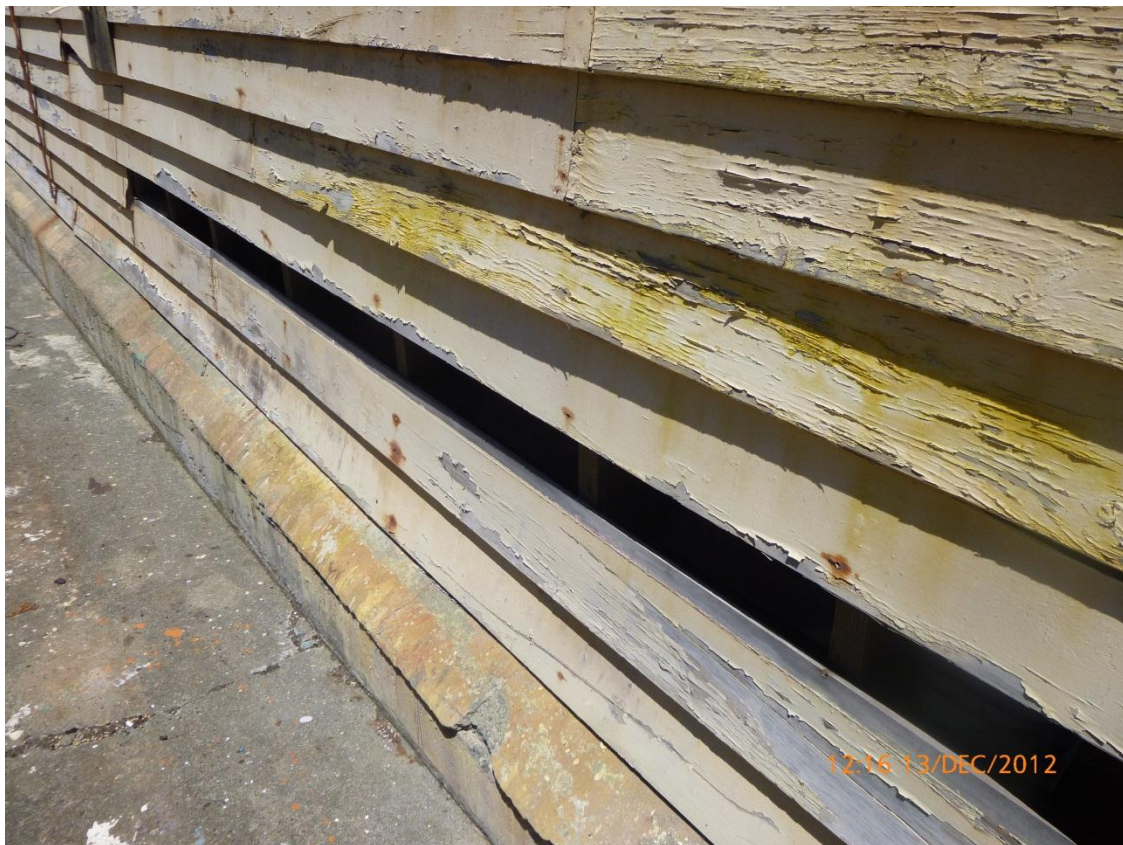
The original exterior cladding is timber weatherboard and is current. In the January 2008 Building Condition Assessment there was evidence of rotting and missing areas of weatherboard. Remedial works were proposed but have not been undertaken and subsequently rotting has increased along with sun exposure and the thin layer of paint that remained has peeled off in many areas providing no protection to the exposed weatherboard. Many weatherboards have also started to bow and split with small signs of borer starting on internal studs.

An estimated 20% of the weatherboards are missing along with 30% non-repairable; therefore approximately 50% of the weatherboard are condemned and require removal and replacement.

Figure 8: Weatherboard cladding

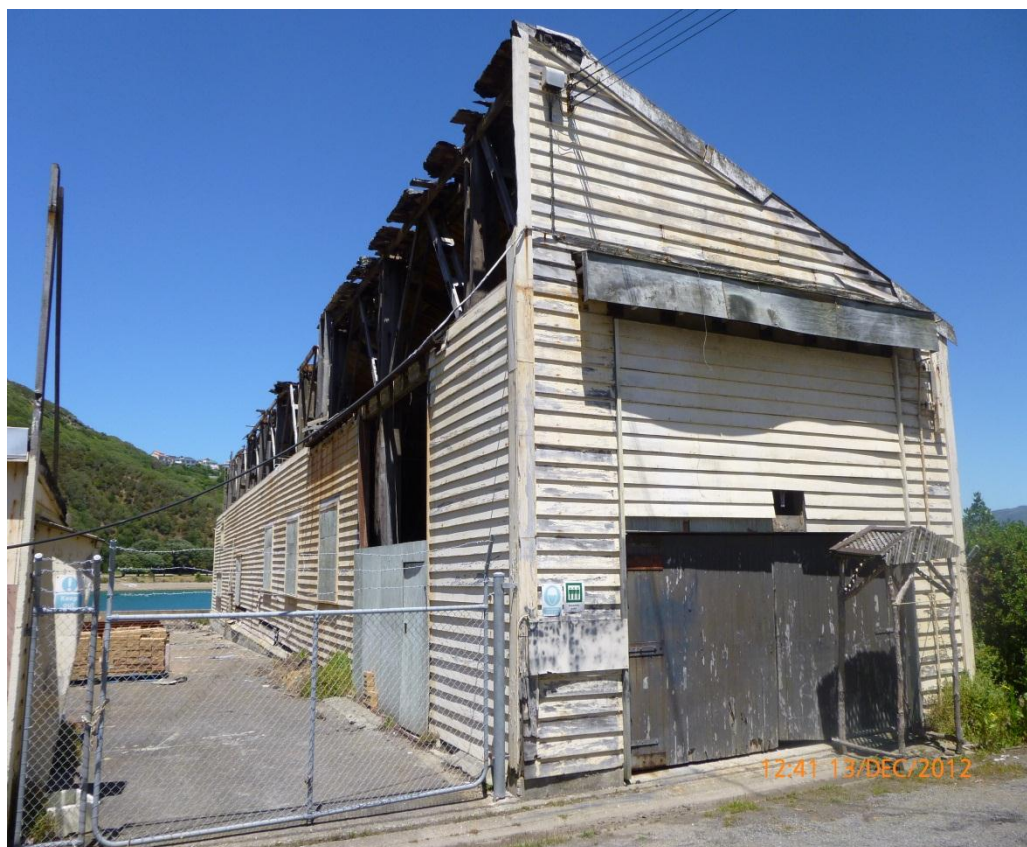
The eastern roller door has been removed and been framed out to half height with a door for access as shown on the left of Figure 9. The northern doors shown below in Figure 9 below are functional however the larger original door has been removed and it has been retrofitted with a smaller door, approximately half the height of the original. This prevents large machinery/items being stored in the building. External doors on the remaining facades are boarded up to provide additional security.

Figure 9: External view of former roller door

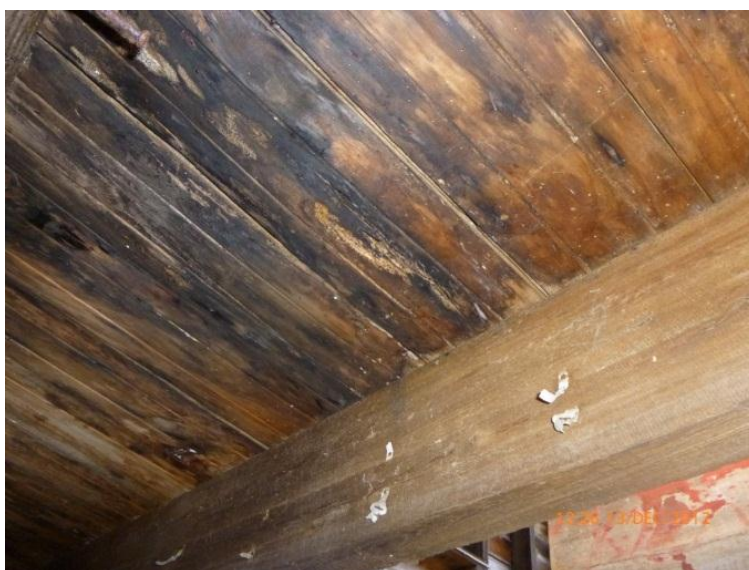
From the definition it is considered that if the building was occupied it would be considered insanitary as it is 'likely to be injurious to health because it is in a state of disrepair and has insufficient of defective provisions against moisture penetration as to cause dampness in the building.'

Figure 10: Moisture damage to internal timbers

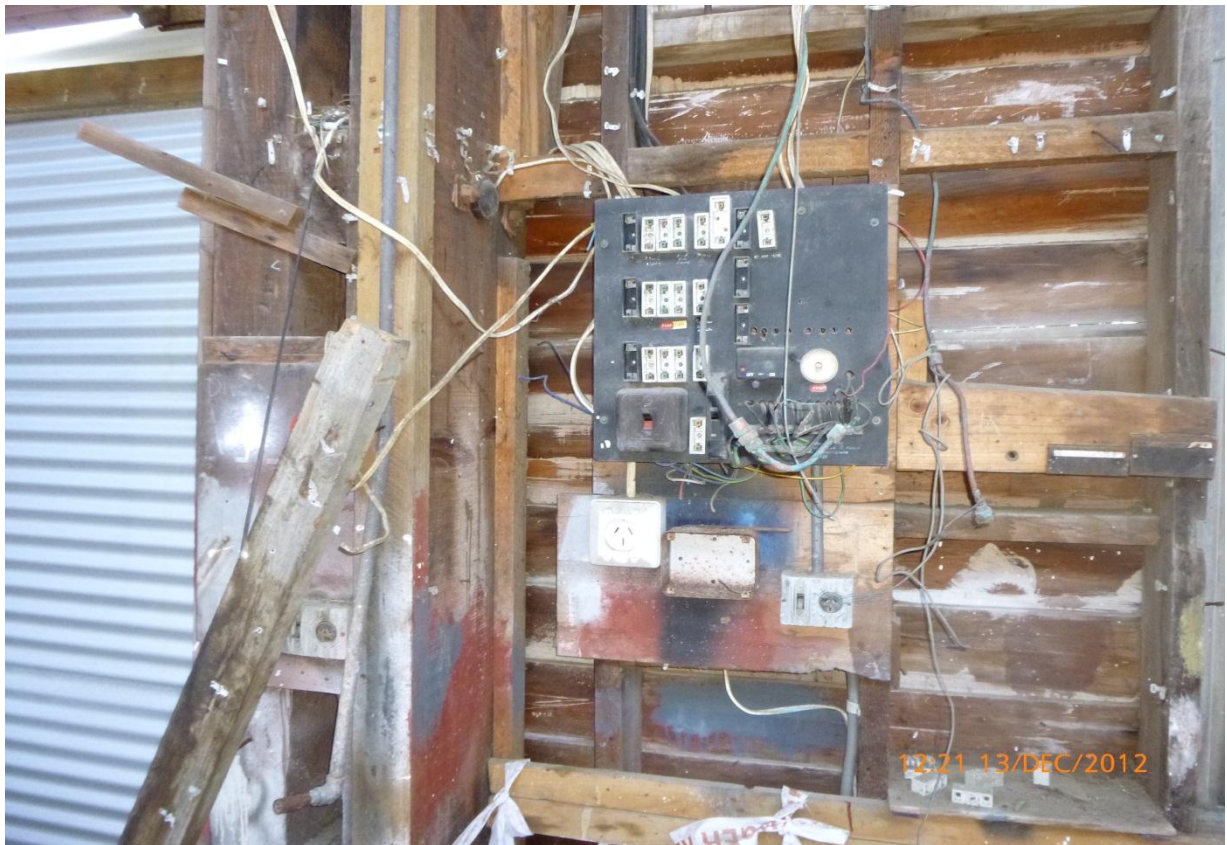
Exposed wiring is damaged by rats and water along with switchboards. Scorch marks on a number of power points and the main switchboards is evidence of unstable loads which indicate probable failure in wiring and and/or tripping of the switchboards.

The main switchboard is in poor condition with a number of fuses and wire missing.

Figure 11: Switchboard

Opus understands the electrical services are currently disconnected and advice not reconnecting until a detailed electrical analysis is completed by a suitably qualified person and the outdated and damaged electric services are replaced.

Removal of wiring and associated electrical fittings is the sole option for the supply and distribution of safe electricity within the Slipway.
