Sea Wall and Band Rotunda HERITAGE REPORT

Ian Bowman Architect and conservator

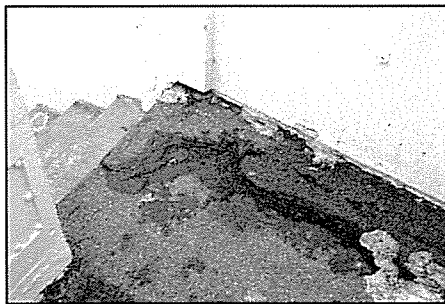
Broken and cracked asphaltic paving

Clean down all painted surfaces and repaint;
Repair all cracked concrete;
Replace roofing membranes
Replace existing steel handrail with original design concrete handrail;
Reputty all windows;
Reglaze broken and cracked windows;

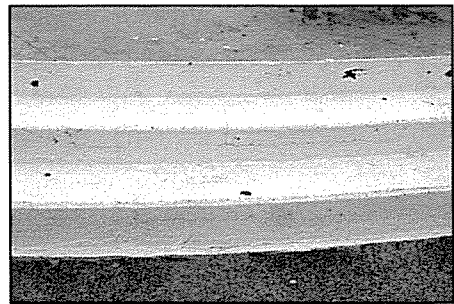
Cracked concrete steps

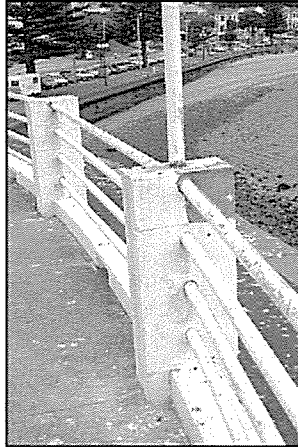
Rusting steel balustrading causing spalling concrete

The new balustrading does not comply with the Building Act and it is deteriorating. It is recommended that the new steel balustrading and lighting be replaced with balustrading and lighting to match the original design. It is also recommended that the stair balustrading more closely resemble the design of the original Art Deco forms.

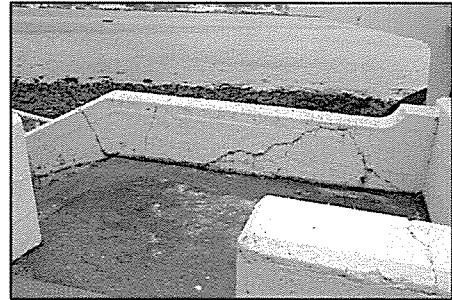
Cracked concrete wall

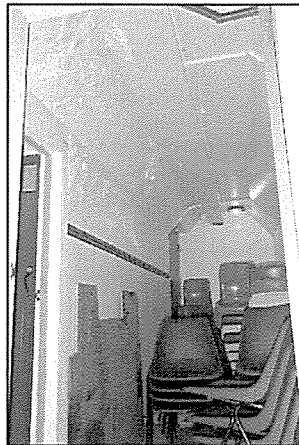
Efflorescence and spalling plaster

The following is a summary of internal remedial measures:
Clean down all coated fabric and recoat;
Repair all windows, replace or refurbish all window fittings;
Ease all windows and doors to ensure in good working order;
Repair damaged doors, refurbish or replace furniture and hardware;
