Wellington City Council
Property Services
P O Box 2199
WELINGTON

Band Rotunda – Updated Report on Slab Investigation Work

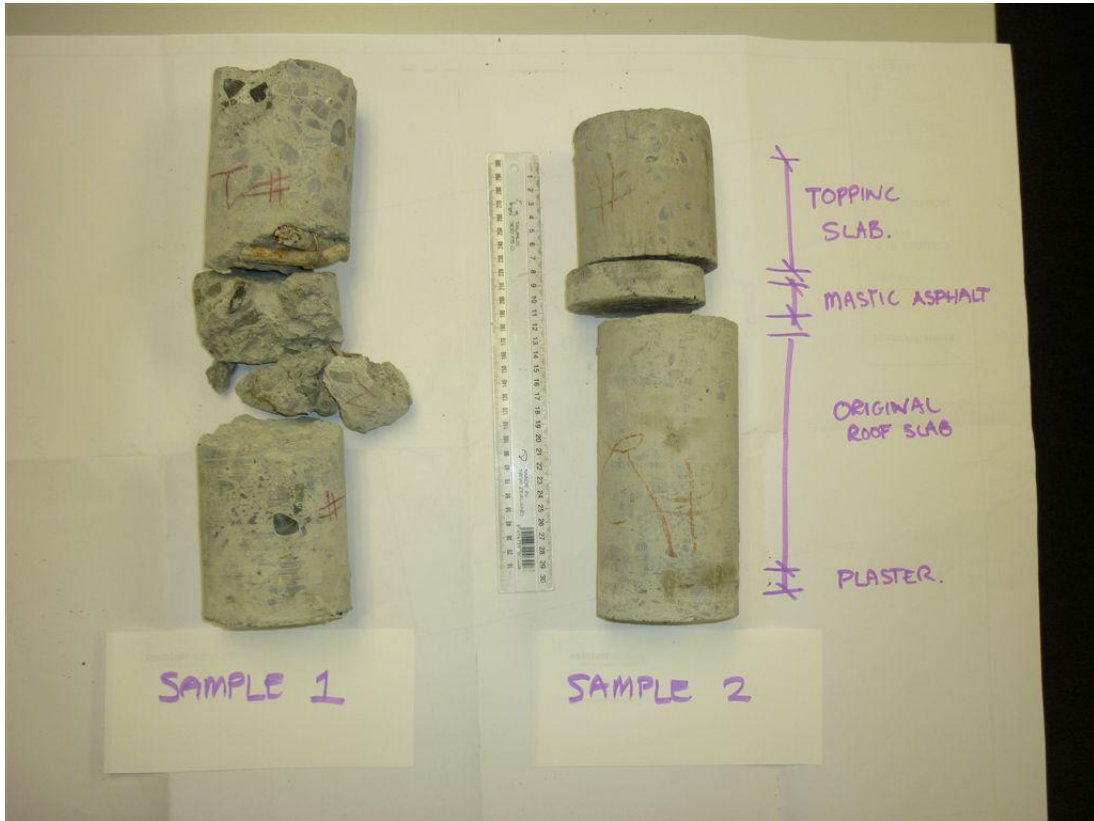
The cores show that the floor to the "Fisherman's Table" restaurant was not built in accordance with the construction drawings, in particular the raised timber floor detailed in the construction drawings was not constructed, and a structural topping slab of approximately 100mm thick has been poured over the existing roof slab instead.

The topping slab appears to have been poured directly over the old roof without removing the existing mastic asphalt roof membrane and there appears to be no key or bond of the new to the existing.

The test cores however showed the original roof slab has also not been built in accordance with the original design and is thicker at 7" (approx 180mm) deep instead of the 6" (152mm) slab shown on the drawings. This increase in depth does increase the strength of the slab and largely offsets the additional load.

We did not observe any deterioration of the top surface similar to the bottom of the slab however we note the sample cores only cover a very small sample area in comparison to the total floor. The asphalt membrane is about 25mm thick and appears to be still in good condition and may have assisted in protecting the top surface of the existing slab.

Photo 1 – Core Samples 1 and 2

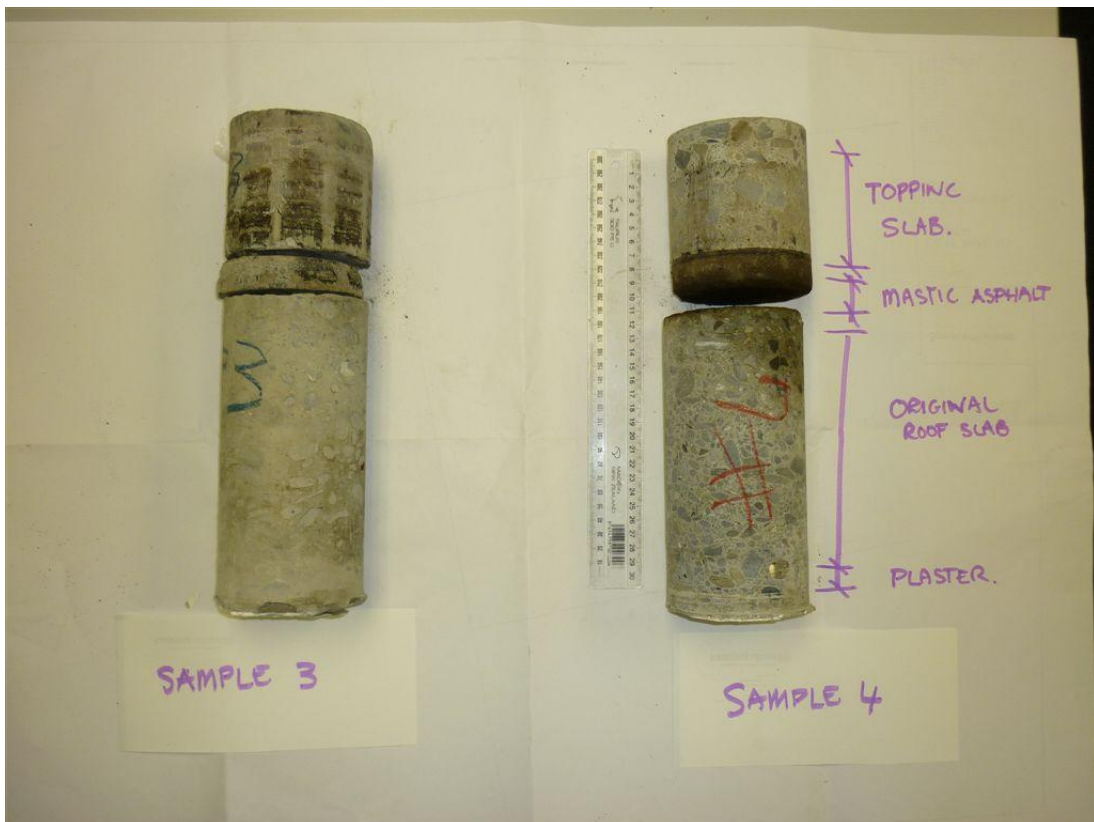
Photo 2 – Core Samples 3 and 4
