Arboricultural Assessment

Southern Cross Hospital, Newtown

Report Prepared
03 September 2018

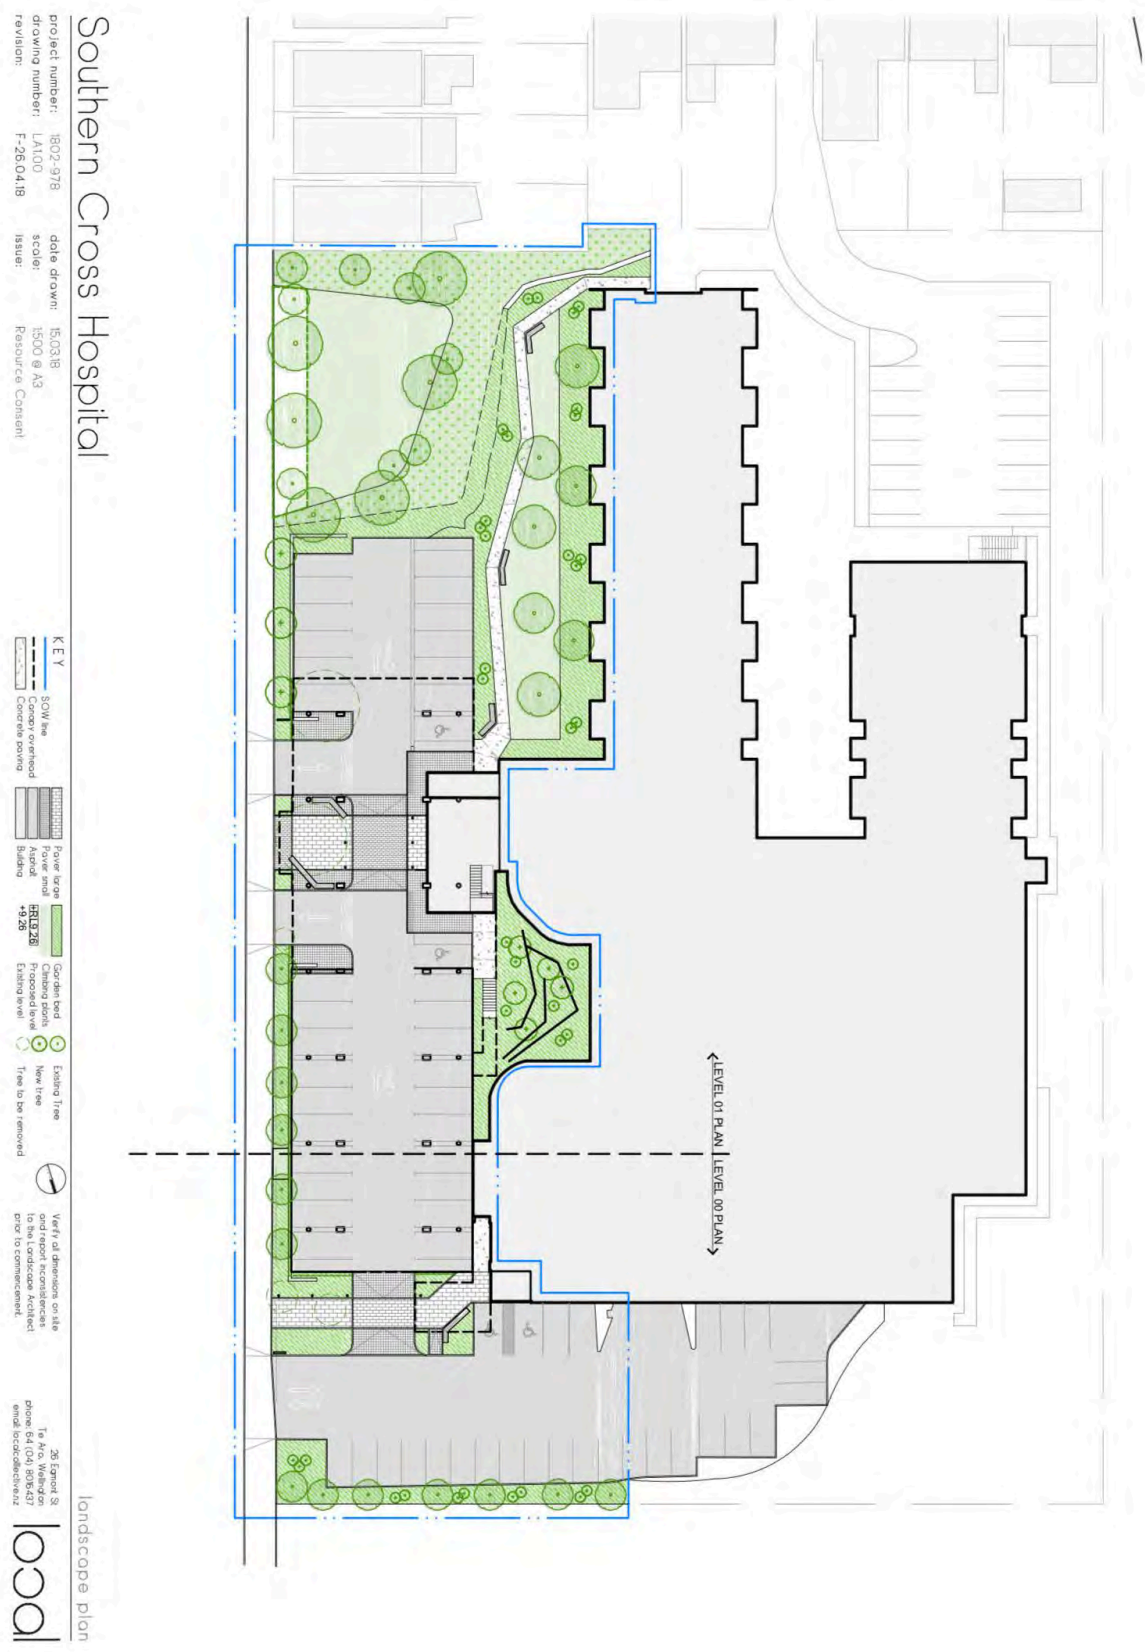
landscape plan

The location of a substation in the eastern garden bed is likely to impact on the adjacent two *Podocarpus totara* (Totara). For installation to take place it is likely trenches will need to be dug and underground services laid.

The plans supplied don't provide measurements and exact locations for the substation so an exact root zone incursion cannot be calculated.

The plan outlines the removal of 3 of the existing *Podocarpus totara* (Totara). The removal of these trees and stump removal may impact on the adjacent trees being retained. Particularly the removal of the stumps. Care must be taken that no roots are damaged during this process and it is recommended to have these works performed by suitably qualified arborists.

In the first instance, re-location of the substation away from the critical root zones of the trees being retained is preferable.

If the substation must be installed in this area, further consultation with an arborist is recommended to establish a low impact works methodology.

- Appoint a site arborist to oversee the works within the garden beds
- Re-locate the substation or provide detailed plans of its location and measurements in consultation with an arborist
- Implement tree protection plan
