**Hawkins Hill Right of Way**

**Service Levels and Maintenance Review**

Prepared for  
Wellington City Council

Prepared by  
Tonkin & Taylor Ltd

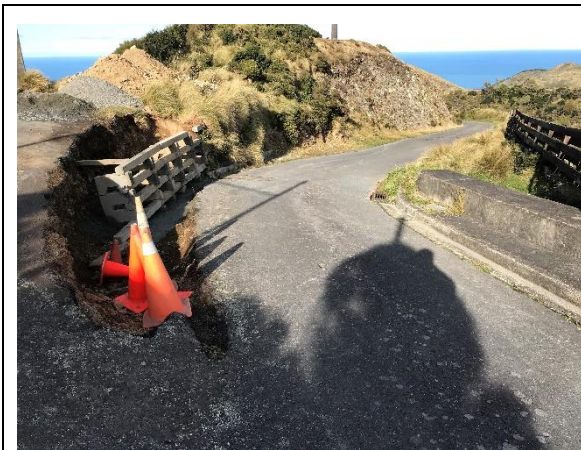
*Photograph 3-17: Retaining wall under construction at access to radome*

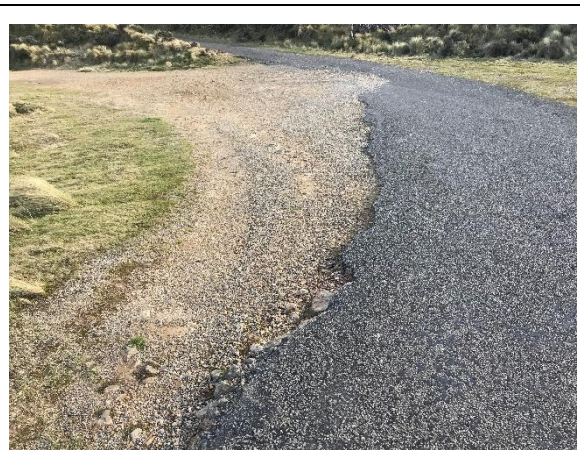
*Photograph 3-18: Edge break at start of unsealed RoW section*

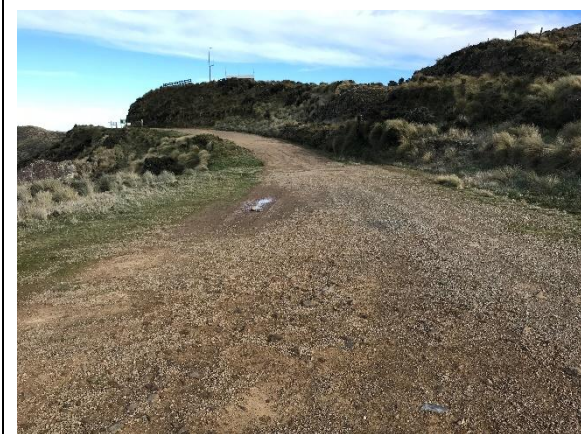
*Photograph 3-19: First 100m of unsealed RoW ending at farm gate*

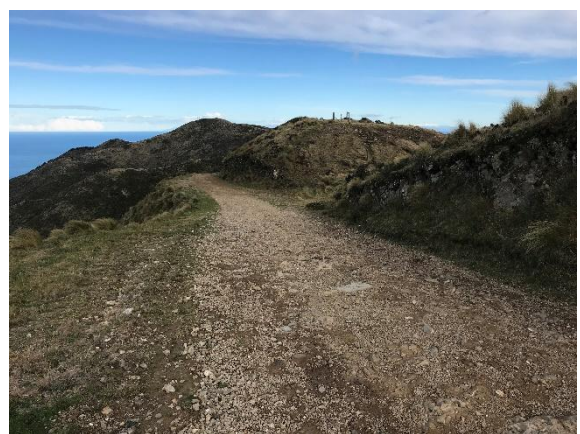
*Photograph 3-20: Typical view of remaining farm track RoW to access the reserve*
