Wellington City Council
PO Box 2199
Wellington 6140

Geotechnical and Contamination Assessment, 55-85 Curtis Street, Karori - Stage 2 Report

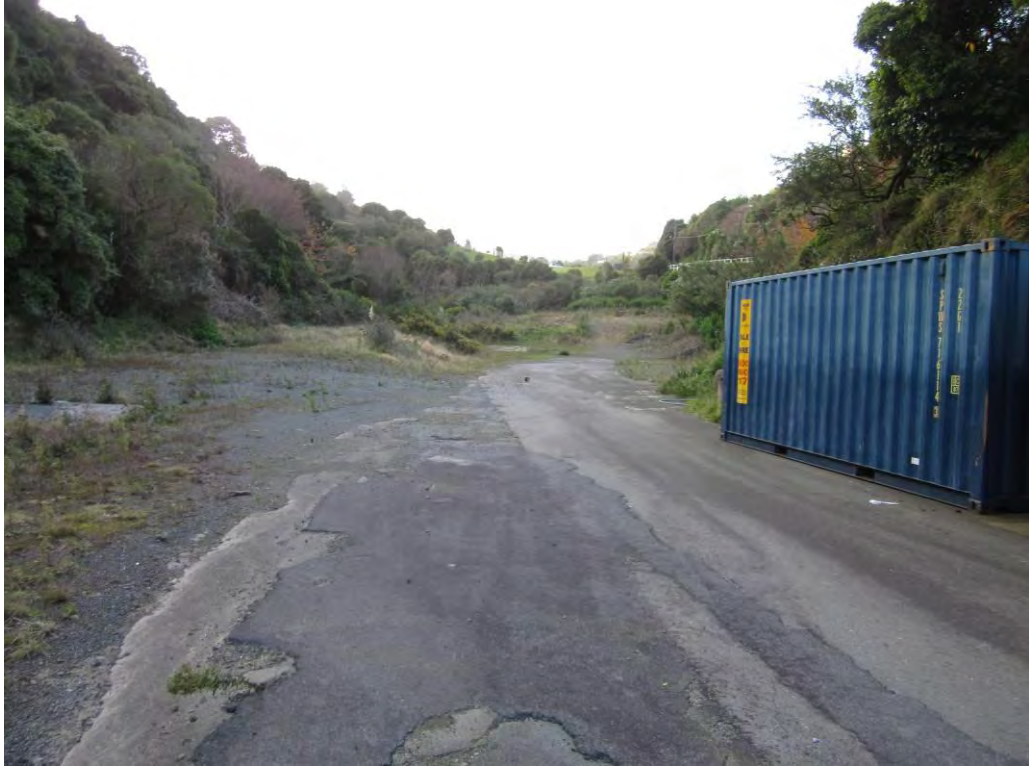
The site is characterised by being relatively bare and flat in the centre and southern end, with localised stockpiles of rubble and demolition waste spread over the surface.

Photograph 1 Looking north from southern (flat) end of site

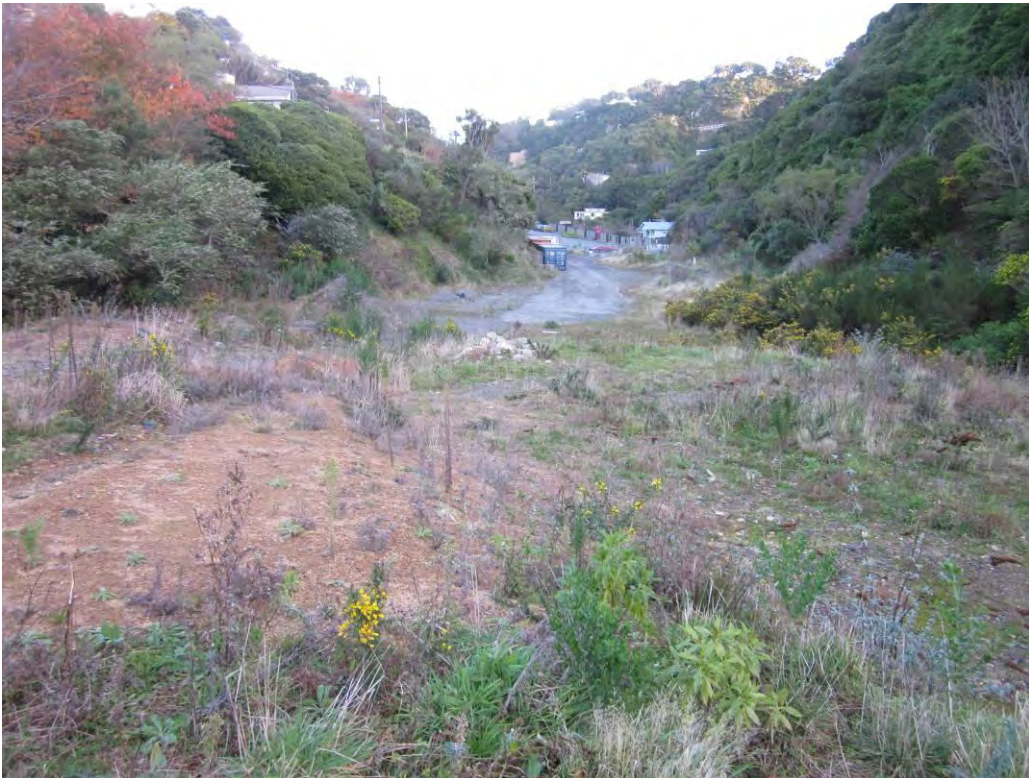
The site becomes more undulating and variable at the northern end, and the surface is characterised by stockpiles and mounds of fills, with thick vegetation and ponded water.

Photograph 2 Undulating northern end (looking south)

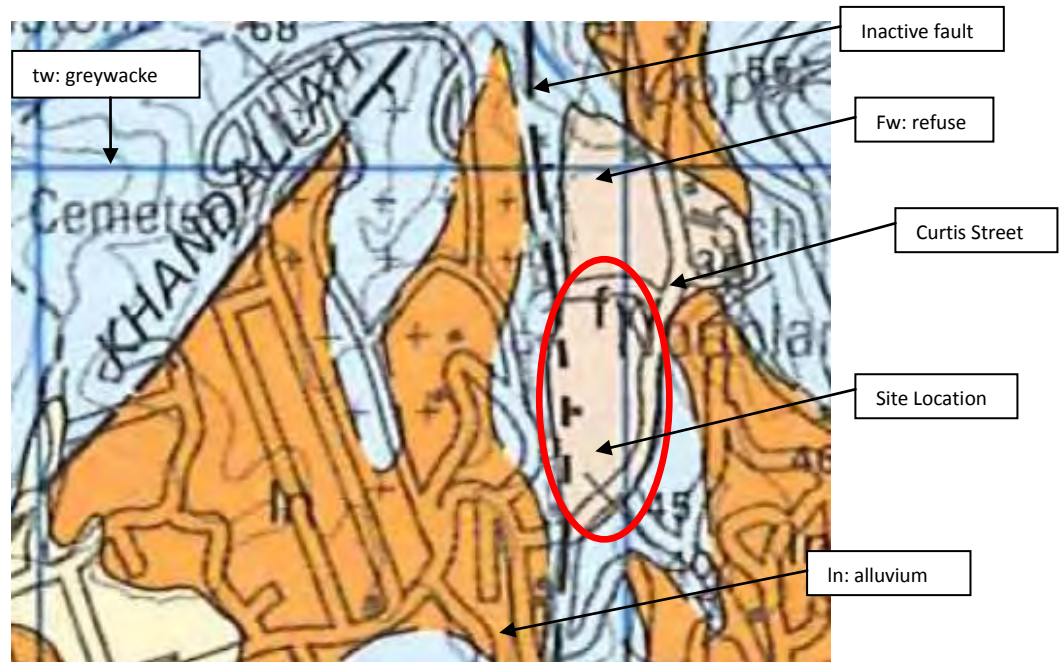
The 1:50,000 scale Geological Map of the Wellington area ¹ infers the site to comprise “fw” refuse landfill deposits. The site is bounded to the east and west by greywacke rock. The greywacke within Wellington typically comprises sandstone and siltstone with lesser mudstone. The rocks are steeply dipping and contain closely and very closely spaced fractures. Pleistocene Age (over 12,000 years old) alluvium is also recorded around the site (brown “In” on Figure 1).

An inactive fault is identified running north / south along the western side of the site, with down throw to the east (i.e. onto the site).

Figure 1 – Geology of the site (from Begg and Mazengarb 1996)

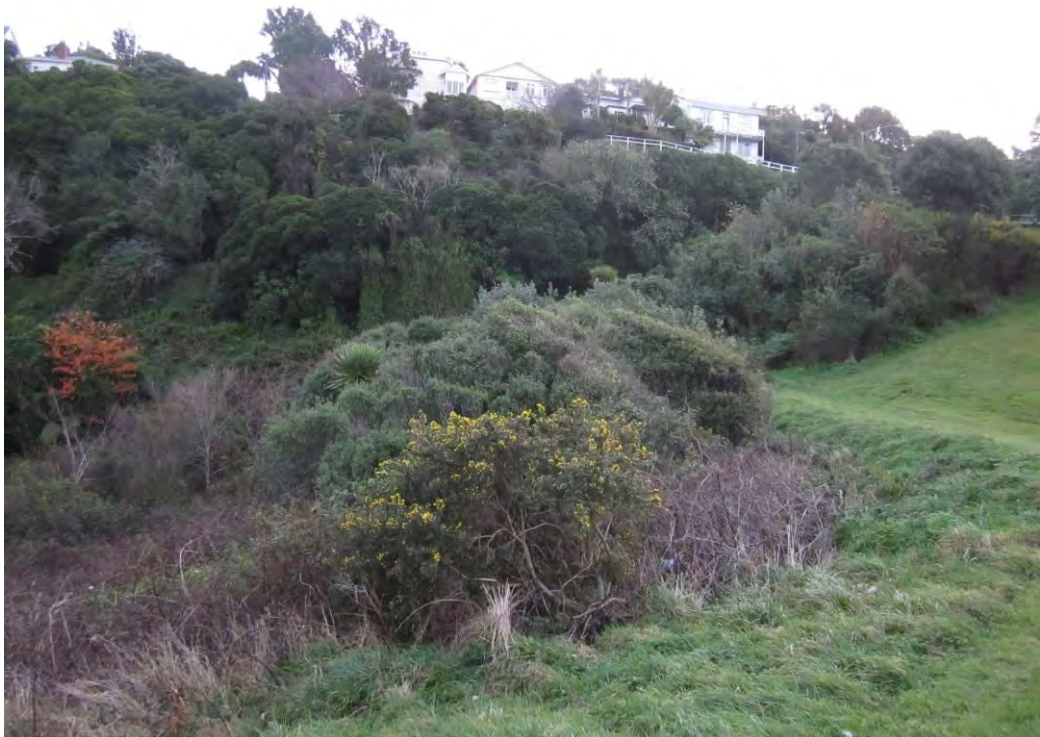
At the northern and north eastern end of the site, the Type A fill overlies landfill refuse (Type B fill). The Type B fill comprises silt, sand and gravel materials mixed with building waste and rubbish. A test pit at the northern end inferred the Type B fill was at least 4m thick. The thickness of Type B fill is likely to increase to the north.

Photograph 3 Type B fill slope (to right) and thick vegetation

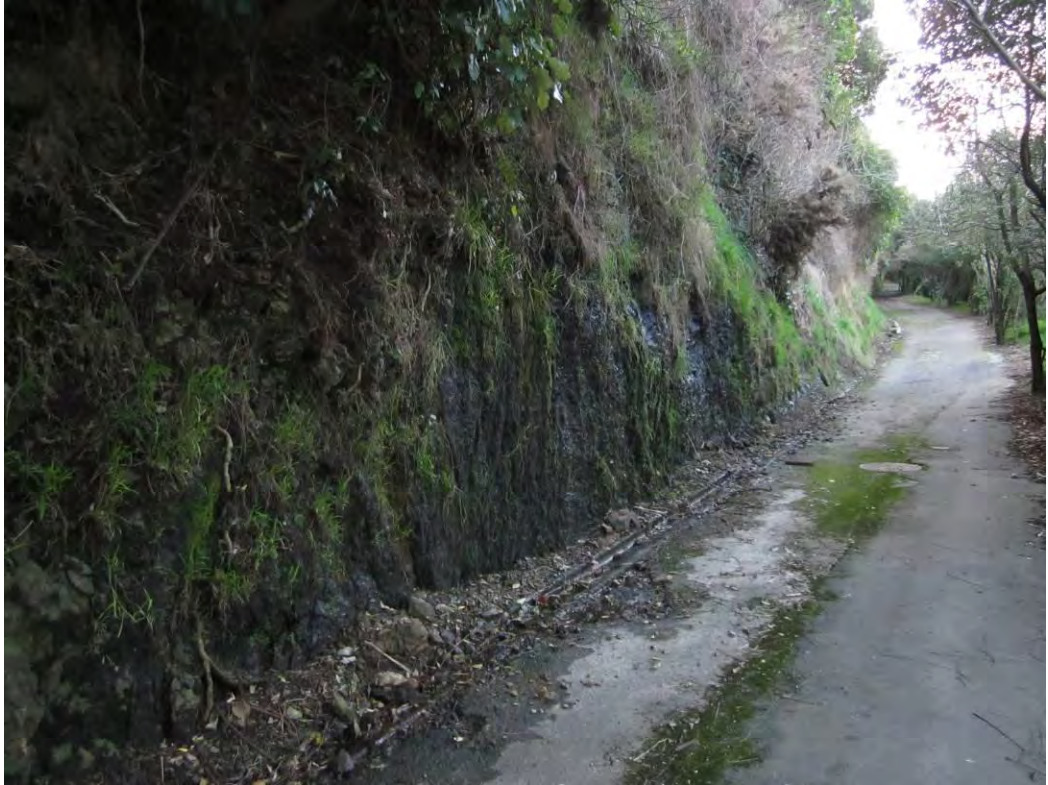
The site is bounded on its northern, eastern and southern sides by steep slopes. The northern slope is a fill slope created by historic landfill disposal. The valley slopes to the east and west are steep (over 35°), and are cut into natural ground comprising greywacke rock and overlying soils. The rock has been cut on the west side to form Old Karori Road. The cuts are at an angle of over 60°.

Photograph 4 Steep rock cut adjacent to Old Karori Road

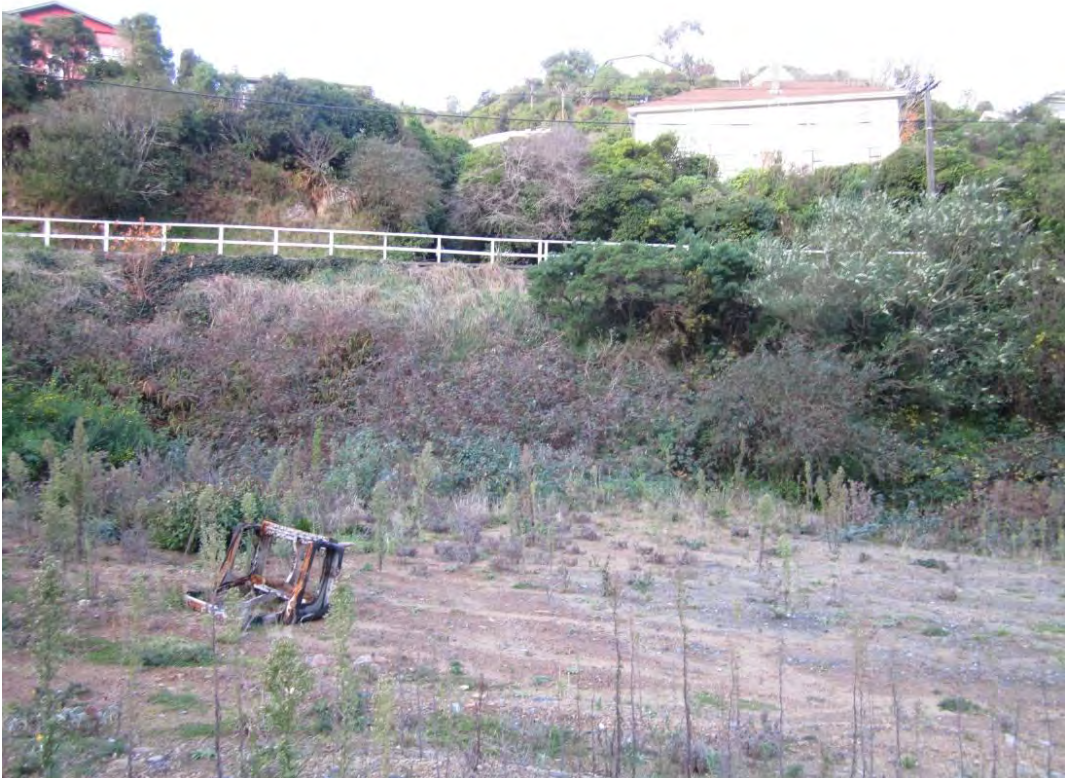
The slope to the east below Curtis Street is locally shallower (less than 35°).

Photograph 5 Slope below Curtis Street and example obstructions to be expected
