ALL ASBESTOS & INSULATION LTD

Asbestos survey carried out at 314 The Terrace Wellington

A Type 2 Non-Destructive Asbestos Survey, based on the standard MDHS100 HSE UK2001, was conducted at the above premises on the 1ST December 2014.

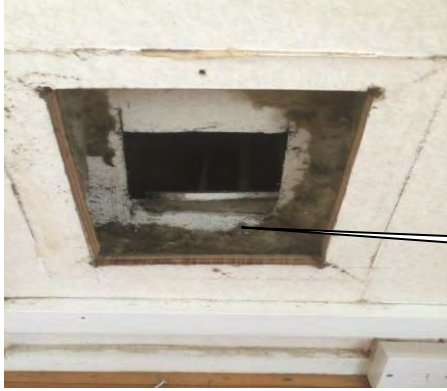
Board Not Asbestos (1)

Sample 1 Internal lining to riser backing lounge unit 115
(CES REPORT No 132356 Attached) No Asbestos detected.

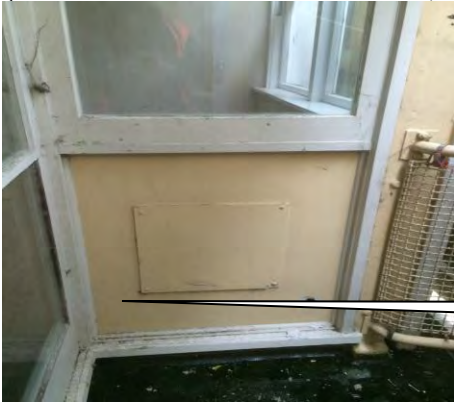
Asbestos sheet (2)

Sample 2 Panel under windows to exterior balcony
(CES REPORT No 132357 Attached) Amosite Asbestos detected.

Hazard algorithm score 4(very low) while not disturbed

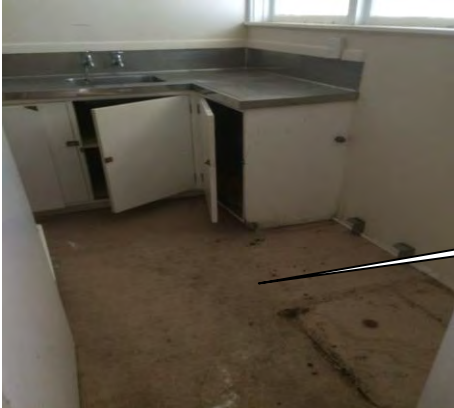
Vinyl flooring not Asbestos (3)

Sample 3 Vinyl to Kitchen floor unit 115.
(CES REPORT No 132358 Attached) No Asbestos detected.

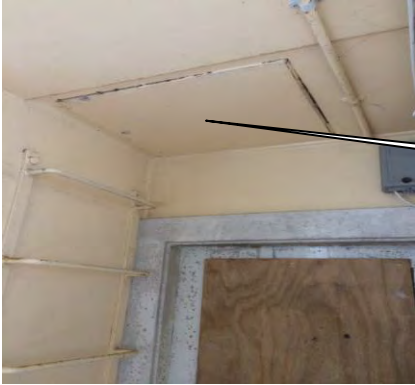
Asbestos sheet (4)

Sample 4 Hatch cover to fire escape above entrance unit 115.
(CES REPORT No 132359 Attached) Amosite Asbestos detected.

Hazard algorithm score 4(very low) while not disturbed

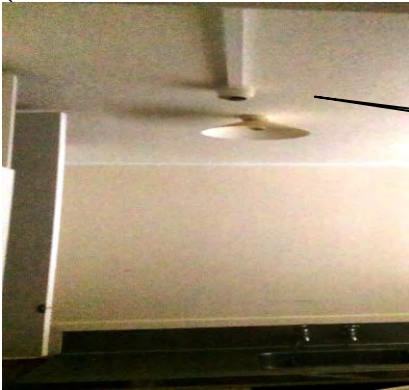
Textured coating not Asbestos (5)

Sample 5 Textured coating to ceiling unit 115.
(CES REPORT No 132360 Attached) No Asbestos detected.

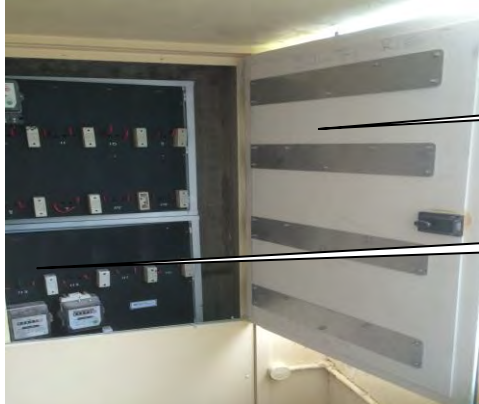
Sample 6 Lining to Electrical riser level 1 Stairs south. (Refer to photo below)
(CES REPORT No 132361 Attached) No Asbestos detected.

Sample 7 Electrical board panelling.
(CES REPORT No 132362 Attached) Positive for Chrysotile Asbestos.

Asbestos sheet (6)

Asbestos sheet to power board (7)

Hazard algorithm score 3(very low) while not disturbed (for power board only)

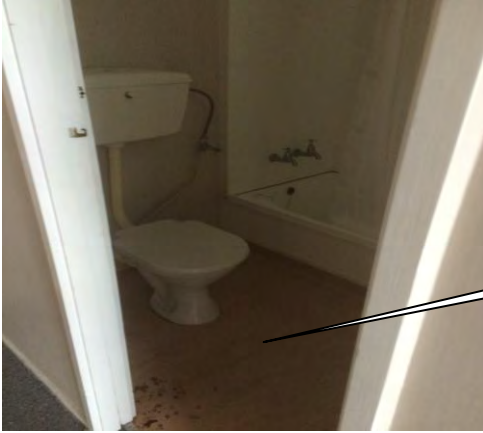
Vinyl flooring not Asbestos (8)

Sample 8 Vinyl to toilet unit 215.
(CES REPORT No 132363 Attached) No Asbestos detected.

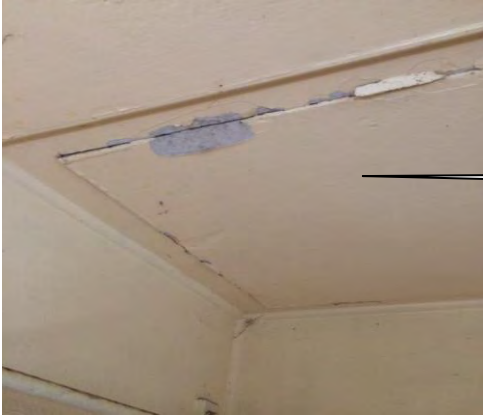
Asbestos sheet (9)

Sample 9 Hatch panel soffit entry outside room 215.
(CES REPORT No 132364 Attached) Amosite Asbestos detected.

Hazard algorithm score 4(very low) while not disturbed

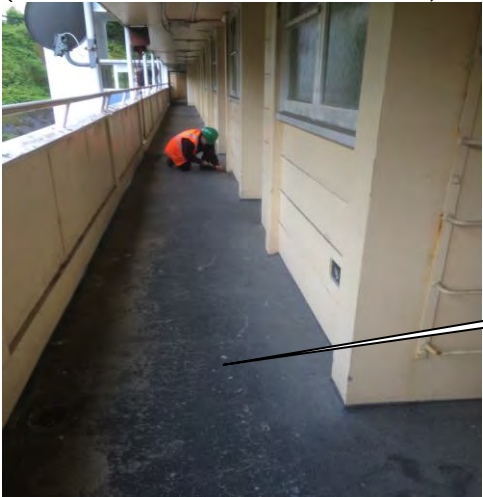
Landing membrane not Asbestos (10)

Sample 10 Exterior landing membrane level 2.
(CES REPORT No 132365 Attached) No Asbestos detected.

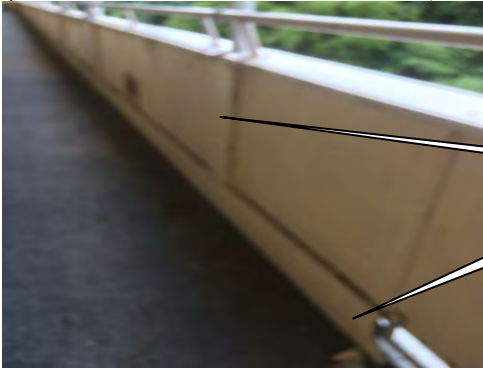
Sample 11 Base board level 2 handrails. (Refer to the photo below)
(CES REPORT No 132366 Attached) No Asbestos detected.

Sample 13 joiner panels to handrails level 2.
(CES REPORT No 132368 Attached) No Asbestos detected.

Base board not Asbestos (11)

Joiner not Asbestos (13)

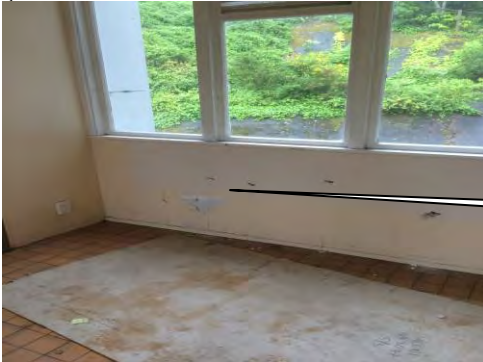
Asbestos panels (12)

Sample 12 Lift lobby level 2 Cladding under windows.
(CES REPORT No 132367 Attached) Amosite Asbestos detected.

Hazard algorithm score 4(very low) while not disturbed
Note not all the cladding under the windows is Asbestos there is some Gib board as well.

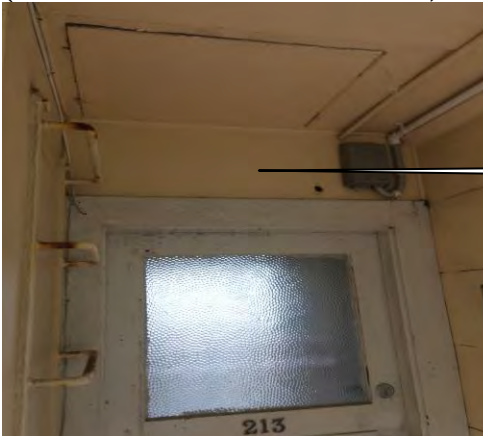
Asbestos sheet (14)

Sample 14 Sheet above entry door outside unit 214.
(CES REPORT No 132369 Attached) Amosite Asbestos detected.

Hazard algorithm score 4(very low) while not disturbed
Note this cladding is above every entry door

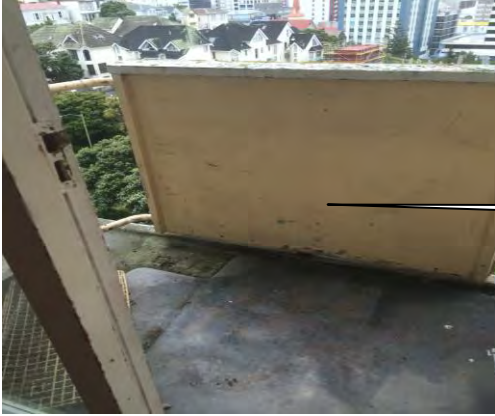
Exterior lining handrail not Asbestos (15)

Sample 15 Exterior face of Handrail unit 315.
(CES REPORT No 132370 Attached) No Asbestos detected.

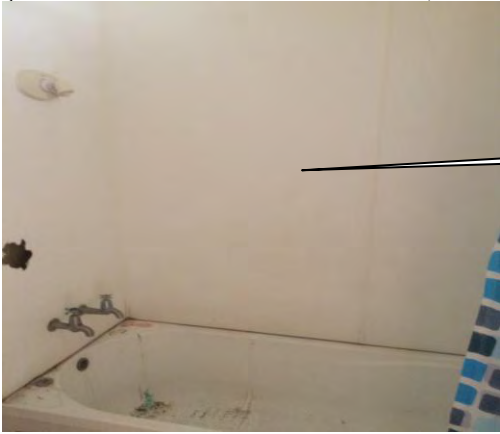
Shower linings no Asbestos backed (16)

Sample 16 Lining to shower unit 315.
(CES REPORT No 132371 Attached) No Asbestos detected.

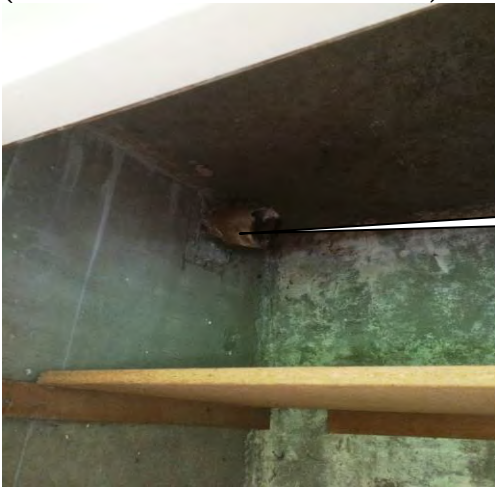
Asbestos vent pipe (17)

Sample 17 Pipe in hot water cupboard unit 315.
(CES REPORT No 132372 Attached) Amosite Asbestos detected.

Hazard algorithm score 5(low) while not disturbed
This is probably a vent and if so is likely to be in place in all rooms.

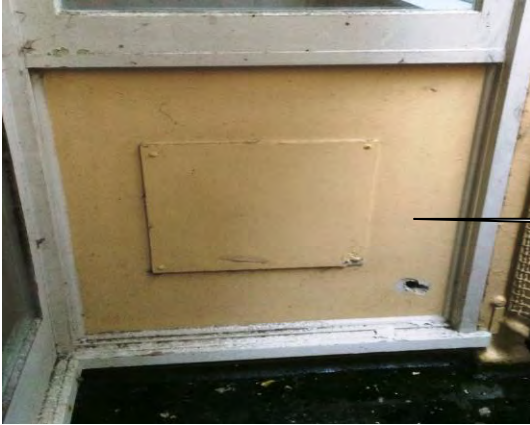
Asbestos cladding (18)

Sample 18 Cladding under windows unit 315.
(CES REPORT No 132373 Attached) Amosite Asbestos detected.

Hazard algorithm score 5(low) while not disturbed

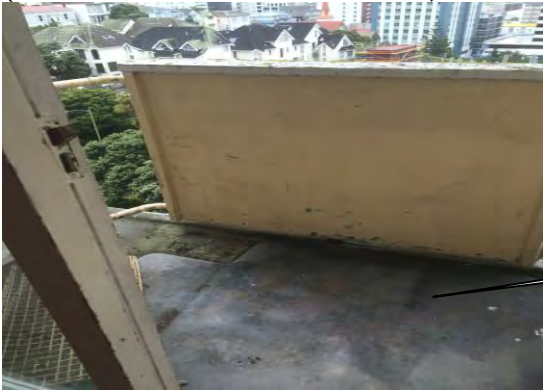
Tar Membrane not Asbestos (19)

Sample 19 Tar membrane to deck unit 315.
(CES REPORT No 132374 Attached) No Asbestos detected.

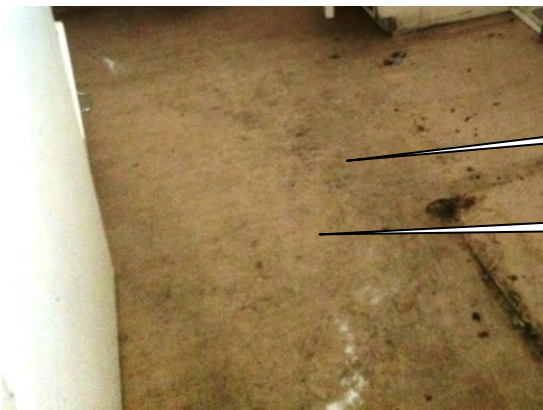
Sample 20 Vinyl to Kitchen unit 315.
(CES REPORT No 132375 Attached) No Asbestos detected. (Refer to the photo below)

Sample 21 2nd layer of Vinyl to Kitchen unit 315.
(CES REPORT No 132376 Attached) No Asbestos detected.

Ist layer of Vinyl not Asbestos (20)

2nd layer of Vinyl not Asbestos (21) under top layer

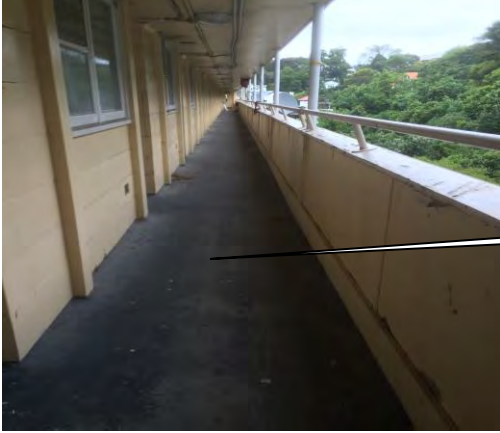
Landing membrane not Asbestos (22)

Sample 22 Tar Membrane walkway level 3
(CES REPORT No 132377 Attached) No Asbestos detected.

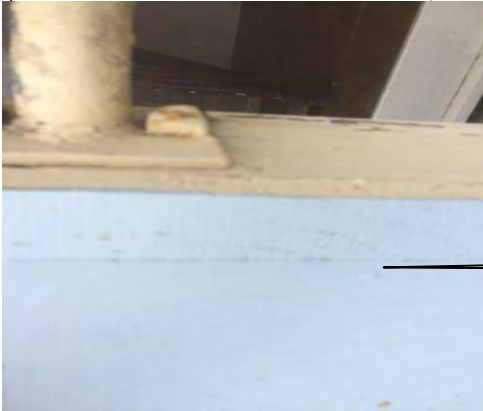
Asbestos cladding (23)

Sample 23 Outside cladding panel Balcony unit 415
(CES REPORT No 132378 Attached) Amosite and Chrysotile Asbestos detected.

Hazard algorithm score 5(low) while not disturbed

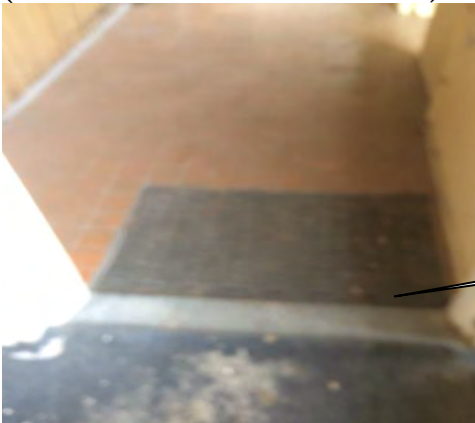
Backing paper not Asbestos (24)

Sample 24 Backing paper under new Vinyl unit 415
(CES REPORT No 132379 Attached) No Asbestos detected.

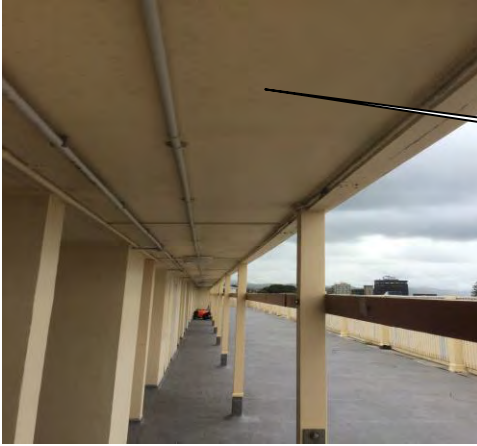
Asbestos soffits (25)

Sample 25 Soffits to exterior top of building
(CES REPORT No 132380 Attached) Amosite and Chrysotile Asbestos detected.

Hazard algorithm score 5(low) while not disturbed

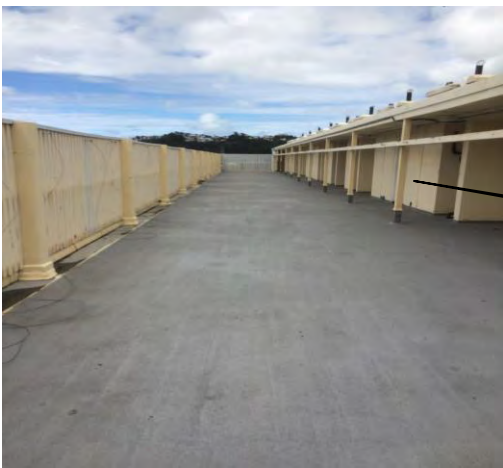
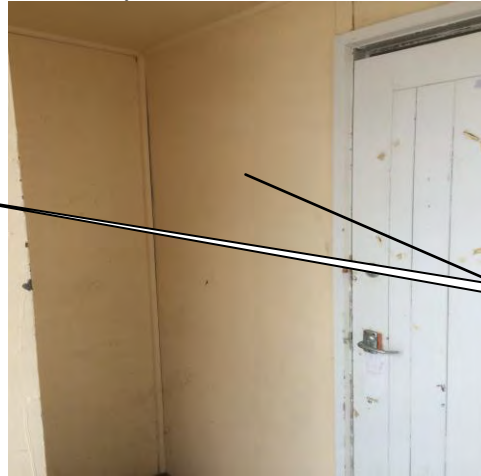
Asbestos cladding (26)

Sample 26 Wall linings exterior top of building
(CES REPORT No 132381 Attached) Amosite and Chrysotile Asbestos detected.

Hazard algorithm score 5(low) while not disturbed

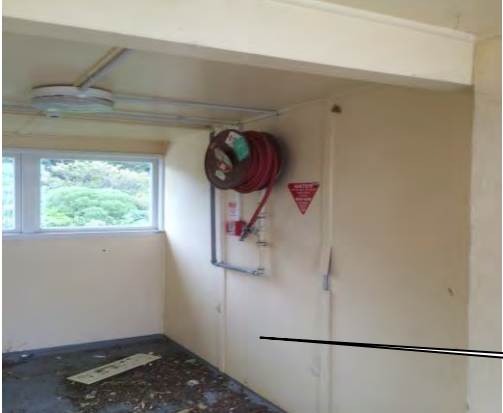
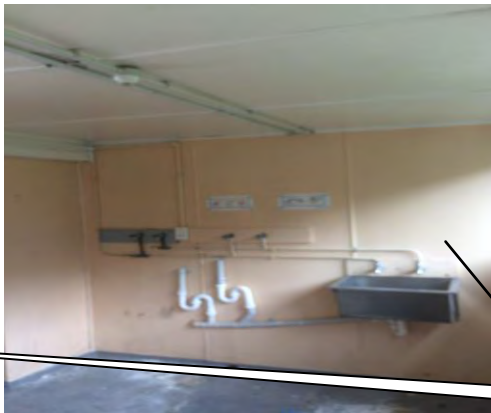
Asbestos cladding (27)

Sample 27 Wall linings interior top of building
(CES REPORT No 132382 Attached) Amosite and Chrysotile Asbestos detected.

Hazard algorithm score 5(low) while not disturbed

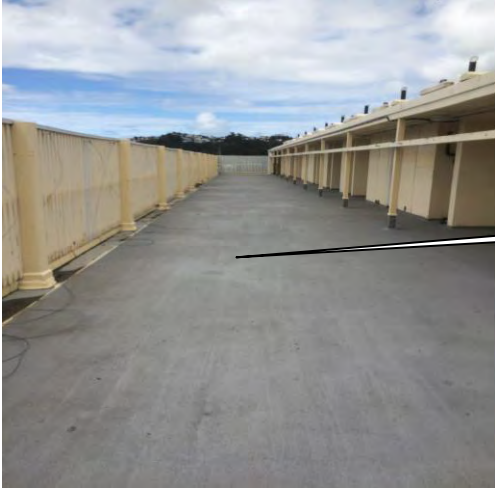
Lower roof membrane not Asbestos (28)

Sample 28 Lower Roof Membrane
(CES REPORT No 132383 Attached) No Asbestos detected.

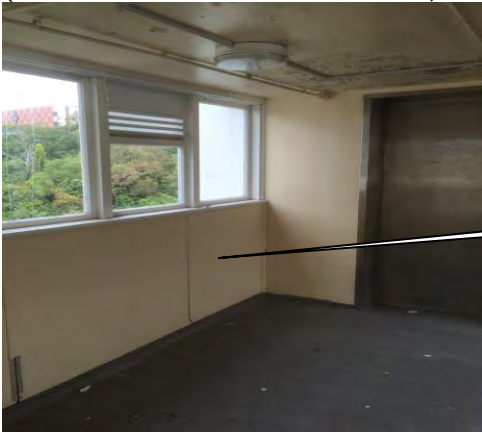
Asbestos cladding (29)

Sample 29 Wall panels lift lobby Top level
(CES REPORT No 132384 Attached) Amosite and Chrysotile Asbestos detected.

Hazard algorithm score 5(low) while not disturbed

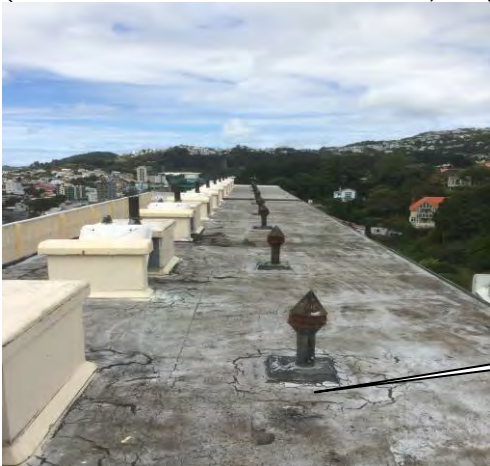
Asbestos content in roofing membrane (30)

Sample 30 Upper Roof Membrane
(CES REPORT No 132385 Attached) Chrysotile Asbestos detected.

Hazard algorithm score 4(very low) while not disturbed

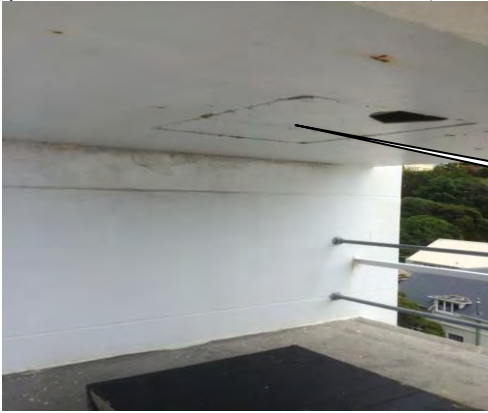
Asbestos cladding (31)

Sample 31 Roof Hatch

(CES REPORT No 132386 Attached) Amosite and Chrysotile Asbestos detected.

Hazard algorithm score 5(low) while not disturbed

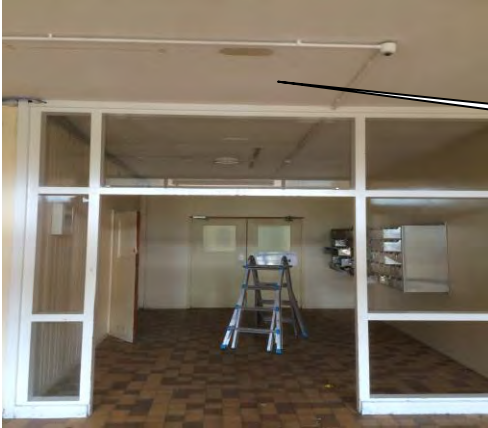
Ceiling texture not Asbestos (32)

Sample 32 Textured ceiling coating to entrance lobby ground floor
(CES REPORT No 132387 Attached) No Asbestos detected.

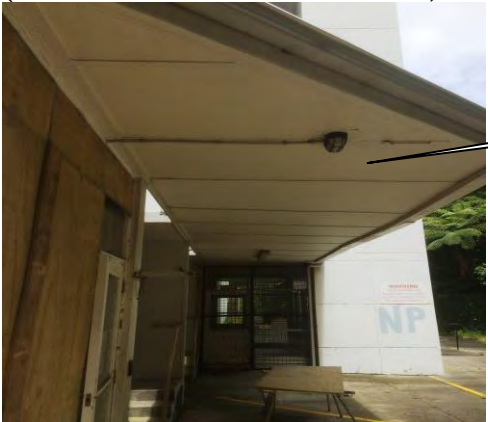
Asbestos soffits (33)

Sample 33 Textured ceiling coating to entrance lobby ground floor
(CES REPORT No 132388 Attached) Amosite Chrysotile & Crocidolite Asbestos detected.

Hazard algorithm score 5(low) while not disturbed
