Wellington City Council Targeted Assessment Programme

following the
Kaikoura Earthquake of 14 November 2016

Summary Report

Summary of the Technical Report on the Wellington City Council Targeted Assessment Programme Following the 14 November 2016 Kaikoura Earthquake

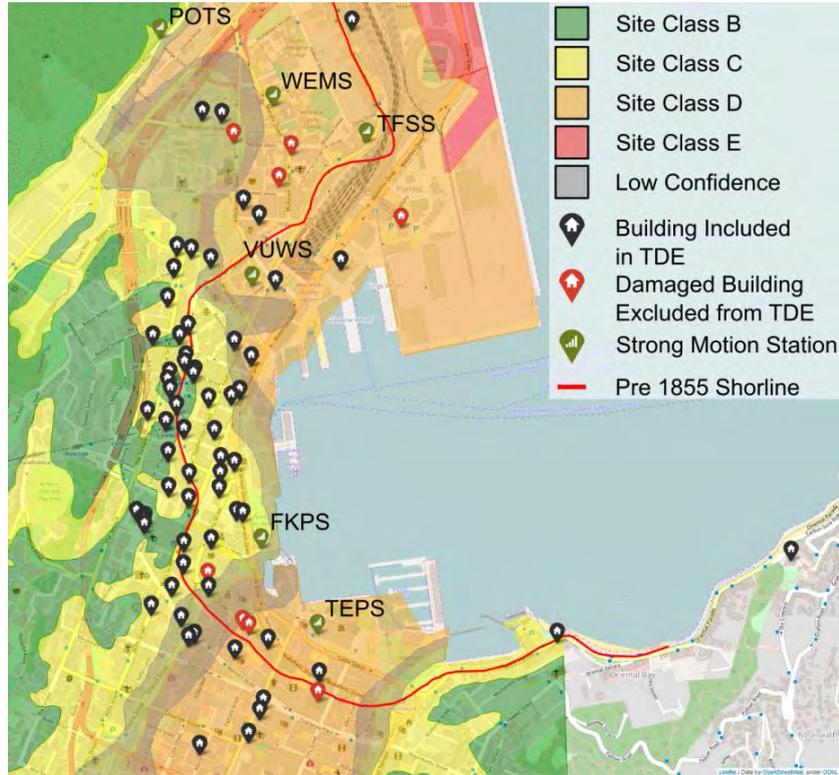
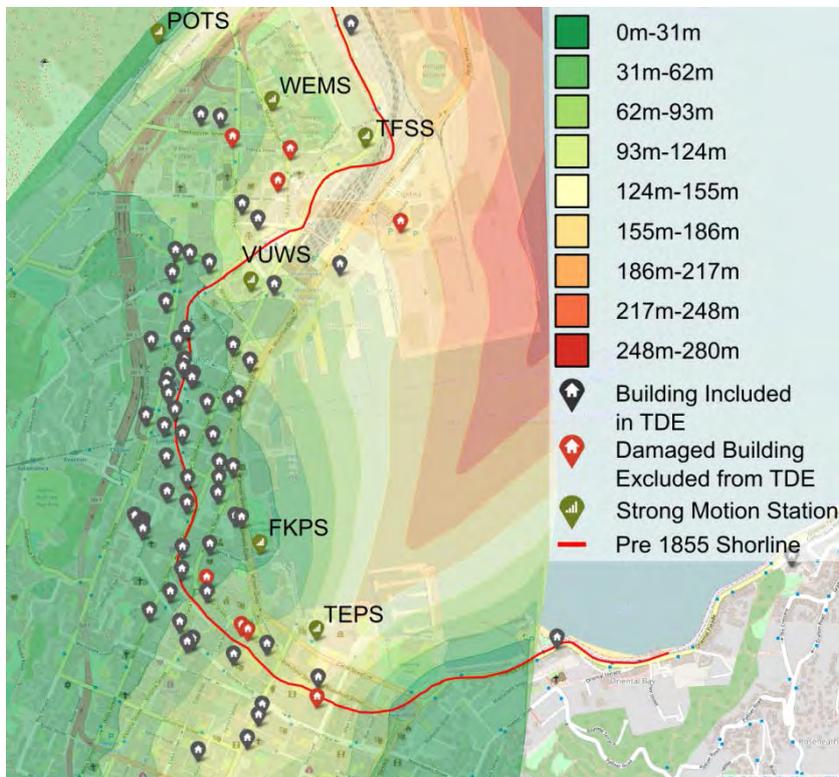
Map of (a) site class and (b) depth to bedrock with location of buildings

The results indicated a trend to an increased level of damage on softer sites with a greater depth to bedrock. There is no apparent relationship with the damage and whether or not the building was located on reclaimed land. This is most likely because the materials used for the reclamation often make up only a small portion of the overall soil profile thickness at each location, and the reclamation materials may be stiffer than the underlying natural deposits.
