**Hawkins Hill Right of Way**

**Design Report**

Prepared for  
Wellington City Council

Date  
February 2020

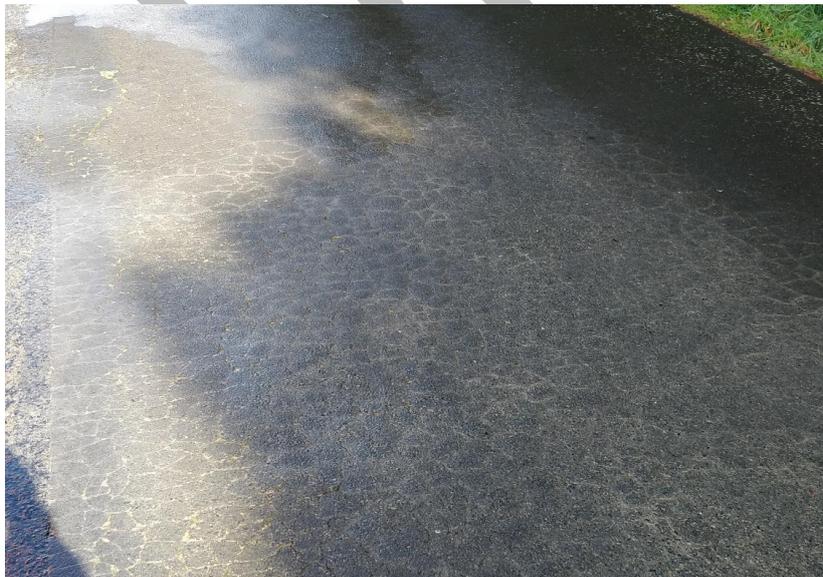
An existing section of asphalt concrete (AC) repair is noted as having failed and is subject to crocodile cracking. Full width, full depth reconstruction is recommended in this location and is identified on the drawing 1006626.2000-1202 in Appendix A. This area of failed AC is shown in Figure 4-1 below.

Figure 4-1: Area of failed AC with crocodile cracking evident

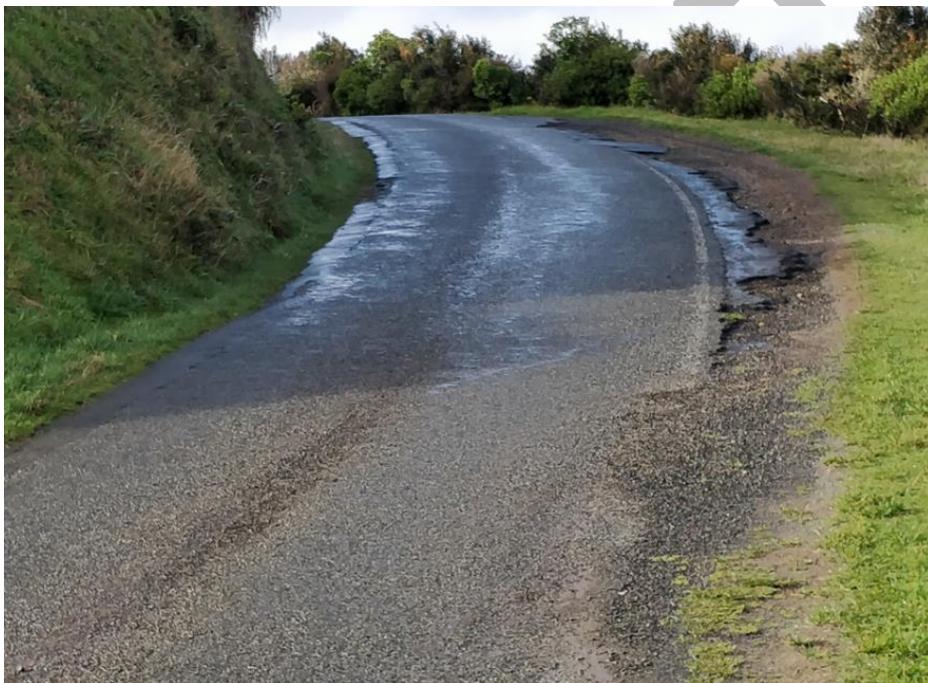
Edge-break and crocodile cracking are apparent in a number of locations in Section B where uncontrolled stormwater flow has scoured and damaged the edges of the existing pavement. An example of this is shown in Figure 4-2 below. The areas have been identified on the Drawings and will be reinstated in accordance with detail drawing 1006626.2000-7102.

*Figure 4-2: Typical example of edge break seen in Section B*

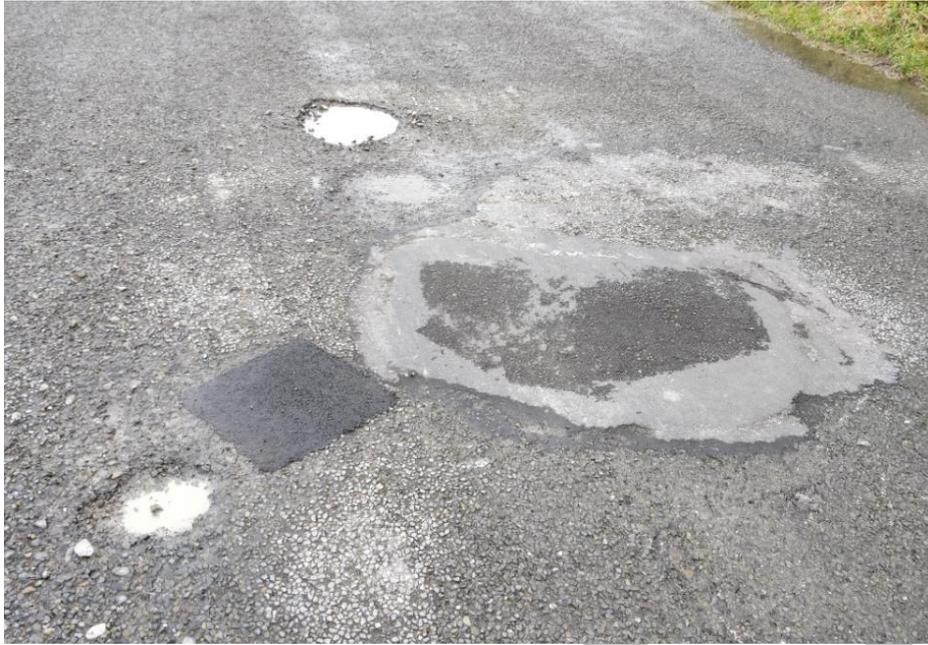
Potholes are also evident in a number of locations in Section B (Figure 4-3), some of which have been patch repaired in the past, others have established more recently. These will need to be excavated and repaired in accordance with detail drawing 1006626.2000-7102.

*Figure 4-3: Typical example of potholing in Section B*

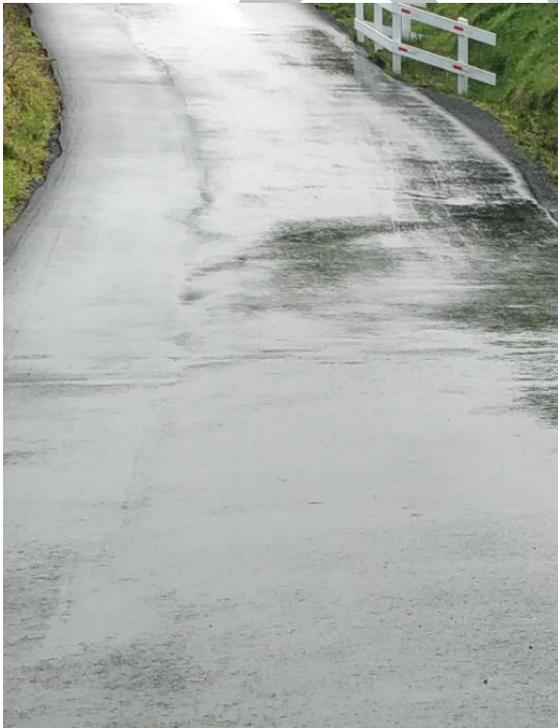
Recent repairs to two sections of the RoW with an AC surface course appear to be performing well with no visual signs of damage or deterioration. These are close to either end of Section B, one is close to the wind turbine access gate and the other is approaching the Southernthread Road intersection. These are shown in Figure 4-4 and Figure 4-5 respectively.

*Figure 4-4: Recent AC pavement repair on Section B (Near wind turbine)*

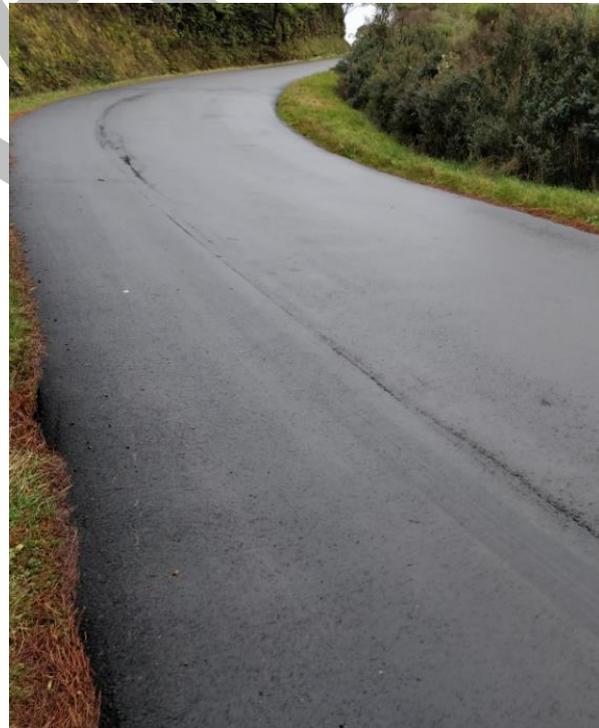
*Figure 4-5: Recent AC pavement repair on Section B (Near Southernthread Road)*

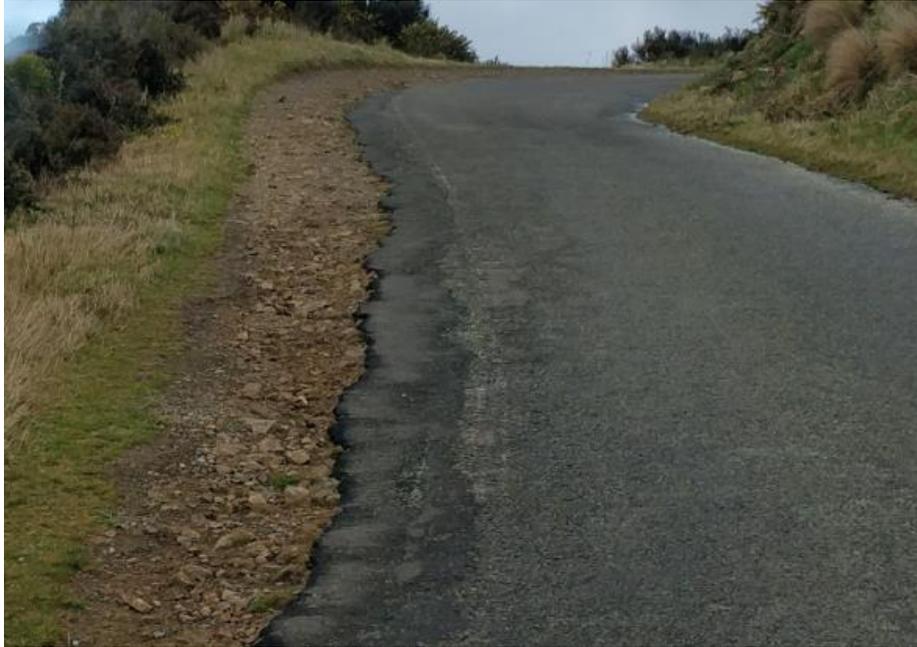
The pavement in Section C appears to be generally performing well. Some edge-break is evident, a typical view of which is shown in Figure 4-6 below, which should be repaired in accordance with detail drawing 1006626.2000-7102. Some verge re-shaping on the outside of the curve should also be carried out in accordance with the detail shown on 1006626.2000-7201 to control stormwater flow.

Figure 4-6: Typical view of edge-break in Section C

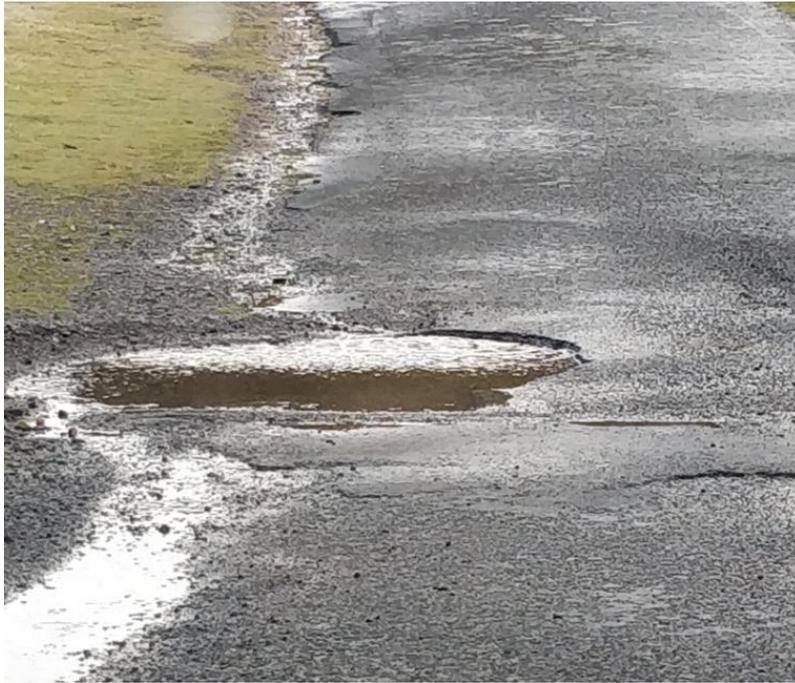
There is a large pothole (Figure 4-7) approximately 100m beyond the start of Section D (Woofingtons) which will need to be repaired in accordance with detail drawing 1006626.2000-7102. Otherwise, the pavement in this section is fit for purpose with no obvious visual signs of deterioration. Minor areas of pothole repair and edge break reinstatement are also indicated for this section.

Figure 4-7: Large pothole requiring repair in Section D
