T&T Ref: 85581  
05 October 2012

Wellington City Council  
101 Wakefield Street  
Wellington

## 8-28 Jaunpur Crescent, Broadmeadows - Geotechnical Assessment and Peer Review

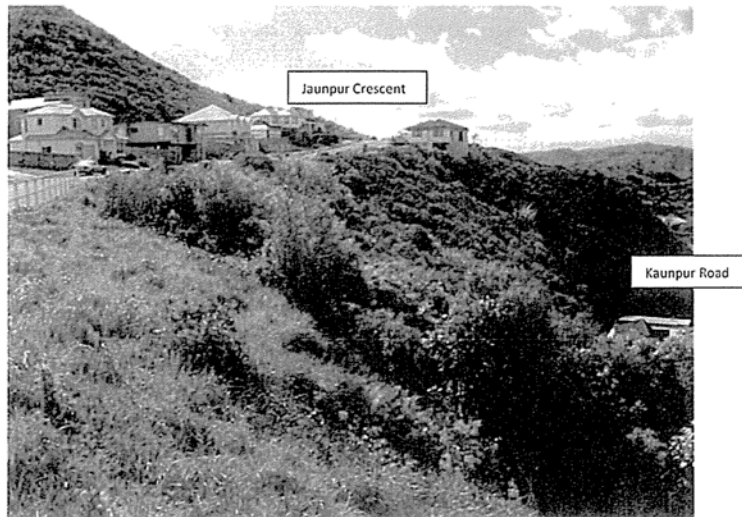
The slope is well vegetated and it has been cut at the base to allow the formation of lots on Kanpur Road. We understand from the ABuild report that there is a bench extending across the slope at about mid height.

Photograph 1 Subject site (looking north)

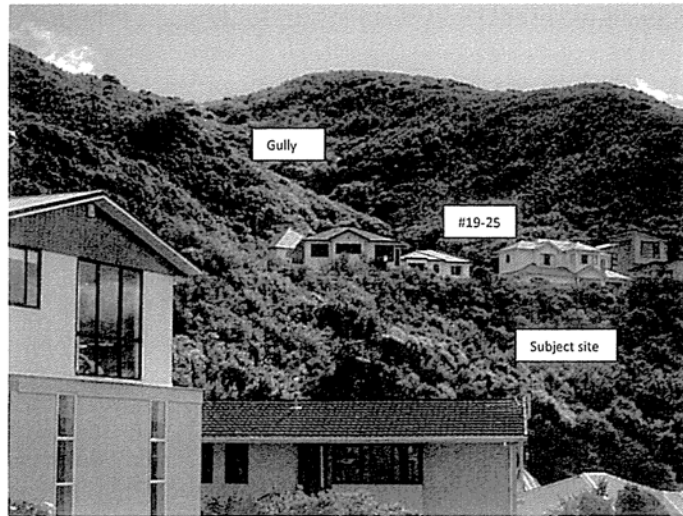
At the top of the slope is Jaunpur Crescent, and on the inside of the road are a number of houses (#19 through to #25). Behind these houses (to the west and upslope), the natural topography is one of defined gullies and ridges. A large gully runs down behind #23 and #25. The gully profile is lost on the subject site below Jaunpur Crescent.

Photograph 2 Gullies and ridges above site

The earthworks have resulted in cuts being made to the ridges, and filling of the gully shown in Photograph 2. The fills have extended out to allow the construction of Jaunpur Crescent. They have also been placed to re contour the upper part of the subject site.

Based on our observations, we would expect that the middle part of the site (opposite 19-25 Jaunpur Crescent) to contain the greatest thickness of fill. This is because it aligns with the centre of the large gully observed on the hillside behind (see Photograph 2).

Based on the information provided, and our understanding of the site, we would recommend that some additional investigation work is completed.

These works would be focused on confirming the fill depth, profile and consistency in the middle of the site (across the gully). This will confirm whether there is likely to be significant cost implications to foundations affecting the middle lots.

Physical investigations should comprise three machine boreholes drilled on the side of the road where the fill is expected to be at its thickest. Boreholes should be drilled to rock with standard penetration tests at close centres.
