# Landscape Features Inventory

## Truby King Park

<b>Truby King Landscape Features</b> <b>120 DUNCAN TERRACE, MELROSE</b> <b>Heritage Inventory Report</b>	
Prepared by	The Heritage Practice Limited 0211396662 <a href="mailto:moira@theheritagepractice.co.nz">moira@theheritagepractice.co.nz</a>
Author(s)	Lianne Cox and Moira Smith
THP reference	116
Date	March 2022
Site visit(s)	2022-05-21 & 2022-05-20
Version	FINAL v1
Reviewed by	Moira Smith, The Heritage Practice
Cover image	Lianne Cox, 2022

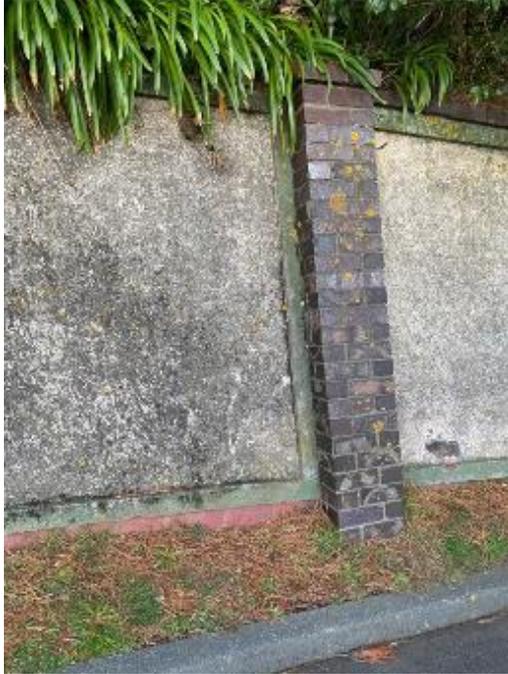
*Figure 6. Detail of eastern retaining wall at lower driveway showing brick pilasters, concrete infill, timber frame, and brick coping. Note non-original concrete kerb.*

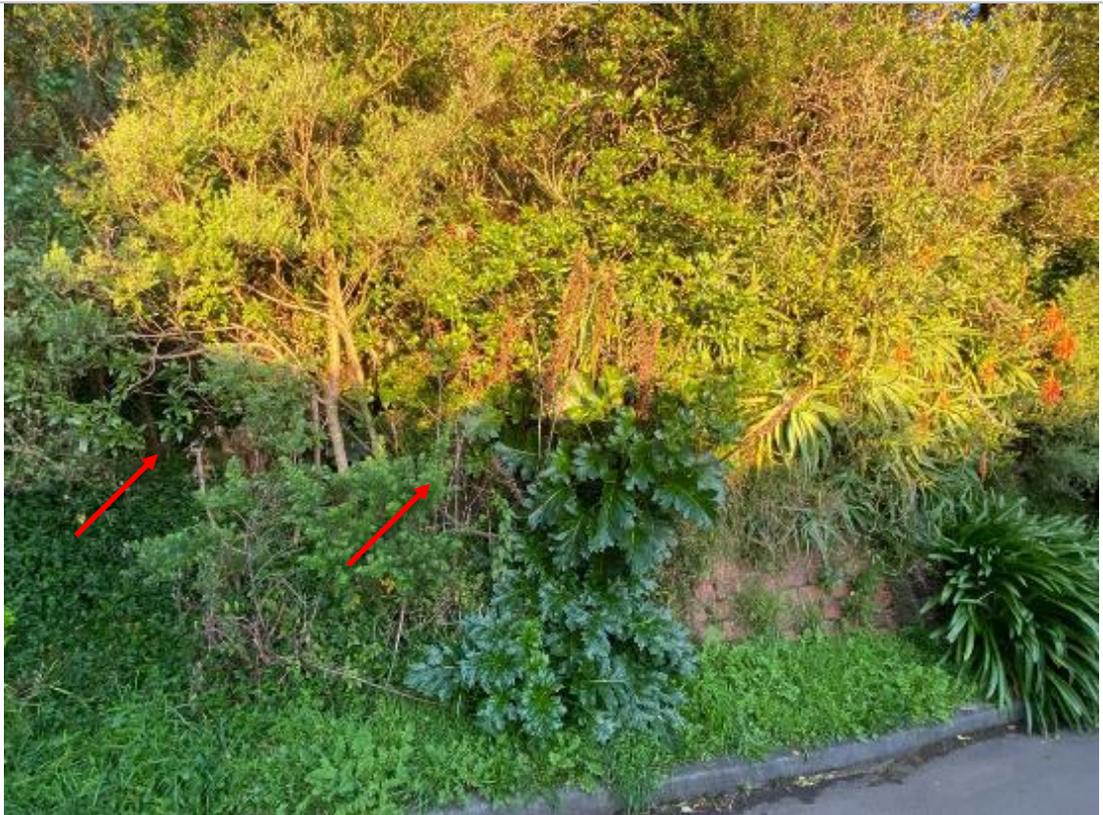
*Figure 7. This is a gap in the eastern retaining wall in the lower driveway. The land steps back and there are brick pilasters hidden in the undergrowth.*

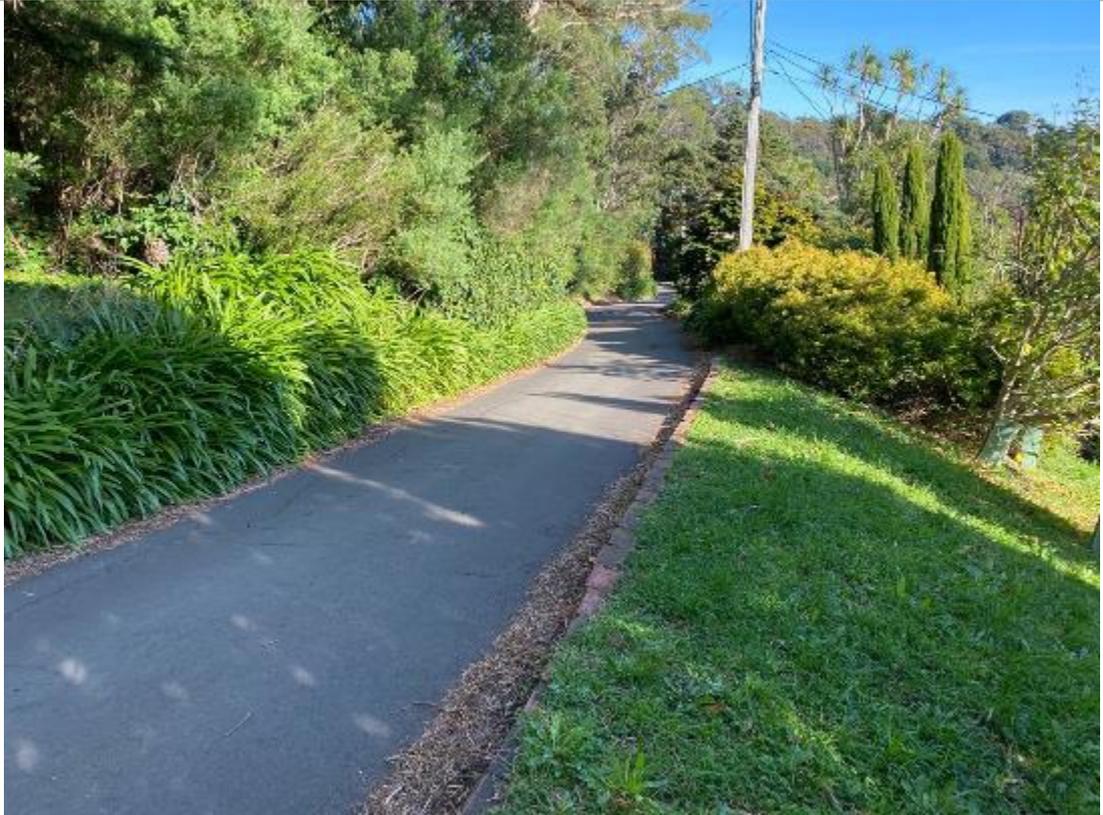
The western side has an end-to-end brick kerb that is partially damaged/removed.

*Figure 19. Looking from south on middle driveway. Low retaining wall hidden at LHS of drive and brick kerb. Brick kerb to RHS drive (west).*

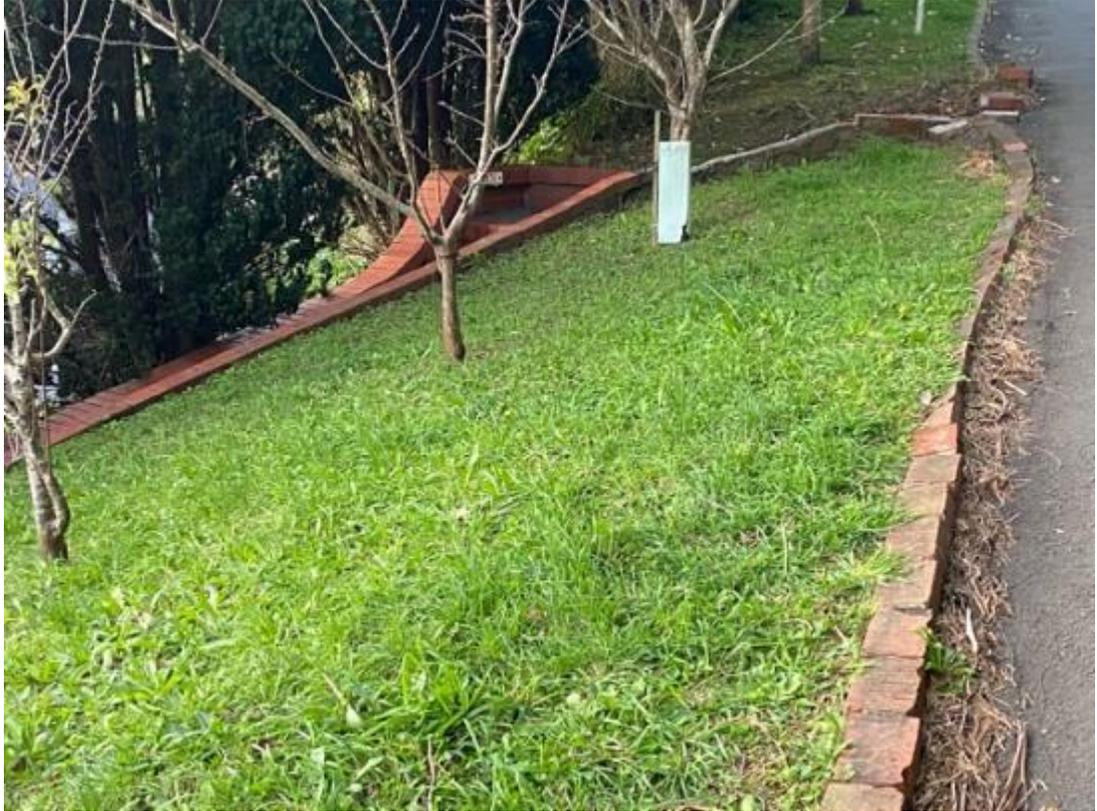
*Figure 20. Looking from south on middle driveway at the entry of path to the former Karitane Products factory. Note new or repaired brickwork to far wall.*

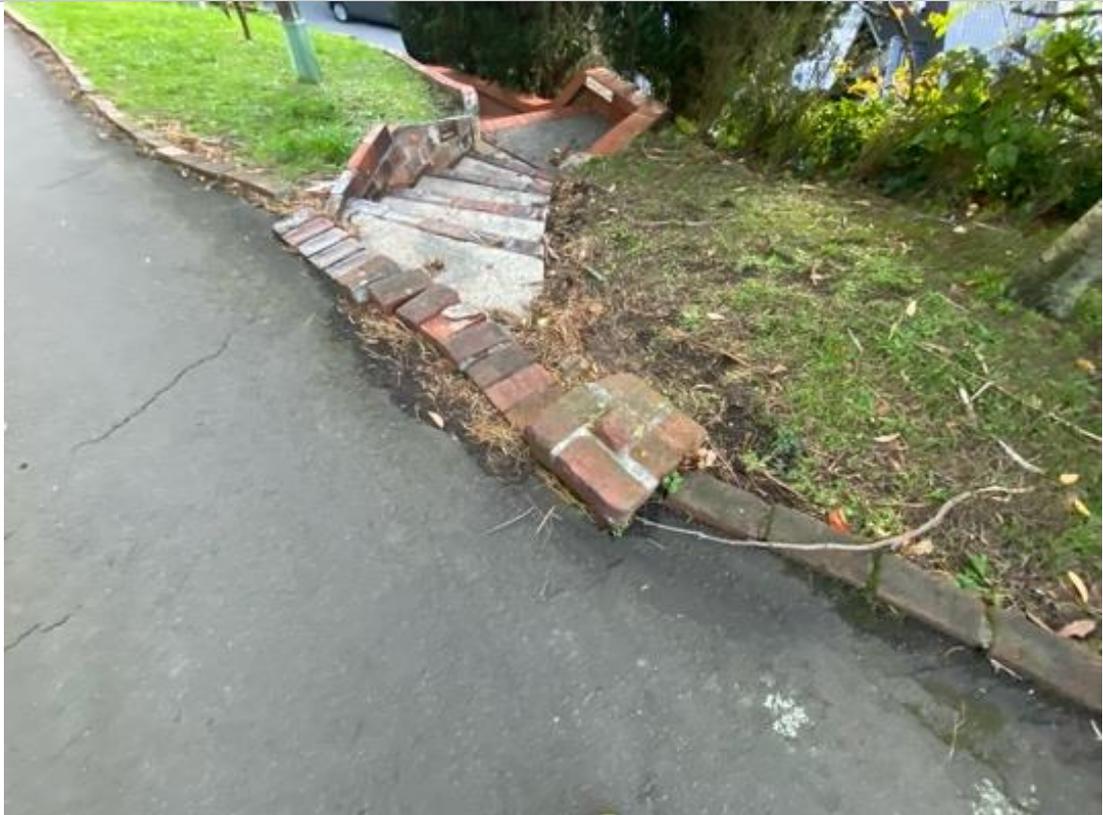
*Figure 21. Looking from north on middle driveway at the entry of path to the former Karitane Products factory. Note new concrete, and probably repairs to lower wall.*

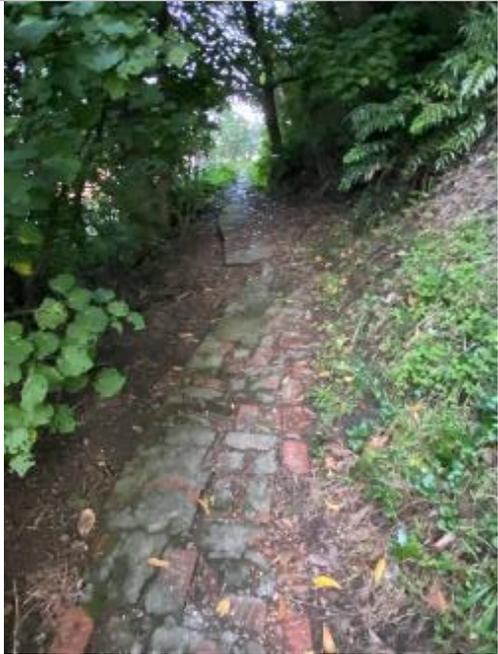
Figure 31. Southern dell track, hospital path. Oddments of brick set in earth or concrete.

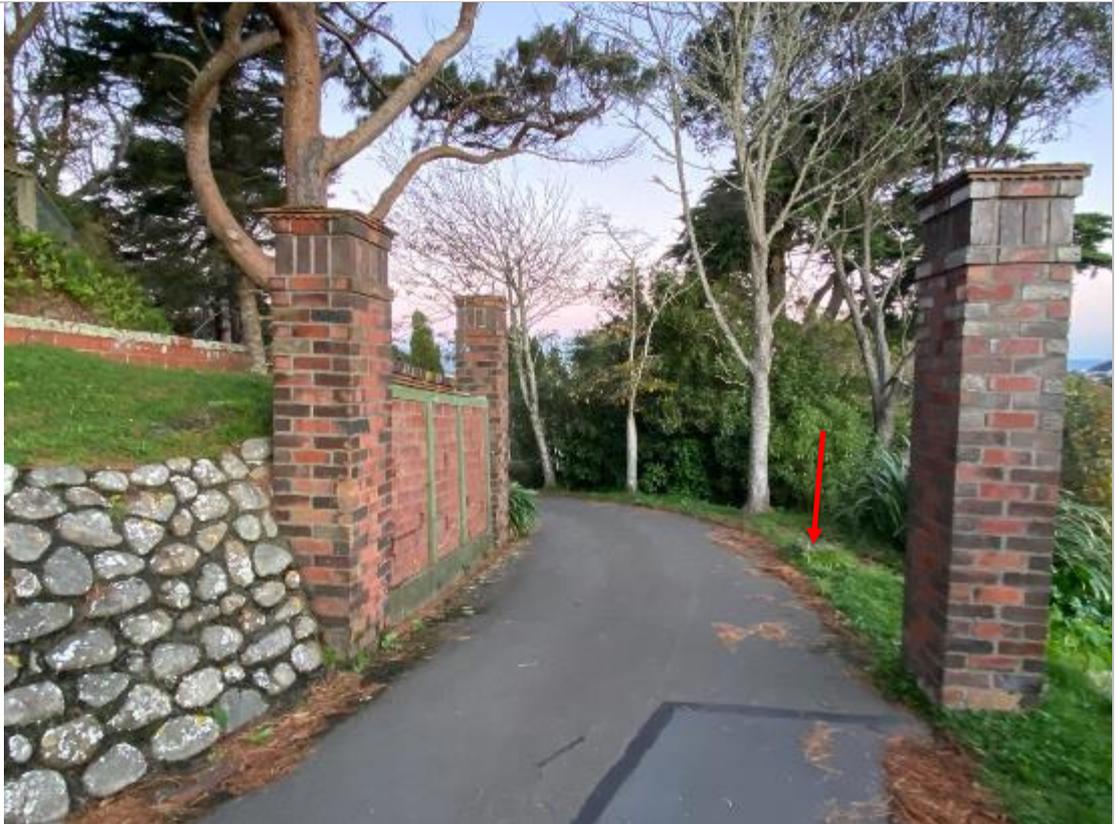
Figure 40. The upper group of three piers on the 'up loop' driveway, viewed from north. Note foundation for missing pier.
