Shelly Bay Development

Preliminary Geotechnical Assessment Report

Client: The Wellington Company

19-Jan-2016

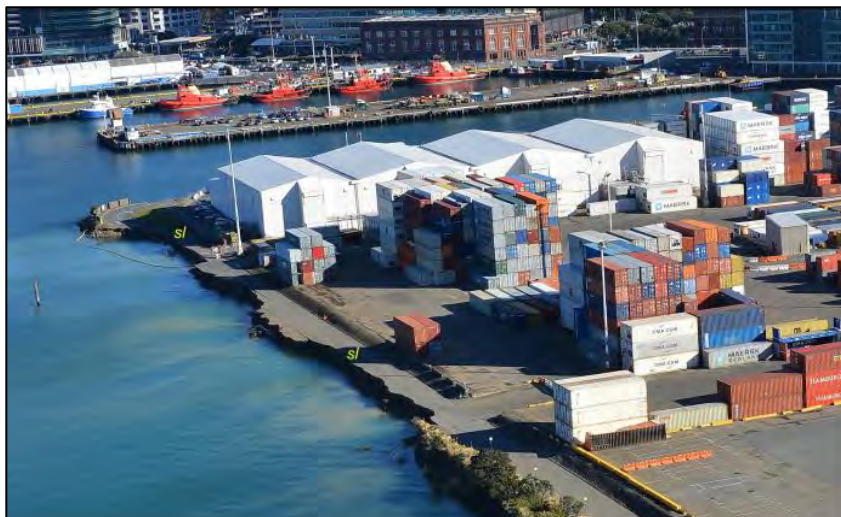
Instability of a quayside wall bounding reclaimed land alongside Wellington Centerport was observed following the 21st July 2013, M6.5 Seddon Earthquake. The existing coastal protection, and part of the reclaimed area, was lost to sea, as shown in Figure 4. In this instance, effects of lateral spread were observed up to approximately 150 metres back from the face of the quayside wall (Ref. 9).

Figure 4 Effects of Liquefaction and Lateral Spreading upon Quayside Wall, Wellington, 2013 (Ref. 9).

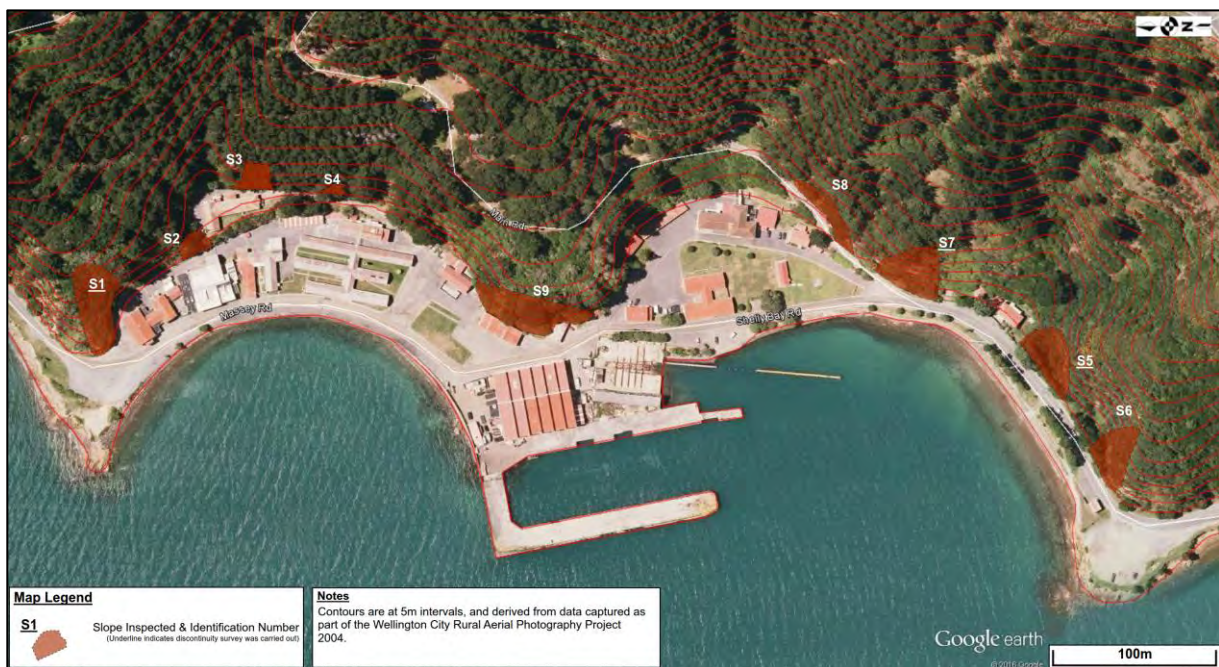
3 sites in total (Slopes 1, 5 & 7) were also subject to detailed discontinuity mapping, either as a result of visibly unfavourable discontinuities 'daylighting' across the outcrop, visual evidence of large or recent debris falls, and where access to the feature on foot was possible. A detailed site walkover and observations matrix has been compiled for each slope and is included in Appendix B. General observations from the inspection are discussed and analysed in the following sections.

Figure 5 Location of Slope Inspections at Shelly Bay

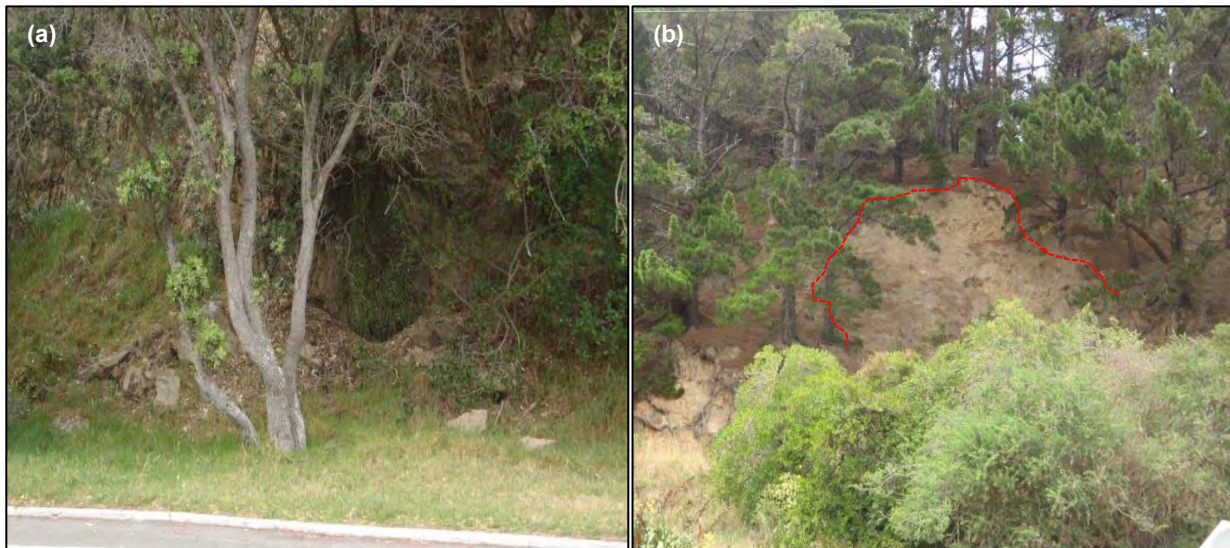
At the majority of slopes, debris volumes were substantially less than 0.5m^3 , with only a few discrete blocks of very weak to moderately strong greywacke up to 400mm across present in the resulting slides, and only at some sites. However, at slope 5, a much larger, albeit older debris flow, potentially up to 10m^3 in volume was observed, with intact boulders of moderately strong to strong greywacke rock up to 900mm across present in the debris pile. This is shown below in Figure 6(a).

Limited shallow translational failures in the superficial cover of soil overlying the greywacke rock were observed during the walkover and survey. However, the dense cover of vegetation and generally difficult access to the higher areas of Mount Crawford means that the possibility of such slope failures elsewhere cannot be discounted. It is likely that the dense vegetation covering much of the hillside has acted in part to stabilise this shallow surface layer, however such failures are very common in slopes of similar geology and topography in the Greater Wellington region, and are often triggered by periods of intense rainfall or seismic activity. Consideration should be given to the potential for such failures during detailed design, if significant removal of vegetation from slopes is required. One such failure, at Slope 8, is illustrated below in Figure 6(b).

Figure 6 (a) Rock fall debris at toe of Slope 5; (b) Extent of shallow surface failure above greywacke outcrop at Slope 8

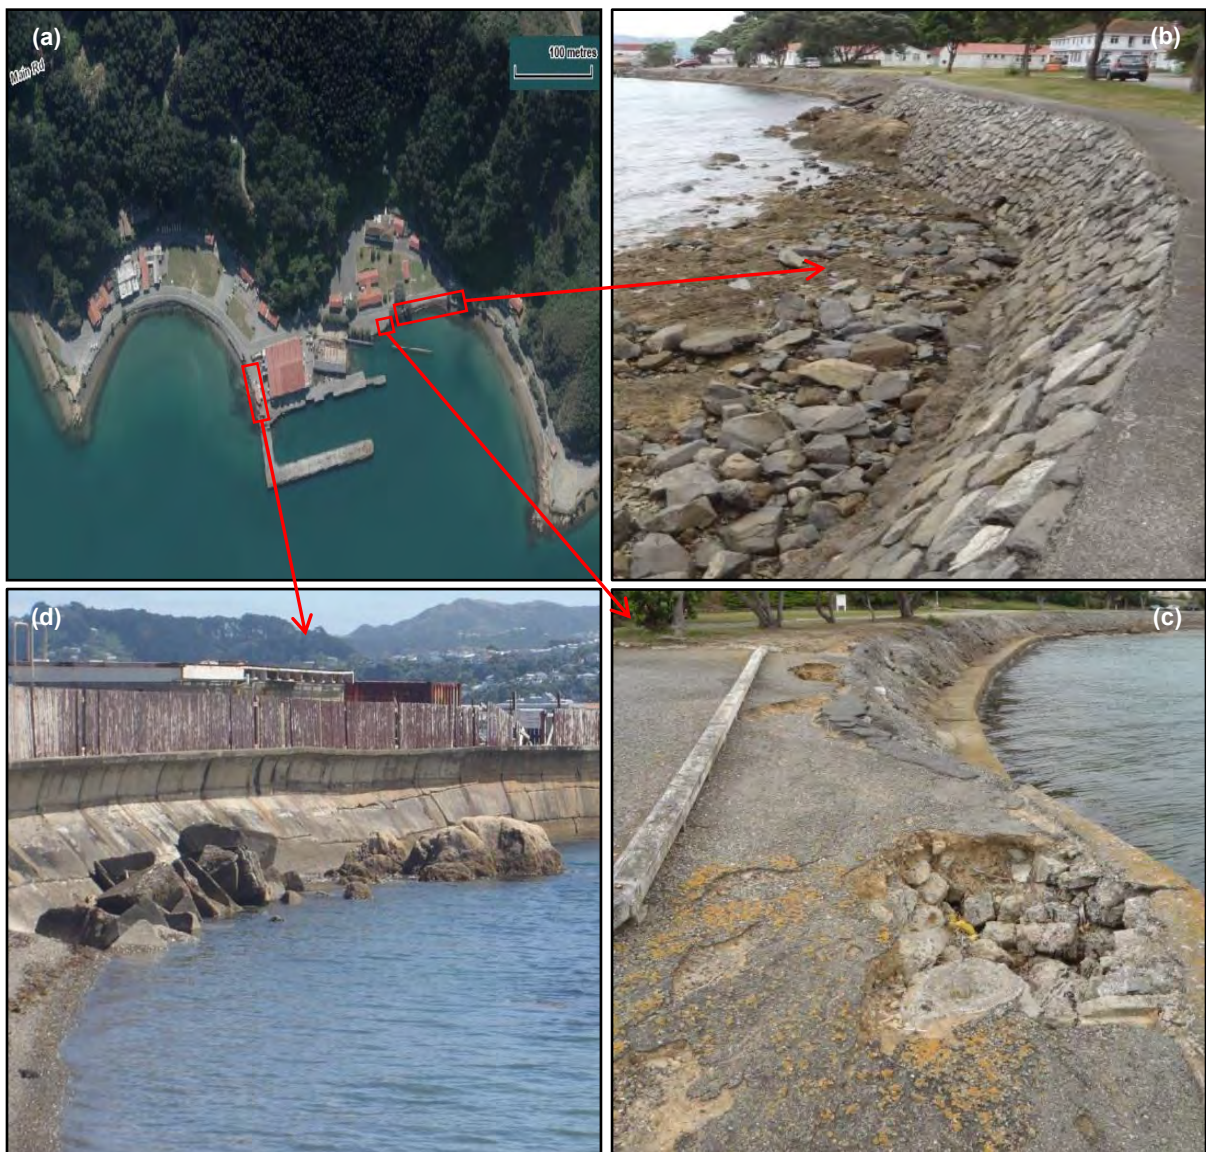
Whilst some of the existing sea walls appear in good condition, others are not and some have even undergone partial collapse. In general, the seawalls are not considered to offer significant resilience to lateral spread, and may have been founded directly upon liquefiable sediment. These features may require retrofit or complete replacement.

Figure 8 General impression of existing seawalls around the site: (a) Location Plan; (b) Concrete/greywacke boulder facing founded directly onto bedrock; (c) damage to existing seawall in southern bay; (d) collapse of seawall in vicinity of Shed 8.

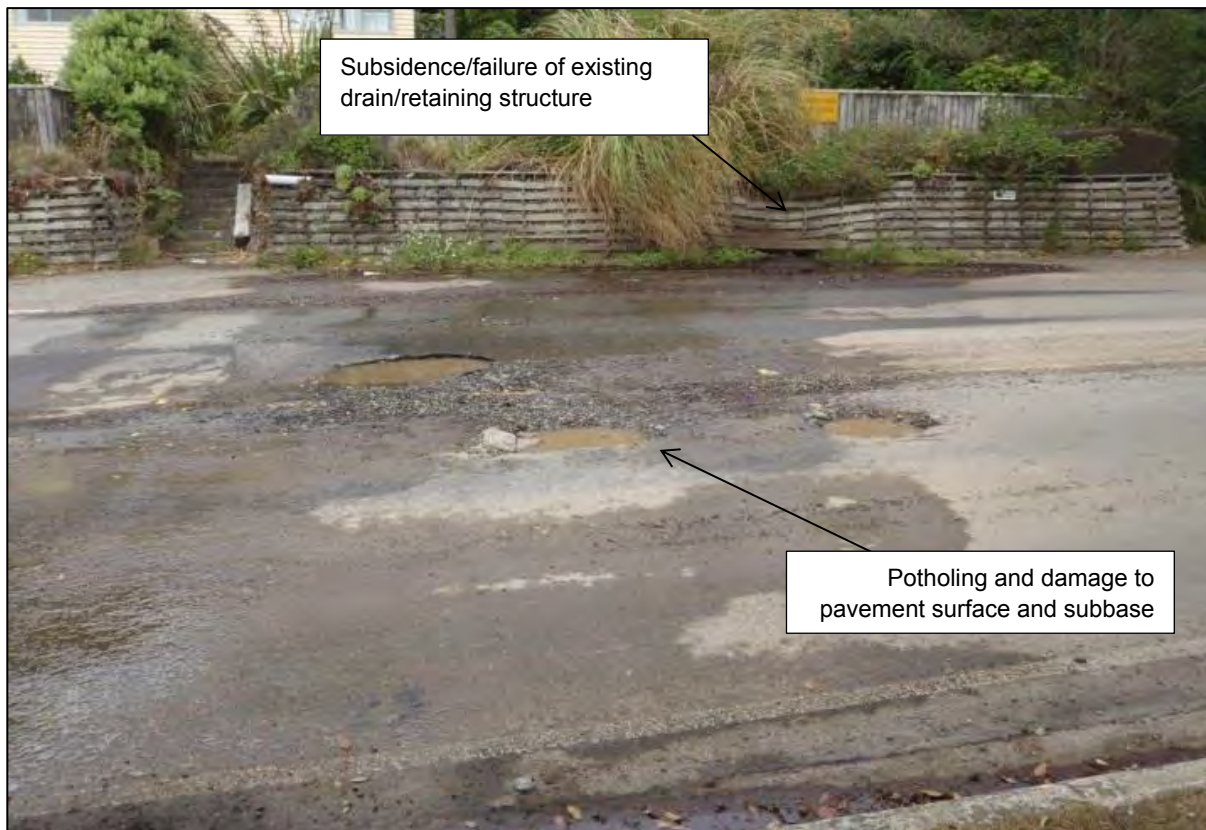
Figure 10 Road damage due to surface water from gully runoff

Consideration should be given to rerouting the stream, which currently drains from the gully in the southeast of the site (shown on the geological interpretive map in Appendix A), into a culvert below the existing road level. The existing drain beneath the structure in this location is in a state of considerable disrepair, and the constant flow of surface water across the road has caused substantial localised damage to the pavement, as per Figure 10 below.
