Appendix O – Natural Hazards Risk Assessment

Natural Hazards and Geotechnical Assessment

Wellington Sludge Minimisation Facility (SMF)

7 July 2022

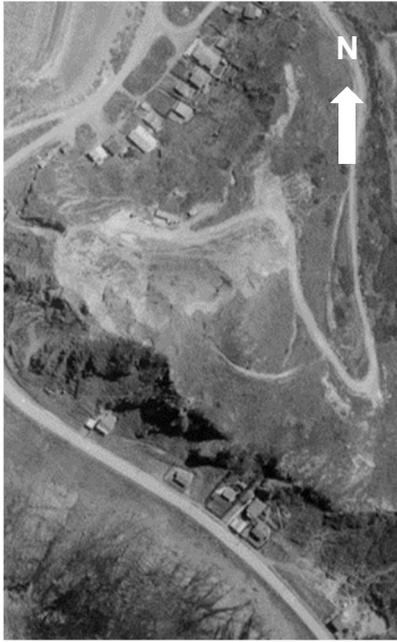
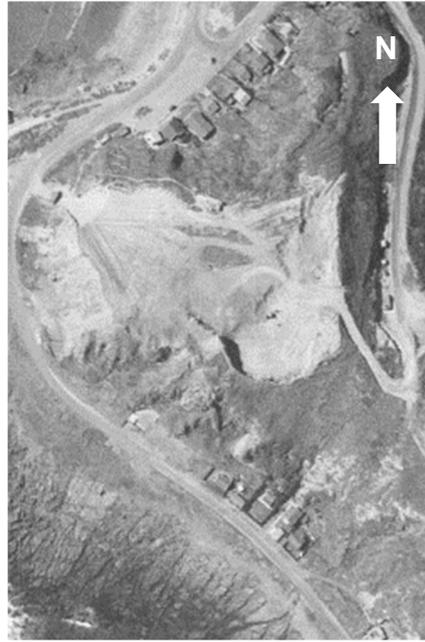
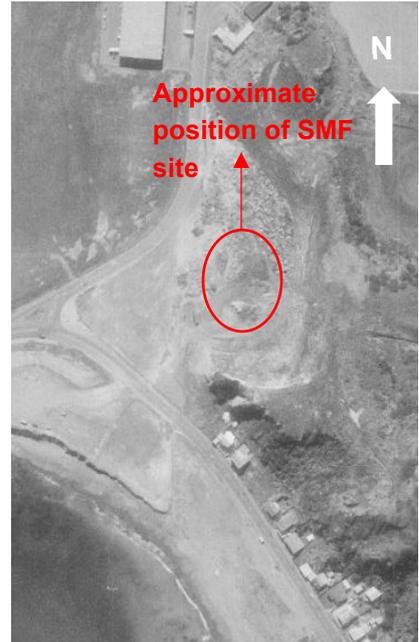
Figure 2: Historical aerial photographs.

- A. The slip was mainly a block of rock failing on a semi-continuous outward dipping defect in the rock mass, which daylighted in the quarry face.
- B. A secondary part of the failure was an about 8m wide zone to the south (*behind the AGS building*), possibly a reactivation of an older slope failure, adjacent to a more resistant zone of rock.
- C. The central and southern parts of the quarry face and recent toe cut were relatively stable (*in about 1989*).
- D. Ongoing periodic failure was expected toward the north end of the cut, and the report recommended stability of the slope be reassessed should the Milliscreen Plant be used for more than 10 years (*i.e. reassessment would have been required at about the year 2000*).

The Beca Stevens (1990) report also describes an old failure scarp offset 10m -15m horizontally from the upper quarry face and extending some 70m length. It is unclear exactly where this feature was located as it appears works to construct the WWTP access road and further instability in subsequent years have obscured it.

A topographic contour plan prepared in December 1989 (prior to the failure noted above) shows a triangular notch in the cut slope at the north end of the AGS building, with the easternmost part reaching an elevation of 28m. Current topographic contours (WCC Webmaps) show this feature is still present and has not regressed further upslope since 1989; the easternmost extent is still at about 28m elevation.

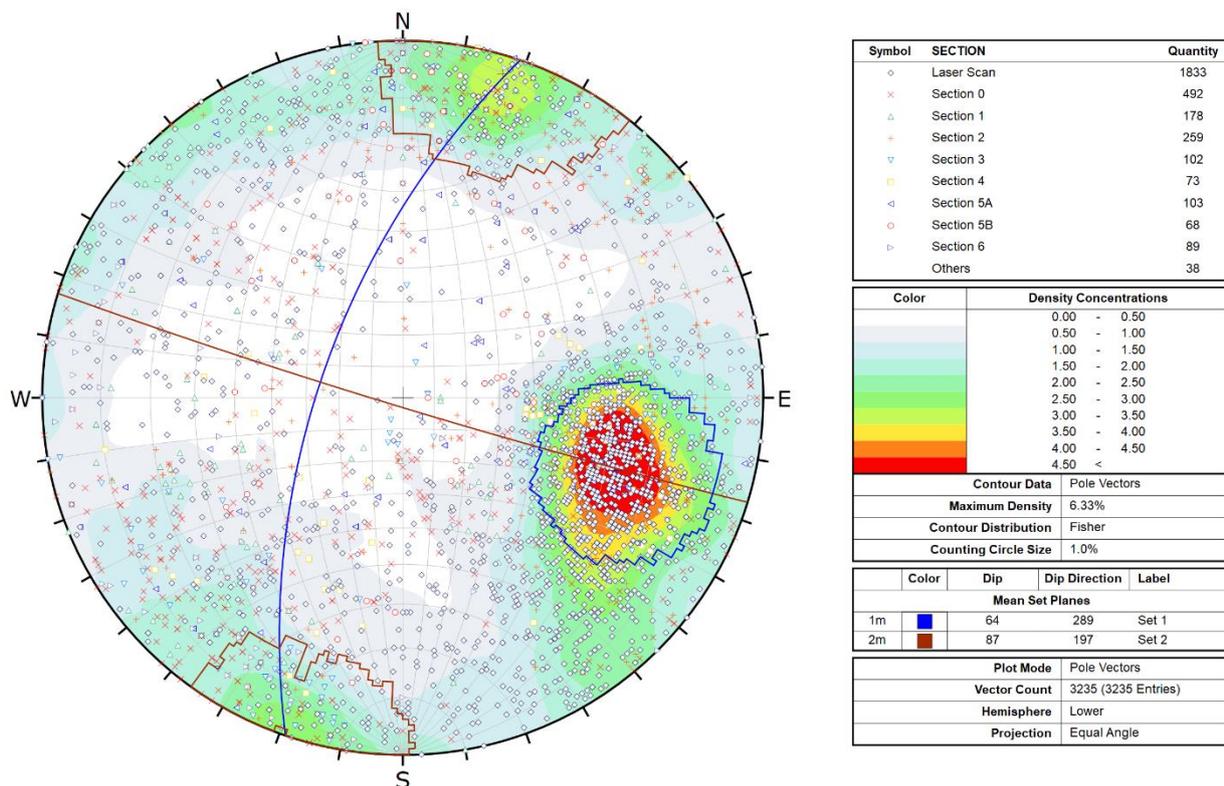
Figure 4. Stereonet showing all defect measurements taken at the site, as well as the two identified defect sets and their mean planes.

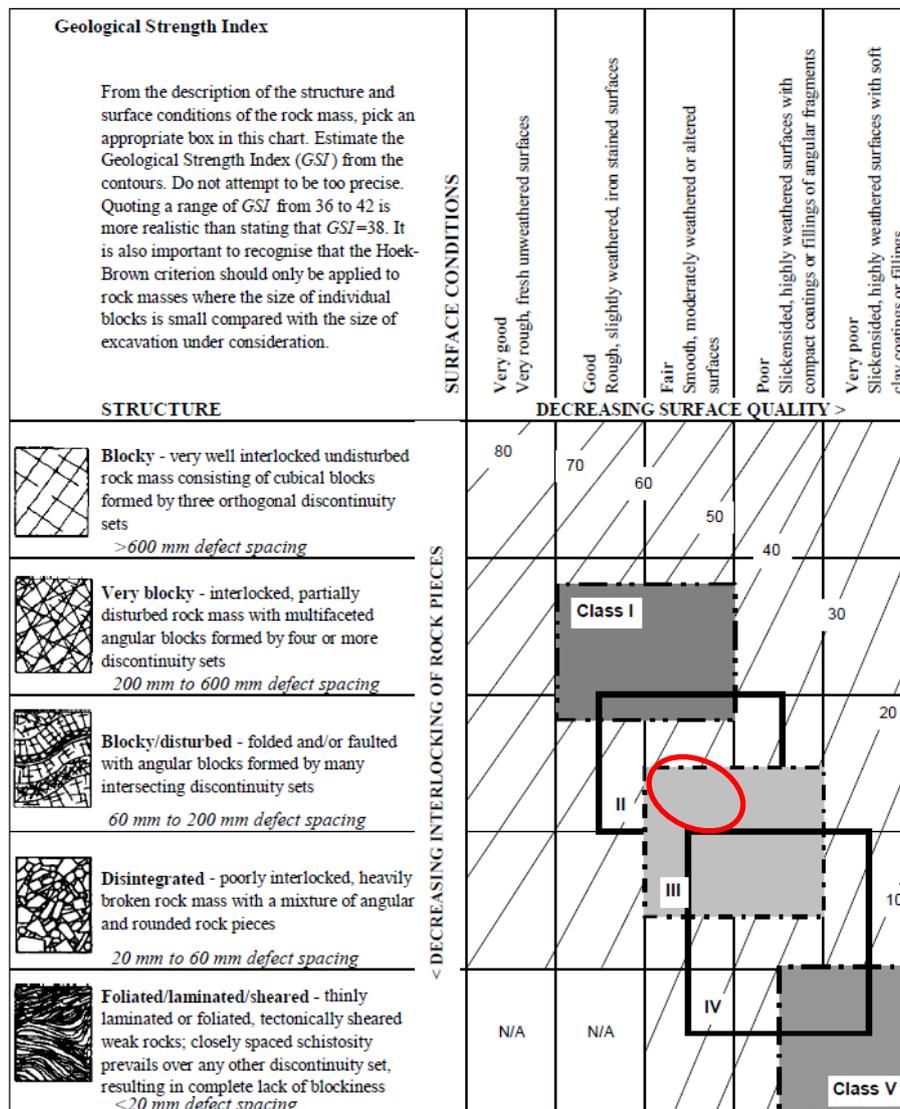
Figure 5. Geological Strength Index (GSI) with informal classes of New Zealand greywacke overlaid (Read et al., 2000). The red circle represents the estimates GSI range for the greywacke observed at the site.

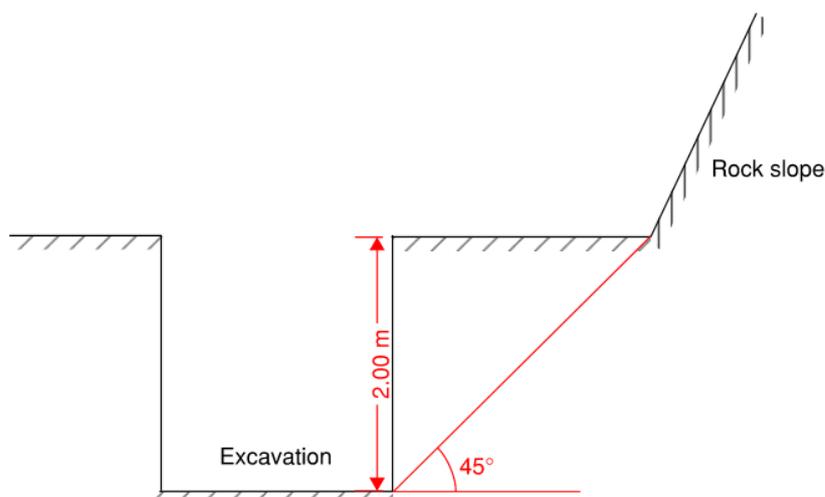
Figure 6. Sketch showing the minimum buffer (45° from the toe of the excavation) required from the toe of excavations up to 2m deep. Note that the sketch does not account for any shoring, benching or battering of the required for stability during construction.

For excavations greater than 2m deep, or if soils are encountered, specific geotechnical advice will be required prior to proceeding with the excavation.
