**KIWI POINT QUARRY  
NAURANGA GORGE  
REPORT ON THE  
POTENTIAL DEVELOPMENT OF THE QUARRY**

**For:** Holcim New Zealand Limited  
Kiwi Point Quarry  
PO Box 13341  
JOHNSONVILLE 6440

**By:** Ormiston Associates Ltd.  
P.O. Box 47-822  
Ponsonby 1144

**Date:** July 2015

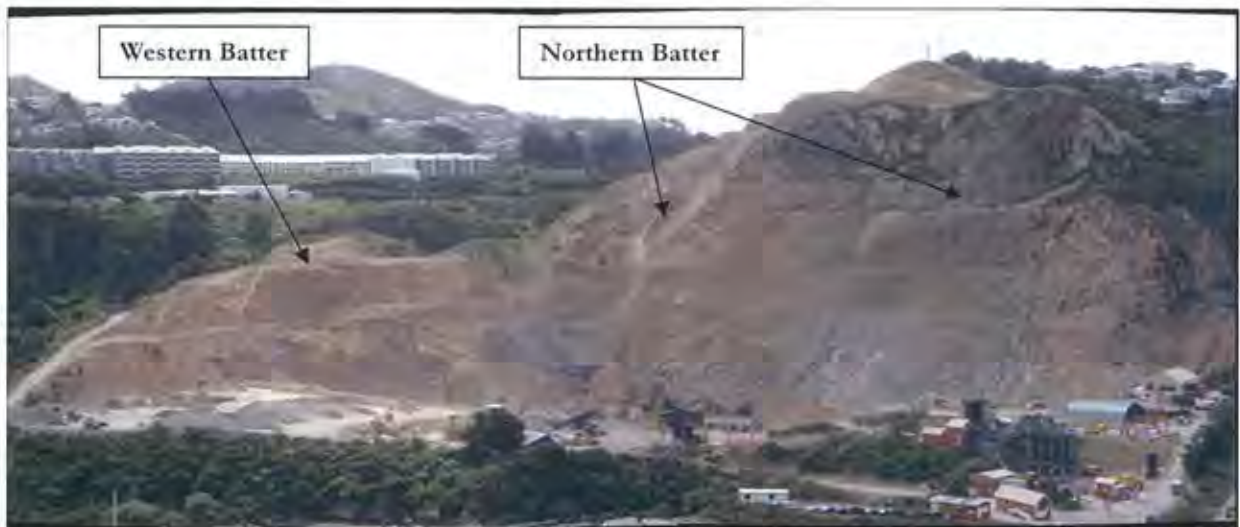
**Plate 1**  
**General view of Kiwi Point Quarry looking to the Northwest with the main northern batter at the right and western batter at the left.**

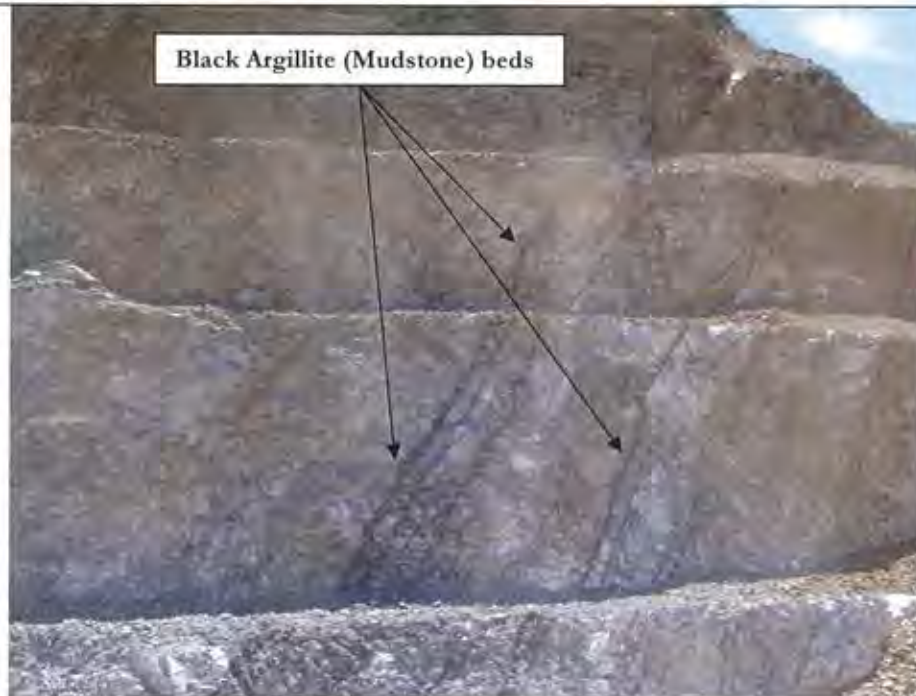
**Plate 2**  
**Northern Batter exposing slightly weathered to fresh sandstone dominant greywacke with bedding dipping to the left as defined by black argillite beds.**

Observation of the Northern Quarry batter slope and Southern Area batter slope (Plate 2) indicates bedding defined by black argillite beds within the sandstone dominant lithology.

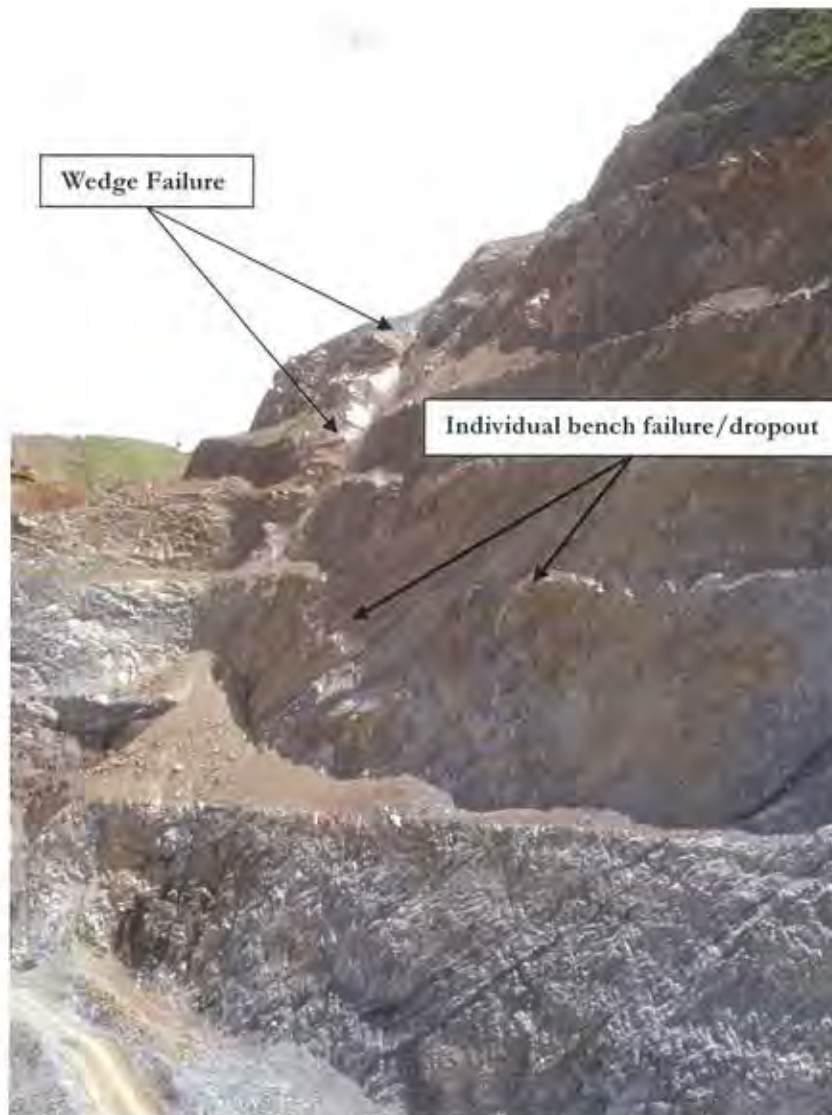
**Bench failure on lower western end of northern batter removing all access to the bench for maintenance. Failure inferred to be stress release on Joint Set 1.**

The ultimate pit northern batter slope crest is currently restricted to the existing batter crest within residual to completely weathered soils at an elevation of approximately RL 210m (See Drawing 3655-1, Sheet 1, Revision 1). We also understand that without a variation to the land use consent, the quarry batter crest cannot be pushed back closer to the northern boundary of the property. There is also a minimum 20 metre buffer requirement between any future ultimate pit crest and residential property boundaries to the north. Geoscience (Reference 1) has recommended a maximum slope batter angle of 40° for this face. Current batters are at 76° or more with an overall slope, including benches, of more than 60°. It is evident therefore that unless the face is cut back at the top to flatten both the batters and the overall slope there will be continual failure of benches and batters on the face. As the benches are generally less than 5 metres wide and, for the most part, significantly less than this due to previous slope failures, the ability to mitigate such failures is limited. Furthermore, previous slope failures on the slope have, in some places, eliminated the benches entirely (see Plates 4 & 5).

Geoscience has assessed the potential for failure on this southeast facing batter (Ref 1 Table 1 page 11). They have identified that planar failure is likely at batter slopes greater than  $35^\circ$  and wedge failure at batters greater than  $40^\circ$ . These are apparent in Plates 6 & 7. A fault running up the intersection between the northern and western faces (see Drawing No. 3655-1, Sheet 1, Rev 1) complicates the structure of the situation (see Plate 5).

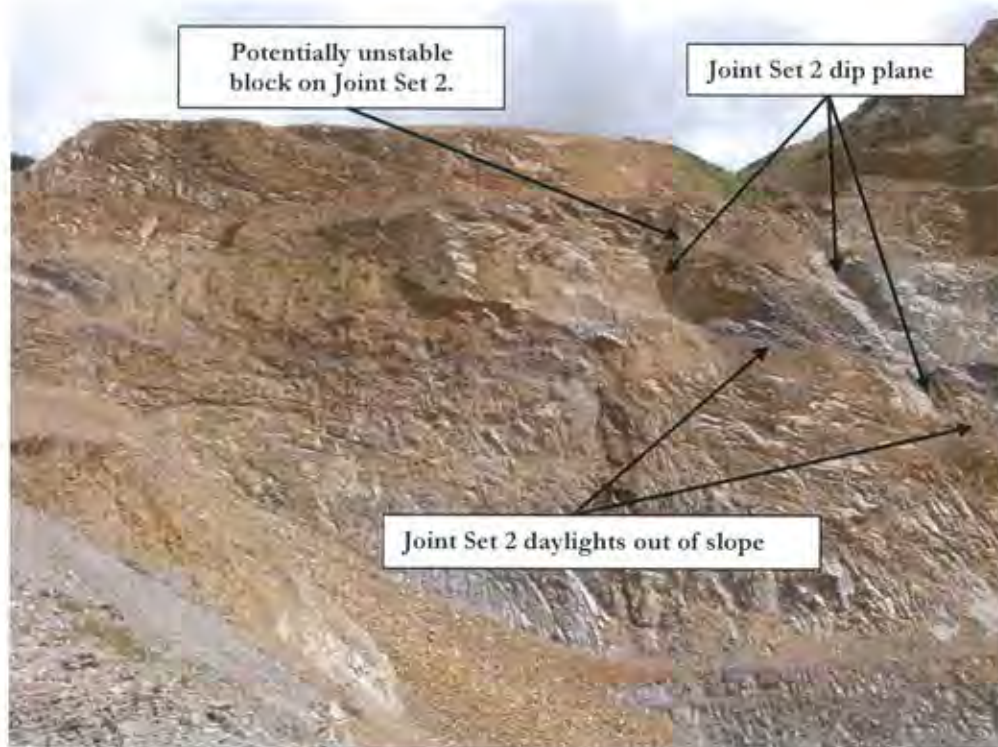
**Plate 6**  
**View to the west of the western batter showing Joint Set 2 dipping out of the face and remnant undermined kinematically unstable blocks perched on the batter slope.**

In the northwest corner of the face (see Plate 6) joint Set 2 dips out of the western batter slope at approximately  $45^\circ$  and at an angle that is less than the existing  $66^\circ$  batter slope forming kinematically unstable large blocks perched on the batter slope that have been undermined by excavation as illustrated in the following Plates 6 & 7.

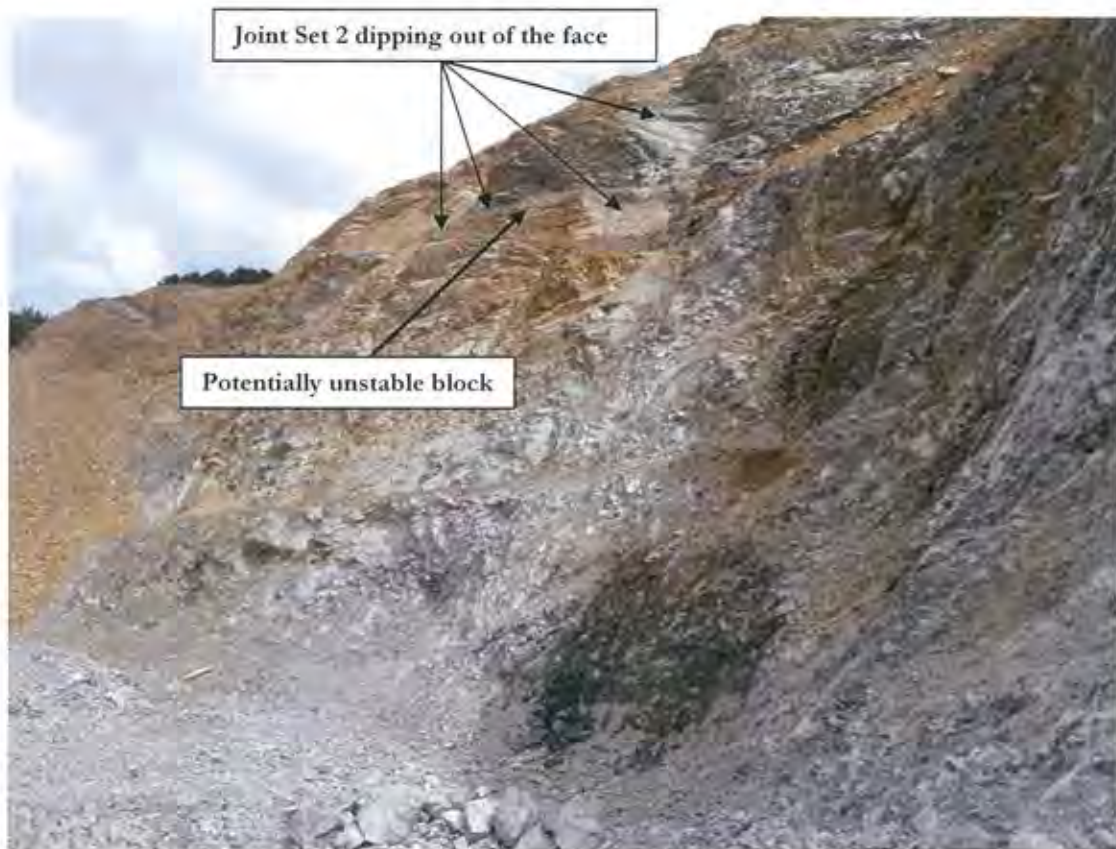
Plate 7

**Joint Set 2 and potentially unstable blocks perched on the batter slope.**

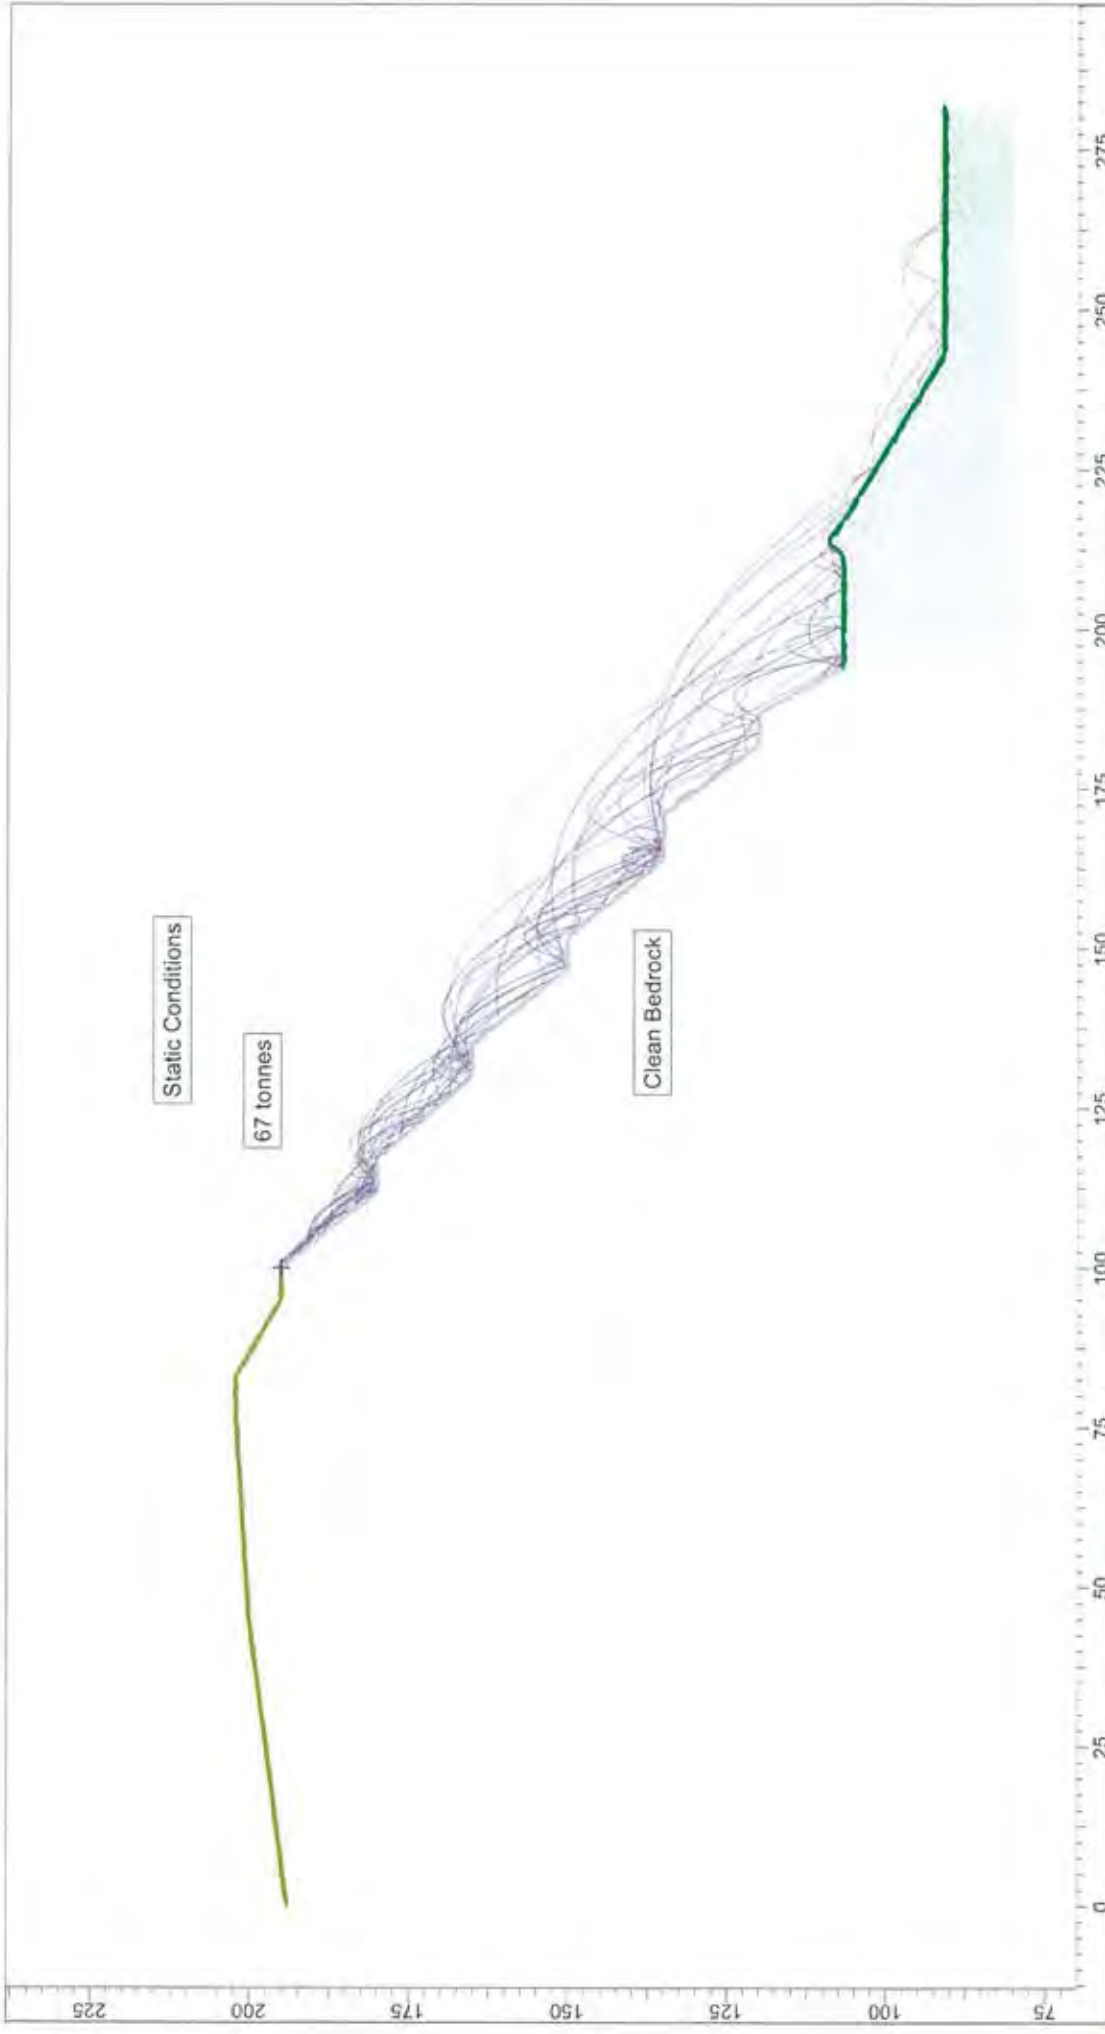
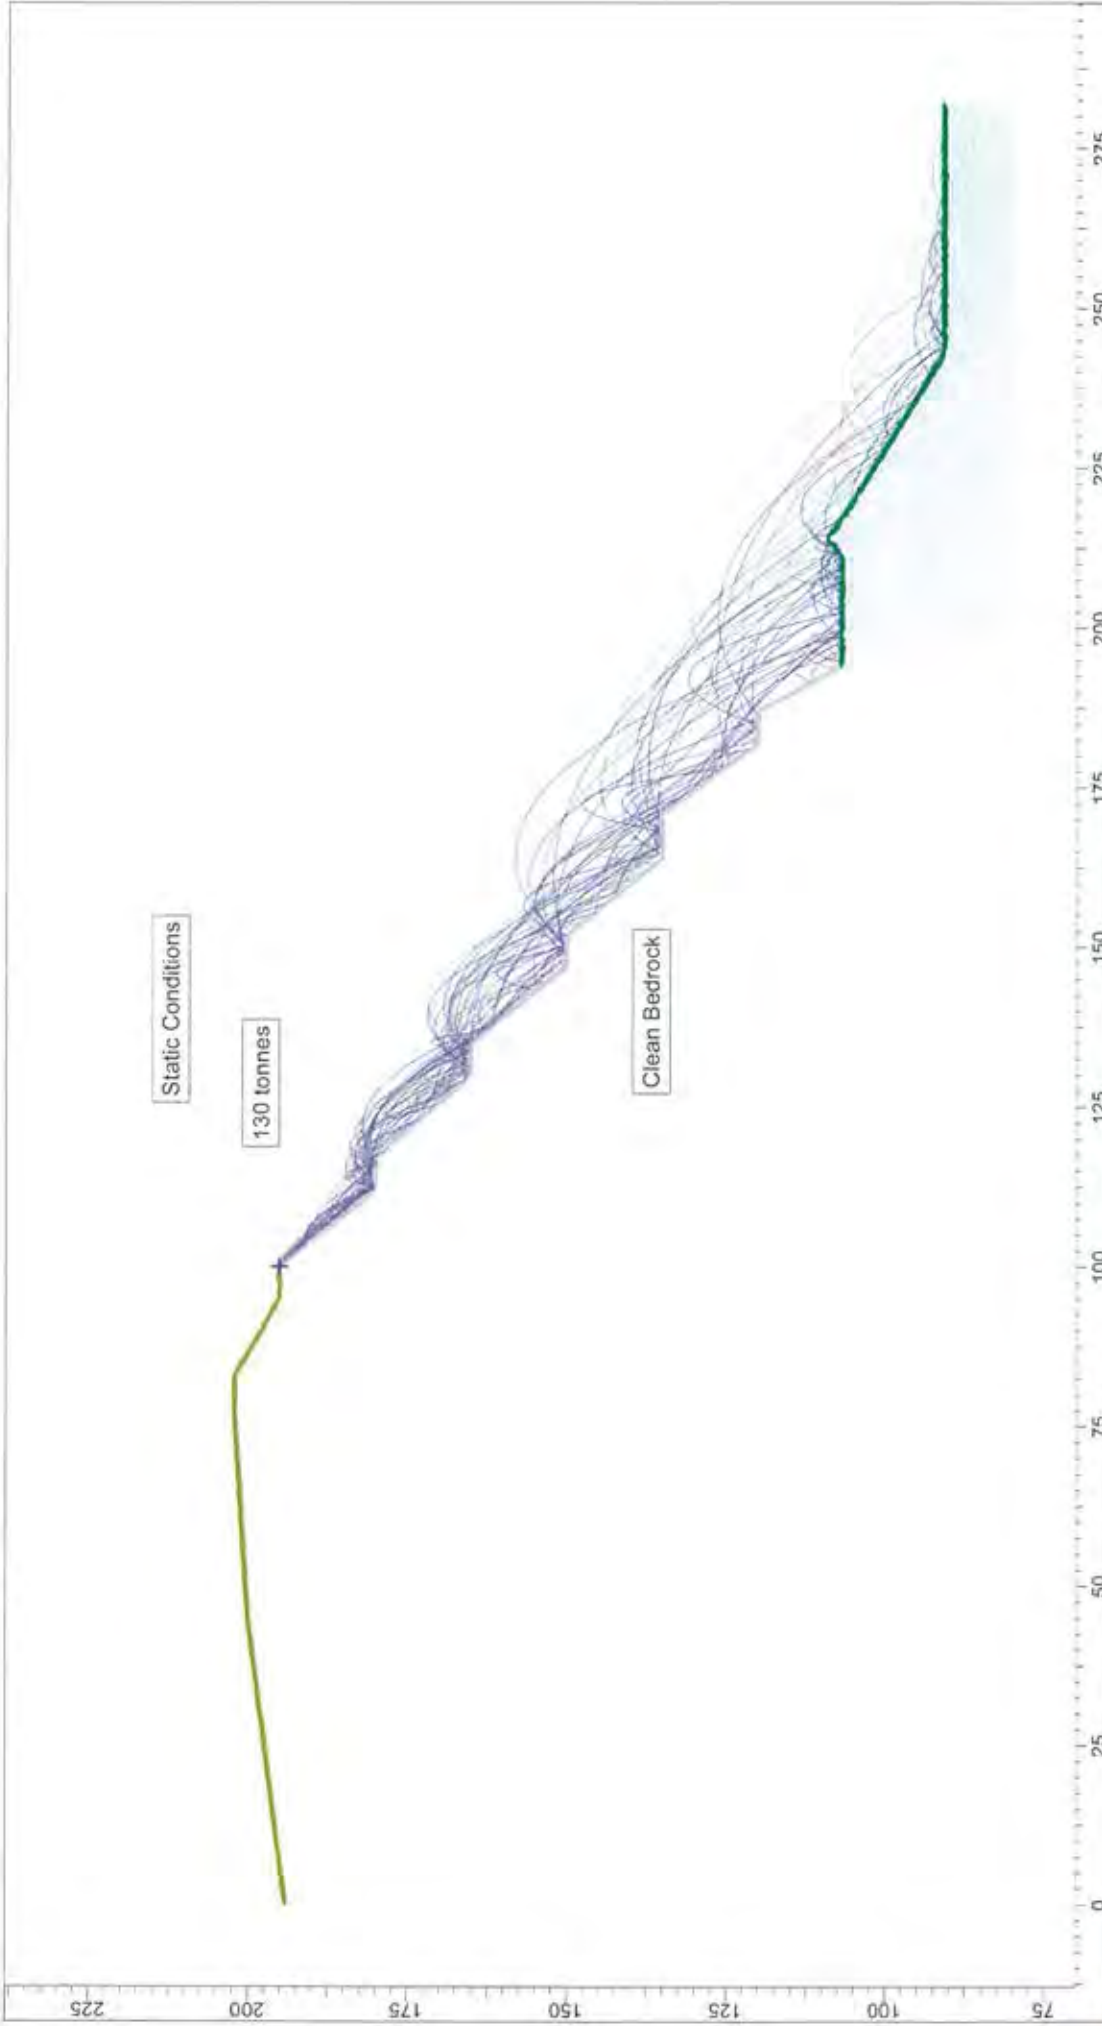
Kiwi Point Quarry, Wellington	
Project	Rock Fall Analysis
Analysis Description	Company
Drawn By	Ormiston Associates Ltd
Date	2a Clean Bedrock, 12t, static.fal5
S Carryer & A Fell	
24/6/2015

Project		Kiwi Point Quarry, Wellington	
Analysis Description		Rock Fall Analysis	
Drawn By	S Carryer & A Fell	Company	Ormiston Associates Ltd
Date	24/6/2015	File Name	2b Clean Bedrock, 67t, static.fal5

<b>Kiwi Point Quarry, Wellington</b>	
<b>Project</b>	Rock Fall Analysis
<b>Analysis Description</b>	Company
<b>Drawn By</b>	Ormiston Associates Ltd
<b>Date</b>	2c Clean Bedrock, 130t, static.fal5
	24/6/2015
	File Name

The analyses presented (Sections 9a to 9c) have been compared with the analyses for static conditions (Section 2a to 2c). These show that under earthquake conditions (SLS), large and huge rockfalls are not significantly different than for static conditions. It is interesting to note that the runout and amount of rocks for a small (12 tonne) in a 1 in 50 year scenario decreases compared to static conditions.

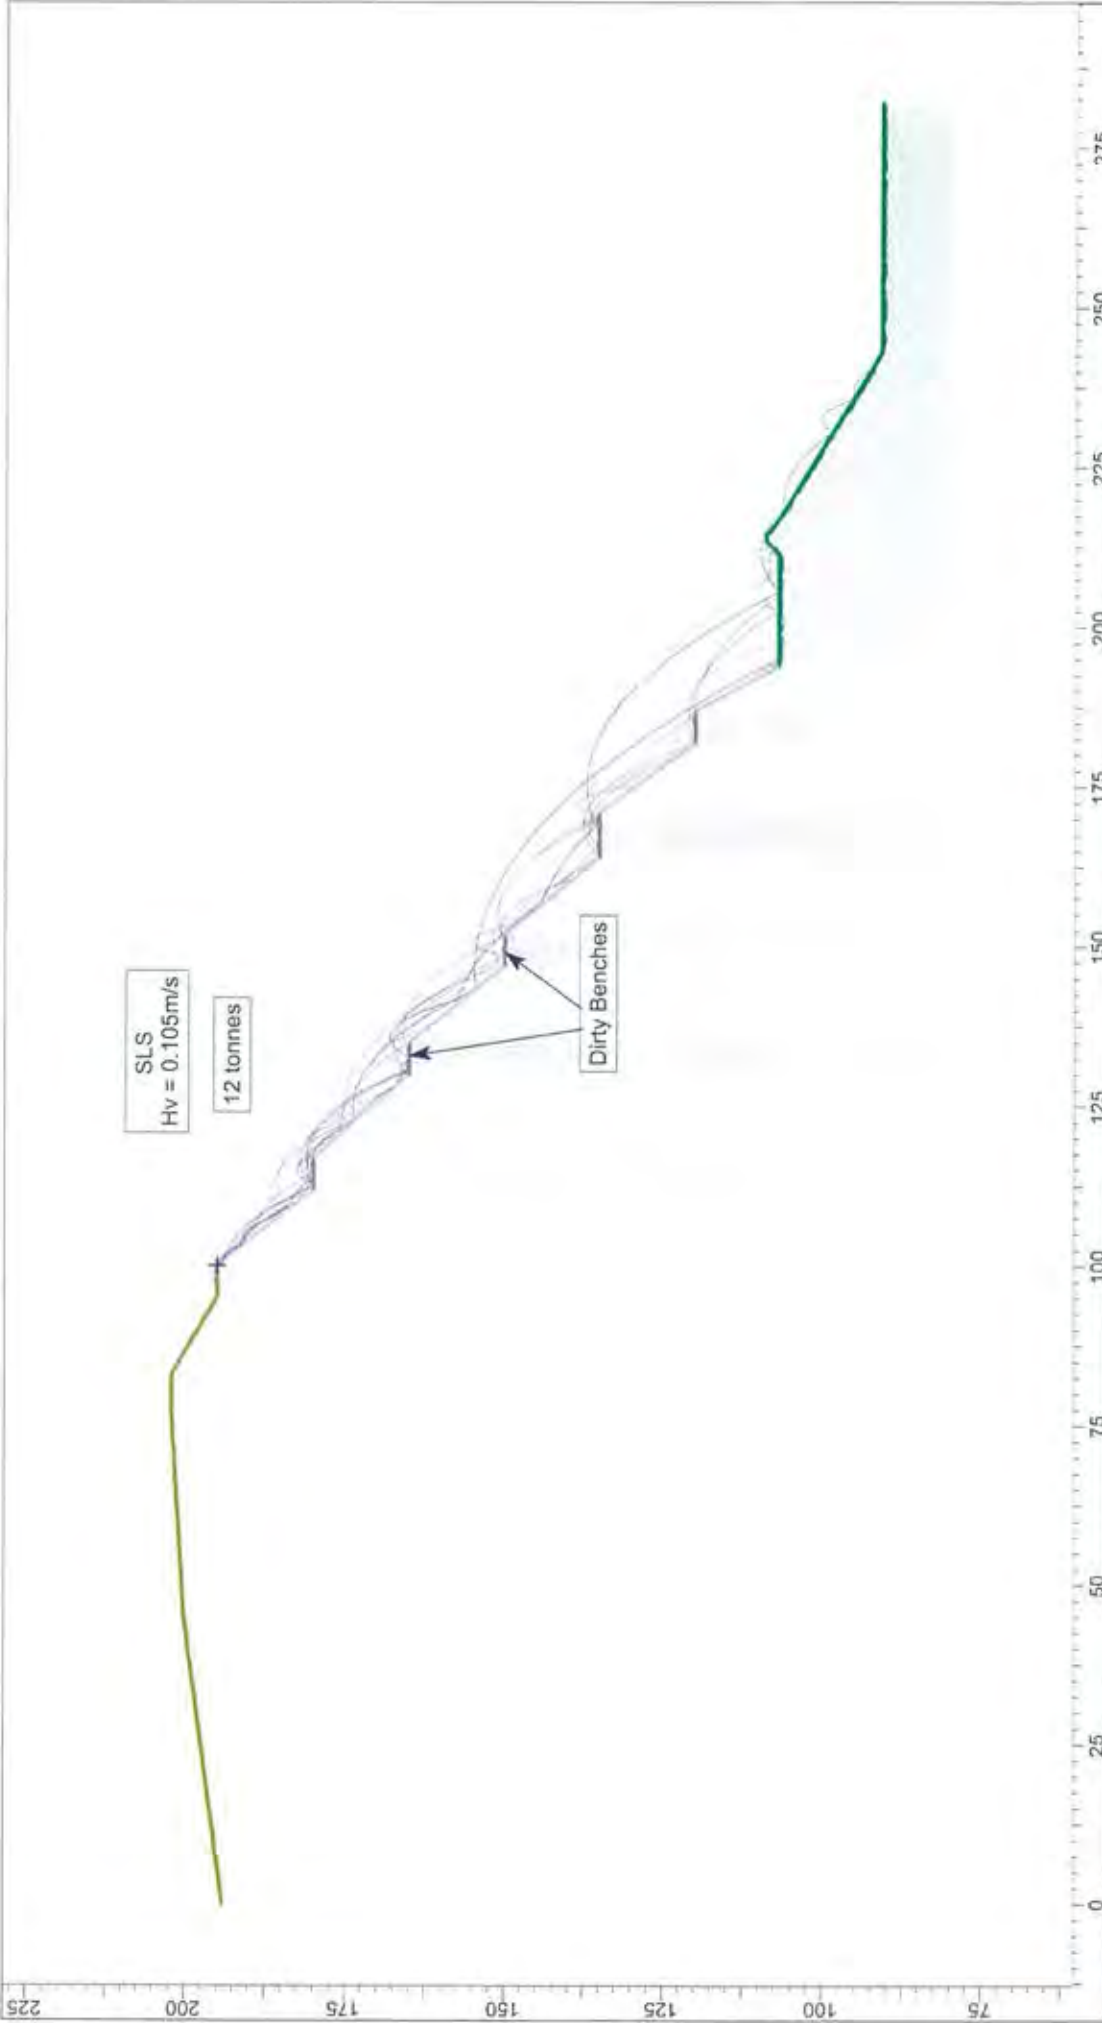
Kiwi Point Quarry, Wellington	
Project	Rock Fall Analysis
Analysis Description	Company
Drawn By	Ormiston Associates Ltd
Date	10a Dirty Bench, 12t, SLS.fal5
	24/6/15

Kiwi Point Quarry, Wellington	
Project	Rock Fall Analysis
Analysis Description	Company
Drawn By	Ormiston Associates Ltd
Date	10b Dirty Bench, 67t, SLS.fail5
	24/6/15

The analyses presented (Section 10a to 10c) show that there is a decrease in runout and amount of rocks breaching the containment in all size rockfalls, compared to a clean bench SLS scenario (9a to 9c). There seems to be no significant change in runout or amount of rocks breaching the containment for all rockfalls compared to the dirty bench, static condition (Section 8a to 8c).
