# KARORI CEMETERY CONSERVATION PLAN

## *Four Decades Conservation*

Wellington City Council

June 2003

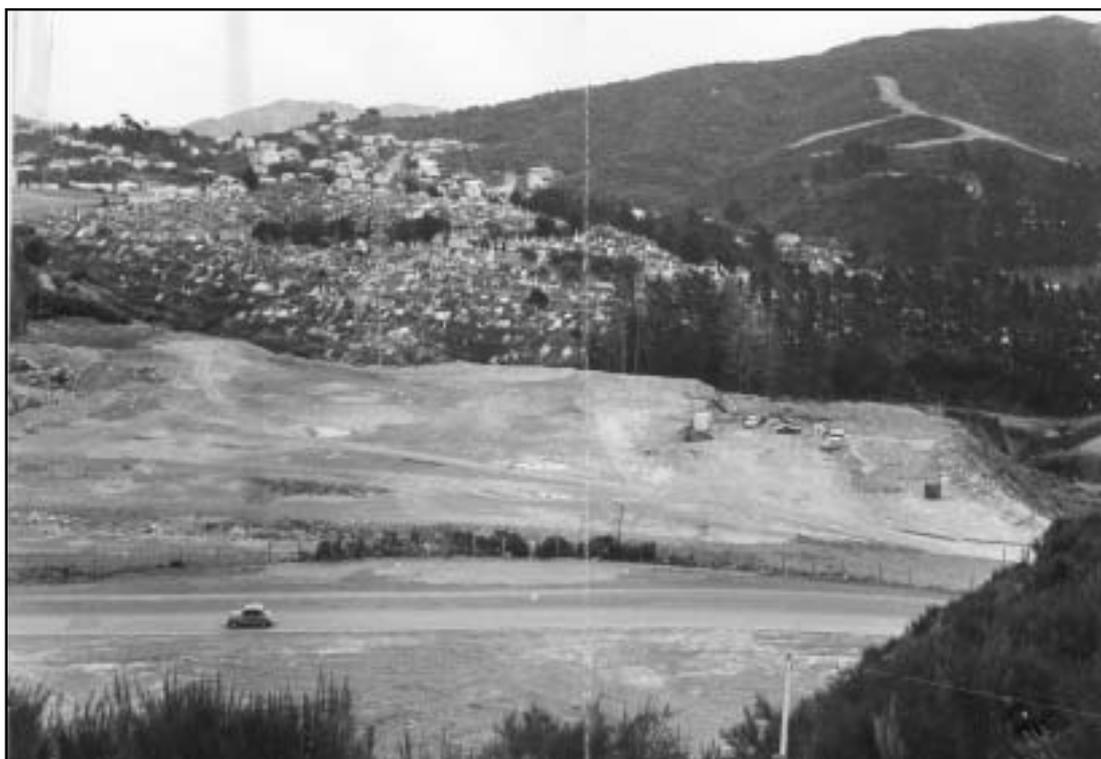
*Figure 13:* Wilton Tip (now Ian Galloway Park) with the “stark and unattractive” graves behind it. The pine trees on the right were planted in the north-east corner in 1927 to screen the cemetery from parts of Wilton. (WCC Archives 00004\_48\_4-6-1 pt3 - 32b)

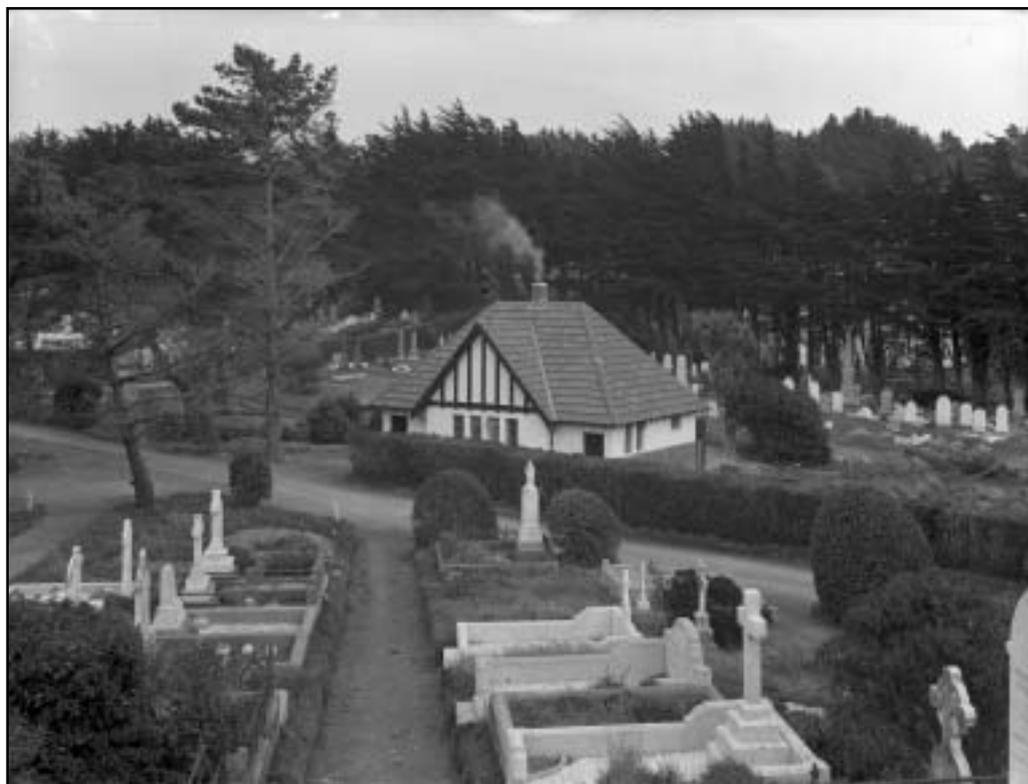
*Figure 15:* The Mess and Toolshed in 1927 soon after its completion (and before its additions) reveals the quality of the City Engineer's building designs. The growing macrocarpa and pine trees were by then becoming a maintenance issue. (ATL G247521 1/1)

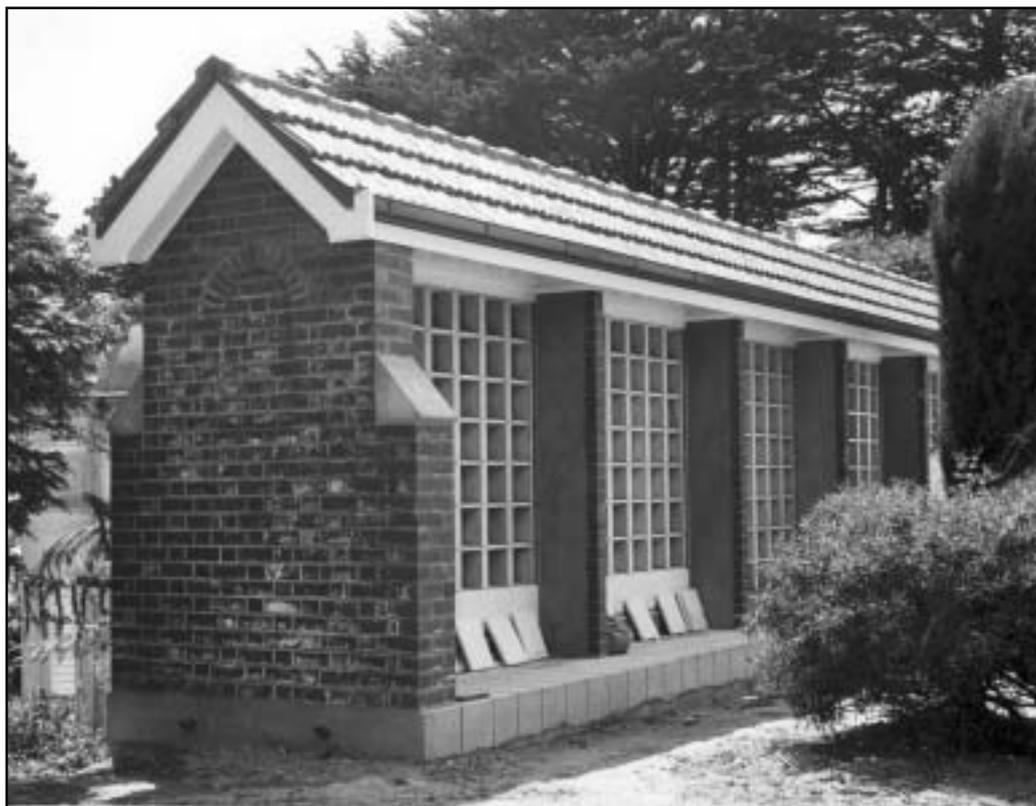
*Figure 19:* The columbarium to the immediate north of crematorium chapel nearing completion, 1949. (WCC Archives 00009\_266\_7-2-1 pt .1)

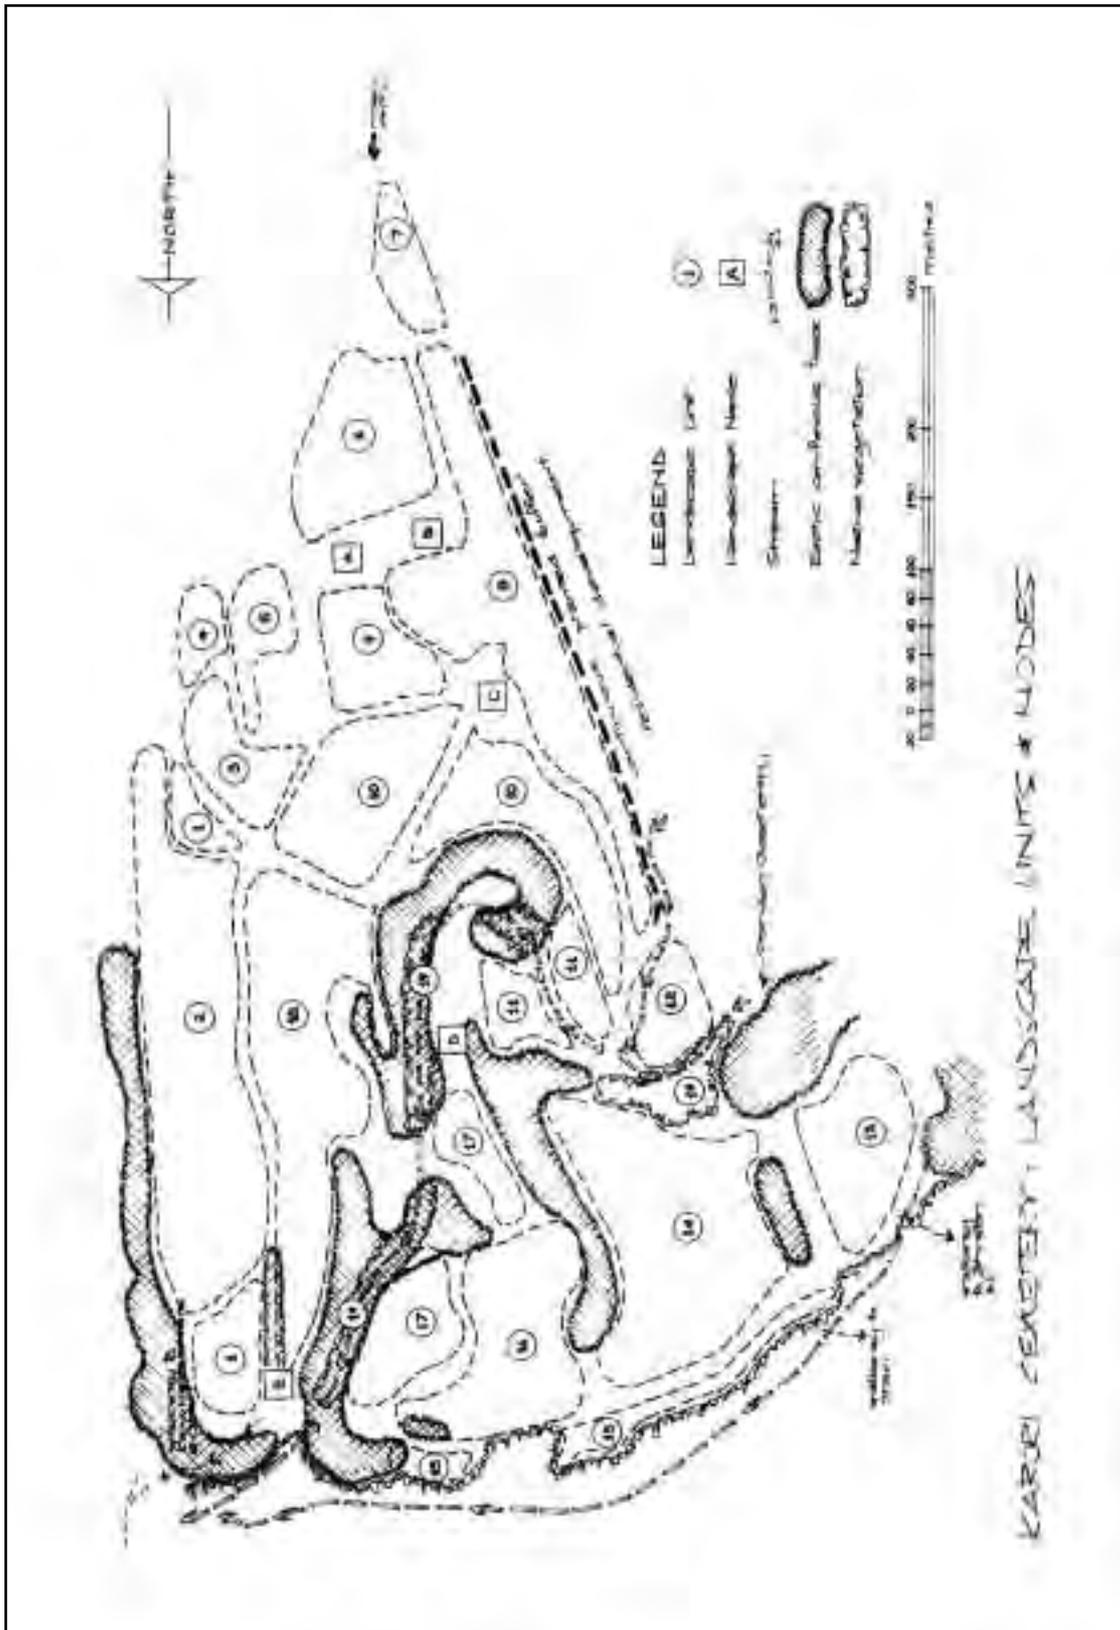
Figure 4: Karori Cemetery, landscape units and nodes. (Neil Aitken)

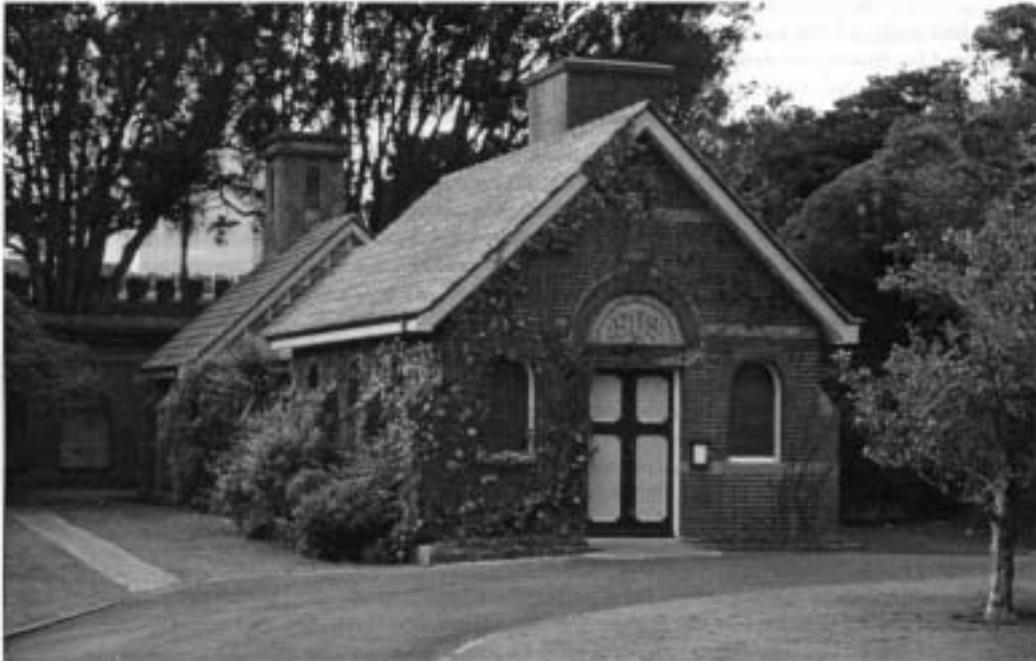
### Old Karori Road Crematorium and Chapel

Architect:	John Sydney Swan	NZHPT Register:	Category I (includes the cemetery) reference 1399
Date of Construction:	1909	District Plan:	Map 14 reference 164/1
Material:	Masonry	Legal Description:	Karori Cemetery, PT A316 Lot 3 DP 36479848 12348 etc

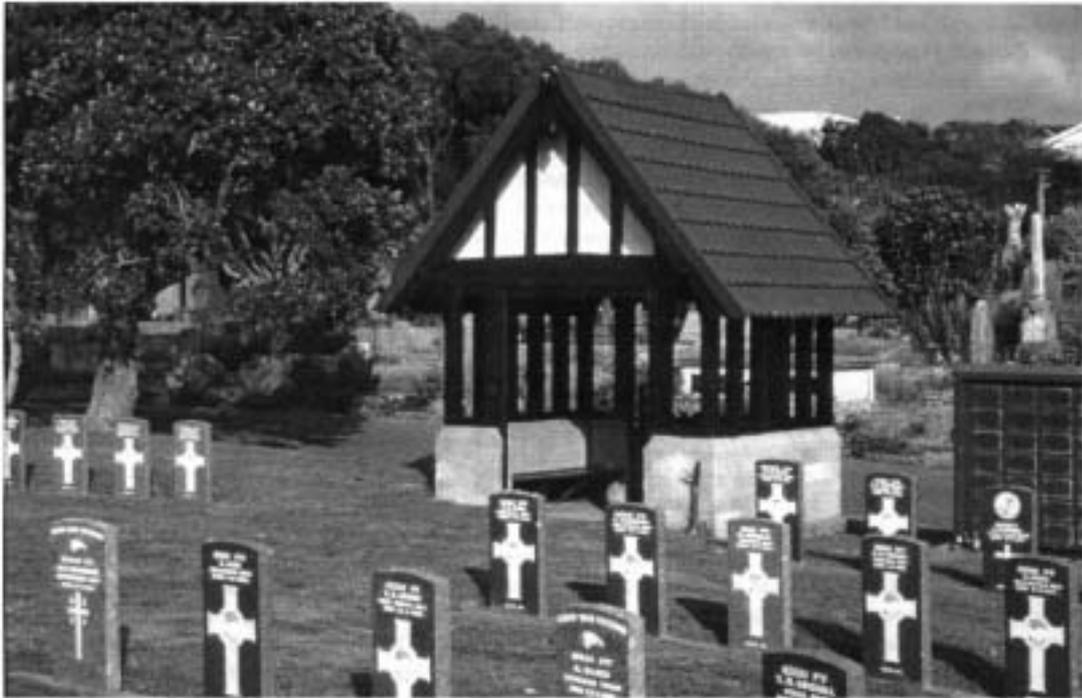
## Lychgate

Architect:	Not known	NZHPT Register:	Category II reference 1400
Date of Construction:	1921	District Plan:	Map 14 reference 164/2
Material:	Stone and timber	Legal Description:	Karori Cemetery, Pt A316 Lot 3 DP 3647 12348 etc

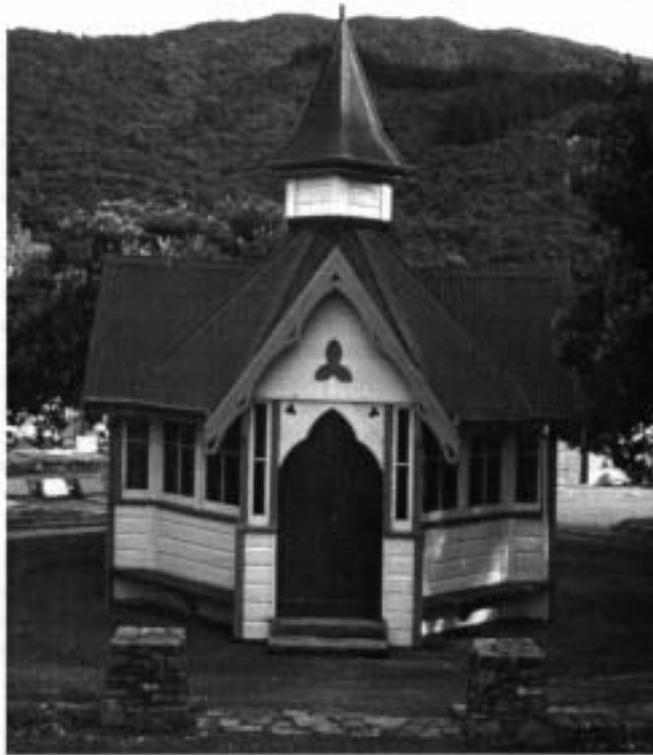
### Jewish Chapel

Architect:	Not known	NZHTP Register:	Category II, reference 1362
Date of Construction:	1896 (1902)	District Plan:	Map 14, reference 165
Material:	Timber	Legal Description:	Karori Cemetery, Pt A316 Lot 3 DP 3547 9848 12348 etc

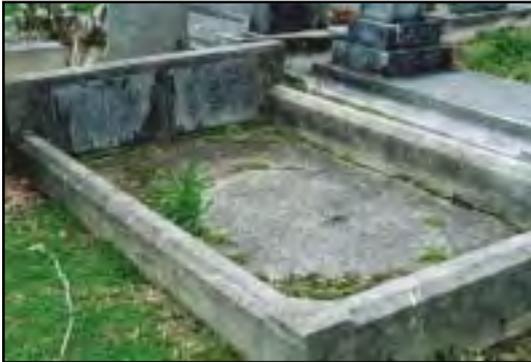
Photo 4  
*Fault* –Cracking to floor only.  
*Reason for repair*–As above.  
*Repair*–As above.

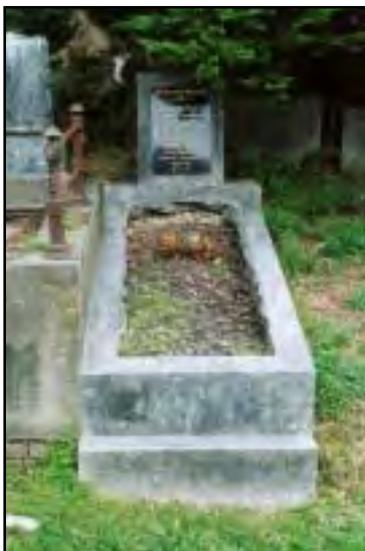
Photo 5  
*Fault* – Missing floor.  
*Reason for repair* – To keep water out of the grave.  
*Repair* – Cut concrete to neat edge; cast new concrete slab on compacted hardfill.

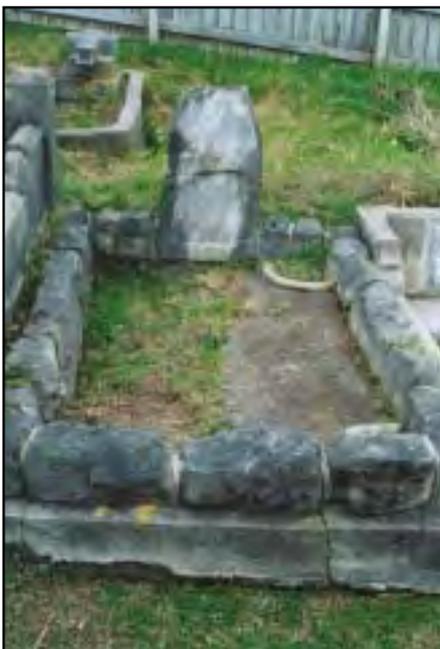
Photo 6  
*Fault* – Half missing floor.  
*Reason for repair* – To keep water out of the grave. *Repair* – Cast new concrete on compacted hardfill; note colour and texture to be matched.

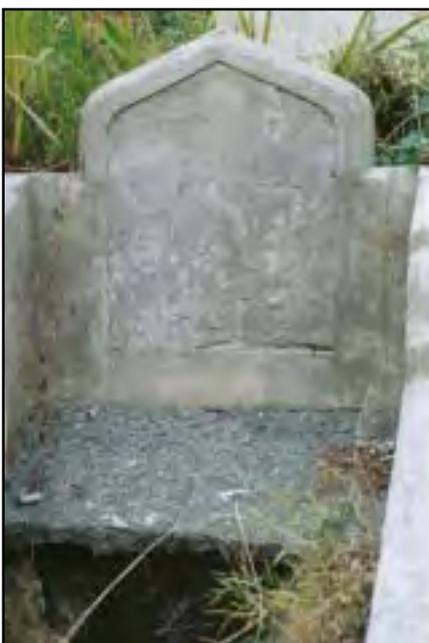
*Photo 9 Fault* — Missing headstone.

*Repair* Do nothing, unless headstone is found, in which case re-attach.

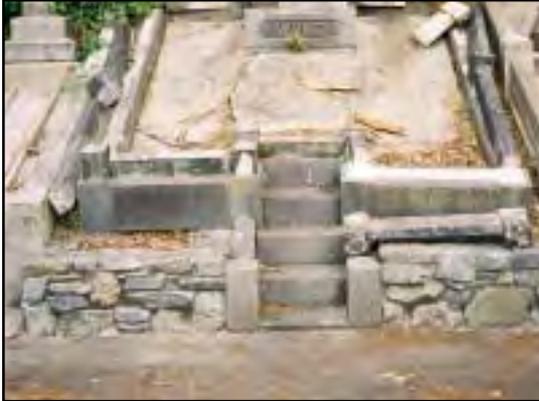
Photo 13

*Fault* — Fallen/broken components.

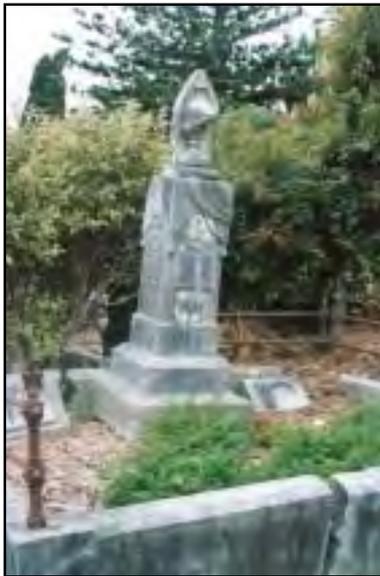
Photo 14

*Faults* — monument tilting, wall of grave broken, components of wrought iron railing missing.

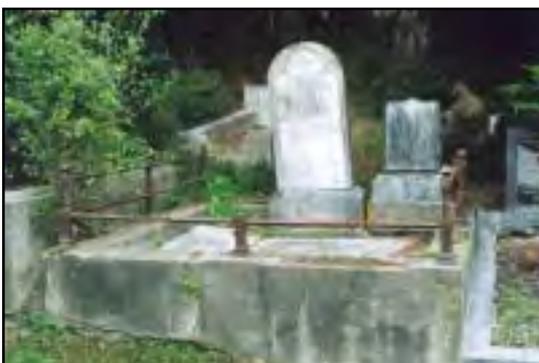
Photo 15 :

*Faults* – monument tilting, wall of grave cracked, plaster missing, floor of grave slumping, components of wrought iron railing missing.

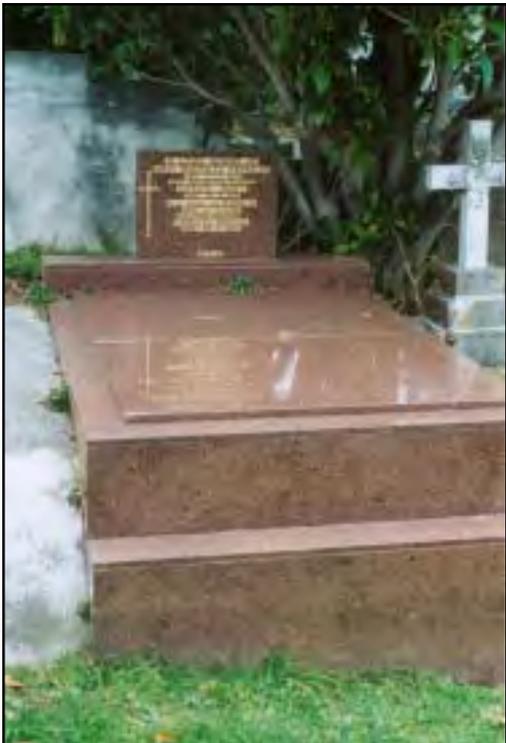
Photo 16

And many graves are in perfect condition, photos 16 and 17.
