North Kumutoto Precinct Project, Wellington:
Archaeological assessment of proposed
redevelopment of Kumutoto Site 9

Report to Willis Bond Capital Partners No.3
Limited

Mary O’Keeffe
Heritage Solutions
Wellington

June 2018

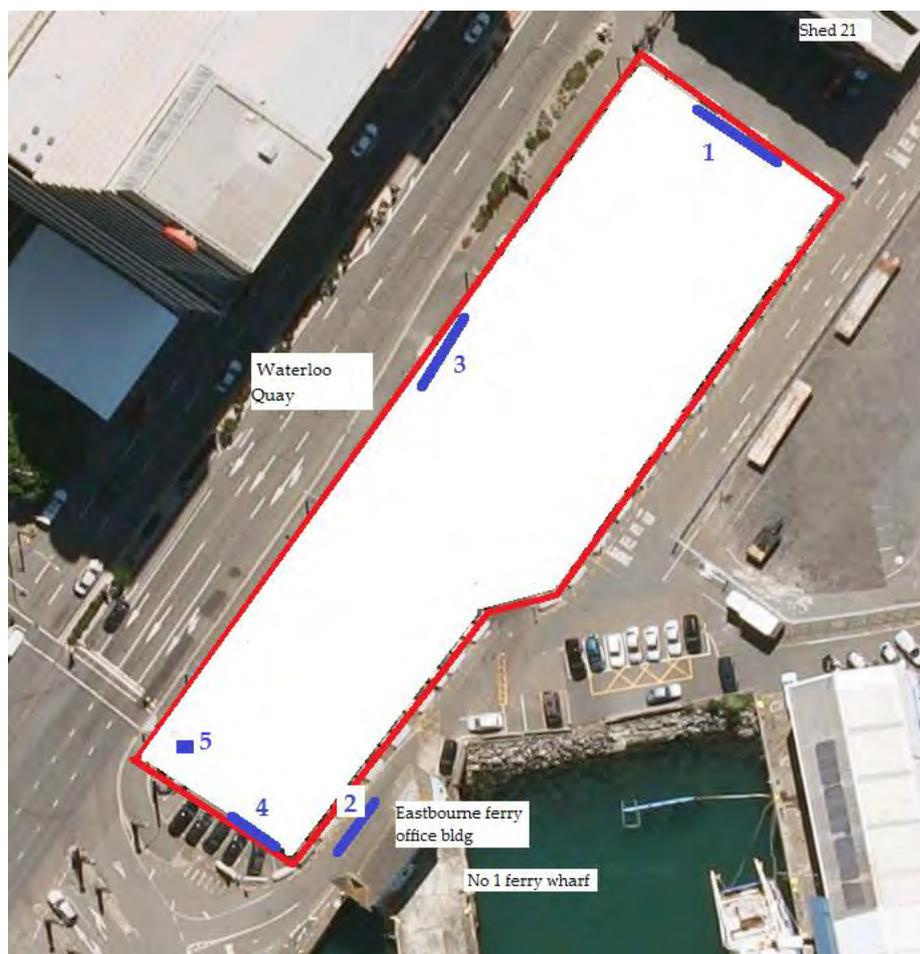
Figure 13: Location of archaeological features found during monitoring

The archaeologist undertook monitoring of the site during construction, under HNZ authority 2016/860¹⁹. Features located were:

- Wooden cobbles
- Inner end of ferry wharf no 1
- Wooden sea wall
- Customhouse foundations
- Pile

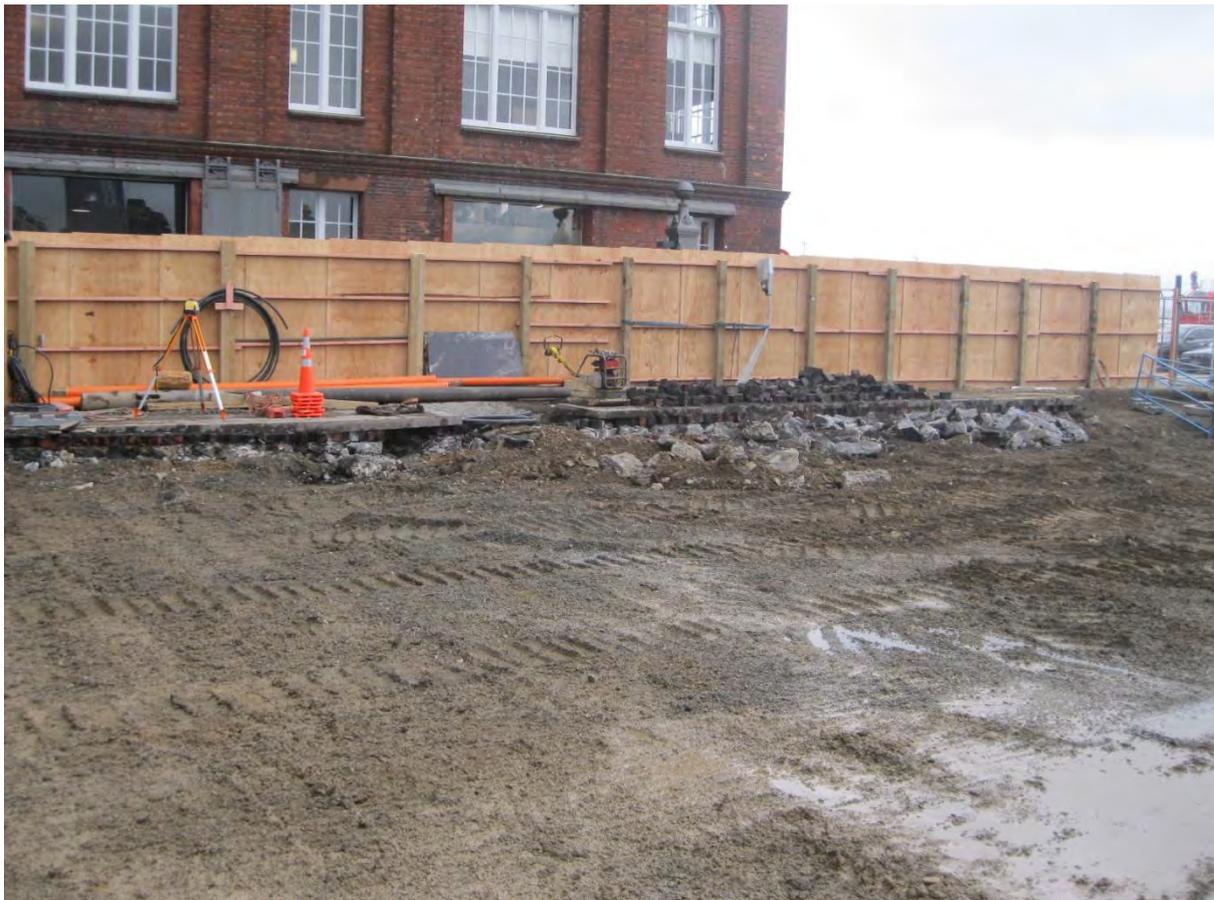
The cobbles had been revealed in section, through excavation of a deep area for foundations for the new building on site. The section was at the north end of the site, beside the temporary wooden site boundary fence, immediately south of the adjacent Shed 21.

The cobbles were visible along a section about 8.5m long. They had been placed on the original ground surface, beneath a more recent concrete slab. The cobbles were constructed of very dense hardwood, with bitumen seal between and over them. They had been placed over rough concrete.

Figure 14: Location of exposed cobbles; north site boundary and Shed 21 in background

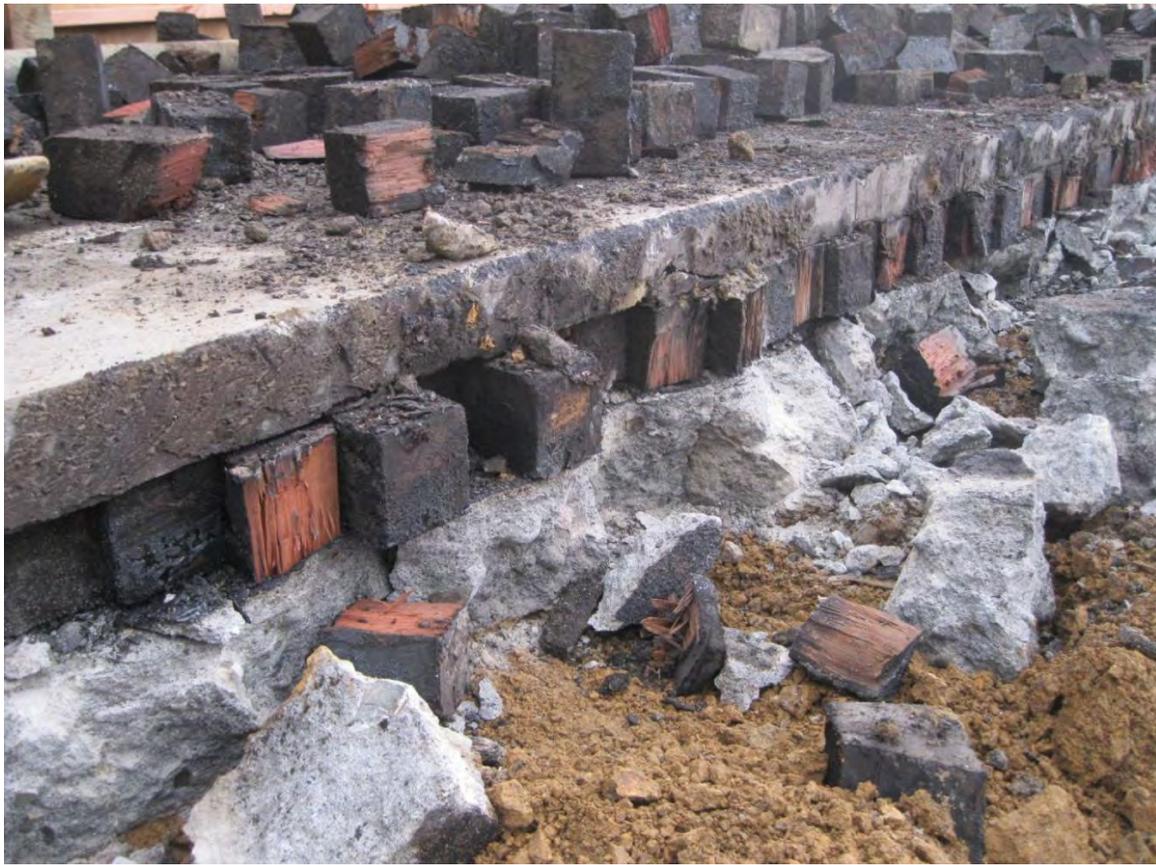
Figure 15: Detail of exposed cobbles and removed cobbles

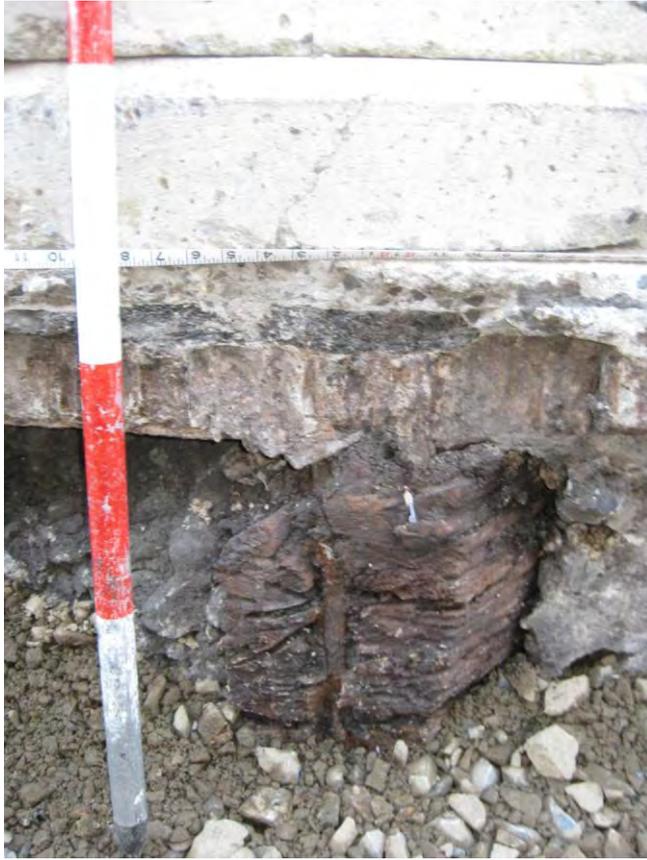
This particular site was at the point where the old stringers had been exposed and the concrete seawall poured under and around them. The stringers were laid at an oblique angle to the trench (i.e. on the alignment of the ferry wharf) and had an exposed face about 23 cm wide and 28 cm deep; this indicates stringers 17 x 28 cm (or 8 x 12 inch dressed). There is some evidence that there may have been parts of capping beams exposed supporting the stringers and doubling up of the stringers where they had been joined (marked by bolts). However, the key parts had been partly re-buried, and it was not possible to record them adequately.

The concrete of the seawall had been poured to the level of the top of the stringers. On this surface had been laid hardwood sets (10.5 cm deep) and asphalt on top of that.

Figure 16: Stringer end C

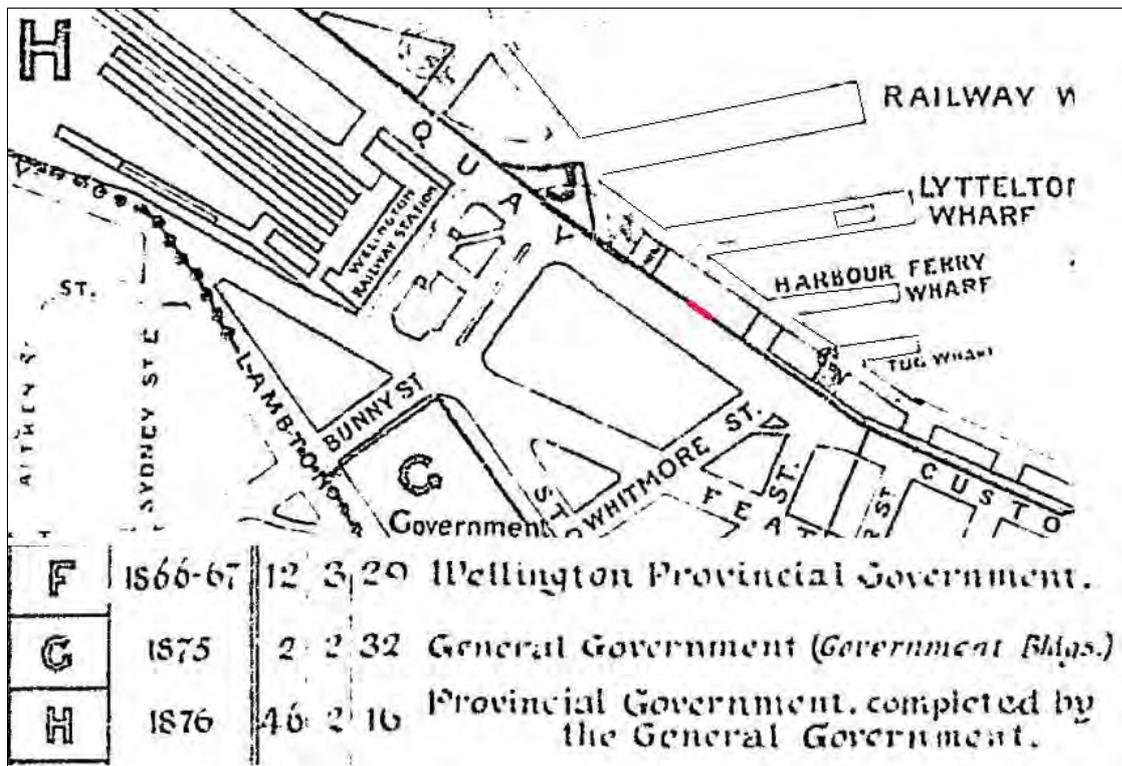
Figure 17: Location of 1876 seawall
From SO 23656, Location of exposed seawall shown in red

The seawall is almost certainly part of a large seawall constructed as part of the 1876 reclamation on land inlands from what is now Waterloo Quay, shown as area H on Figure 17. The seawall is shown as a red line. The seawall is constructed of heavy timbers which are braced against each other.

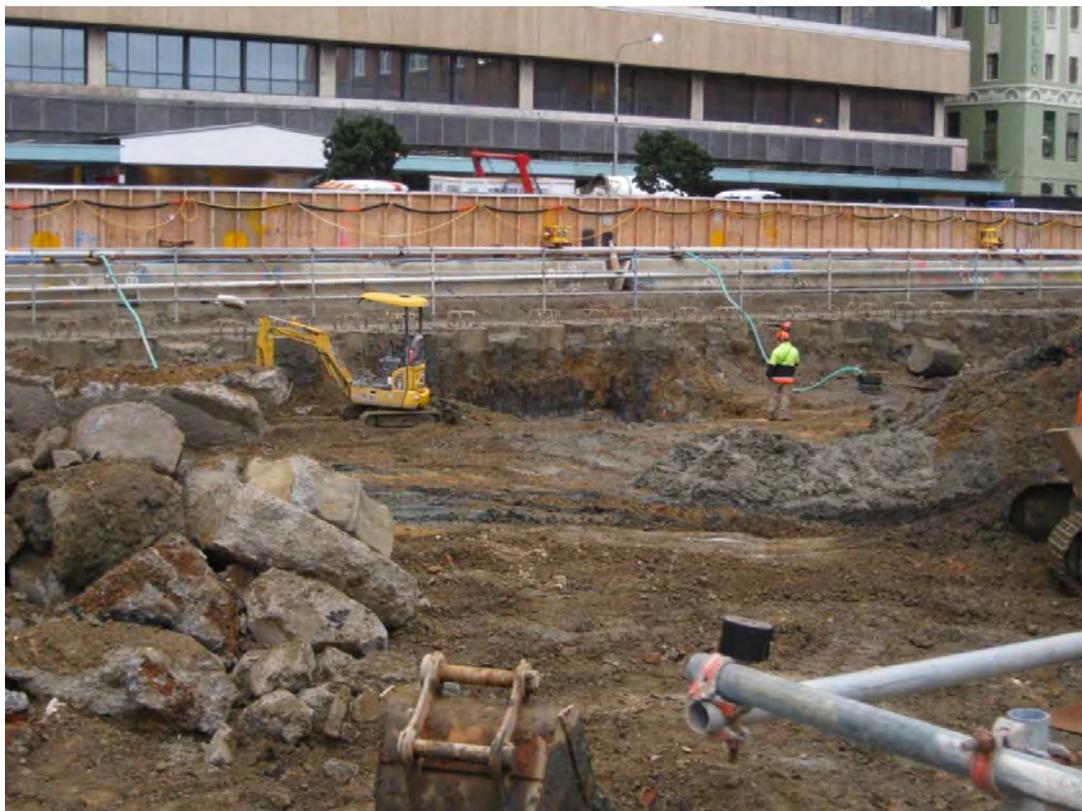
Gleyed sand, presumably original pre-earthquake shoreline, was visible at the base of the wall. Small pieces of ceramic were observed in the fill surrounding and behind the sea wall. Beach shells were observed in the sand at the base.

Figure 18: General view, looking west.
Exposed seawall in centre of image, immediately to right of digger O'Keeffe

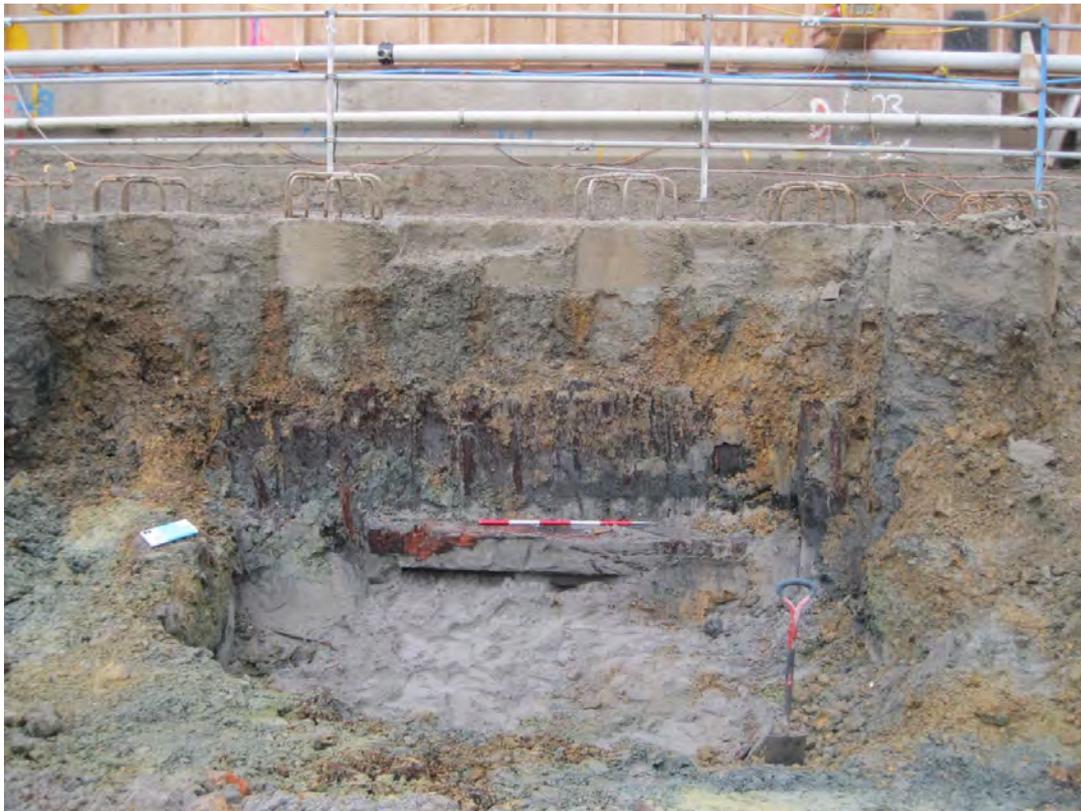
The wooden bearer was very red in colour and appears to have been totara.

Figure 19: Detail of exposed seawall, bearer, beams and piles visible
O'Keeffe

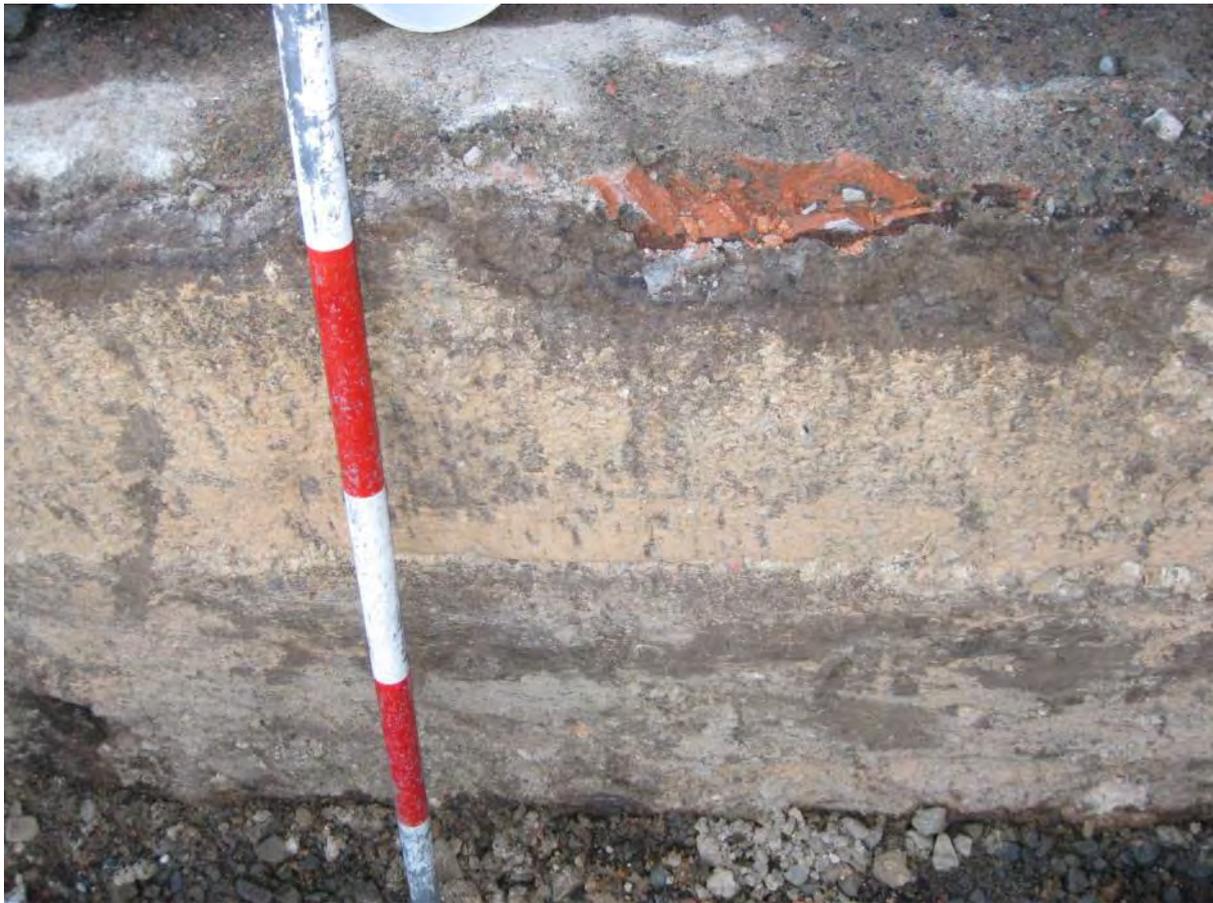
On the south end of the site there was an excavated area about 1 m deep which had exposed the north wall of the Customhouse foundations. These foundations were brick (no width or depth could be established). However, the tanking bitumen was very clear on the north face of the foundations. It had been poured hot or packed in hot behind wooden boxing.

Figure 20: Detail view of tanking (bitumen cast behind boxing?) against brick of the Customhouse foundations.

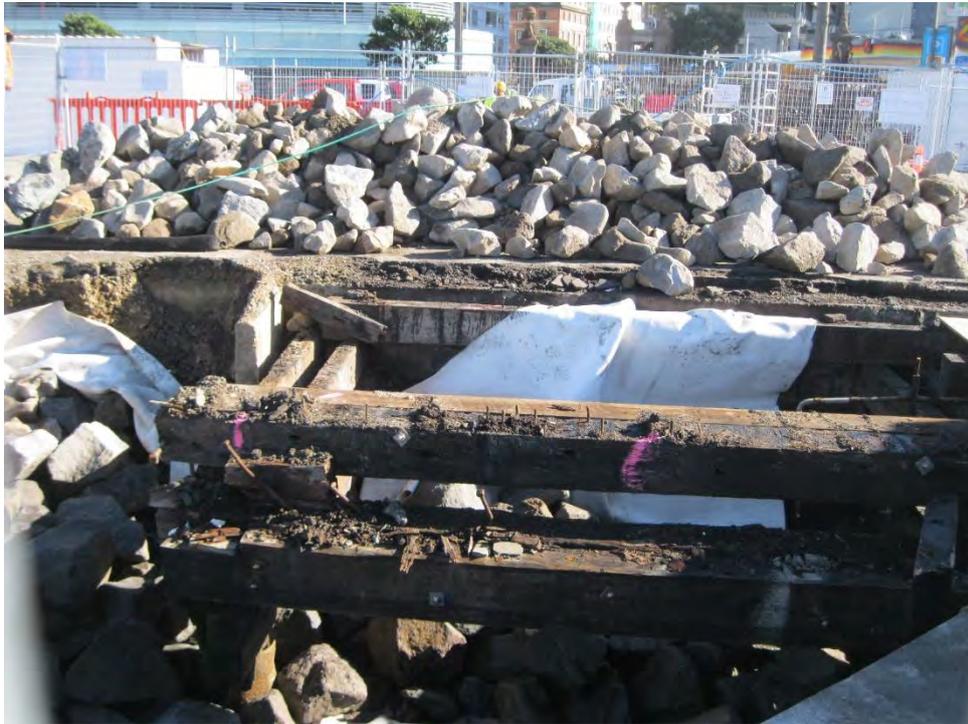
Timbers associated with the 1901 extension of the ferry wharf were revealed during excavation of the land edge to install riprap. In addition the edge of the 1901 seawall was revealed.

Figure 21: 1901 ferry wharf timbers
O'Keefe

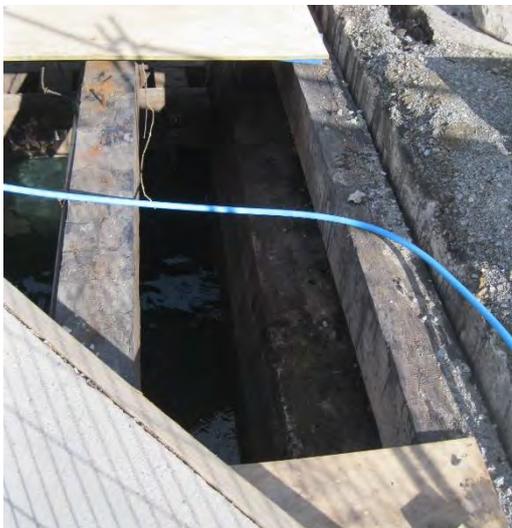
Figure 22: 1901 seawall
Concrete edge of seawall visible beneath timber to right
O'Keefe

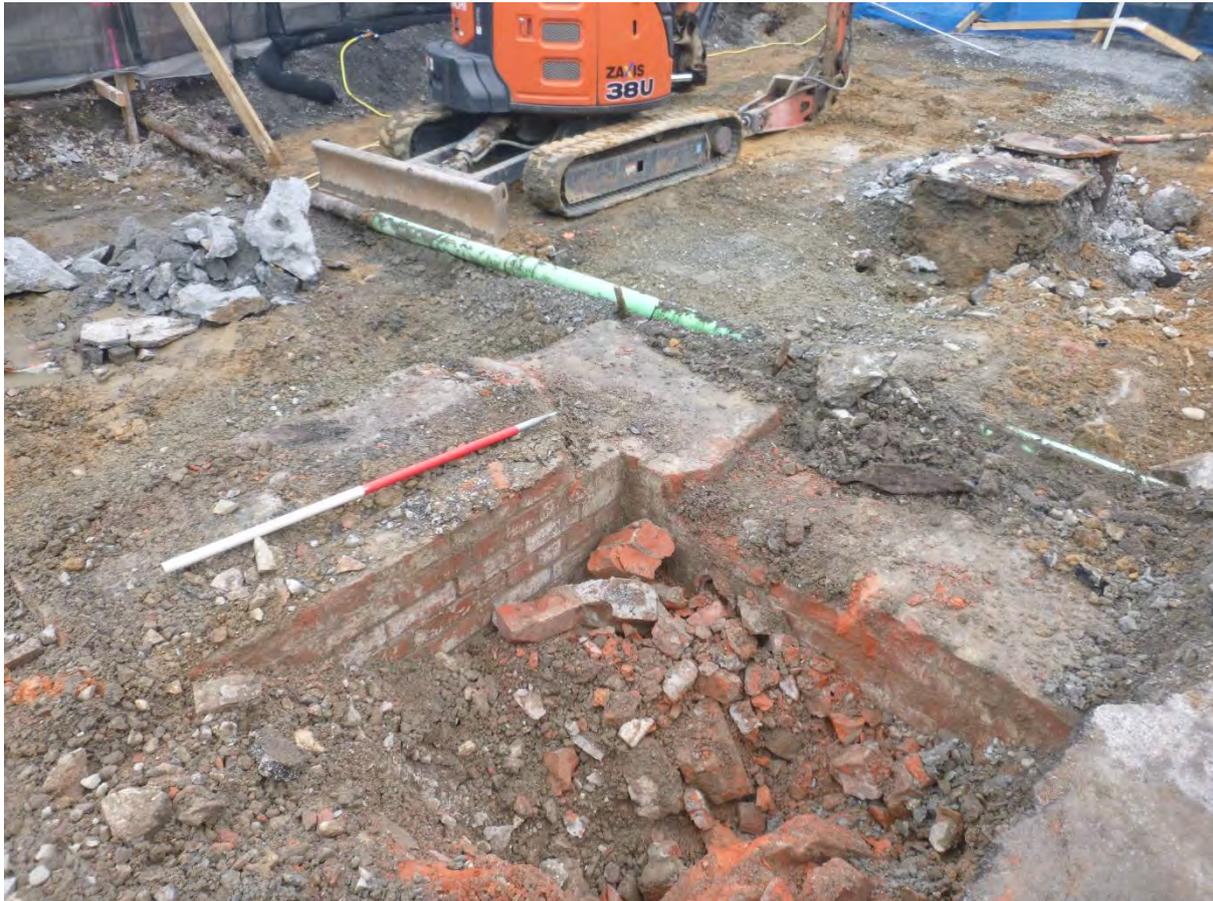
The south east corner and part of the eastern wall of the Customhouse was revealed. The foundations were comprised of a 5 brick thick layer of brick, that had previously been partially destroyed to bring the level to grade.

The eastern wall ran north for just over 9 metres, where the wall had been truncated by a more recent pipe.

Figure 23: Customhouse foundations
O'Keefe

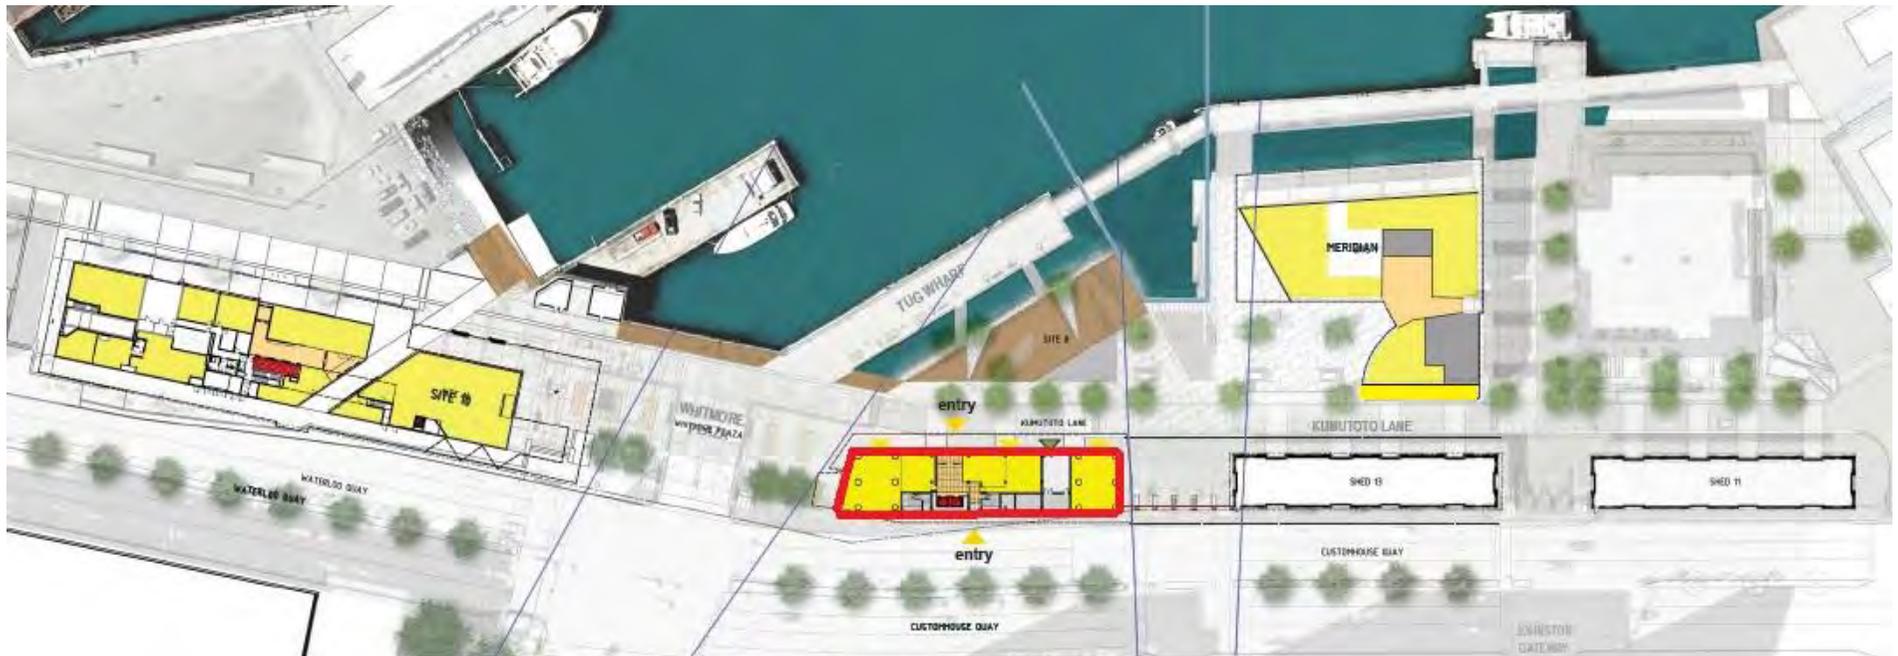
Willis Bond Capital Partners No.3 Limited proposes to construct a five-storey commercial building. The proposed building will occupy the entire site footprint.

The relative location and size of the building is shown in Figure 24.

Figure 24: Proposed site plan
Site 9 building outlined in red

- Having an archaeologist monitor all surface clearing, removal of building foundations, trenching or other invasive subsurface groundwork required for site modification or construction.
- The archaeologist should be given the opportunity to examine any archaeological deposits disturbed by the development work, and to make recommendations for further detailed examination of these deposits where appropriate.
- That the developer considers incorporation of heritage fabric or features recovered and recorded by the archaeologists into historical displays or interpretation within the new building wherever possible

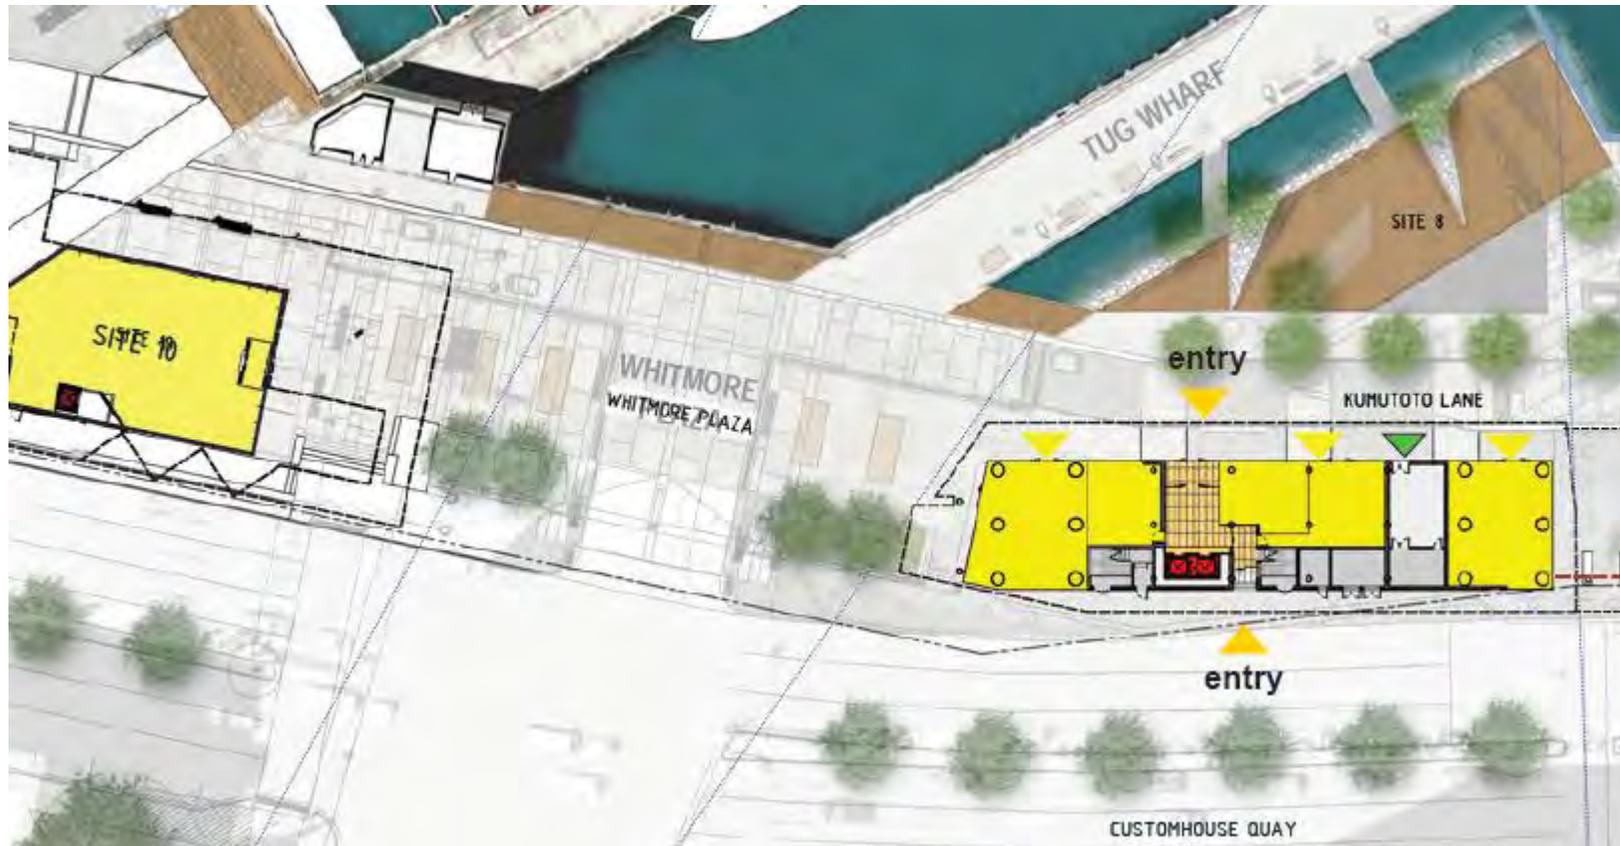
Figure 25: Detail of site location

Detail is shown in Figure 25.

Current landscaping work is taking place in the Whitmore Plaza, between sites 9 and 10, and to the east (coastal edge) of the two sites.
