ASSESSMENT OF ECOLOGICAL
EFFECTS FOR A
PROPOSED EXPANSION OF
C & D LANDFILL, HAPPY VALLEY,
WELLINGTON

JANUARY 2012

Contract Report No. 2438b

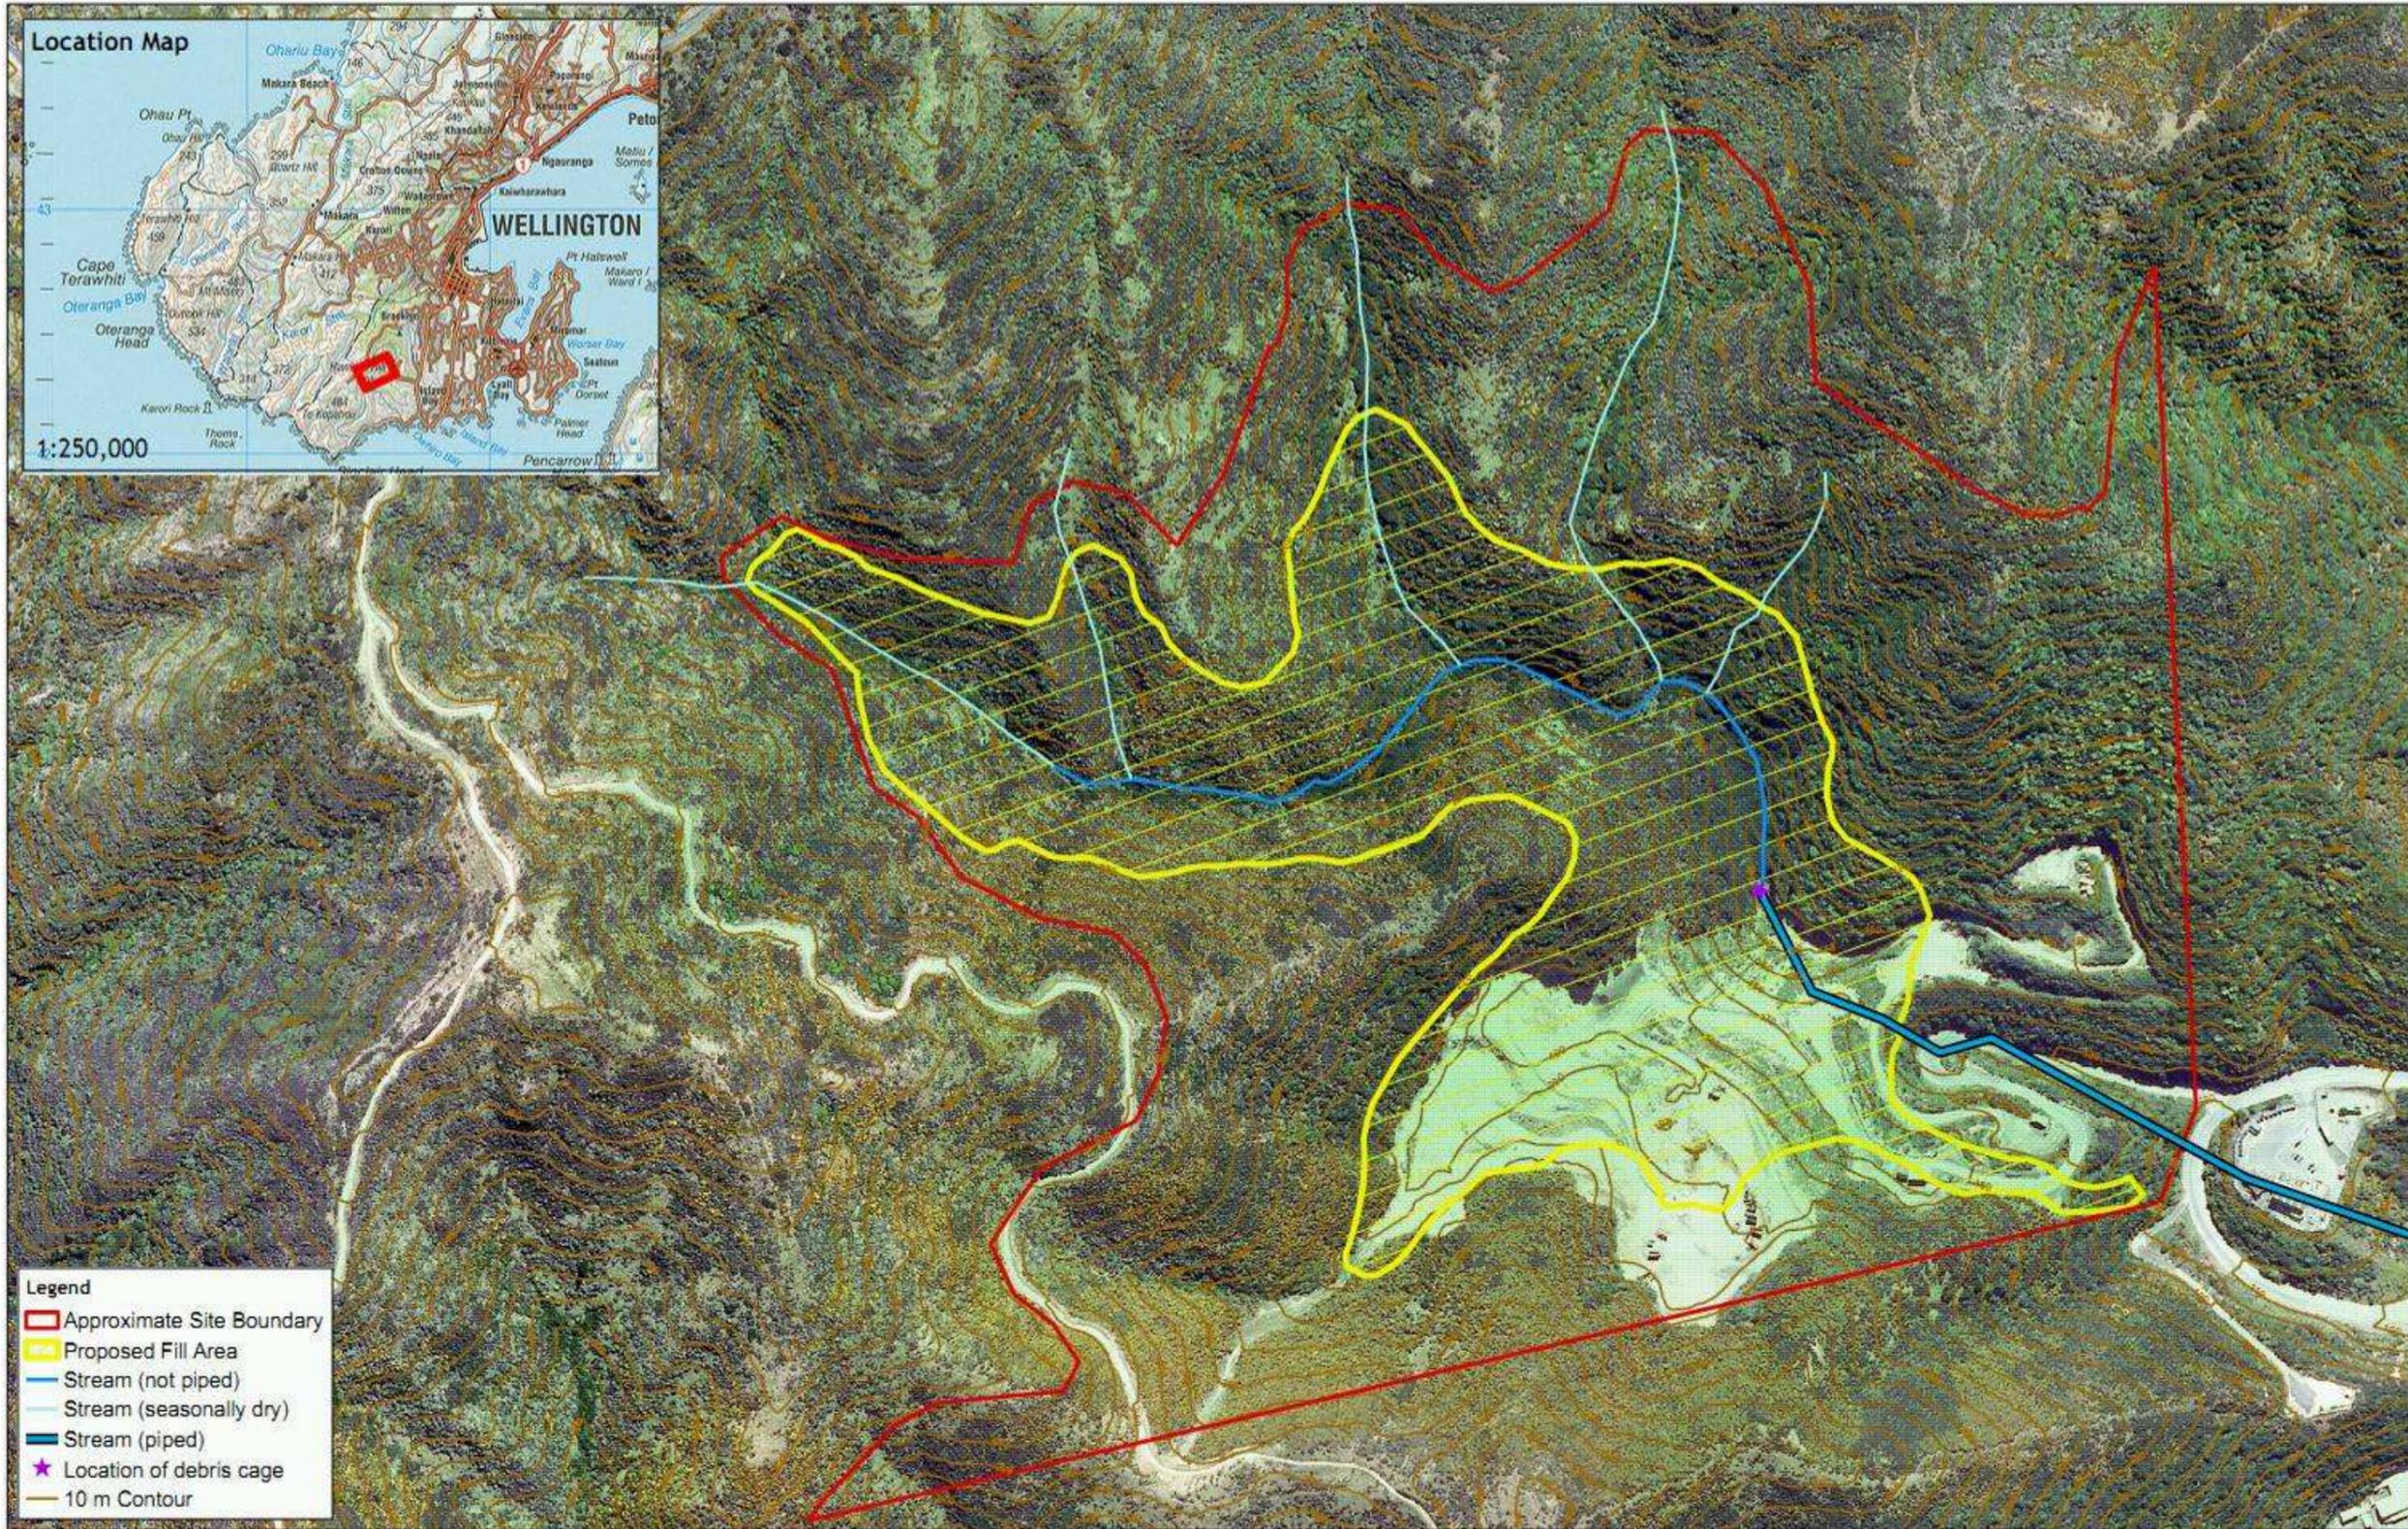
Figure 1. C&D Landfill Site, Happy Valley, Showing Approximate Site Boundary and Proposed Extent of Fill Area

Currently, the unnamed stream (hereafter referred to as Landfill Road Stream Tributary) is piped beneath the landfill in a 900 mm diameter pipe, c.500 m long, which then flows beneath and along Landfill Road, to eventually join with the Owhiro Stream. The proposed extension will require additional piping of the stream, and clearance of vegetation currently within the proposed extension area. The current extent and proposed extension of the C&D landfill site are shown in Figure 1.

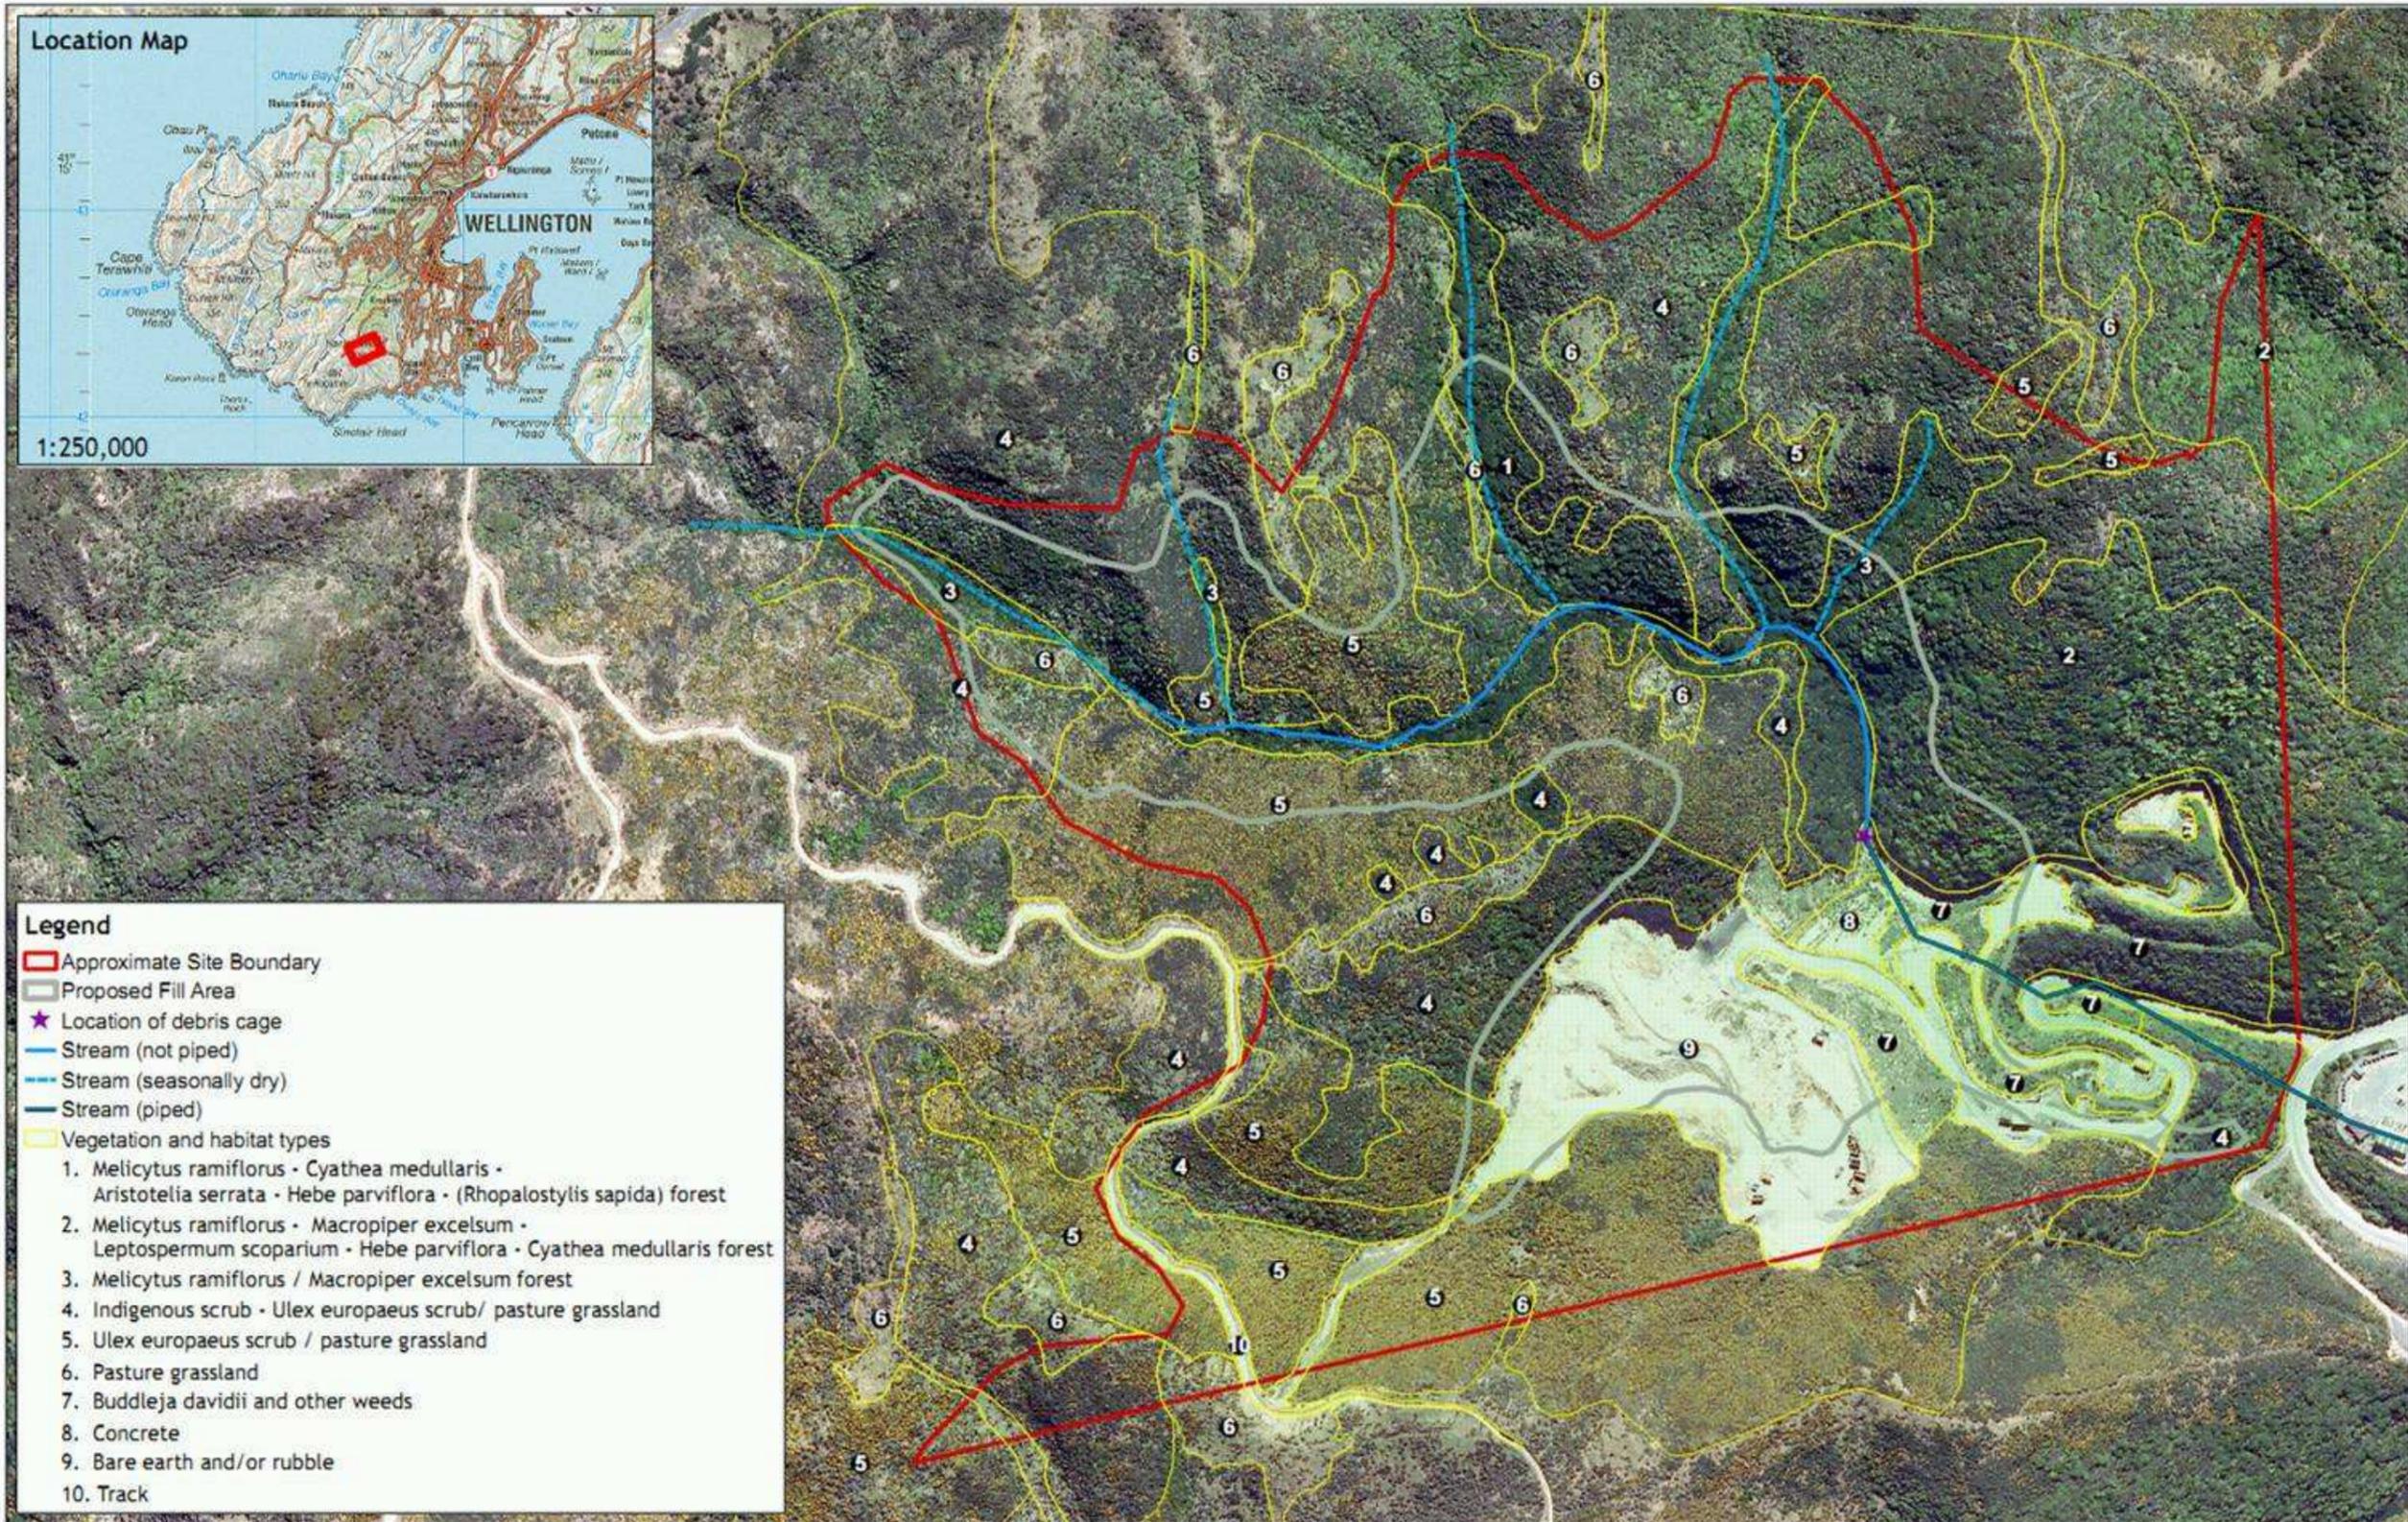
Figure 2. Vegetation and habitat types at the C&D landfill site, Happy Valley

This section describes the ten terrestrial vegetation and habitat types noted at the site and briefly outlines the relative ecological ranking for each. Descriptions of the various vegetation types present in the Study Area are provided below, and mapped in Figure 2.

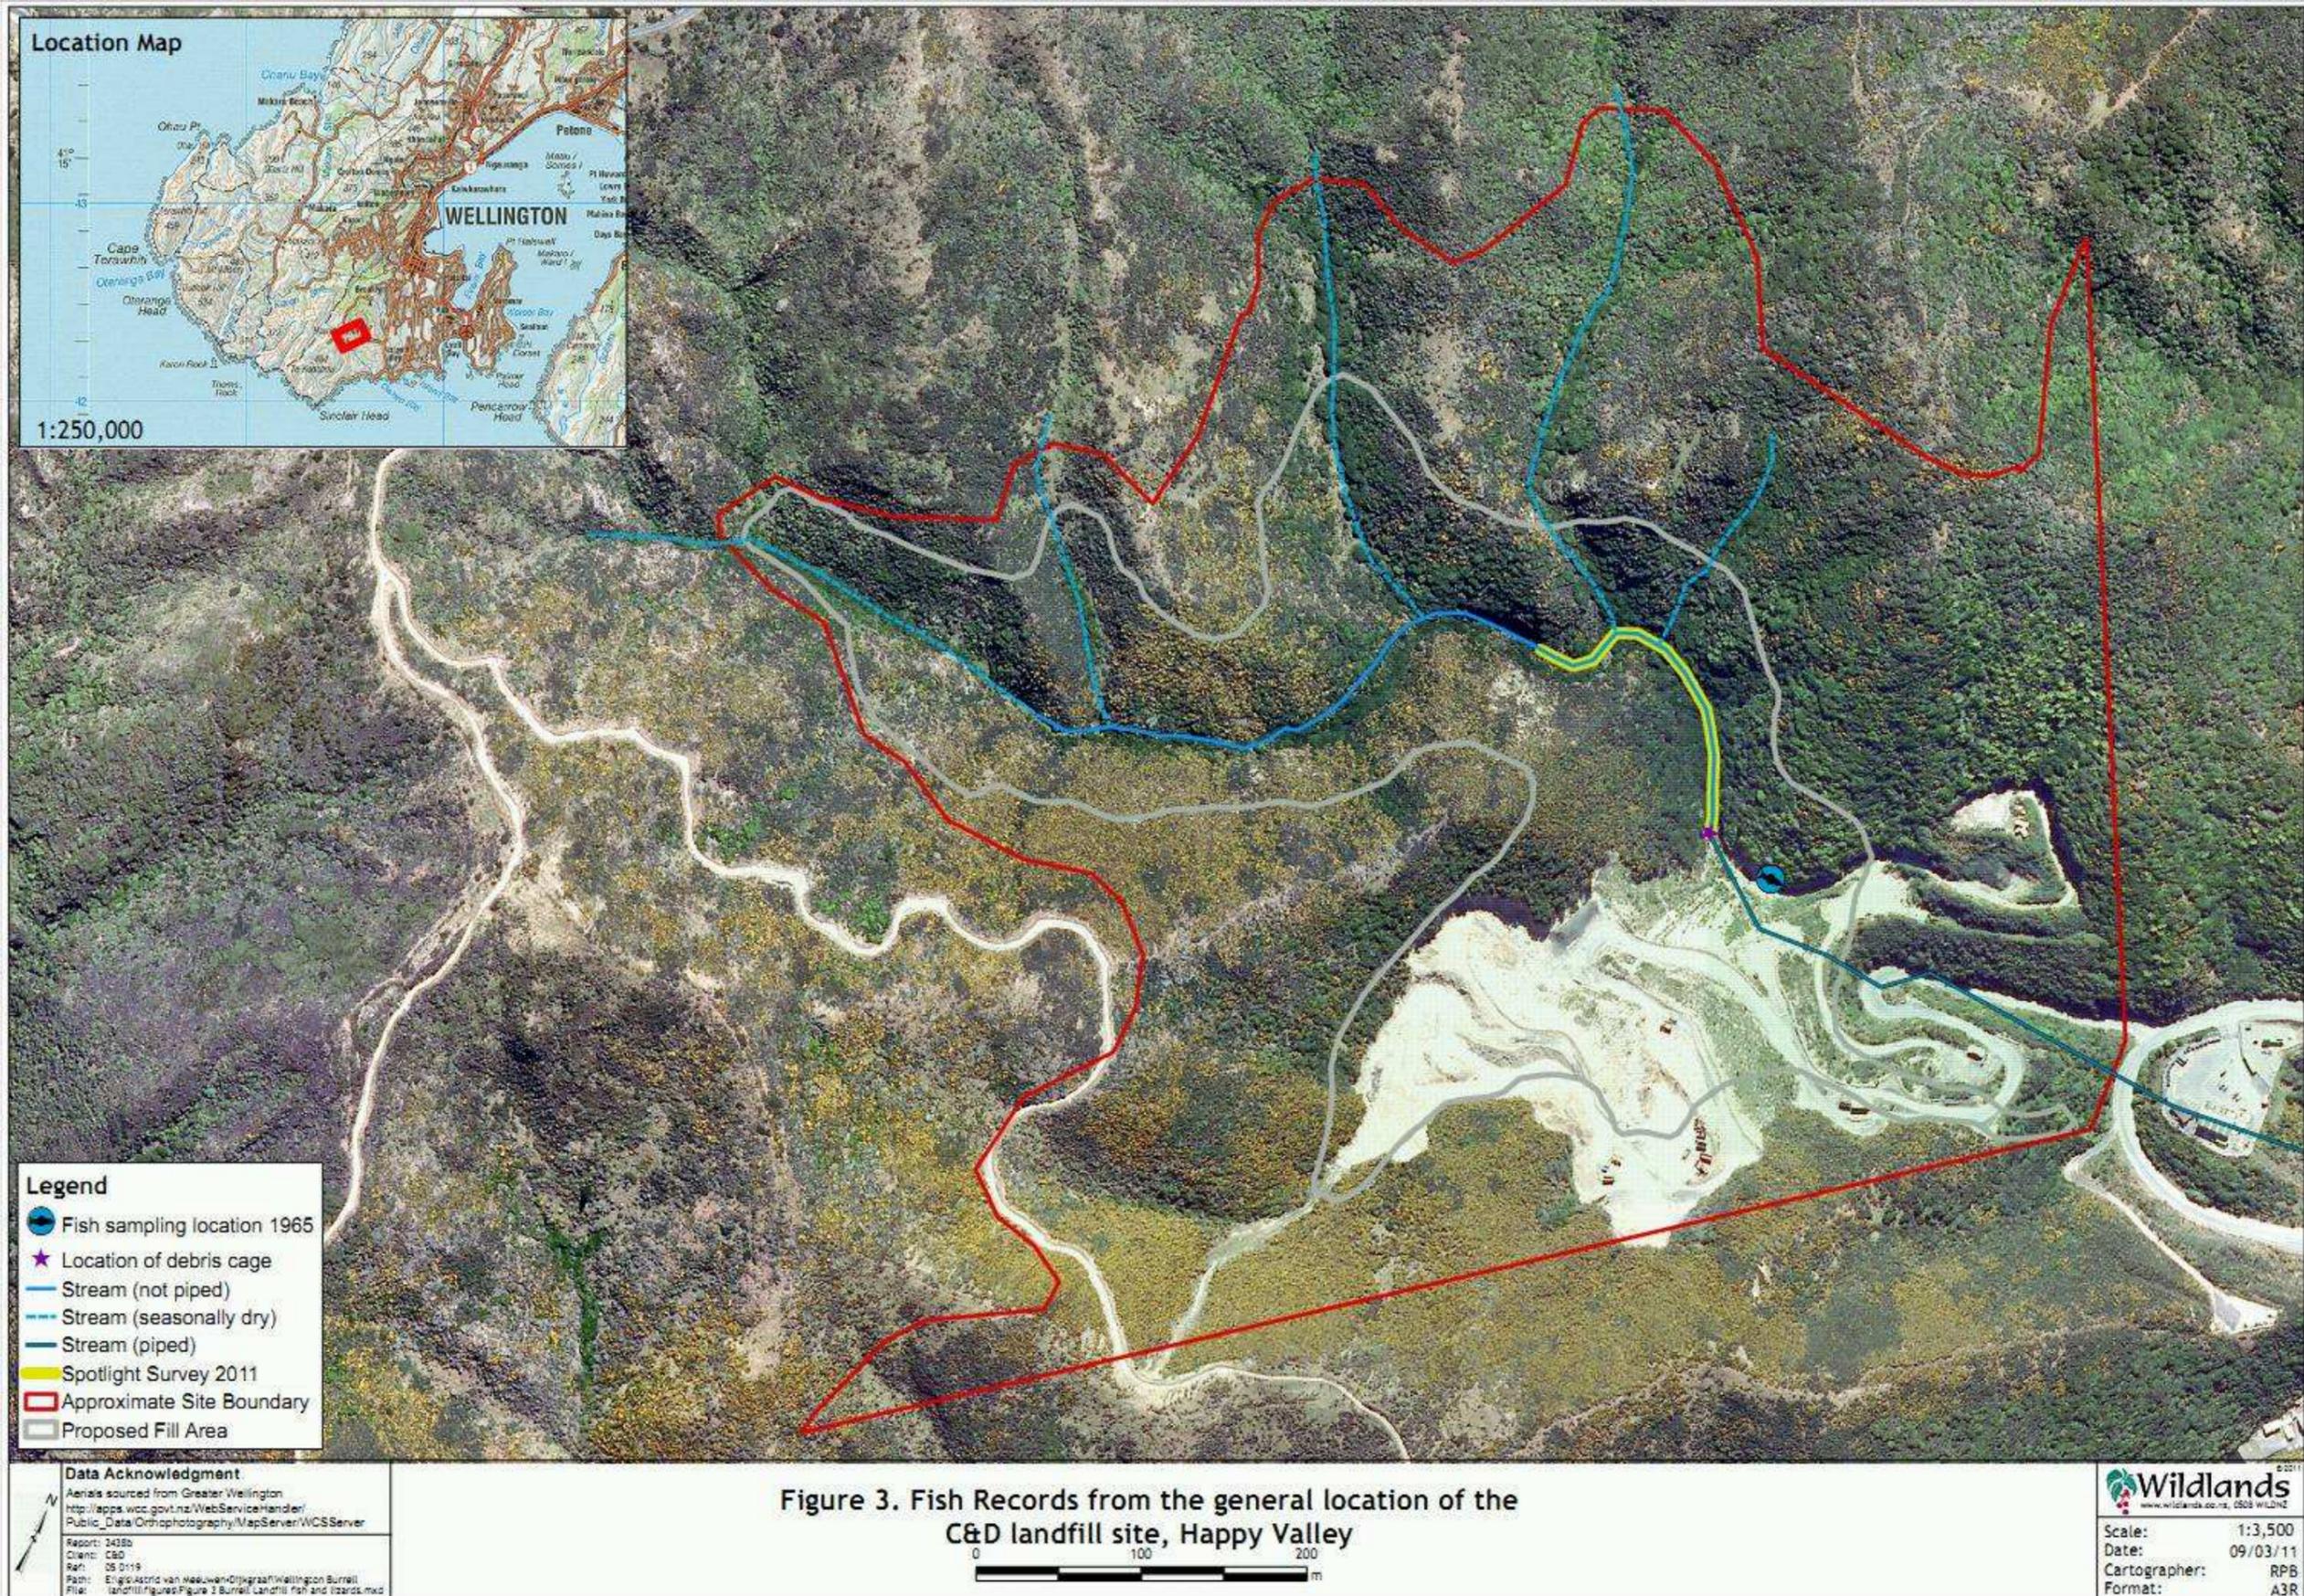
Aquatic life in the stream was investigated in 1965 (NIWA 2011). The actual sampling location is no longer available as that site has been filled (Figure 3). At that time shortjaw kokopu (*Galaxias postvectis*, At Risk-Declining) were found and banded kokopu (*Galaxias fasciatus*, Not Threatened), redfin bully (*Gobiomorphus huttoni*, Not Threatened), longfin eel (*Anguilla dieffenbachia*, At Risk-Declining) and koaro (*Galaxias brevipinnis*, At Risk-Declining) were common (Table 3).

A 250 m section of stream was spotlighted on 28 January 2011 (Figure 3). We noted 5 small (2-7 cm long) koura (freshwater crayfish), two banded kokopu, and eight koaro (summarised in Table 4). Koaro were found in nearly every pool greater than about 1 m across, in water depths from 10 cm to 30 cm. Koaro require rocky, tumbling streams, with very clean waters and cool temperatures, and are generally only found in forested areas. This is the only the only recent record of koaro in the Owhiro catchment and is the only known population of koaro within Wellington City Council, although koaro may also occur in the stream above the Municipal Landfill. Koaro are more widely known from the Wellington Region. The presence of koura (freshwater crayfish) indicates that this is a permanently flowing waterway.

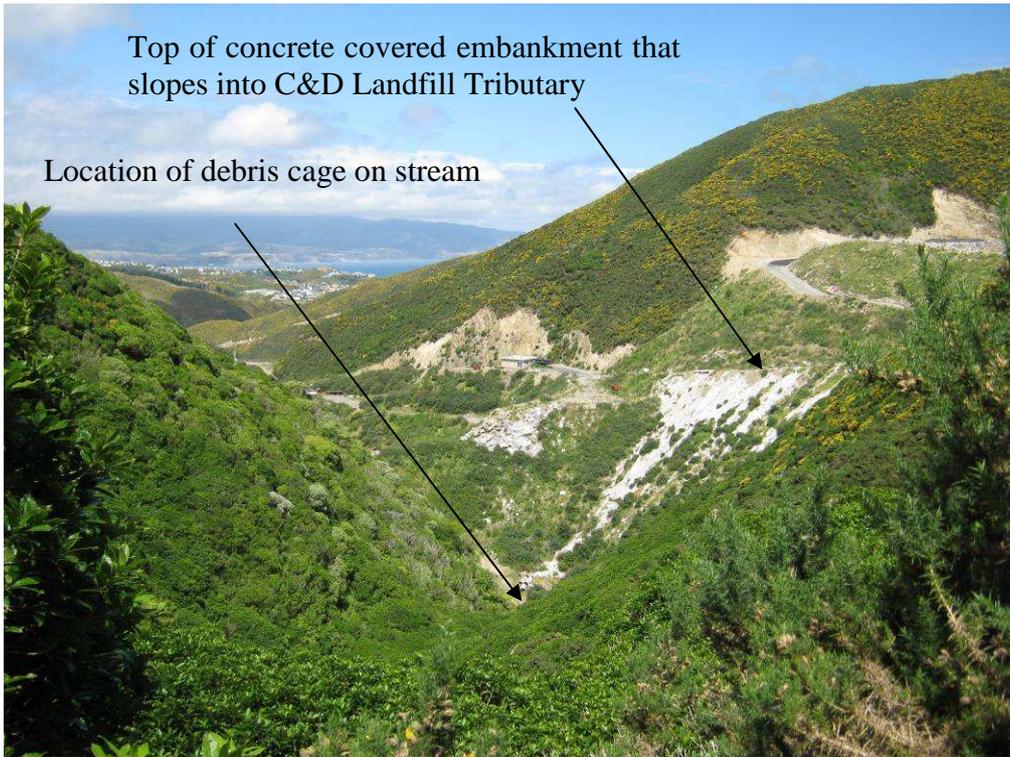
Photograph 1. View down into to landfill site from one of the ephemeral streams. This illustrates the potential 'dam' and the amount of fill that has been placed over the piped sections of the Owhiro Stream Tributary.

The C&D Landfill site lies to the southwest of the Wellington Municipal Landfill site on Happy Valley Road, inland from Owhiro Bay, and to the southwest of Wellington City. The landfill site is leased from Wellington City Council and apparently includes the area up to the 300 m contour line (site boundary as indicated in Figure 1). Access is from Happy Valley Road via a hairpin road that climbs up previously-deposited layers of fill and previous cuttings. Most of the fill operation currently is to the southwest of the Landfill Road Stream Tributary (hereafter called the C&D Landfill Tributary). There are a number of filled platforms, or platforms that are currently being used for the deposition of building materials and other such waste. Overview photographs of the site can be found in Appendix 2, Photographs 1, 17 and 18.

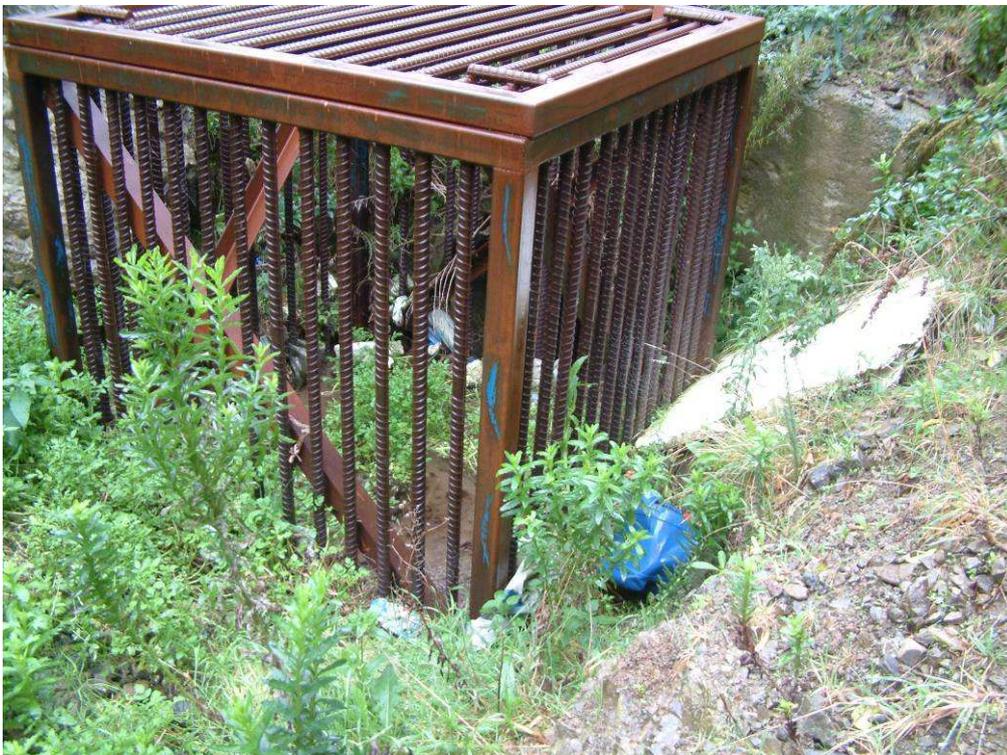
Photograph 2. Debris cage installed in front of 900 mm pipe through which C&D Landfill Tributary has been diverted beneath the landfill.

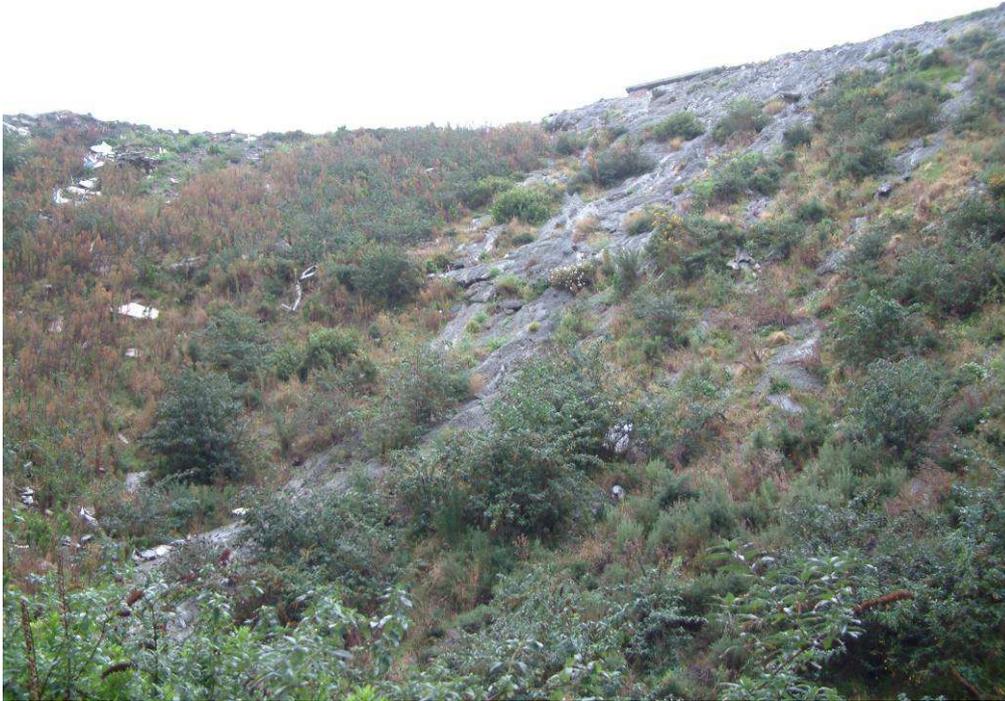
Photograph 3. Landfill embankment immediately adjacent to C&D Landfill Tributary, 24 May 2010. Note concrete poured from the top and patches of buddleia.

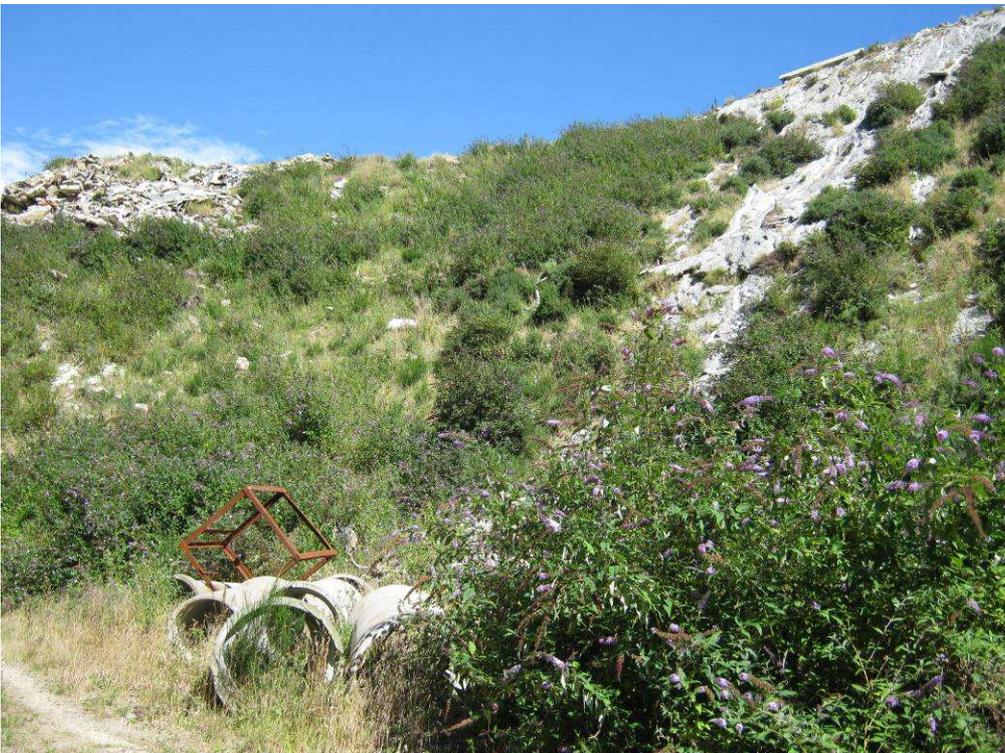
Photograph 4. Landfill embankment immediately adjacent to C&D Landfill Tributary, 28 January 2011. Note the increased cover of buddleia in just 8 months.

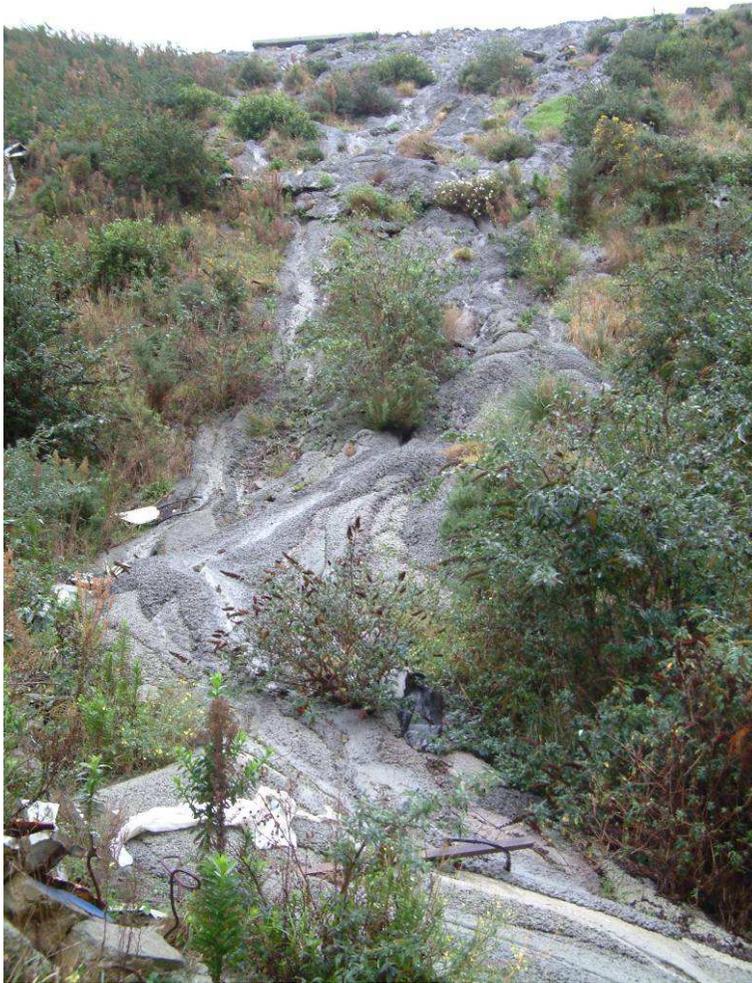
Photograph 5. Uncontained flow of waste concrete occasionally comes very close to the C&D Landfill Tributary. Debris cage is about 5 m to the right of this image, 24 May 2010.

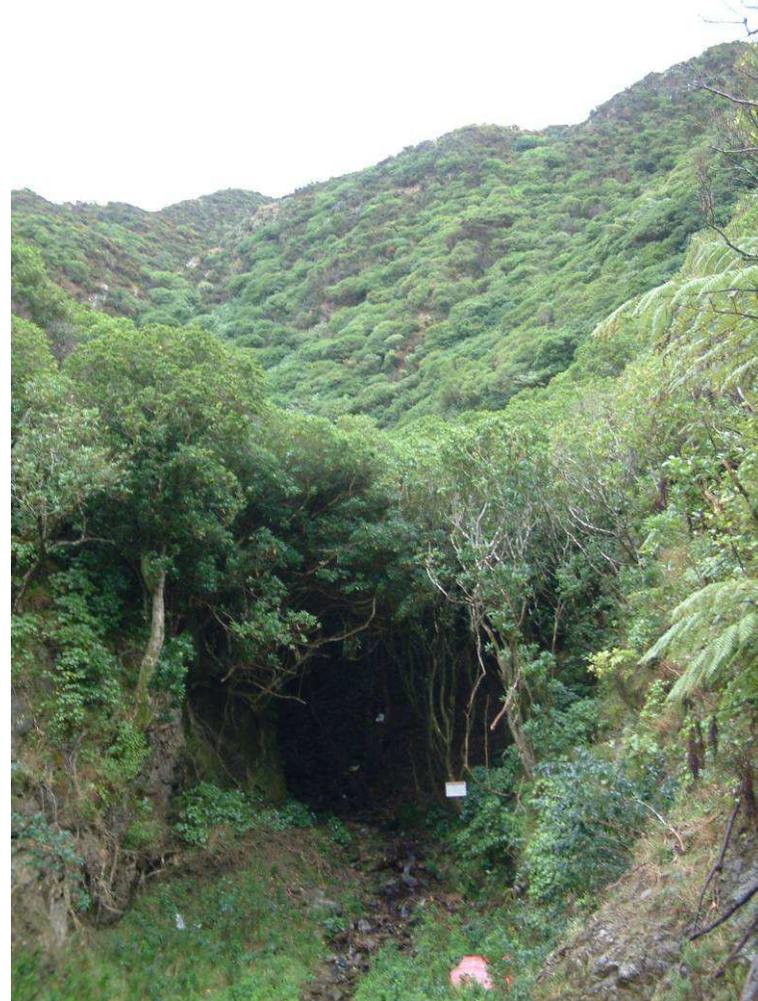
Mahoe and kawakawa are co-dominant. Along the stream the canopy is 10-20 m high with mahoe trunks up to 20 cm dbh (Photograph 6). On steeper slopes the canopy was 4-6 m tall with trunks of up to 8 cm dbh. Along the stream the understorey species are similar to that described in Vegetation Type 2, with the addition of ongaonga (*Urtica ferox*), supplejack (*Ripogonum scandens*), kiekie (*Freyinetia banksii*), and a greater variety of fern species (Photograph 12). On steep slopes the understorey is sparse and dominated by loose shifting gravel screes (Photograph 13). Understorey species occur in more stable areas, or on the

Photograph 6. Just upstream from debris cage, looking upstream into the valley through which the C&D Landfill Tributary flows, 24 May 2010.

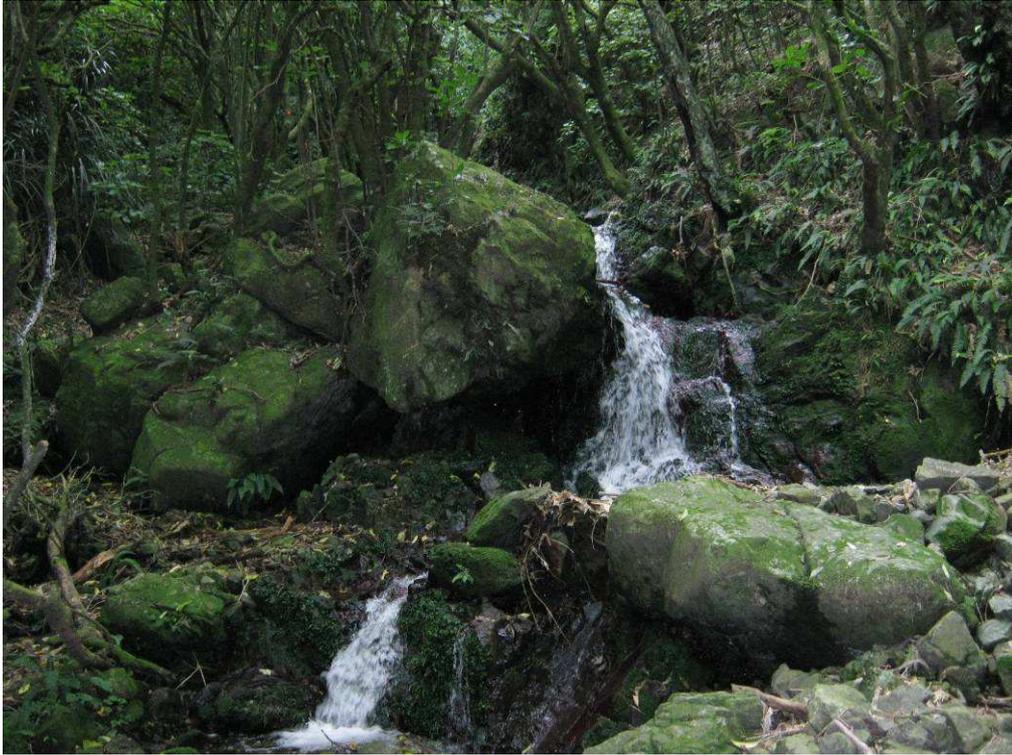
Photograph 7. C&D Landfill Tributary, 28 January 2011, beneath mahoe and kawakawa canopy (Vegetation Type 3) with fern understory.

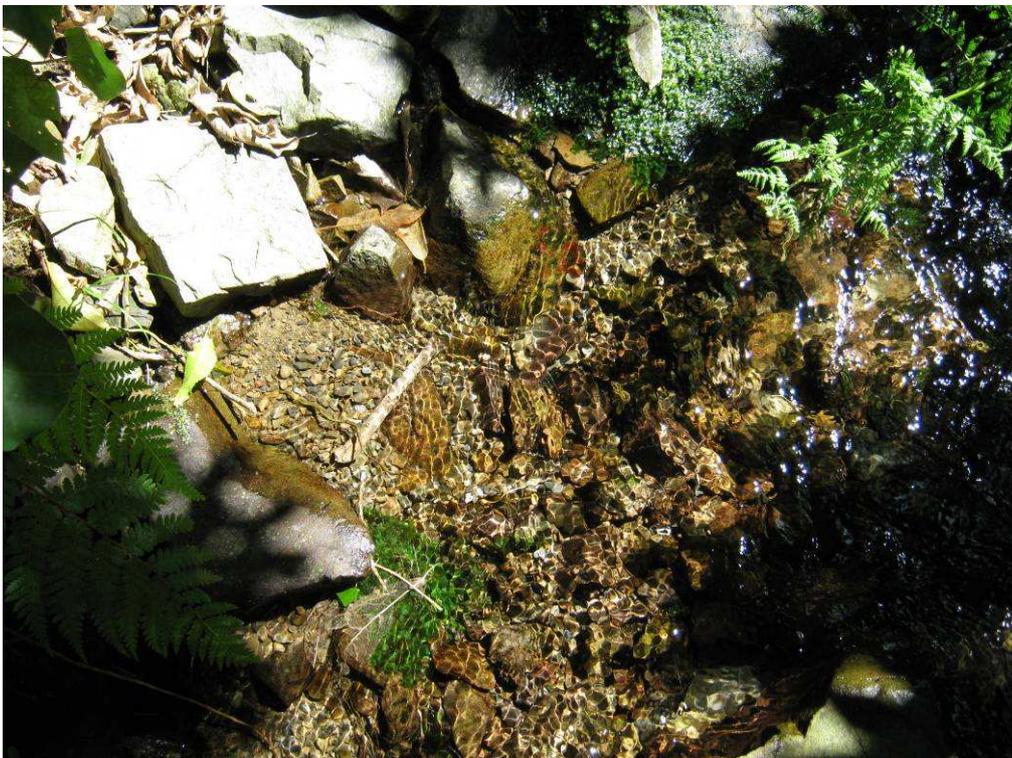
Photograph 8. Clarity of water and substrate in C&D Lanfill Tributary, 28 January 2011.

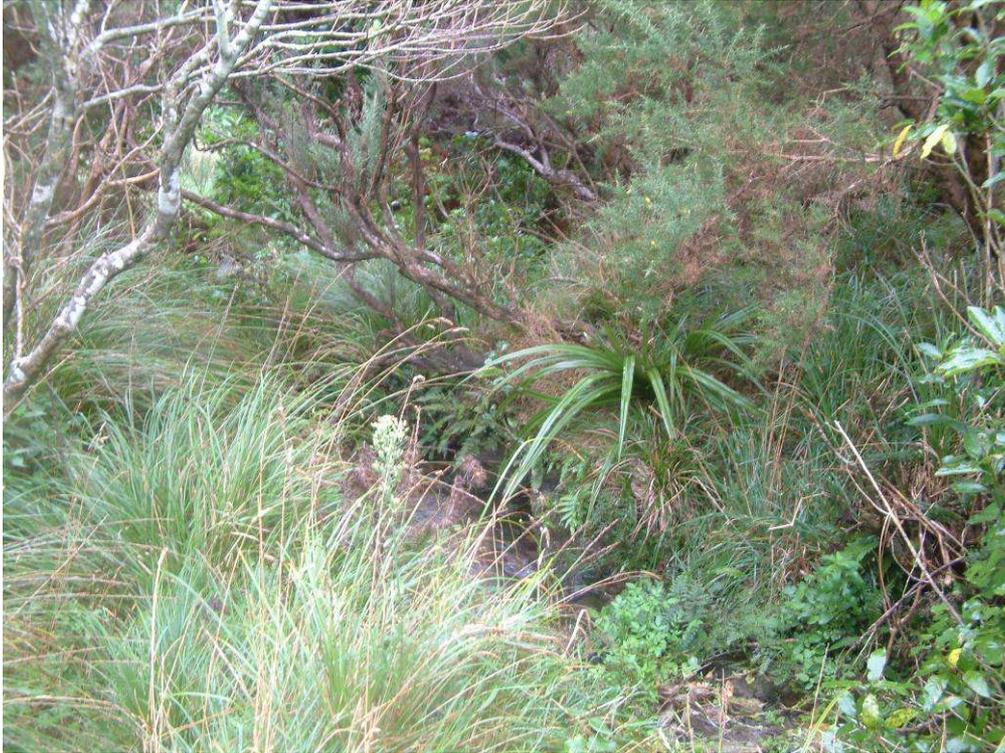
Photograph 9. Riparian margin of C&D Landfill Tributary, in small clearing, 28 January 2011.

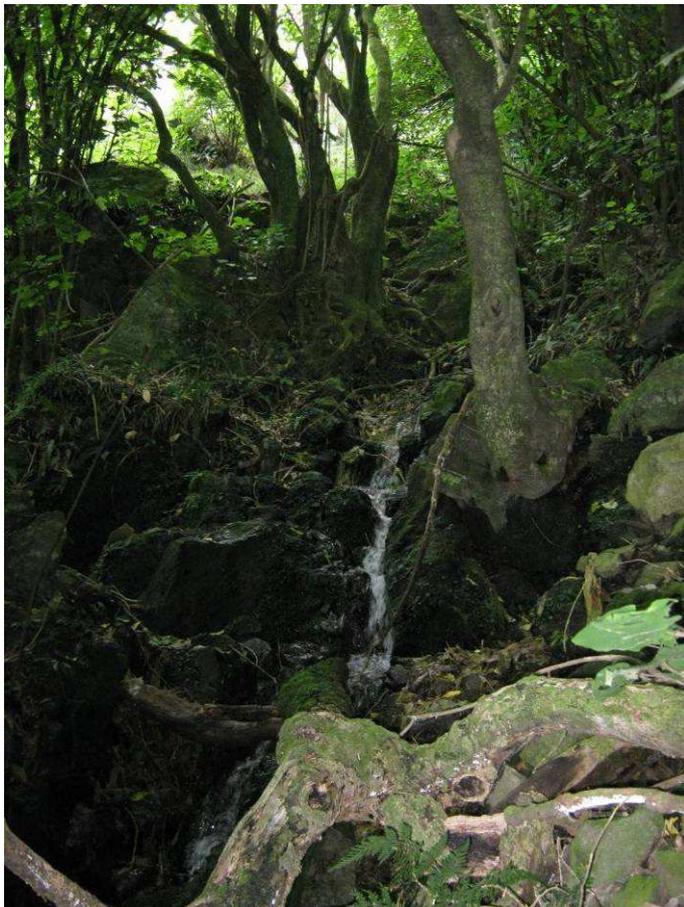
One of the smaller tributaries was investigated and was also still found to have good flows (Photograph 10). The Photograph was taken about 60 m upstream from the confluence with the C&D Landfill Tributary at an altitude of *c.*195 m a.s.l. (60 m higher in altitude than the debris cage).

Photograph 10. One of the small tributaries feeding into the C&D Landfill Tributary, 28 January 2011.

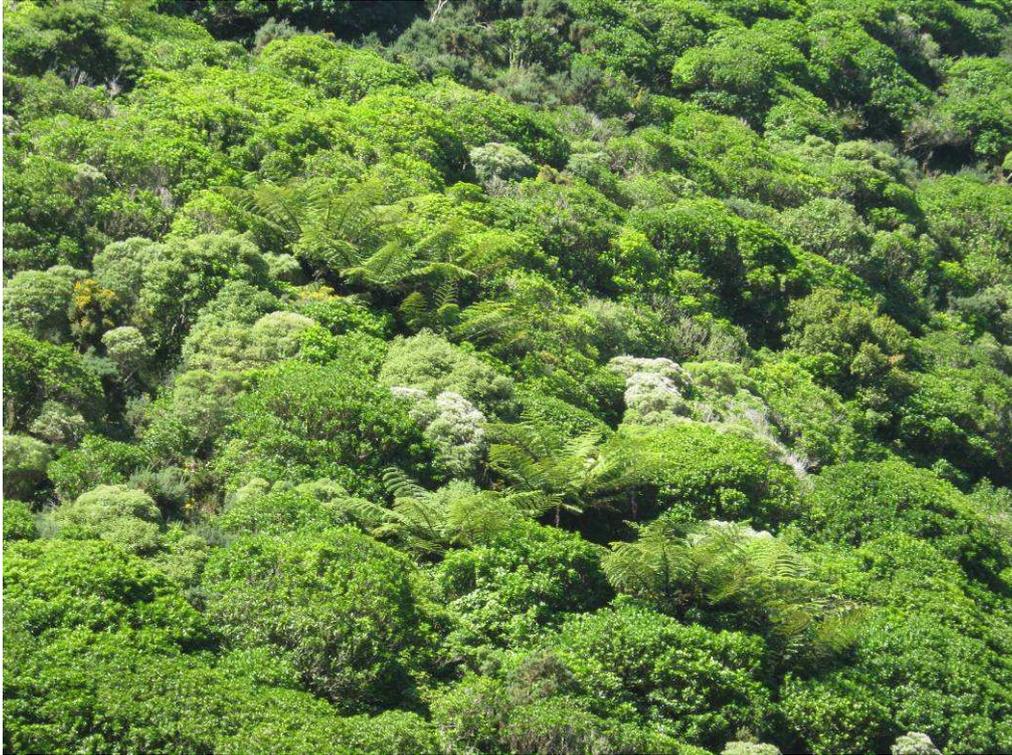
Mahoe trees up to 10-20 m with trunks up to 10-20 cm diameter at breast height (dbh) comprise more than 50% of the canopy with kawakawa in lesser amounts (Photograph 11). The height of the canopy decreases upslope and in exposed areas, but trunk diameter stays within the same size range. Other key canopy species include tree hebe, manuka and mamaku (tree fern). The height of the canopy decreases with increasing altitude and increased exposure to seawinds. The understorey is variable depending on canopy density and shading, slope steepness and the amount of loose scree. In places there is a good understorey comprising species such as rangiora, pate, (*Schefflera digitata*) putaputaweta (*Carpodetus serratus*), karamu (*Coprosma robusta*), kanono (*Coprosma grandifolia*), hangehange (*Geniostoma rupestre* var. *ligustrifolium*), koromiko (*Hebe stricta* var. *atkinsonii*) and occasional mingimingi (*Leucopogon fasciculatus*). There is quite a diverse fern flora, although filmy ferns were notable by their absence. Vine species were generally scarce, but include clematis (*Clematis forsteri*), climbing rata (*Metrosideros diffusa*), pohuehue (*Muehlenbeckia australis* and *Muehlenbeckia complexa*) and bush lawyer (*Rubus cissoides*).

Photograph 11. Mahoe (*Melicytus ramiflorus*) - kawakawa (*Macropiper excelsum*) - manuka (*Leptospermum scoparium*) - tree hebe (*Hebe parviflora*, flowering) - and mamaku (*Cyathea medullaris*) forest canopy (Vegetation Type 2), 28 January 2011.

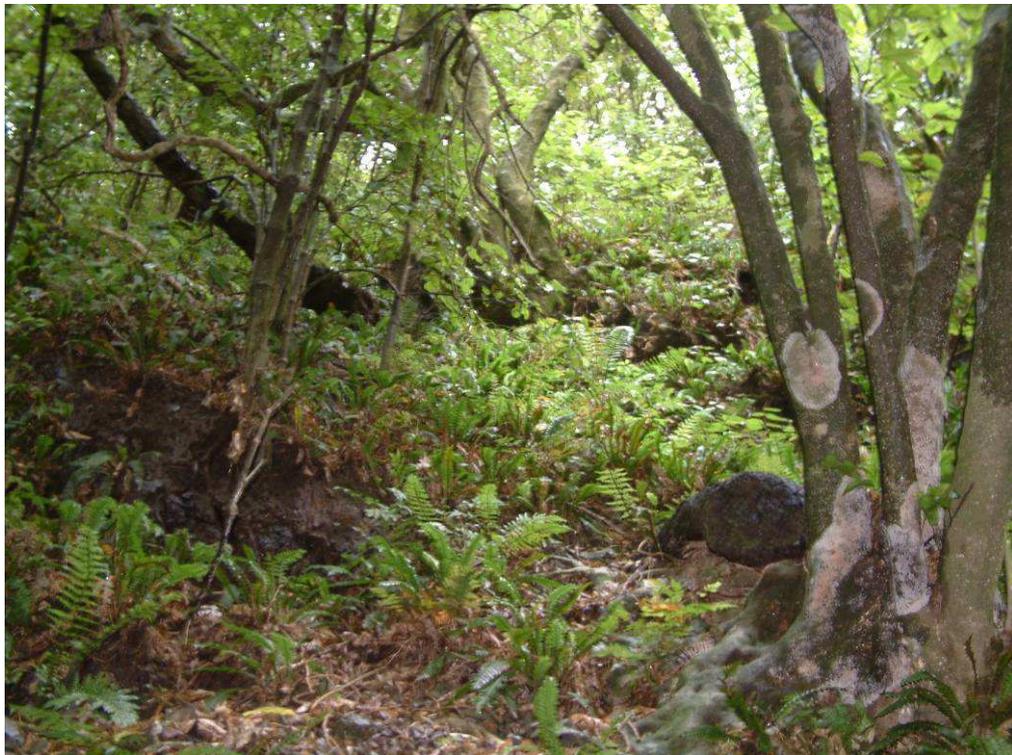
Photograph 12. Fern and shrub understory along C&D Landfill Tributary beneath Mahoe (*Melicytus ramiflorus*) / kawakawa (*Macropiper excelsum*) forest (Vegetation Type 3), 28 January 2011.

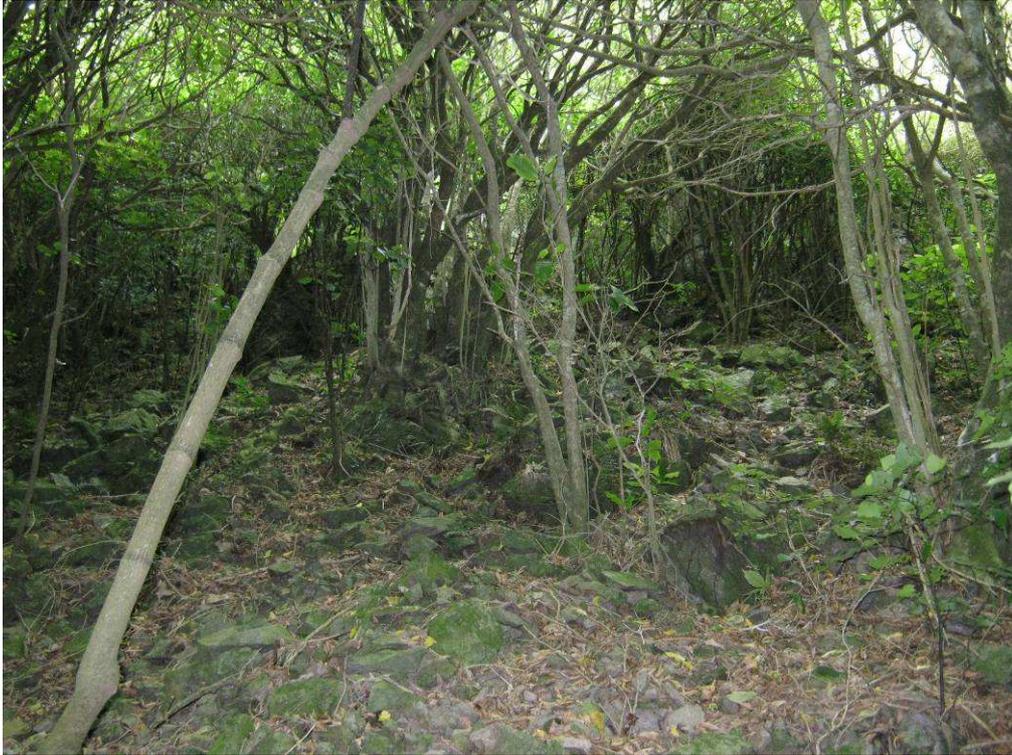
Photograph 13. Sparse understorey and scree on steep slopes beneath Mahoe (*Melicytus ramiflorus*) / kawakawa (*Macropiper excelsum*) forest (Vegetation Type 3, 28 January 2011).
