ASSESSMENT OF ECOLOGICAL
EFFECTS FOR A
PROPOSED EXPANSION OF
C & D LANDFILL, HAPPY VALLEY,
WELLINGTON

JANUARY 2012

Contract Report No. 2438b

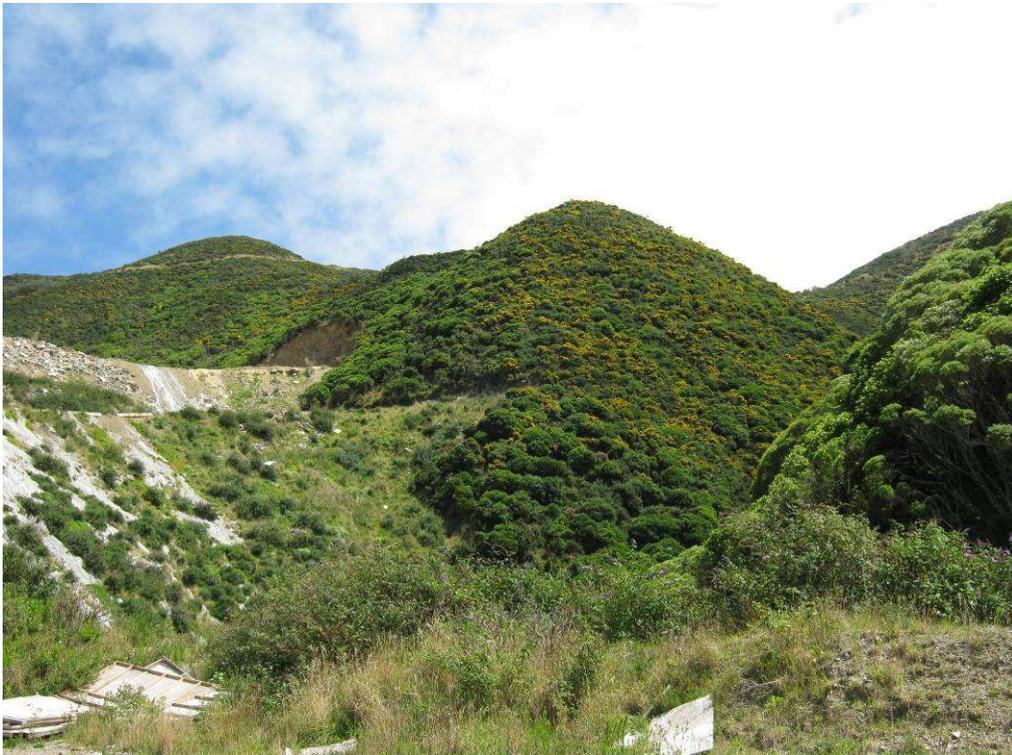
A mosaic of regenerating indigenous shrub species and gorse (Photographs 14 and 15). Canopy density varies from nearly closed to about 20% closed. The density of indigenous scrub versus gorse varies spatially with indigenous species often more dominant in less exposed places. Mahoe is the most common indigenous with lesser amounts of tauhinu (*Ozothamnus leptophyllus*), pate, and tree hebe. Pasture grassland species and *Leptinella squalida* can be found where the canopy is more open and in small clearings.

Photograph 14. Indigenous scrub – gorse (*Ulex europaeus*) scrub/ pasture grassland on left flank (Vegetation Type 4) and gorse (*Ulex europaeus*) / pasture grassland on the right flank (Vegetation Type 5, 28 January 2011).

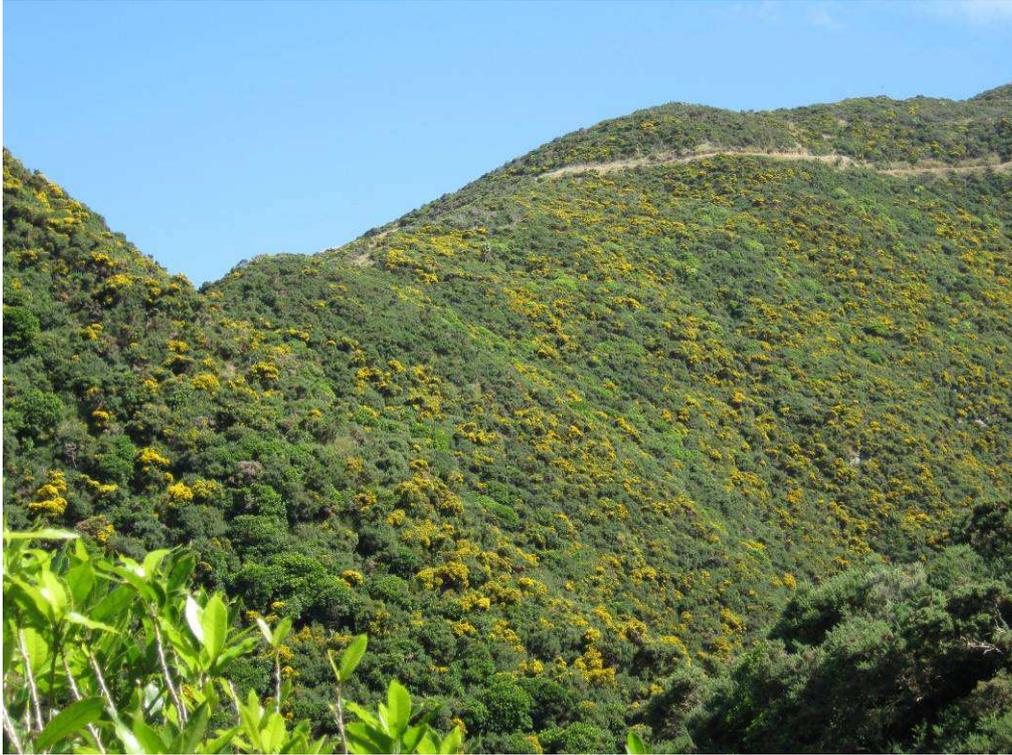
Photograph 15. Areas of Indigenous scrub – gorse (*Ulex europaeus*) scrub/ pasture grassland (Vegetation Type 4) mixed in with areas of gorse (*Ulex europaeus*) / pasture grassland (Vegetation Type 5, 28 January 2011).

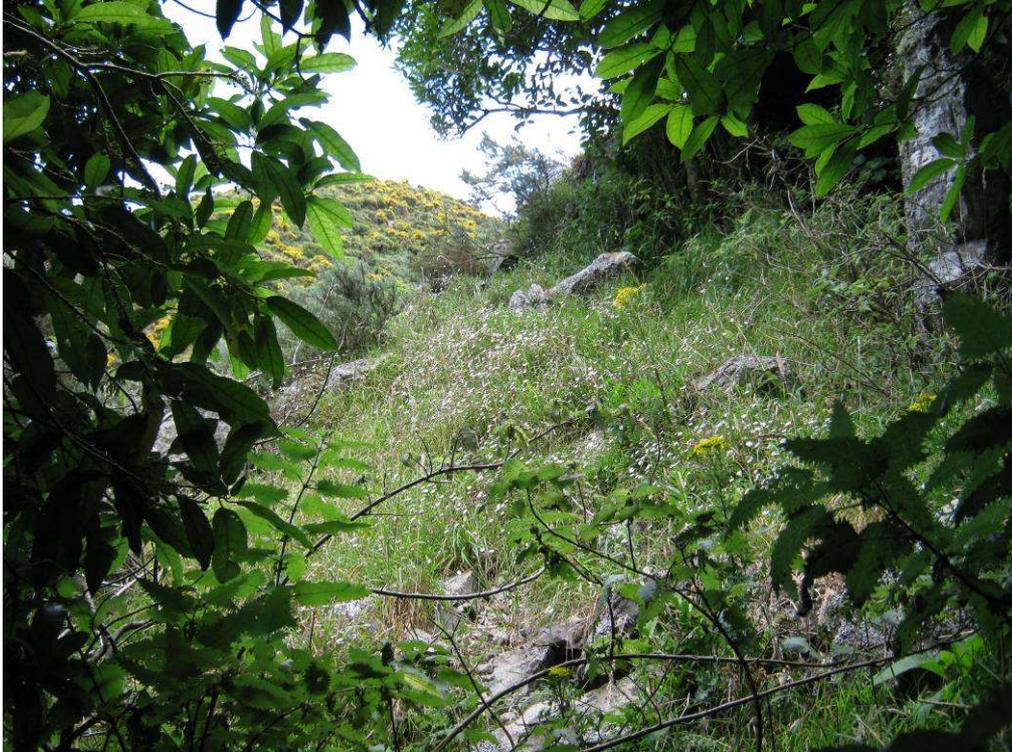
Rough grassland dominated by browntop (*Agrostis capillaries*) and in places by sweet vernal (*Anthoxanthum odoratum*), but mixed with a range of other introduced grass species such as creeping fog (*Holcus mollis*), Kentucky bluegrass (*Poa pratensis*), perennial rye grass (*Lolium perenne*), Cocksfoot (*Dactylis glomerata*), and occasional indigenous grass species such as *Microlaena polynoda*. A range of other species are generally dotted around the clearing including hangehange, tauhinu, pohuehue, and a range of fern species. Ongaonga and clematis could at times be conspicuous along the margins. Lower altitude sites can be infested by Mexican daisy (*Erigeron karvinskianus*) (Photograph 16), and ragwort (*Senecio jacobaea*) is occasional throughout.

Photograph 16. Small clearing halfway up the hill, ongaonga (*Urtica ferox*) in the foreground, Mexican daisy in amongst the pasture grasses (Vegetation Type 6, 28 January 2011).

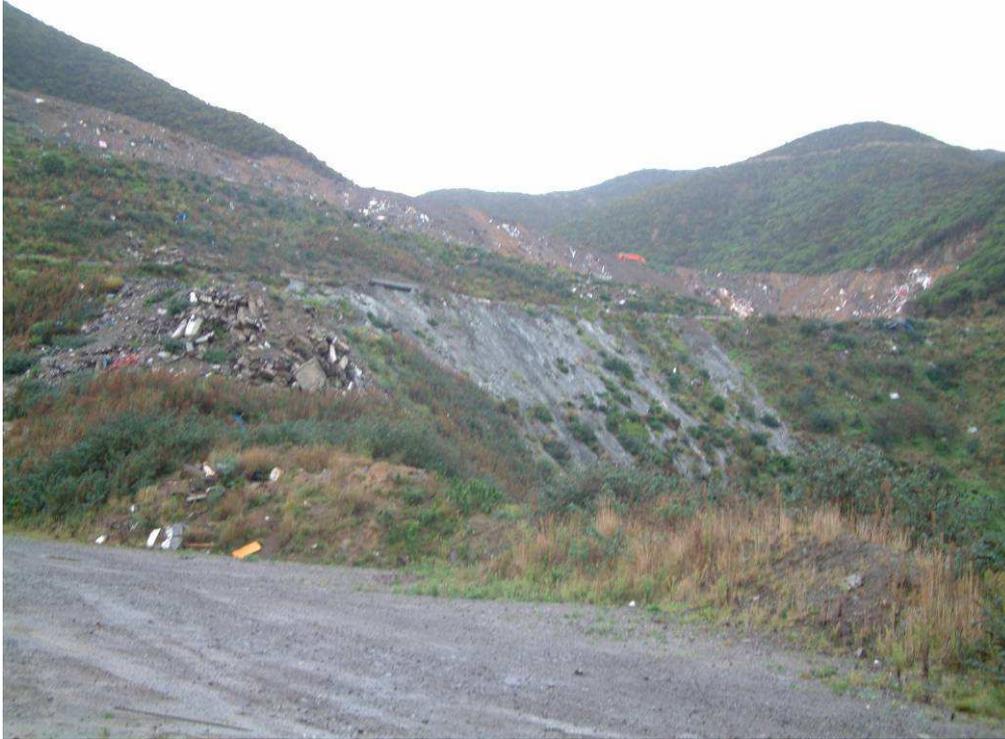
Photograph 17. View of active faces at the landfill site from below (24 May 2010).

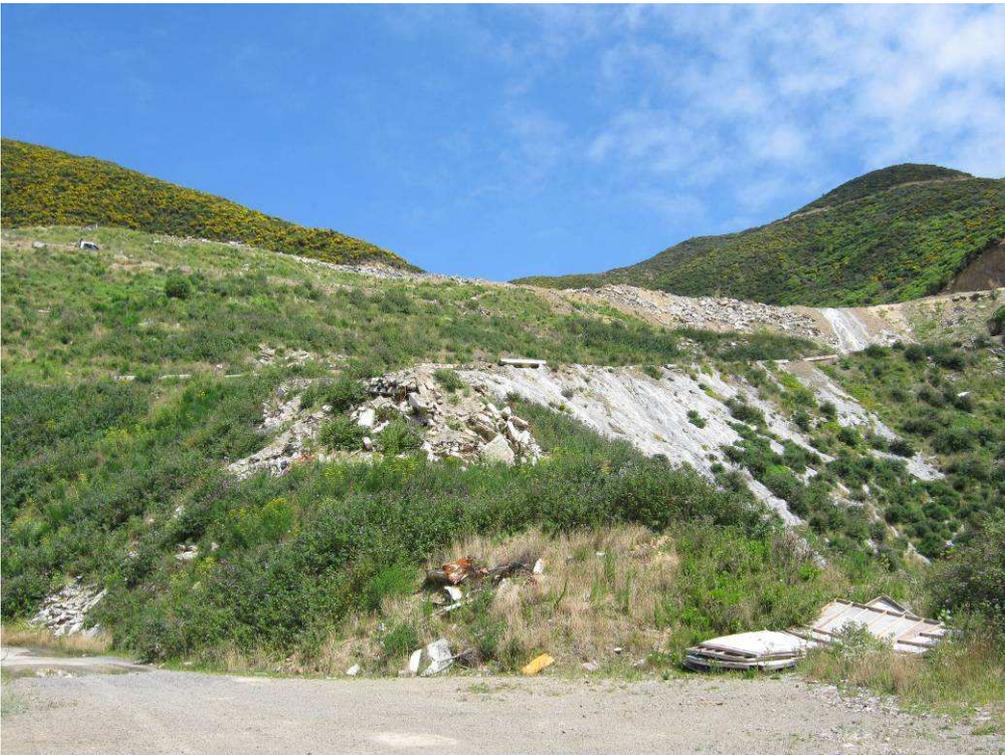
Photograph 18. Same view of landfill site from below (28 January 2011).
