GEOTECHNICAL ASSESSMENT

KSS Properties Ltd
57-59 Kingsford Smith Street
Preliminary Geotechnical Assessment

16 May 2017

Our ref: 773-WLGGE203610AA

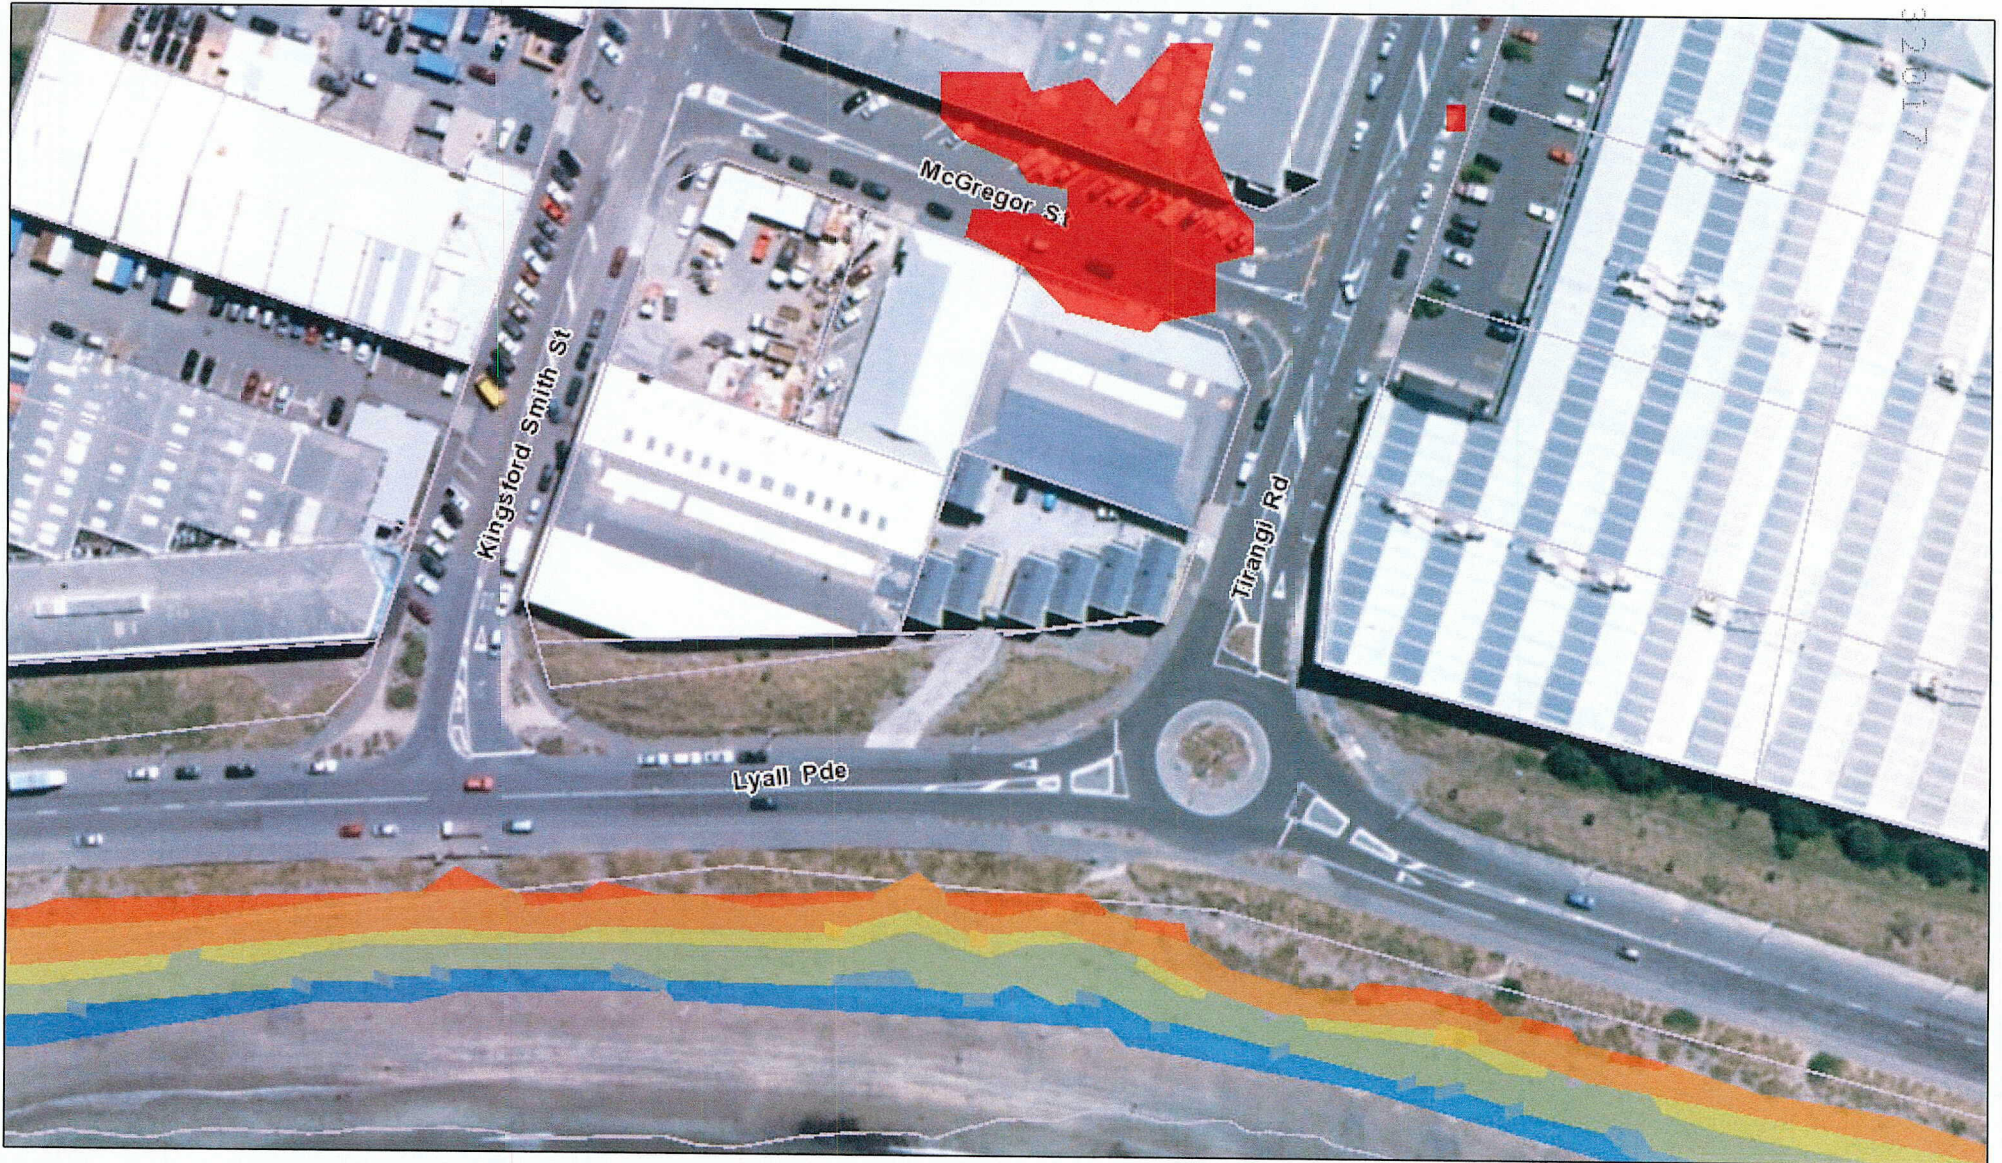
Figure 2 – Coastal Elevation

Coastal Elevation in the Wellington Region - Coastal Elevation

The site lies over 3.0m above the Mean High Water Springs-10 (MHWS10) (refer Figure 2 Appendix A.) This is the mean high water spring tide exceeded 10 percent of the time. The level provides a reference point for infrastructure design works, and also for estimating extreme high (e.g. the 100-

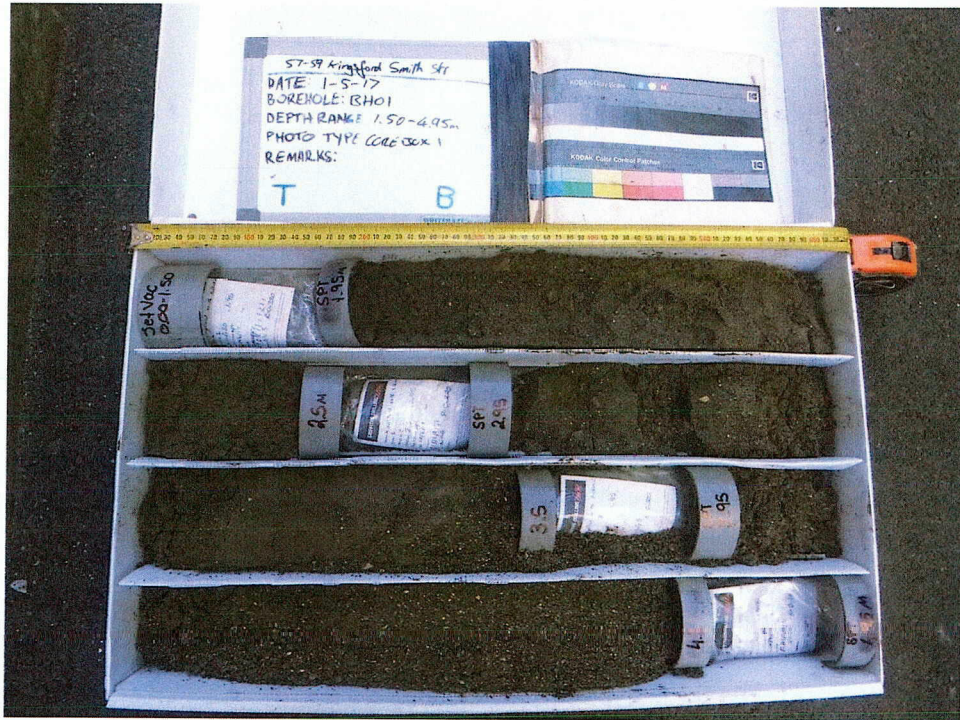
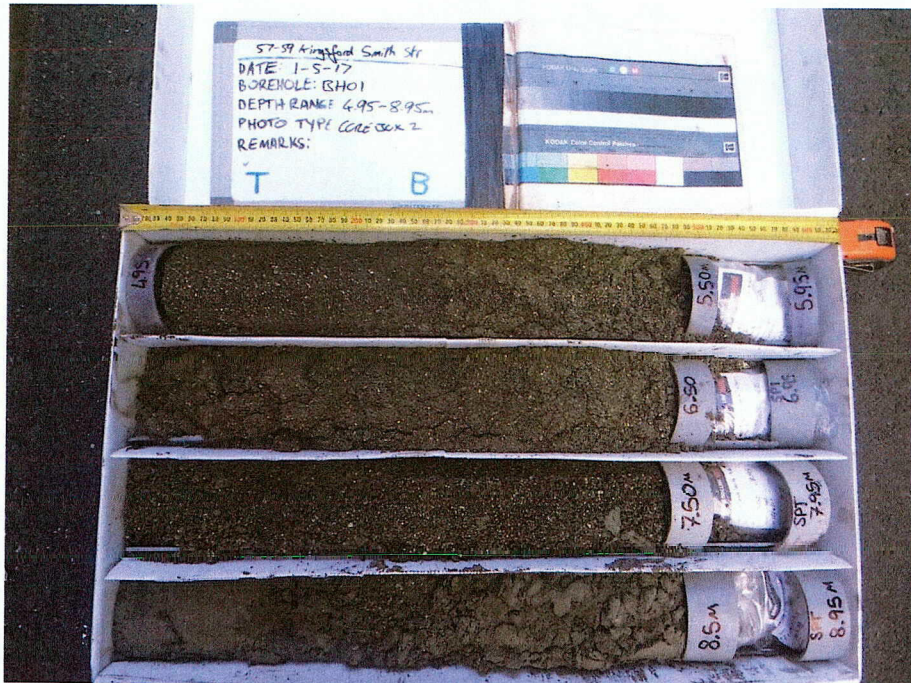
A TETRA TECH COMPANY	client:	KSS Properties Ltd			
approved	KWH		project:	57-59 Kingsford Smith Street Lyal Bay, Wellington			
date	5/05/2017		title:	CORE PHOTOGRAPH BH01			
scale	N.T.S.		project no.	773-WLGG203610	fig no:	PLATE 1	rev: A
original size	A4

BH01 1.50 - 4.95 m - Core Box #1

BH01 4.95 - 8.95 m - Core Box #2

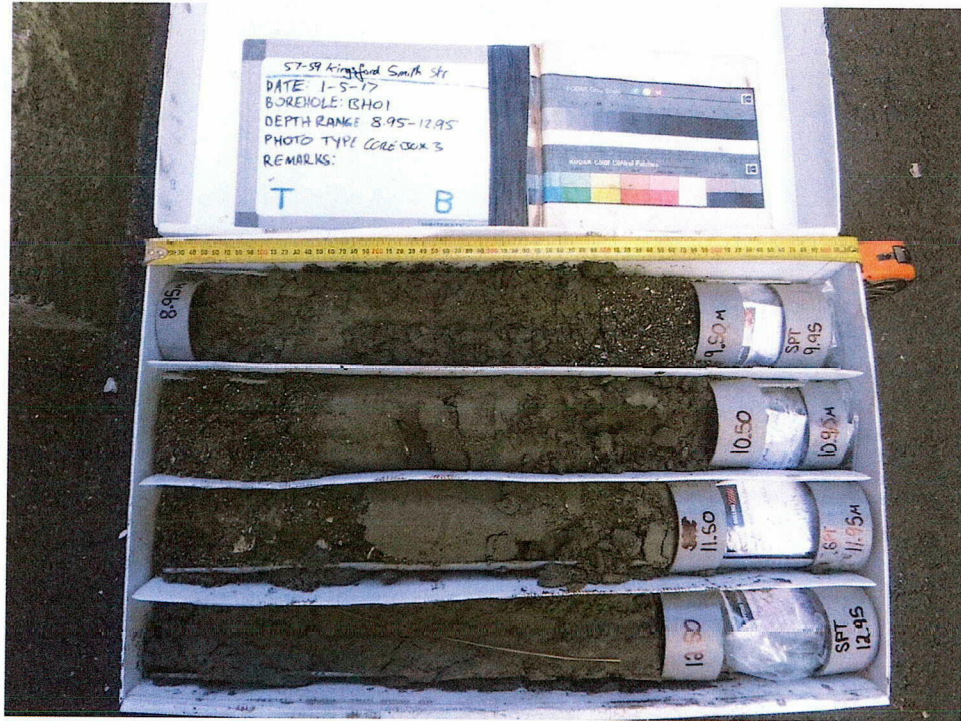
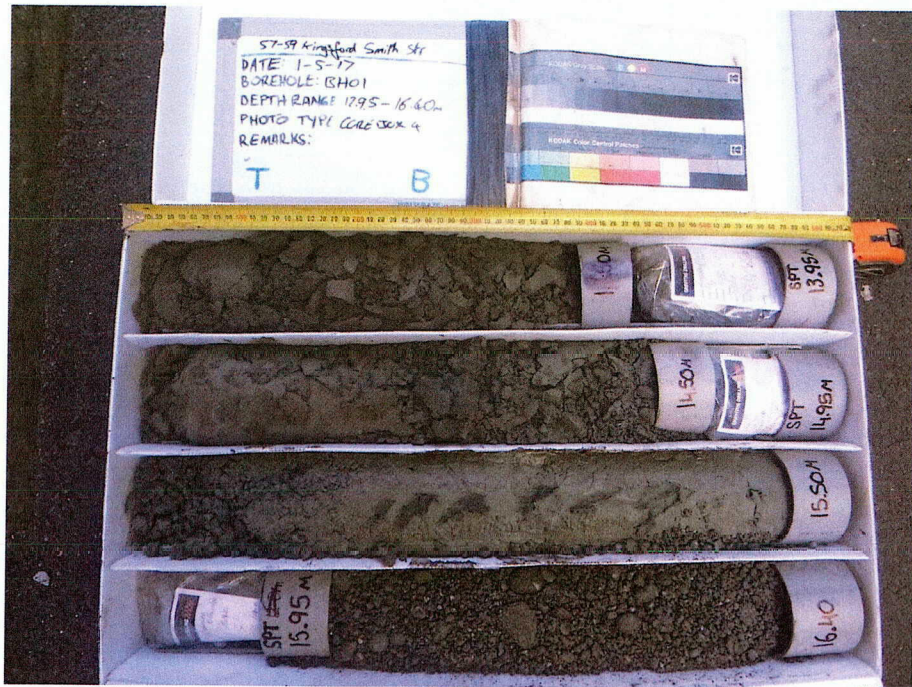
A TETRA TECH COMPANY	client:	KSS Properties Ltd		
approved	KWH		project:	57-59 Kingsford Smith Street Lyllal Bay, Wellington		
date	5/05/2017		title:	CORE PHOTOGRAPH BH01		
scale	N.T.S.		project no:	773-WLGG203610	fig no:	PLATE 2
original size	A4				rev:	A

BH01 8.95 - 12.95 m - Core Box #3

BH01 12.95 - 16.40 m - Core Box #4

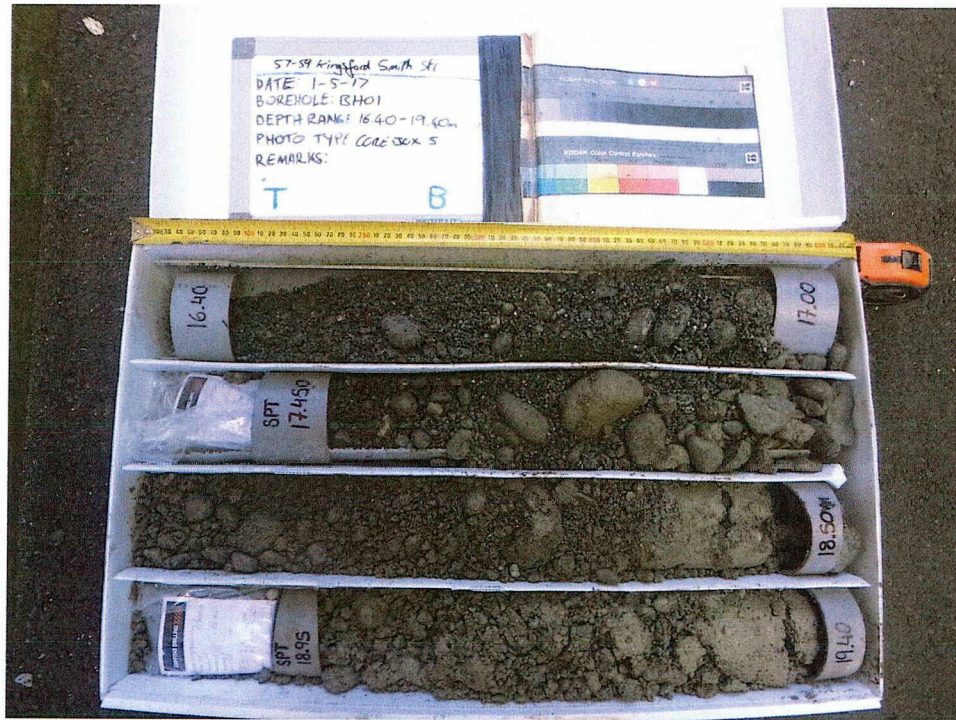
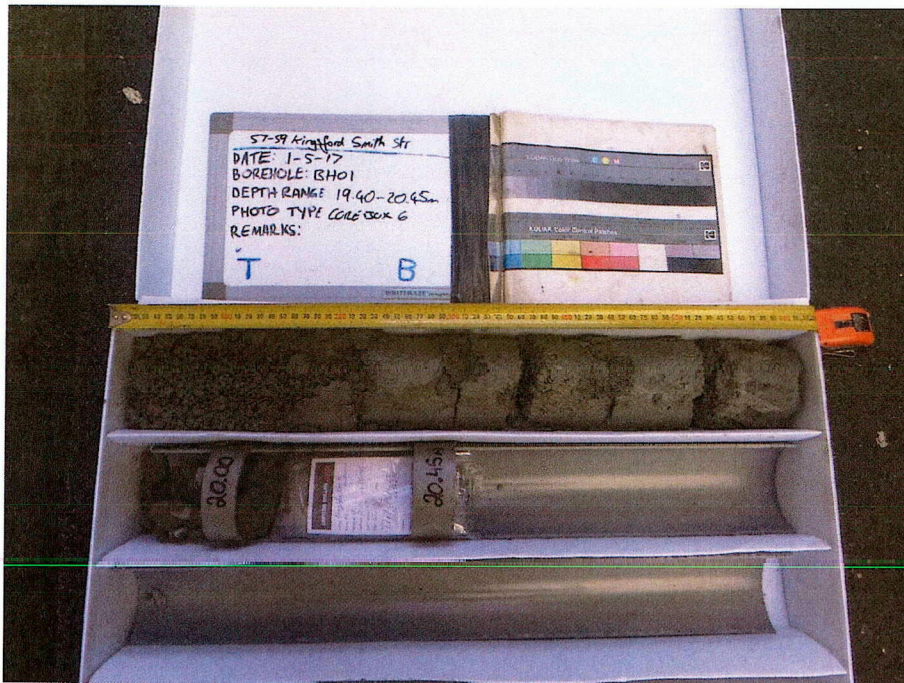
BH01 16.40 - 19.40 m - Core Box #5

BH01 19.40 - 20.45 m - Core Box #6

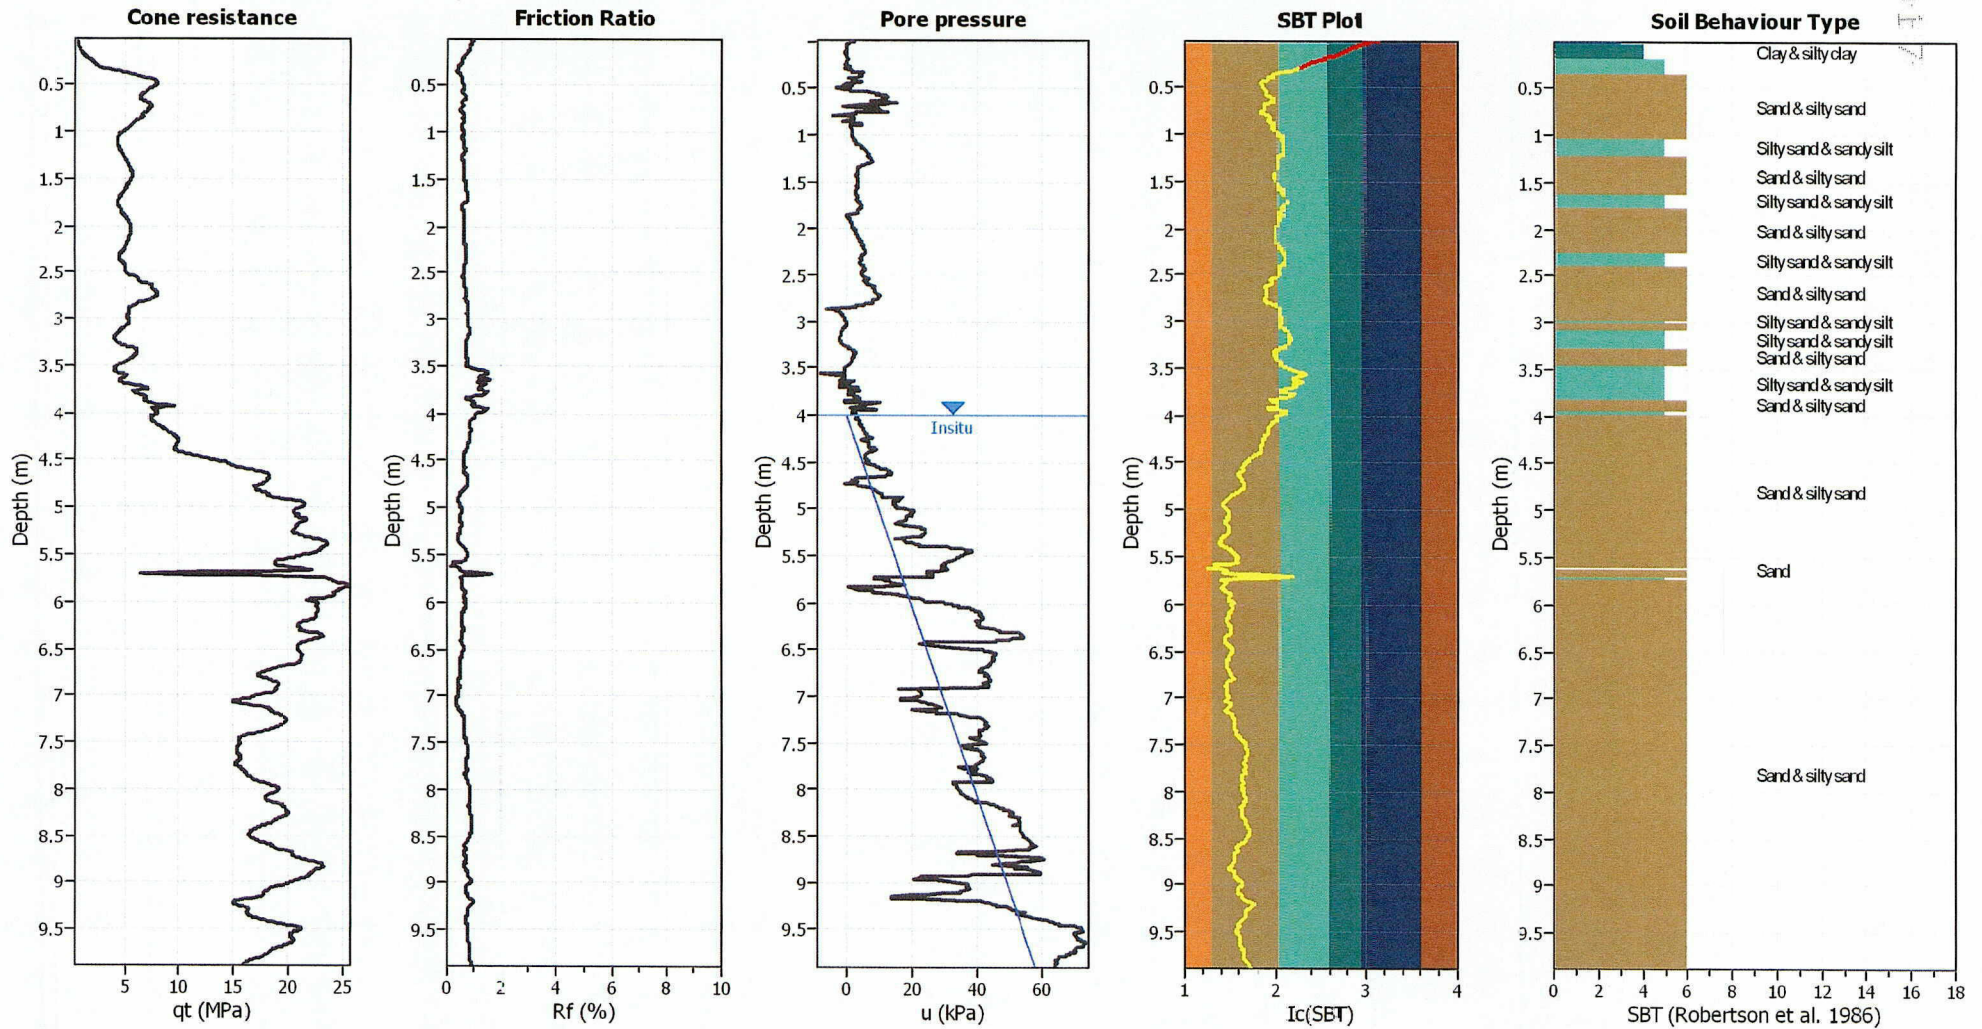
CPT basic interpretation plots

Analysis method:	B&I (2014)	Depth to GWT (erthq.):	4.00 m	Fill weight:	N/A
Fines correction method:	B&I (2014)	Average results interval:	3	Transition detect. applied:	Yes
Points to test:	Based on Ic value	Ic cut-off value:	2.60	K_{σ} applied:	Yes
Earthquake magnitude M_w :	7.10	Uric weight calculation:	Based on SBT	Clay like behavior applied:	Sand & Clay
Peak ground acceleration:	0.35	Use fill:	No	Limit depth applied:	No
Depth to water table (Insitu):	4.00 m	Fill height:	N/A	Limit depth:	N/A
