Landscape Design Statement

For Resource Consent
Issue: D

Southern Cross Hospital
Wellington
Prepared by Local Landscape Architecture Collective
April 2018

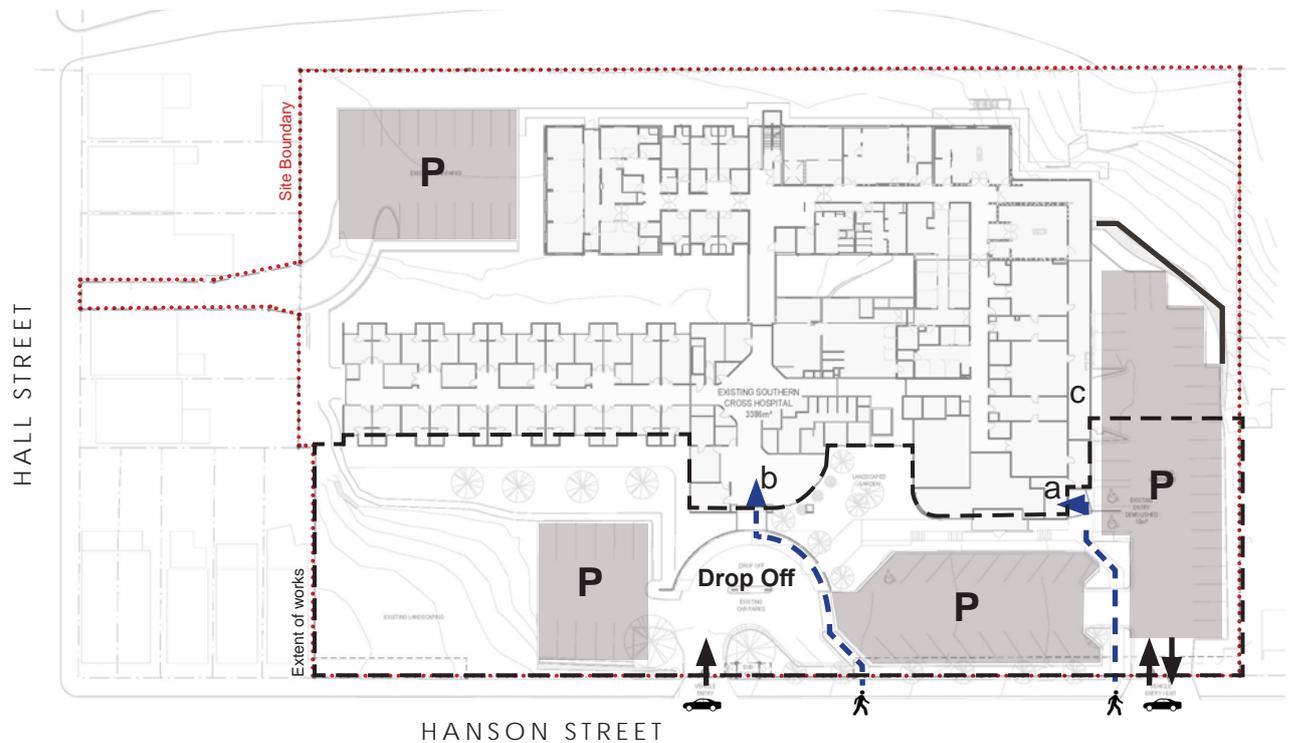
Fig.1 showing existing access and parking

The site (Lot 1 DP 75743) is approximately 1 hectare in area and comprises of the existing Hospital and associated, access and parking and vegetation/gardens. The site is primarily accessed from Hason Street however there is controlled access to some parking from Hall street. The site is terraced into the surrounding topography resulting in a large crib retaining wall at the back of the site. Two pedestrian paths link the Specialist Entrance (fig.1 b) and Main Hospital Entrance (fig.1 a) to Hanson Street. A further service entrance is accessed from Hanson Street (fig.1 c).

The extent of works for this consent application is the zone associated with the proposed new consultation building, highlighted on figure 1.

A large proportion (approximately $\frac{3}{4}$) of the frontage along Hanson Street is dominated by parking and vehicle movements.

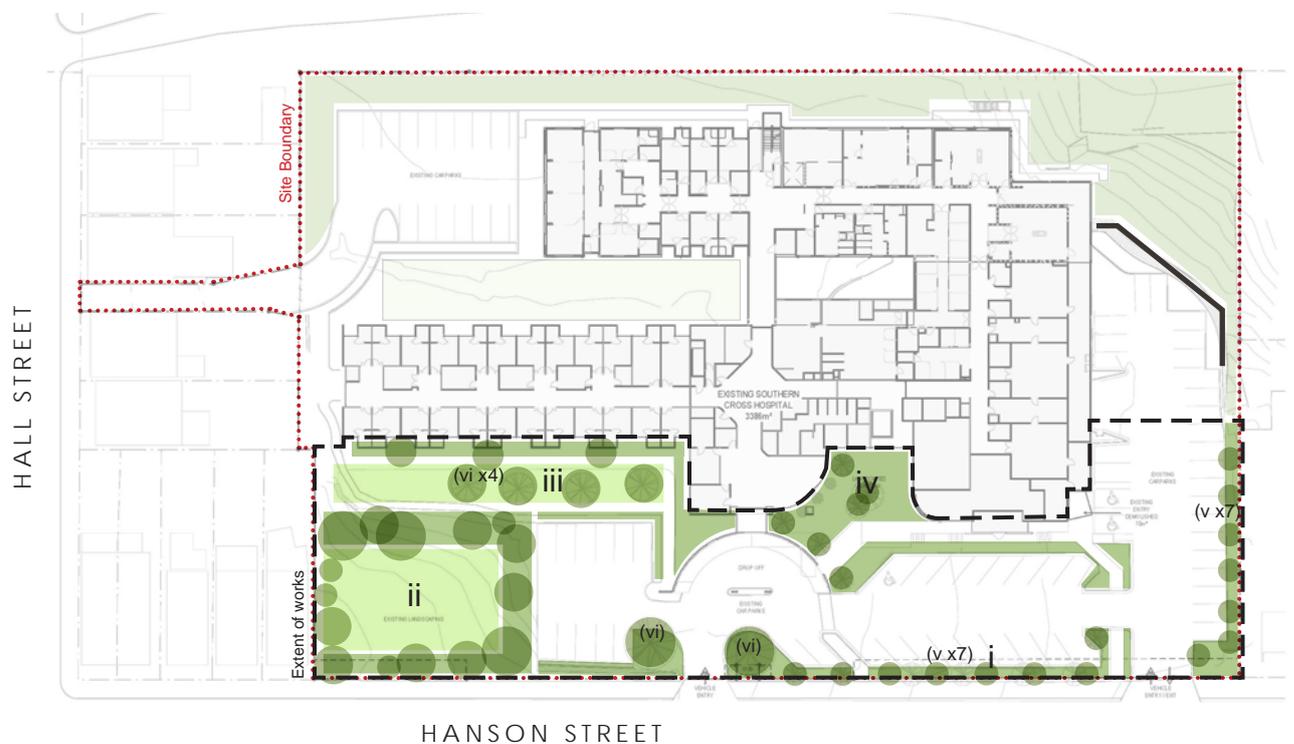
Fig.2 showing existing gardens / vegetation

The existing parking was developed simultaneously with the main building and has a narrow strip of planting along Hanson Street (fig.2 i) and a number of small garden beds that help to soften the car park and views from the street.

An area of lawn (fig.2 ii) to the southern end of the site is accessible from Hanson Street, this is disconnected from the wider site separated by a steep bank / retaining wall. Due to extent of planting in this zone there is little natural surveillance of the area resulting in potential CPTED issues.

A more formal area of lawn and planting (fig.2 iii) is contained by the surrounding topography and visually connected to the hospital. This extends along the front of the hospital with a planted bank (fig.2 iv) providing some visual amenity to those waiting in reception.

Notable vegetation on site includes 14 medium sized *Podocarpus totara Aurea* (Golden totara) located along the Hanson Street frontage (fig.2 v) and adjacent to the northern boundary of the site. The lawn area (fig.2 ii) is surrounded by a mix of *Metrosideros excelsa* (Pohutukawa) and *Coprosma repens*.

The remaining vegetation on site is generally native with the exception of a number of Phoenix palms (vi).

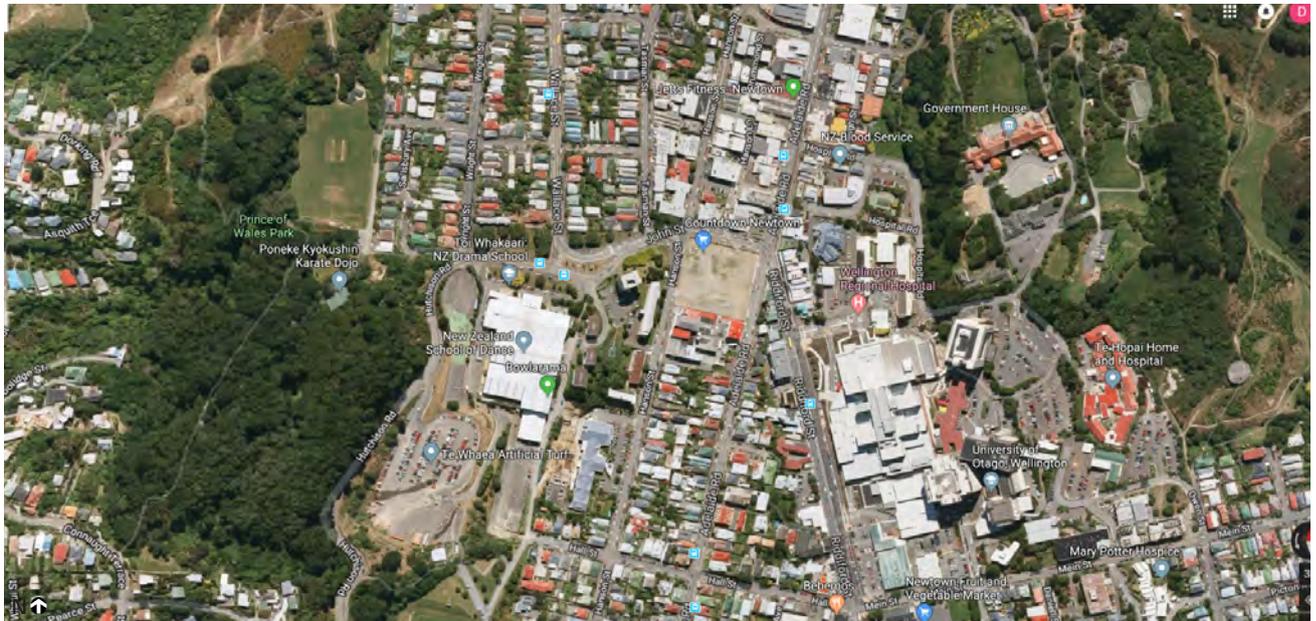
Fig.3 Neighbourhood context

The Southern Cross Hospital sits on Hanson Street approximately 250m from the junction with John Street. This section of street is predominantly defined by a larger scale commercial (countdown supermarket) and industrial building (the former tip top bread factory) on the west side of the street and apartment buildings on the east. This more intensely developed stretch of street gives way to mix of single level residential villas that are located opposite the hospital and further south up the street. Vegetation along the street is generally located within the gardens of private property and as such is located in ad-hoc clusters and comprises of a mix of native and exotic species.

The existing vegetation along the Hanson Street frontage of the site provides one of the more noteworthy zones of planting along the street. When viewed from a distance, the totara's have a positive impact on the street, however closer views of the site are generally dominated by substantial areas of a parking and hard standing.

The cluster of Pohutukawas and Coprosmas to the south of the site provides a good buffer between the hospital and adjacent residential properties and character.
