Preliminary Environmental Site Investigation

90 Hanson Street

Newtown

25.06.2018

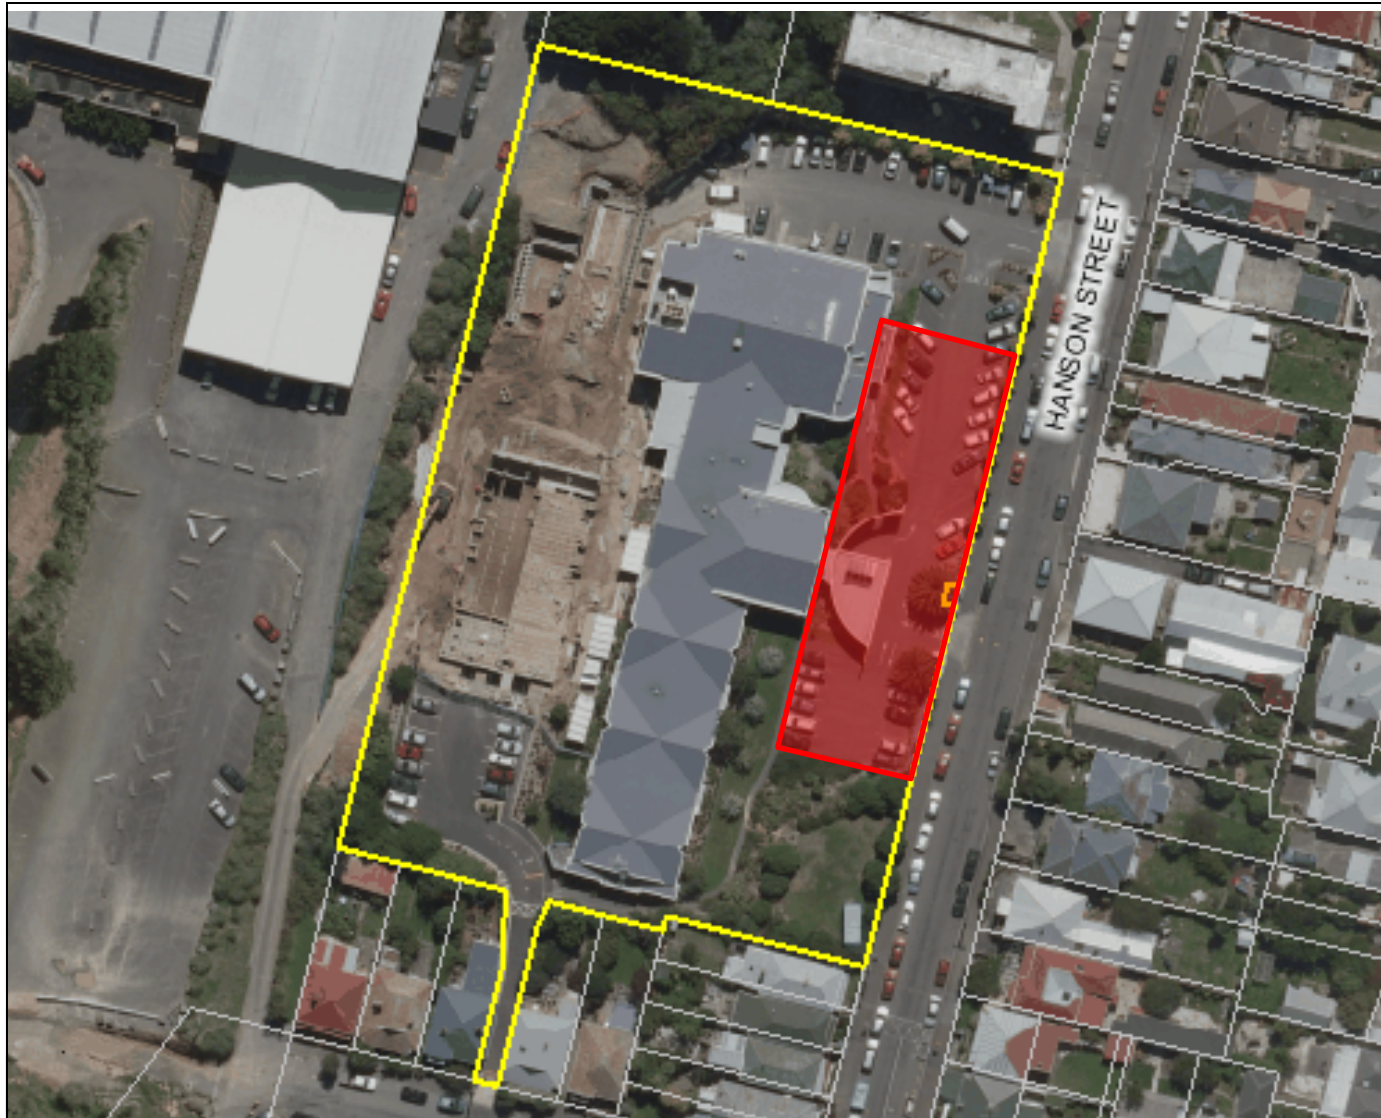
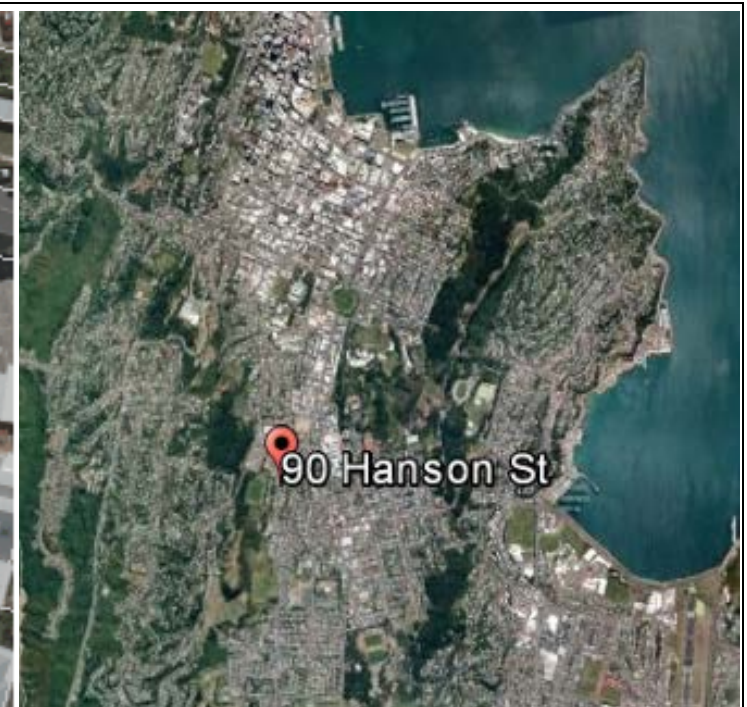
Date	June 2018	Client	Southern Cross Hospitals Ltd
Drawn by	BS	Project	Southern Cross – 90 Hanson Street
Approved by	KJ	Description	Vicinity Map and Site Plan
Scale (approx.)	NTS	ENGEO Ref.	15101.000.000

This PSI is limited to the development area shown on Figure 1 (i.e. the east of the hospital building on 90 Hanson Street).

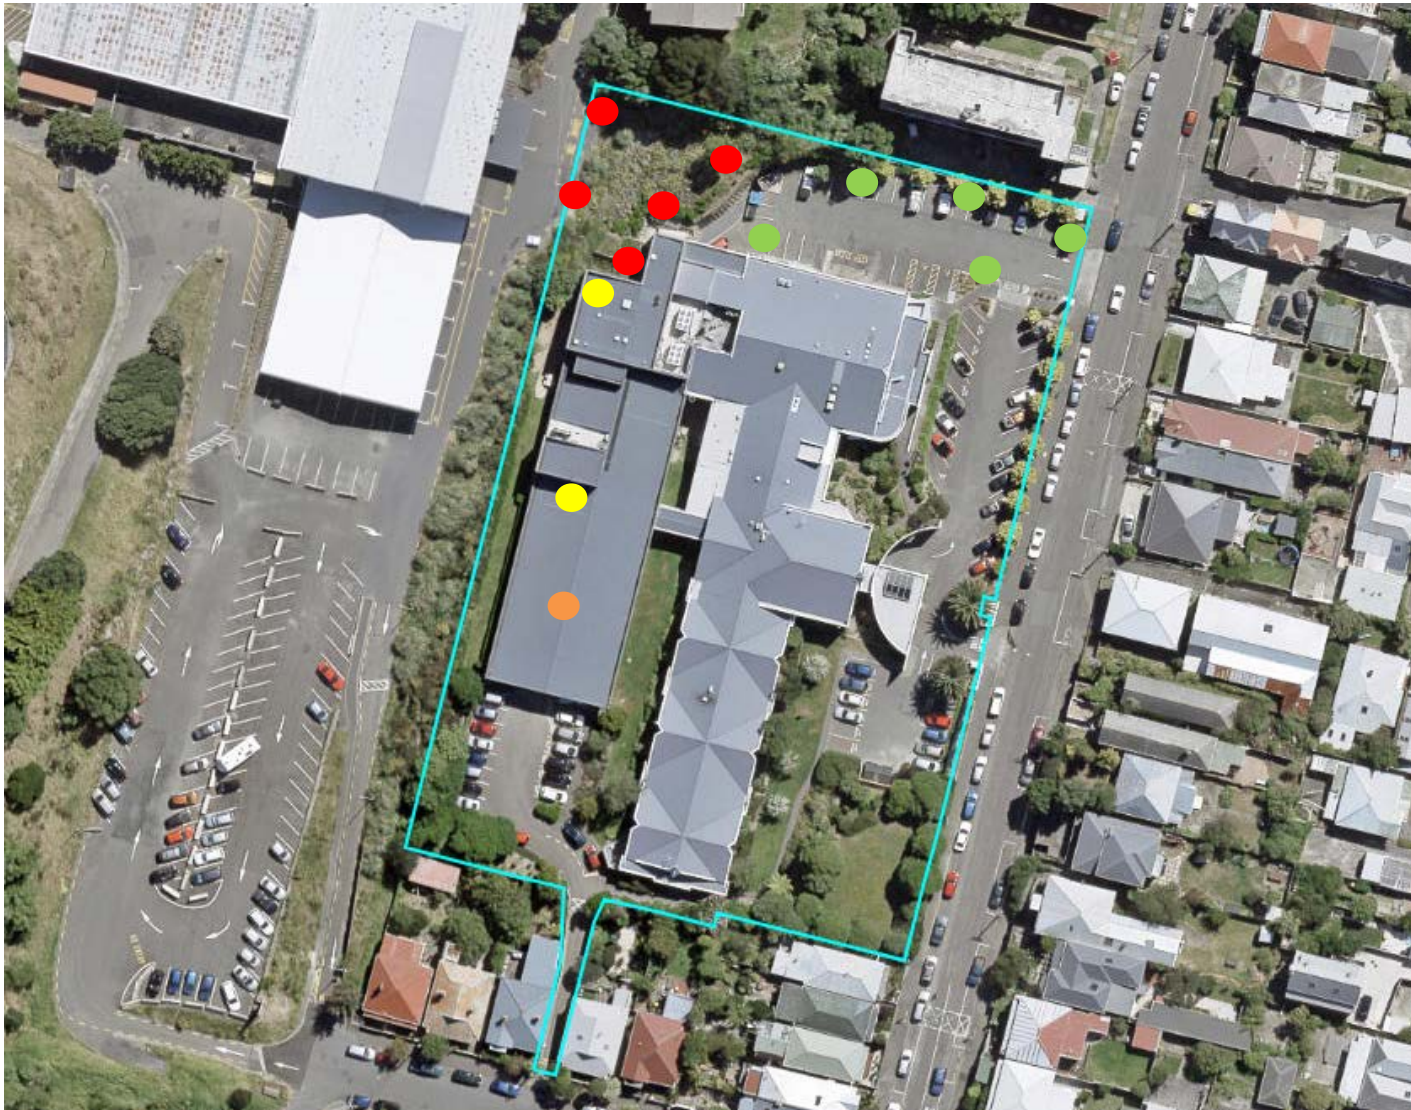
Date	June 2018	Client	Southern Cross Hospitals Ltd
Drawn by	BS	Project	Southern Cross – 90 Hanson Street
Approved by	KJ	Description	Site Plan with Previous Sampling Locations
Scale (approx.)	NTS	ENGEEO Ref.	15101.000.000

One soil sample was obtained from the western portion of the site (see Figure 2) and analysed for heavy metals and polyaromatic hydrocarbons (PAHs). Metal concentrations were below guidelines for commercial land use and excavation worker protection. All of the metal concentrations exceeded background levels for typical Wellington soils. Concentrations of lead and zinc exceeded landfill acceptance criteria. PAHs were present in low concentrations and were below the guideline for commercial land use. The presence of PAHs indicated the soil exceeded normal background levels for typical Wellington soils and therefore soil could not be regarded as cleanfill. Construction debris was noted at shallow depths in test pits performed for the geotechnical investigation.

The soil contamination investigation consisted of the collection of seventeen discrete samples from depths between the ground surface and 1.5 m below ground surface (bgs) in the area of the existing car park area as shown in Figure 2. The following findings were observed during the geotechnical intrusive investigation. Fill was observed across the site from ground surface to between 0.4 m and 3.0 m; Alluvium / colluvium / residual soil, comprising predominantly sand and gravel was observed between 2 m to 3 m and 6 m to 7 m; and Greywacke rock was observed from 0.4 m to 7 m to the end of boreholes for a total thickness of at least 5.15 m.

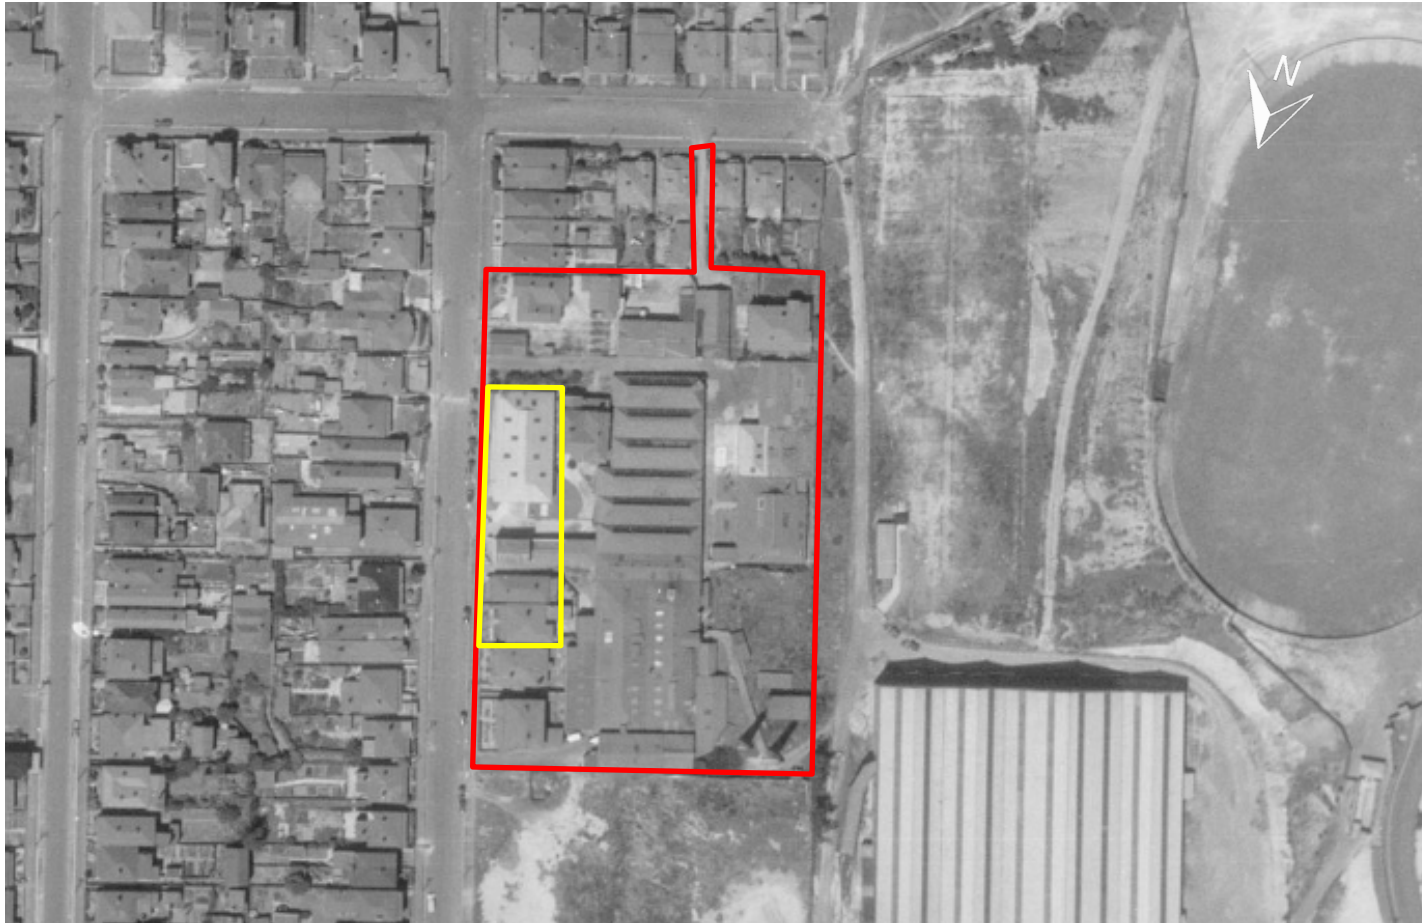
Date	June 18	Client	Southern Cross Hospitals Ltd
Drawn by	BS	Project	Southern Cross
Approved by	KJ	Description	Aerial Photograph - 1939
Scale (approx.)	Not to scale	ENGEO Ref.	15101.000.000

Date	Description – wider site	Description – development site
1939 and 1941 Retrolens	The site is predominantly used for commercial development. Numerous buildings are shown on the property. Surrounding parcels to the east appear to be primarily used for residential development. The western adjacent parcels appear to be vacant and used for commercial purposes. A large warehouse is shown to the west. Residential land is shown to the south and vacant land to the north.	The development site includes one large commercial / industrial building, to the south, and three smaller residential buildings located on the northern portion of the site.
1945, 1954, and 1959 Retrolens	The property appears to have similar uses to the previous photographs. A few additional buildings are now visible on the northern adjacent parcel. The area to the west has become developed for commercial parking.	The development site still includes the larger commercial / industrial building on the southern end of the site. Two of the houses on the northern portion of the site appear to have been redeveloped.

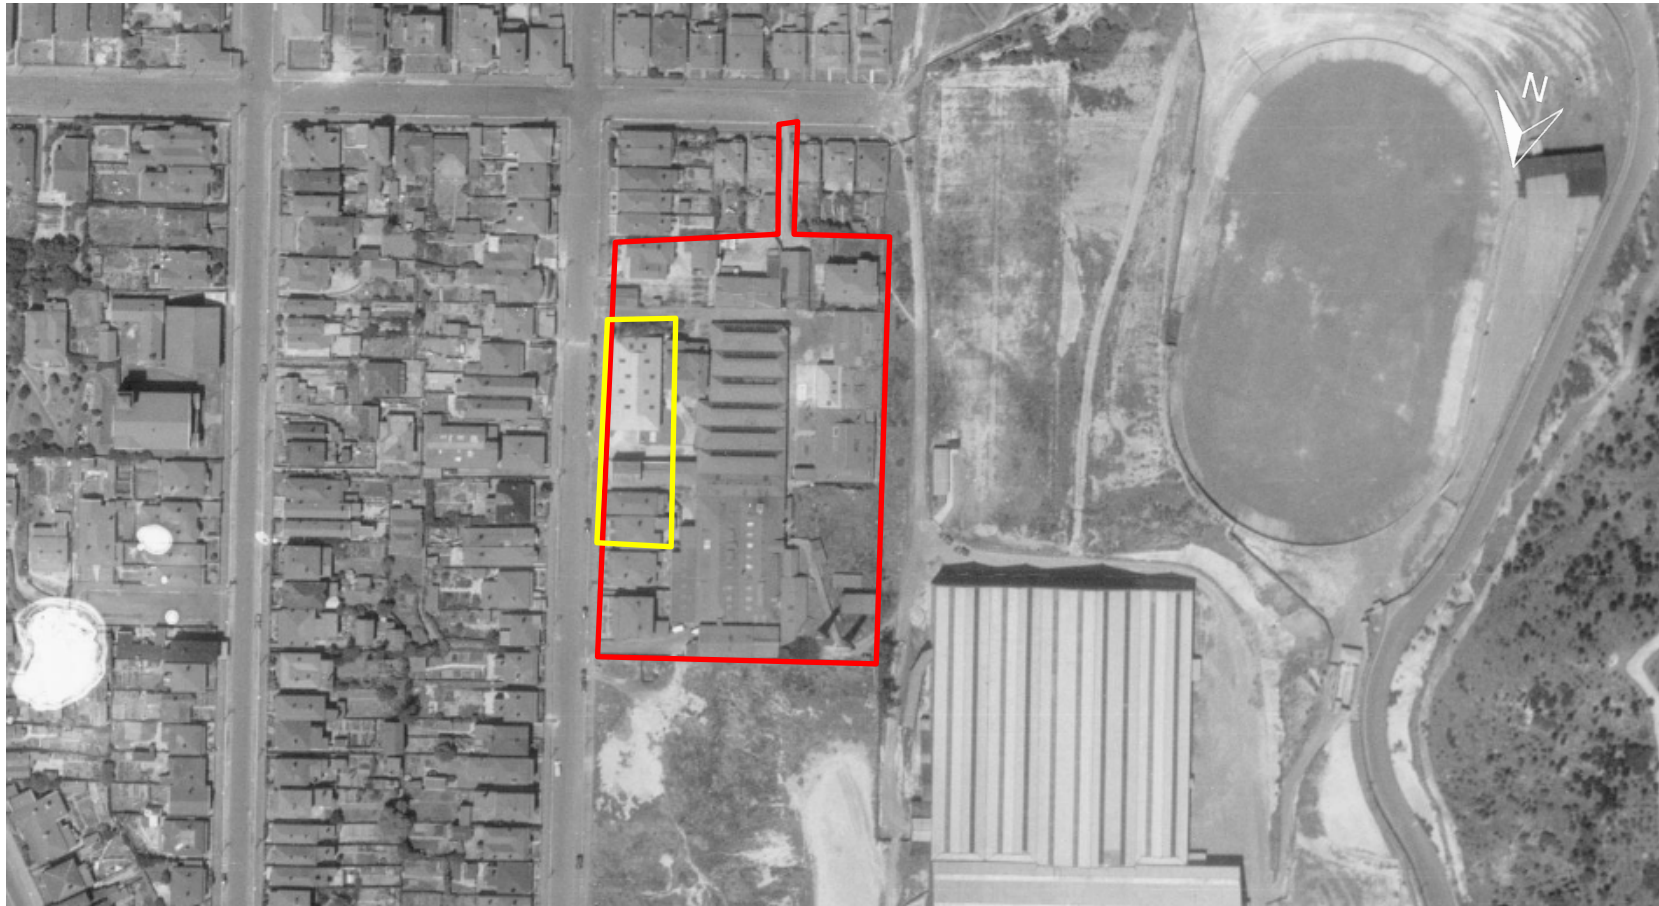
Date	June 18	Client	Southern Cross Hospitals Ltd
Drawn by	BS	Project	Southern Cross
Approved by	KJ	Description	Aerial Photograph - 1941
Scale (approx.)	Not to scale	ENGEO Ref.	15101.000.000

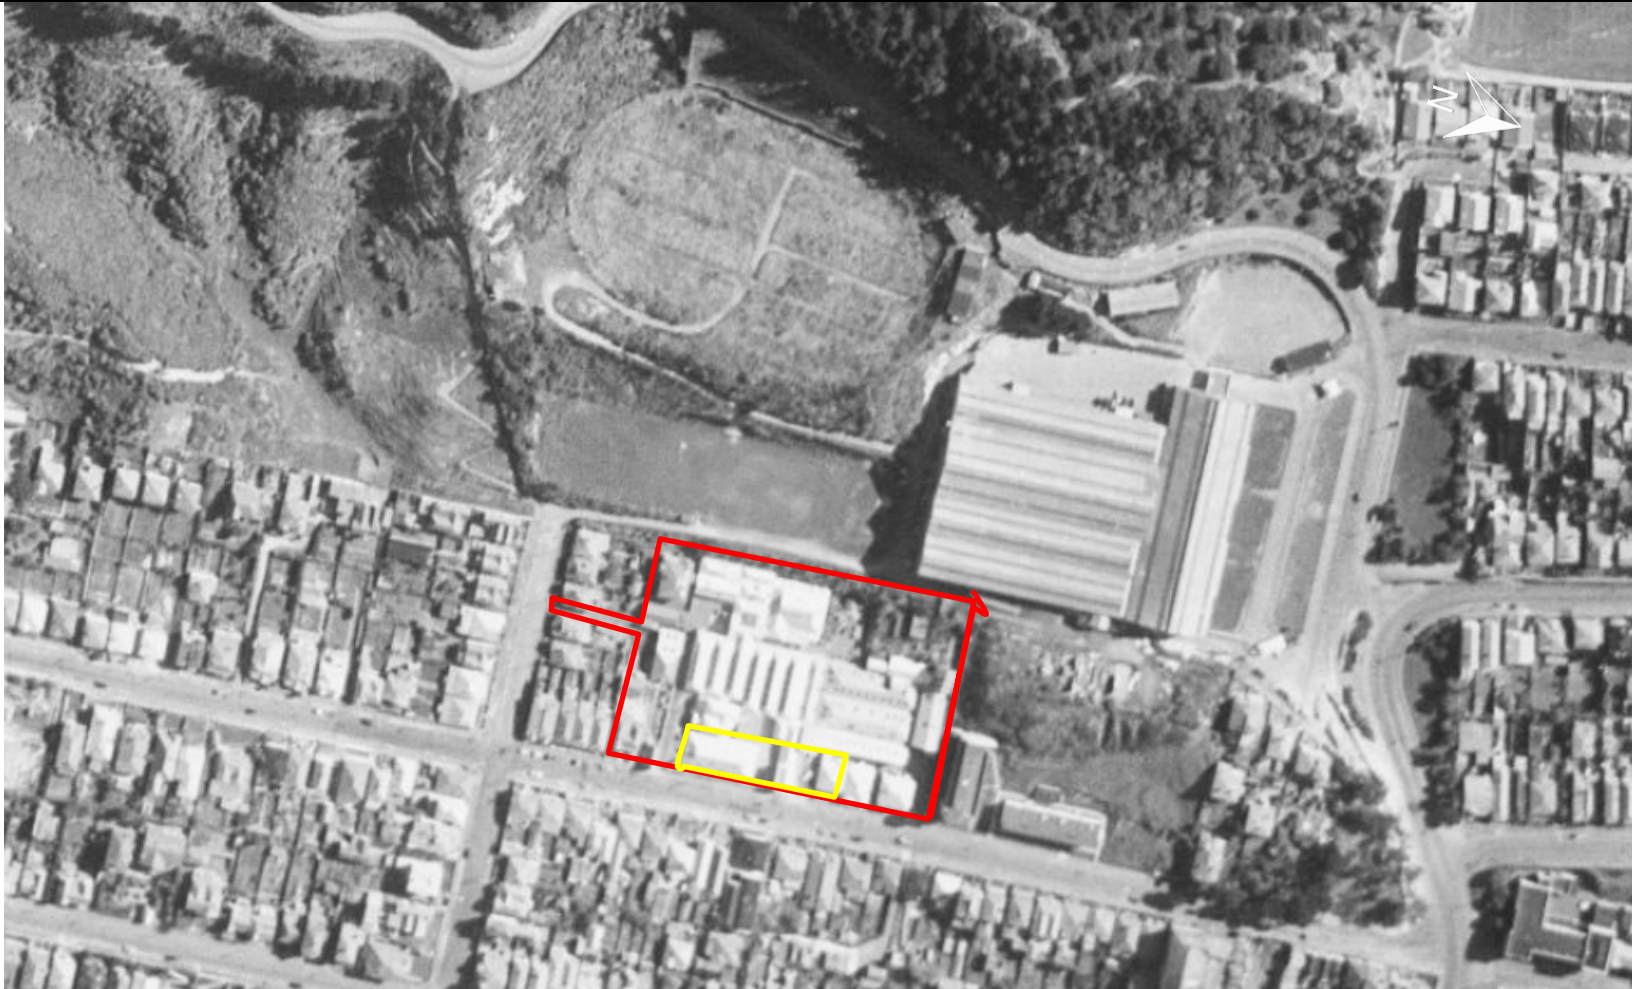
Date	June 18	Client	Southern Cross Hospitals Ltd
Drawn by	BS	Project	Southern Cross
Approved by	KJ	Description	Aerial Photograph - 1954
Scale (approx.)	Not to scale	ENGEO Ref.	15101.000.000

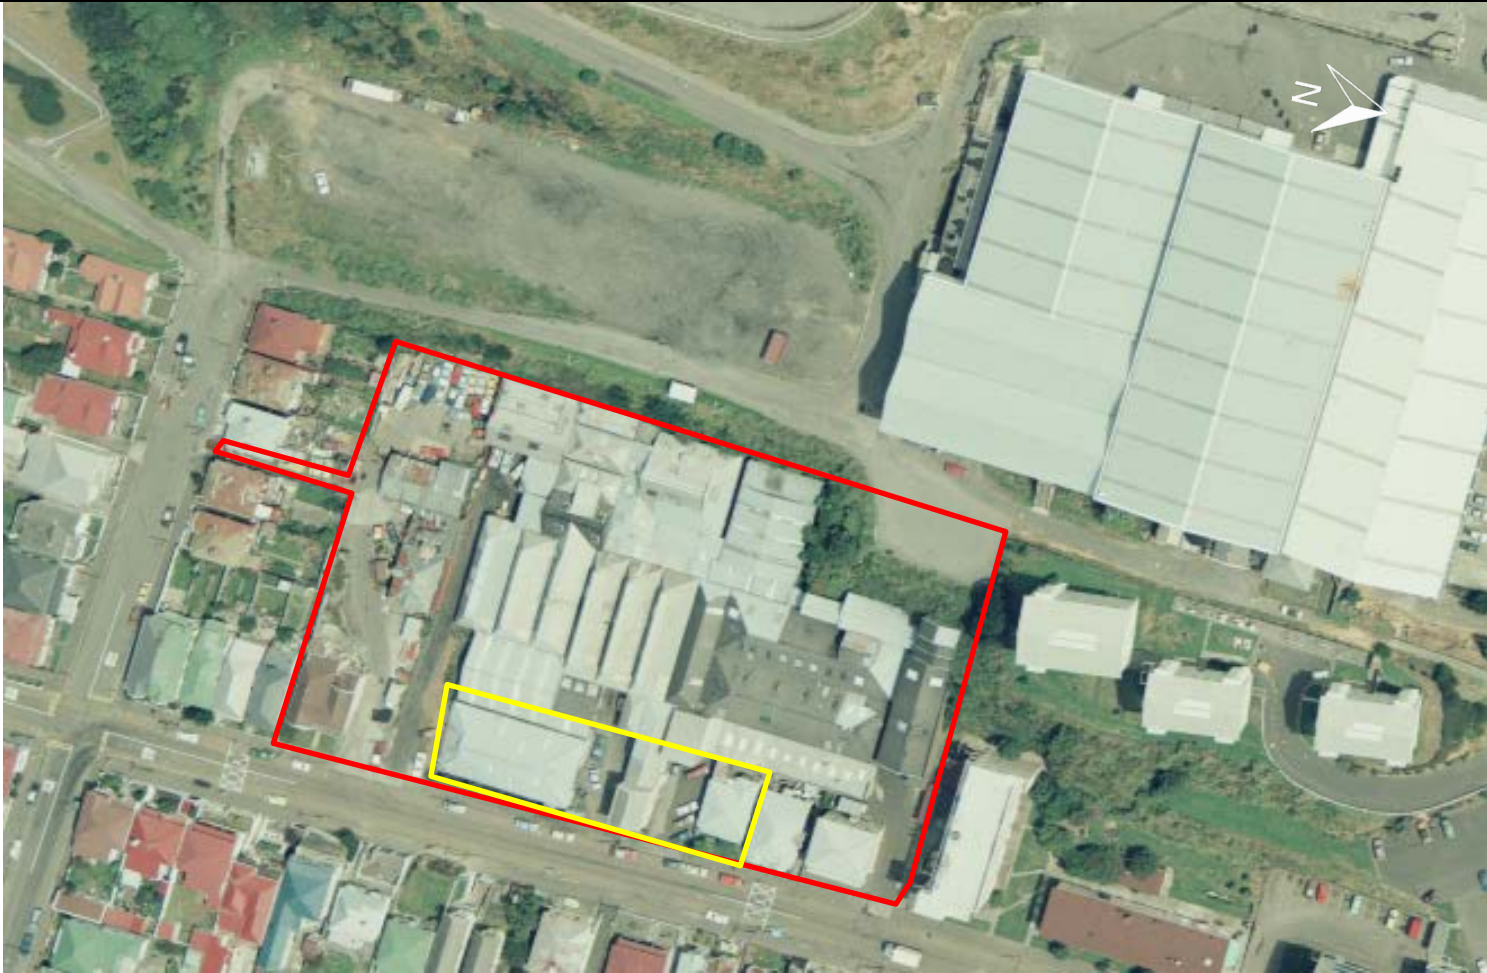
Date	June 18	Client	Southern Cross Hospitals Ltd
Drawn by	BS	Project	Southern Cross
Approved by	KJ	Description	Aerial Photograph - 1988
Scale (approx.)	Not to scale	ENGEO Ref.	15101.000.000

1980 and 1988 Retrolens	The property appears mostly unchanged from the previous photographs. It is more evident in the 1988 photograph that the southern portion of the property is used as a storage lot or car park for the commercial buildings on-site. Surrounding development has expanded. The parcels to the north include additional commercial structures.	The development site appears unchanged from the previous photographs.

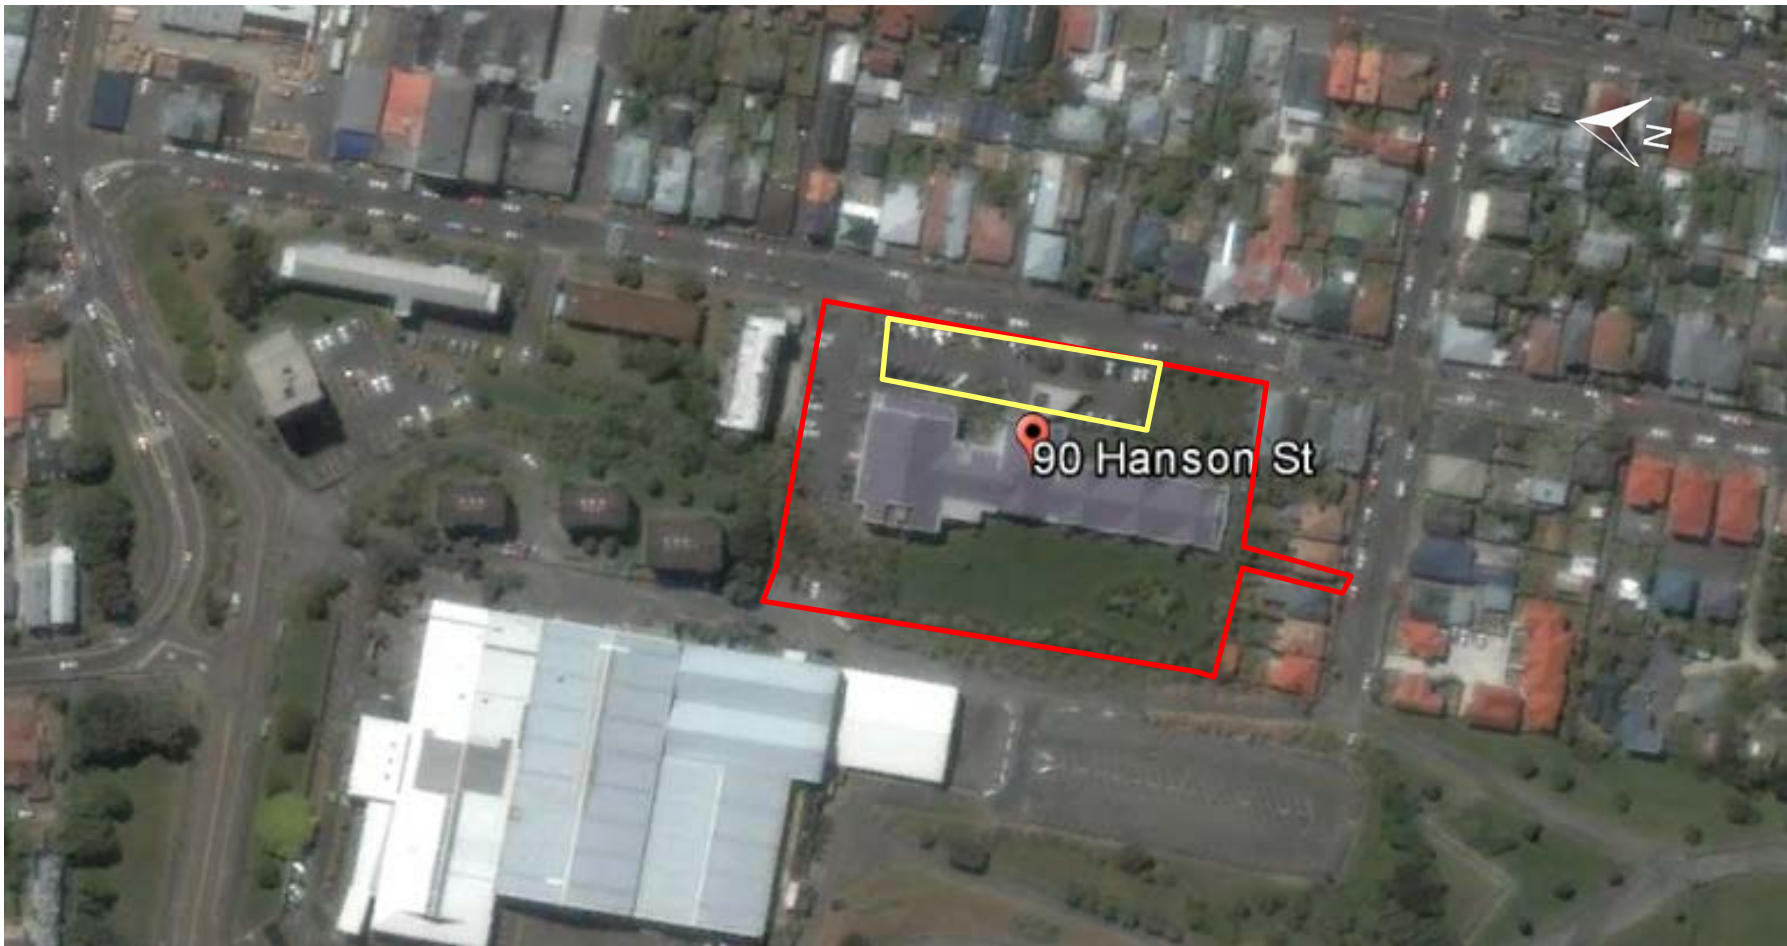
Date	June 18	Client	Southern Cross Hospitals Ltd
Drawn by	BS	Project	Southern Cross
Approved by	KJ	Description	Aerial Photograph - 2002
Scale (approx.)	Not to scale	ENGEO Ref.	15101.000.000

Date	Description – wider site	Description – development site
2002 Google Earth	The property has been redeveloped into the Southern Cross Hospital. One large building is shown with surrounding asphalt parking. Landscaping is shown on the western portion of the Property. Surrounding properties are similar to the previous photographs.	The development site is representative of its current conditions, comprising of asphalt parking and a designated drop-off.
2009 and 2010 Google Earth	The western portion of the property is now under construction. Other portions of the property appear unchanged.	The development site is unchanged from the previous photographs.
2010 and 2017 Google Earth	An addition to the Southern Cross Hospital is now shown on the western portion of the property. The property appears consistent with current site conditions.	The development site is unchanged from the previous photographs.

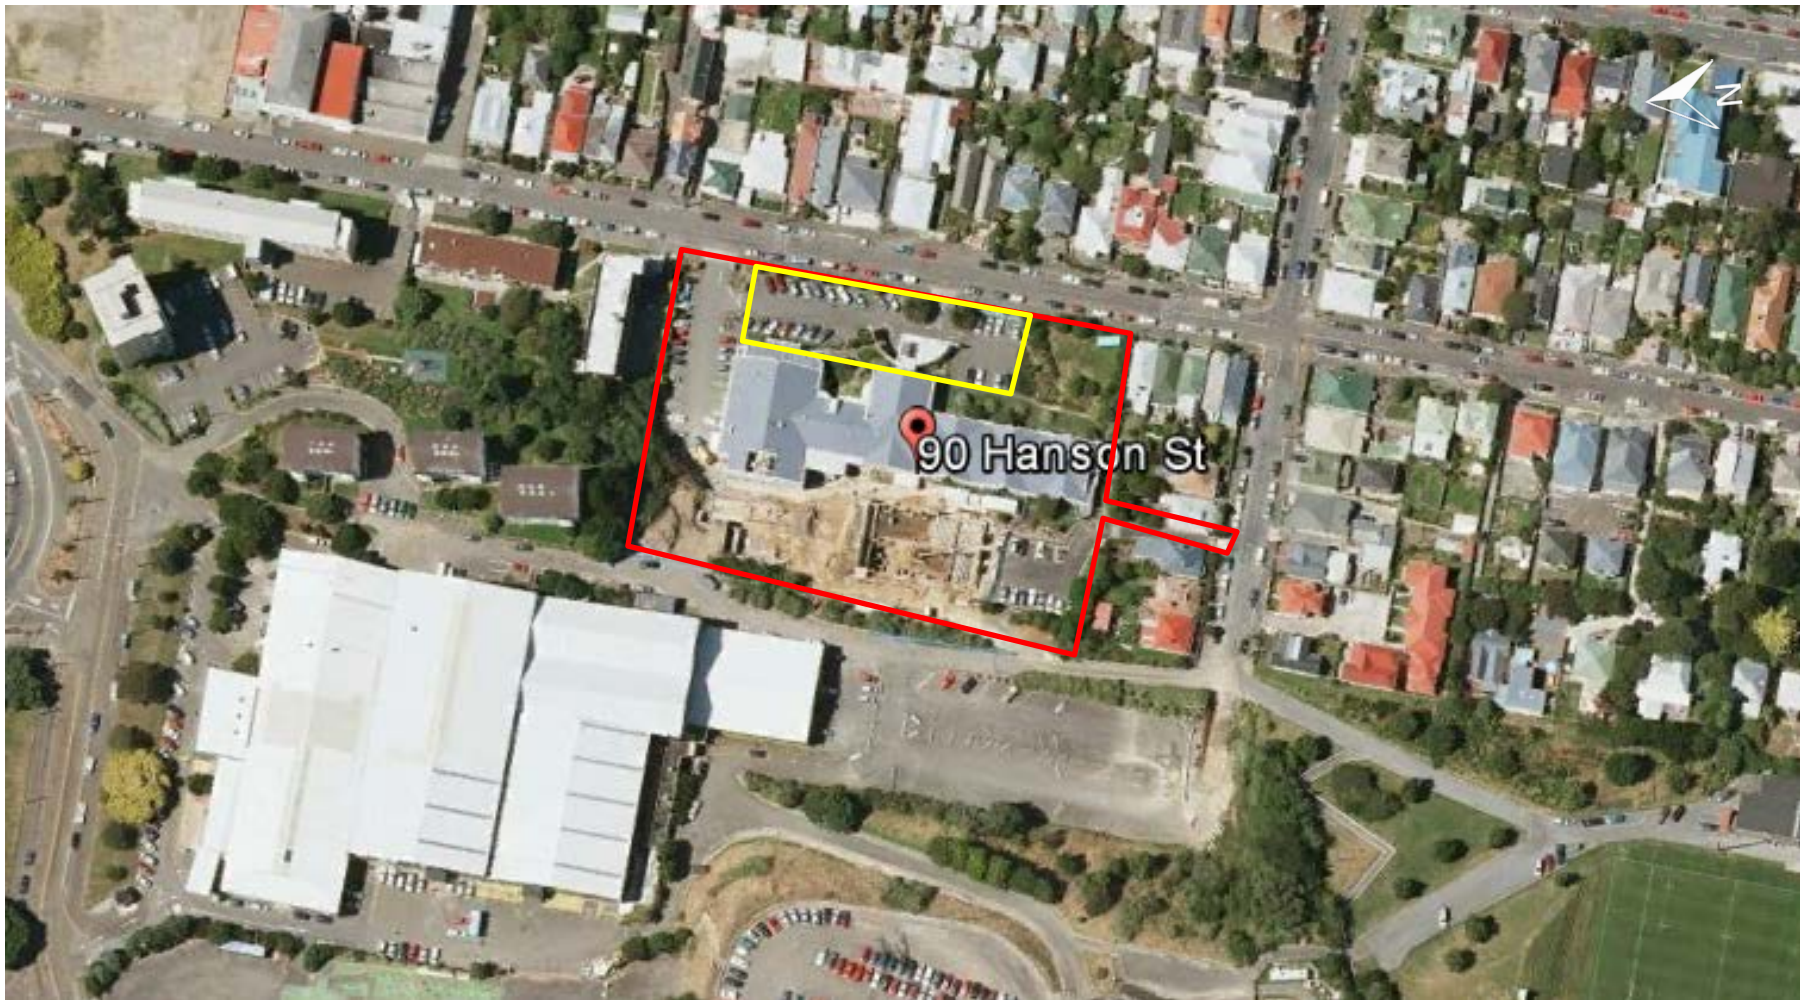
Date	June 18	Client	Southern Cross Hospitals Ltd
Drawn by	BS	Project	Southern Cross
Approved by	KJ	Description	Aerial Photograph - 2009
Scale (approx.)	Not to scale	ENGEO Ref.	15101.000.000

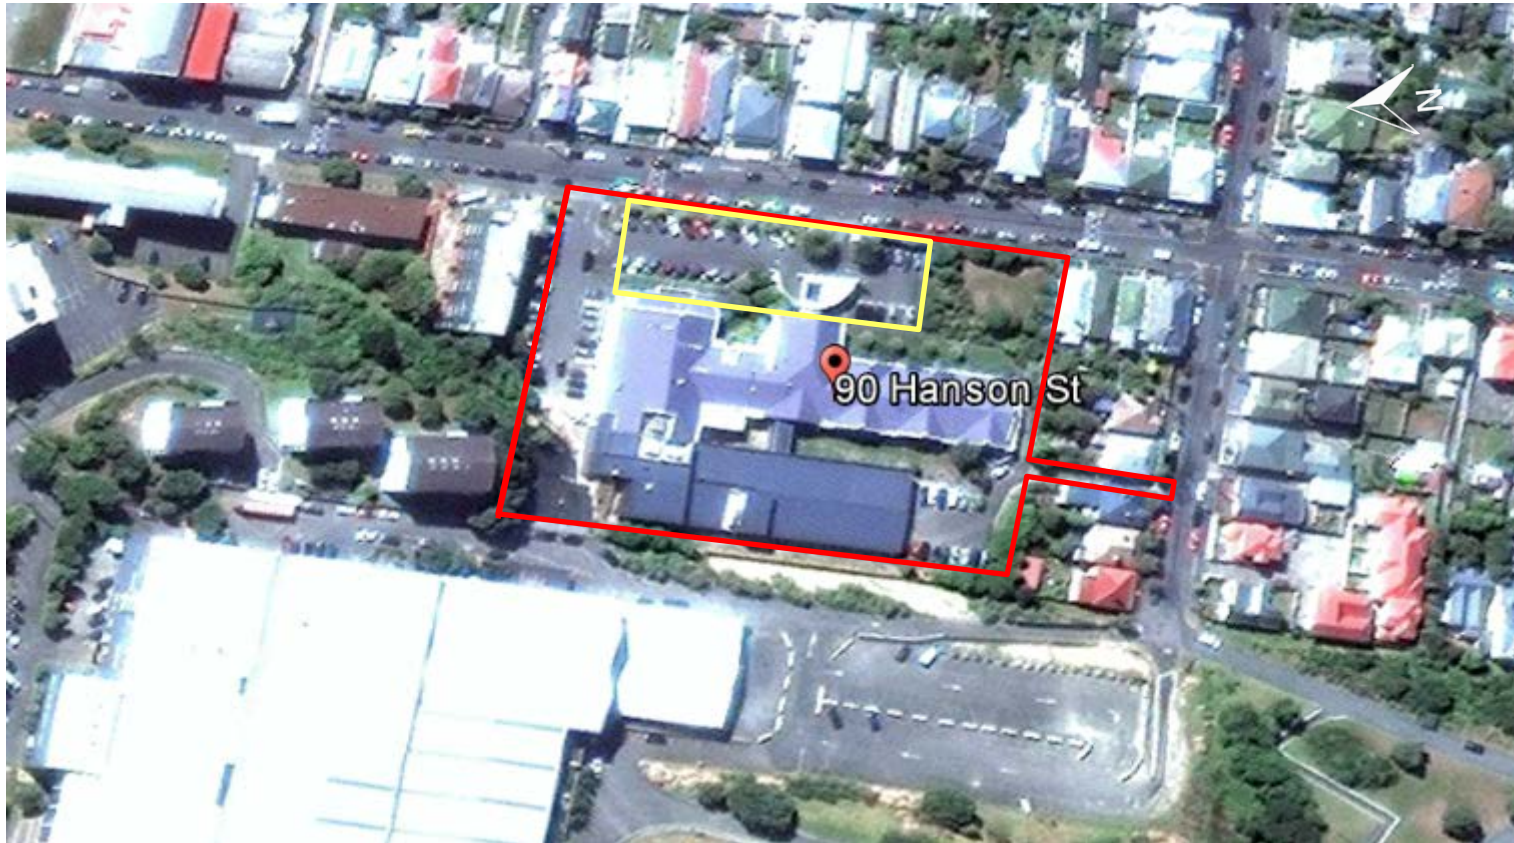
Date	June 18	Client	Southern Cross Hospitals Ltd
Drawn by	BS	Project	Southern Cross
Approved by	KJ	Description	Aerial Photograph - 2010
Scale (approx.)	Not to scale	ENGEO Ref.	15101.000.000

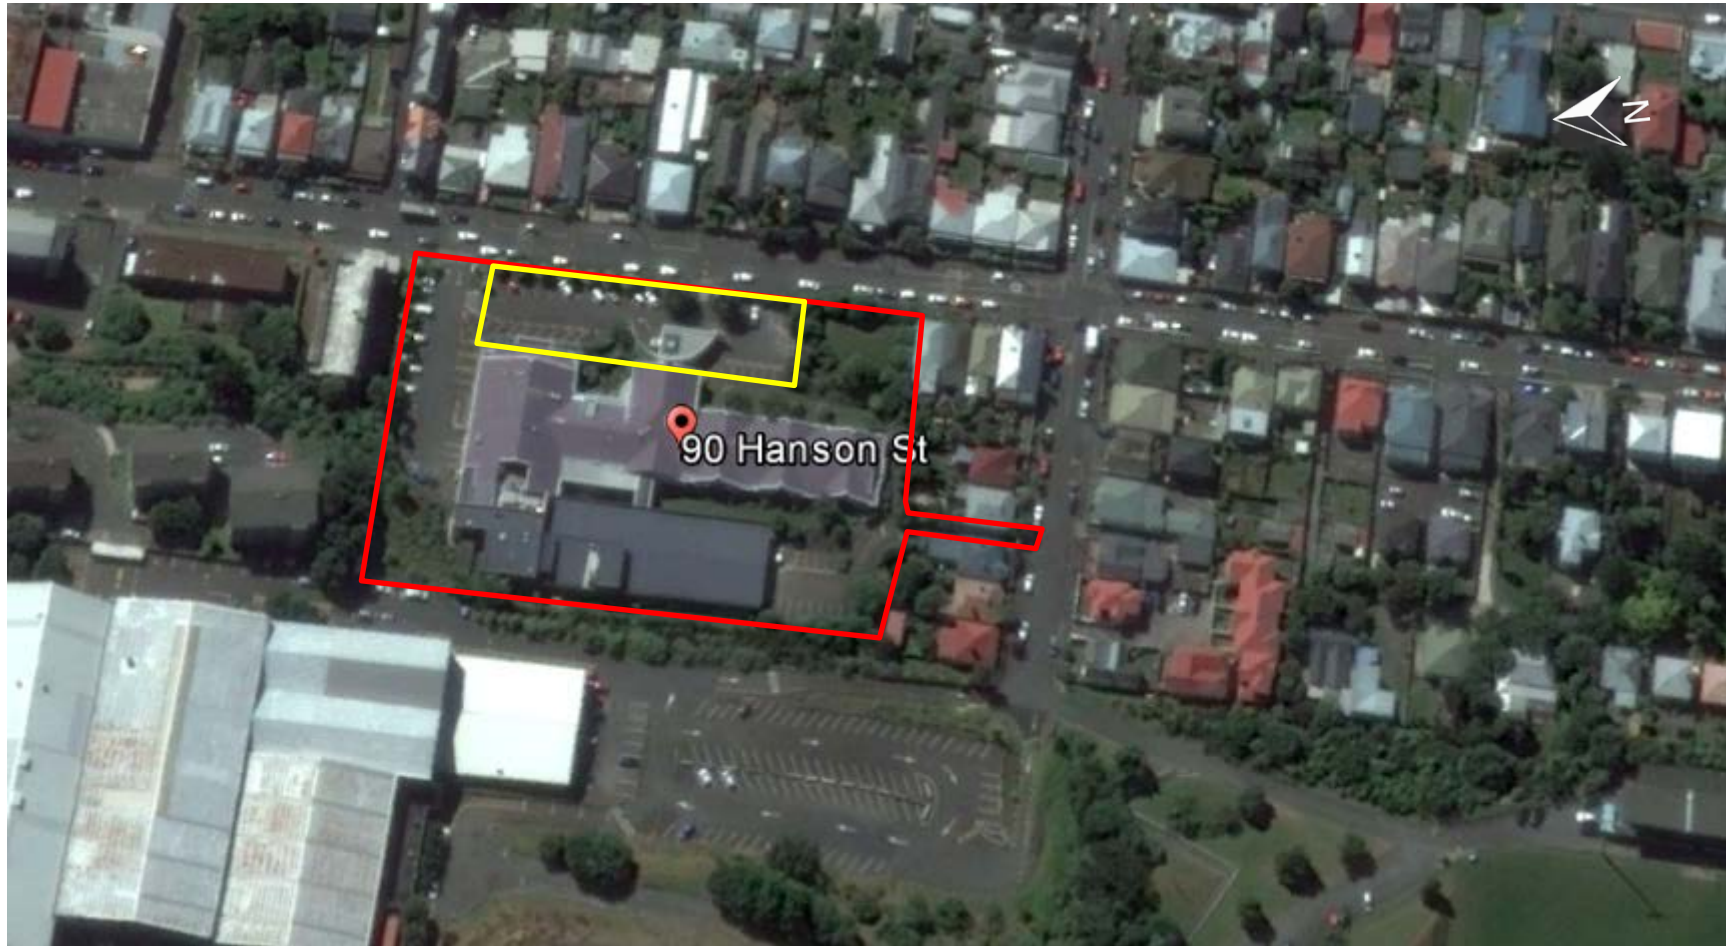
Date	June 18	Client	Southern Cross Hospitals Ltd
Drawn by	BS	Project	Southern Cross
Approved by	KJ	Description	Aerial Photograph - 2017
Scale (approx.)	Not to scale	ENGEO Ref.	15101.000.000

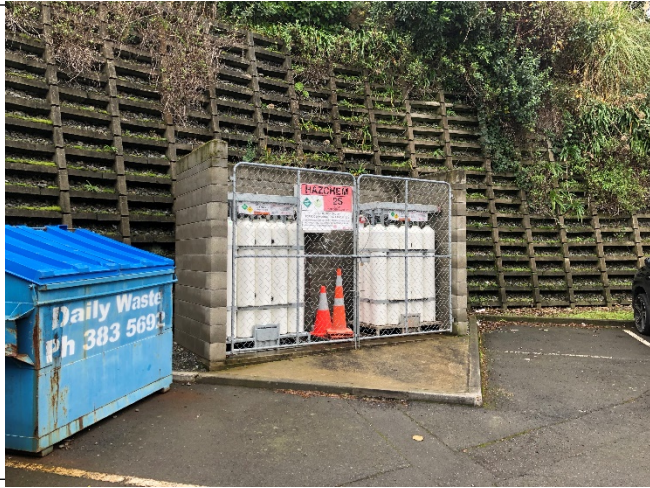
Site Conditions	Description
Visible signs of contamination	General household rubbish was noted on northern boundary of the property, adjacent to dwellings.
Presence of drums, wastes, and fill materials	Oxygen tanks were noted on hardstand in the northwest corner of the site. The tanks appeared to be in good condition.
Surface water appearance	No surface water observed during the site walkover.
Current surrounding land use	The surrounding area is a mixed-use residential / commercial area of Newtown. Hall Street and residential homes border the site to the south, Hanson Street and residential homes to the east, commercial development, including sports warehouses and parking, to the west, and commercial buildings to the north.
Local sensitive environments	No local sensitive environments observed.
Visible signs of plant stress	No visible signs of plant stress were noted during the walkover.
Ground Cover	Modern buildings and tar-seal roads cover the majority of the property.

Photograph 1: Oxygenate Tanks Located on Northwestern Corner of Property.

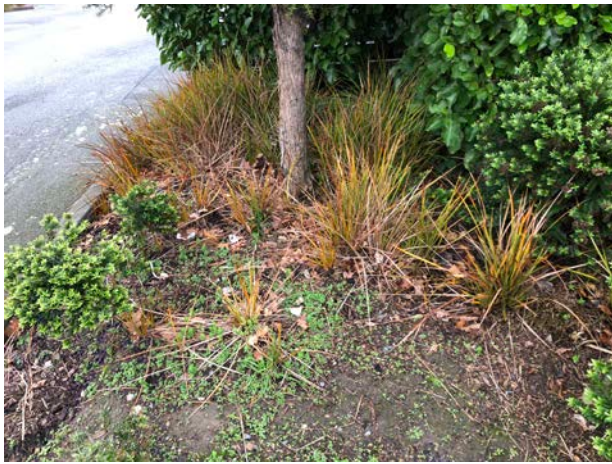
Additional Comments	<ul style="list-style-type: none"> A gas junction was observed on the northeast corner for utility use A substation was located adjacent to the eastern boundary. No staining was noted. Paint chips were noted in the southeast garden that may possibly be of lead-based origin. A painted retaining wall was noted on the eastern boundary of the property. There is the potential for lead-based paints to have been used.

- HAIL ID E:1: *Asbestos products manufacture or disposal including sites with building containing asbestos products known to be in a deteriorated condition.* Given the former buildings on the site since at least the early 1900's in addition to the current building, constructed in 1990, there are the potential for asbestos based products. Further, there are the potential for lead-based paints within building products.

Photograph 3: Minor Paint Chips Noted within Central Garden Area.

As the redevelopment of the site involves soil disturbance, it is possible that soils required to be disturbed have been impacted by the identified potential sources of contamination. It is recommended that further intrusive investigations are completed across the development site with respect to the potential sources of contamination mentioned above with respect to soil, groundwater, and soil vapour. It is likely that Wellington City Council will require a Detailed Site Investigation as part of the resource consent conditions prior to development.

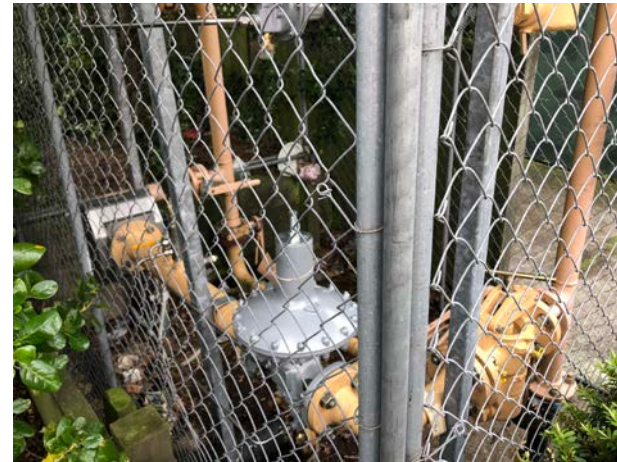
Photograph 4: Utility Gas Junction Located Adjacent to the Northeast Portion of the Property.

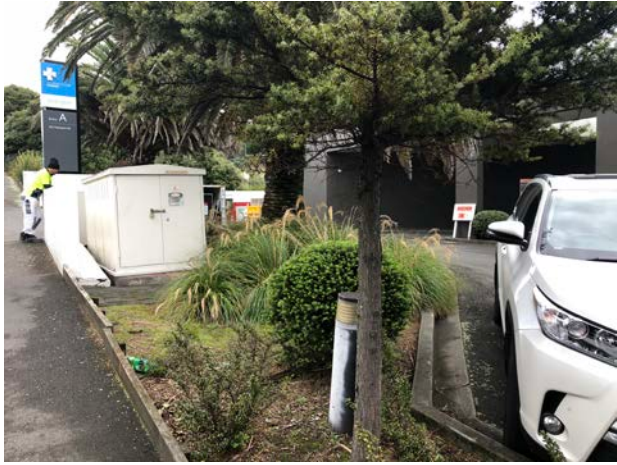
Photograph 5: Transformer Located Adjacent to the Property.

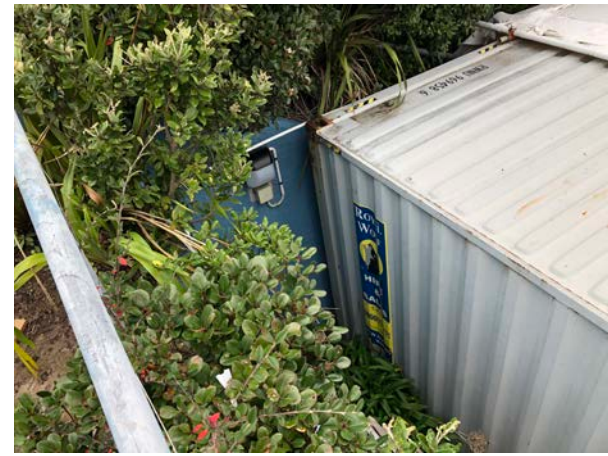
Photograph 6: Retaining Wall and Temporary Storage Containers Along Eastern Boundary.

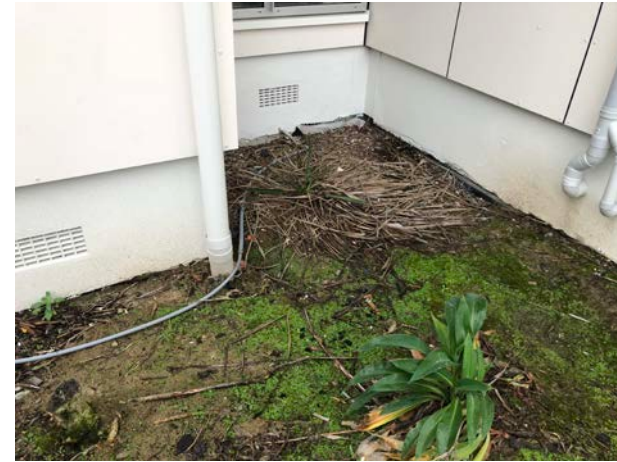
Photograph 8: Deteriorating Paint Along Base of Building.
