Parliament FAS

Ballantrae Place Detailed Site
Investigation

Parliamentary Services

Reference: 255585

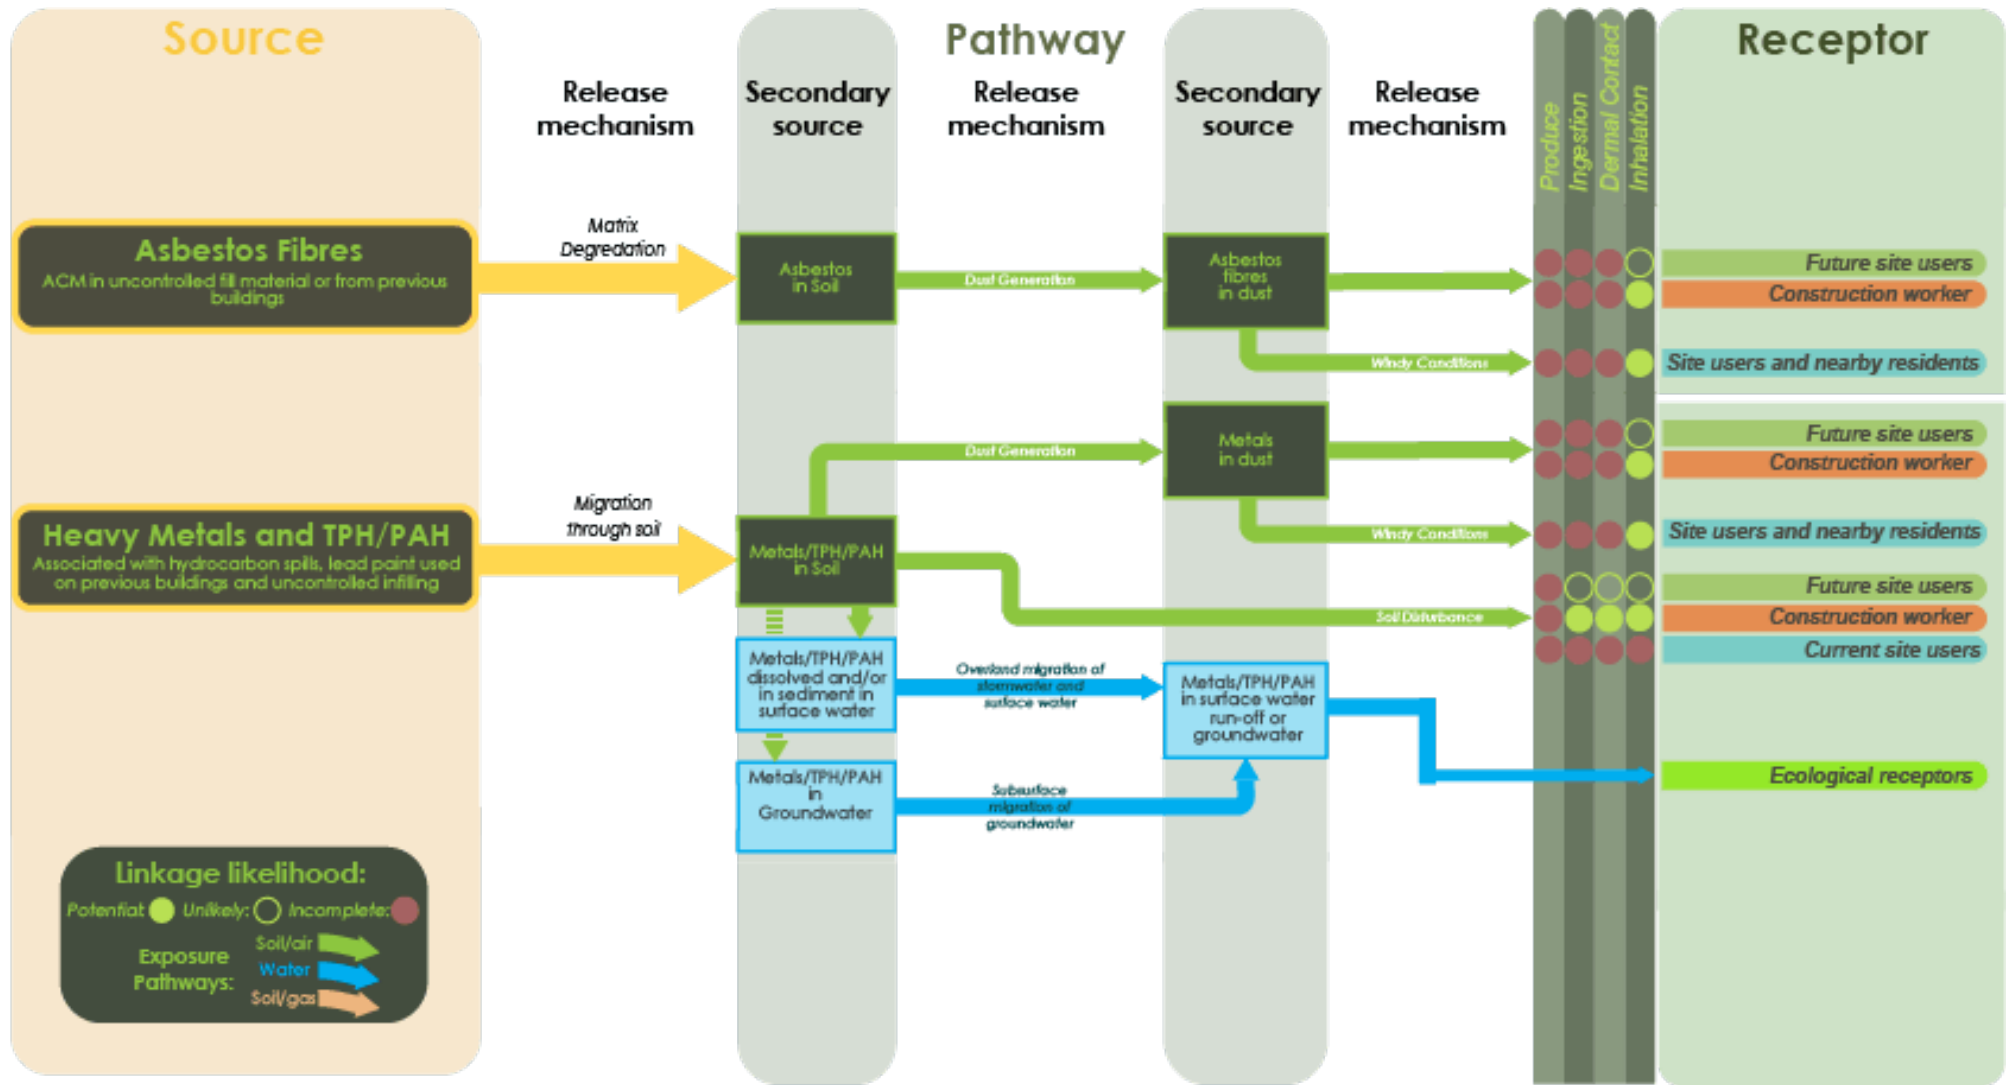
Figure 2 Preliminary Conceptual Site Model

Exposure pathways between potential contaminants and a construction worker may be complete during bulk earthworks for the project, and site users and nearby site users may also have completed exposure pathways.

Exposure pathways may be complete for ecological receptors via flow of impacted stormwater to wellington harbour and to underground infrastructure and groundwater if ground conditions are found to be impacted by the presence of hydrocarbons or unexpected waste fill etc.

The information above has been combined into a flow chart CSM which can be found in Figure 2.

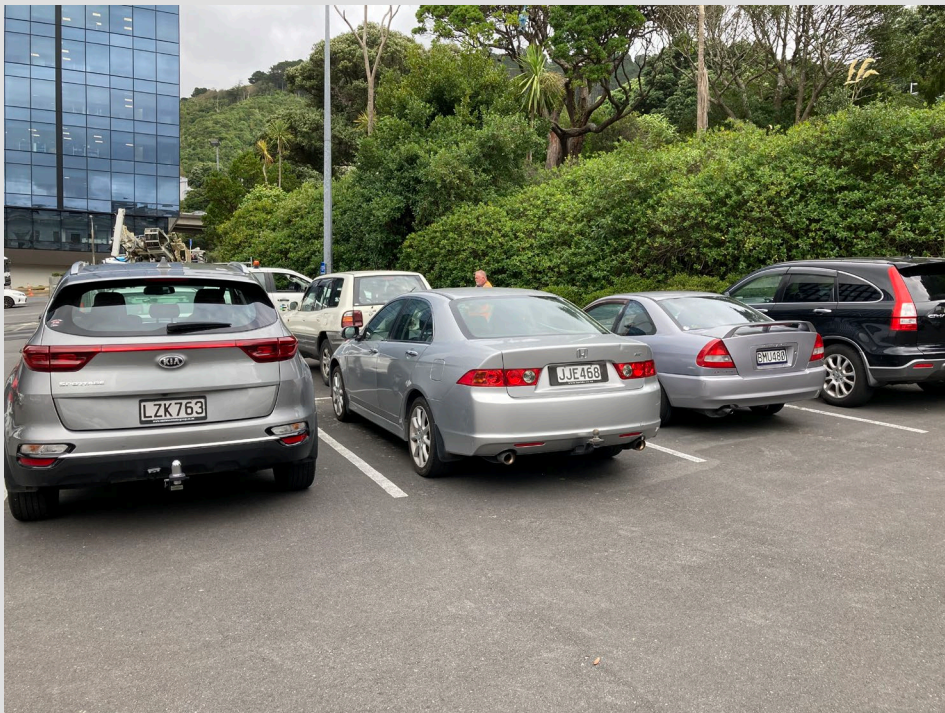
The site is currently in use as a public carpark. The majority of the surface is asphalt which is in good condition, with the hill to the north being covered with mature trees and shrubbery.

Figure 2 Site – Facing North-West, showing the vegetated slope to the north

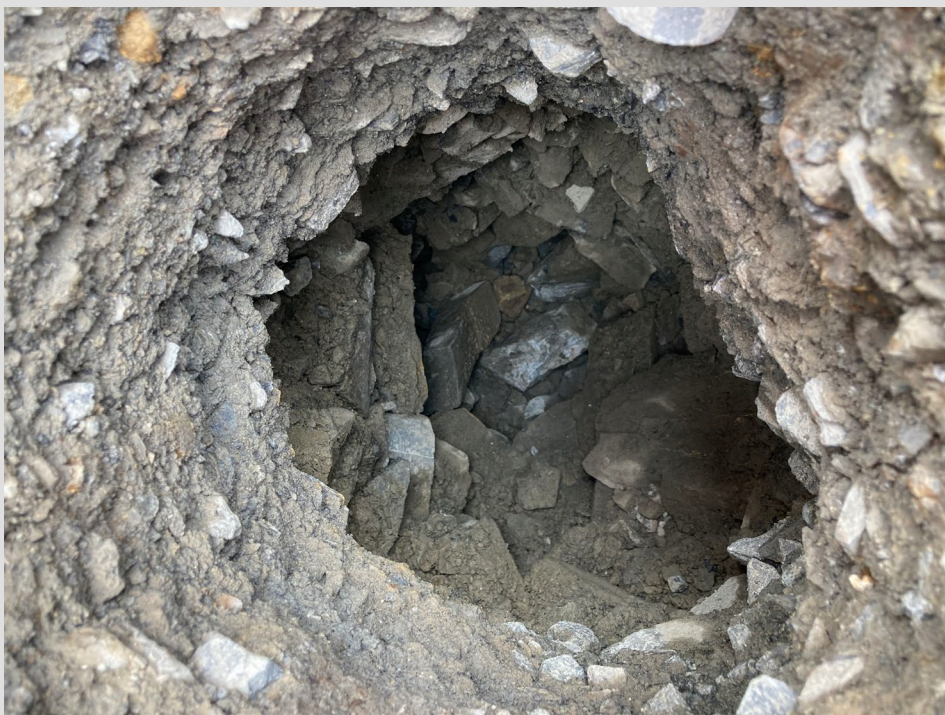
The surface of all borehole locations was covered in asphalt. In BH101 (the western most borehole) the stratigraphy from beneath the asphalt to 1.4 m bgl was gravel with cobbles and boulders. The ground conditions prevented the vacuum excavation from lifting material from any deeper than 1.4 m bgl and the drill rig was unable to begin drilling due to the likely core loss that would result from drilling through cobbles and boulders into a softer material underneath. As a result this borehole was abandoned.

Figure 4 BH101 – Angular cobble/boulder fill in ground

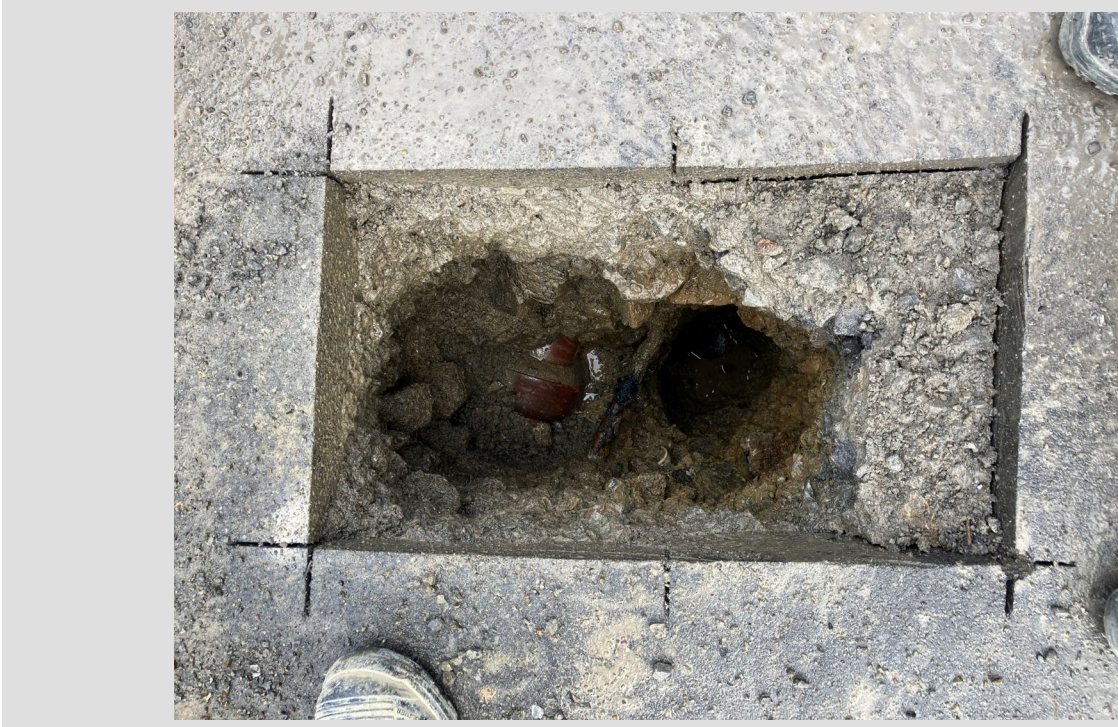
Figure 5 BH102

The stratigraphy at BH102, BH103 and BH104 was in agreement with expected conditions - silt and gravel fill overlying a similar composition of natural ground. A terracotta pipe, likely part of the stormwater drainage

system, was encountered in BH102, which had not been apparent in any plans. The pipe was not damaged and the borehole location was shifted slightly to avoid the service.

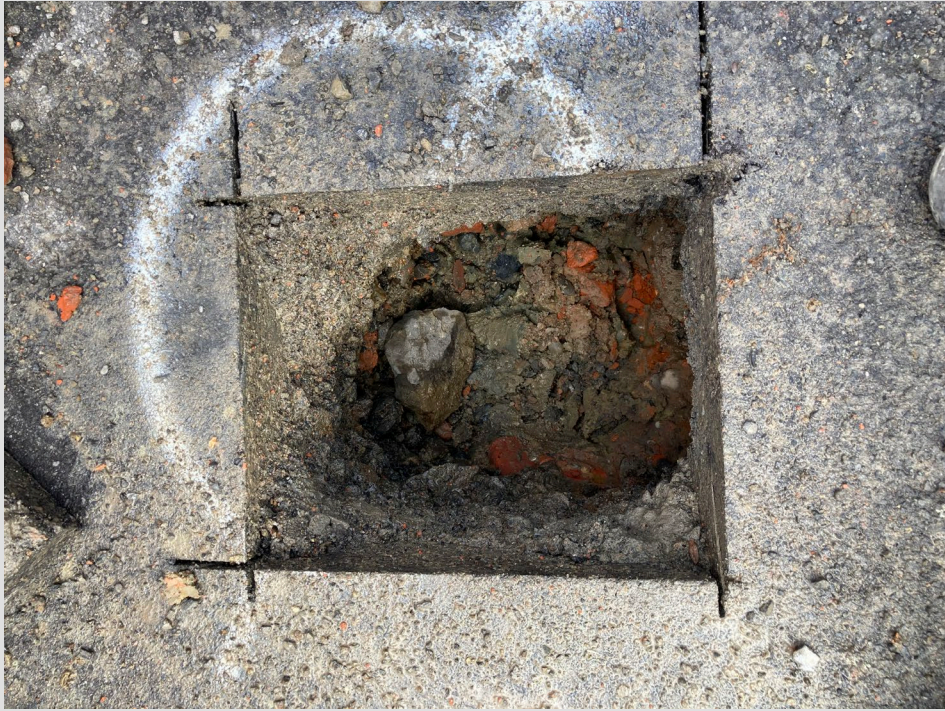
Figure 9 BH104

One detection of asbestos within demolition fill at BH104 could not be quantified due to insufficient sample size and means excavations of the demolition fill from this area may need to be under Class A controls (e.g. air monitoring, suitable PPE, asbestos waste), which would be documented as part of the CSMP. Further sampling is recommended to be undertaken prior to earthworks to ascertain the amount of asbestos present and test pits are required to obtain enough sampling volume for this testing. Depending on the results of such sampling Class A asbestos controls may not be required during the earthworks. A suitable reuse option could be developed for asbestos impacted fill with appropriate controls (such as capping and a long-term site management plan). Earthworks controls for this option could be laid out as part of the suggested CSMP. Depending on the intended use of site won material, it should be confirmed if it is geotechnically suitable.

- None of the samples analysed exceed the applicable health criteria (commercial/industrial land use) for heavy metals, PAHs, TPHs and/or BTEX.
- A total of 12 samples were tested for asbestos (presence/absence). One sample (BH104_0.4-0.5) returned a detection of chrysotile (white asbestos) in the form of loose fibres. This sample came from an area of visible demolition waste fill in the ground comprised of brick fragments and whole bricks in a gravelly silt matrix. No other sample contained asbestos.

- It is recommended that a CSMP be completed for the wider Parliament FAS project;
- It is recommended that a further limited test pit investigation in the areas of BH104 and BH105 be completed prior to the start of earthworks to inform the ground conditions, extent of the demolition fill and the quantity of asbestos present;
- Consideration should be given to the possible reuse of site-won spoil;
- Consideration should be given to the need for further groundwater assessment to inform disposal and management of dewatering during construction, if required; and
- To comply with GWRC's Proposed Natural Resources Plan (Rule R54 – Detailed Site Investigation – Permitted Activity), a copy of this report should be supplied to them.

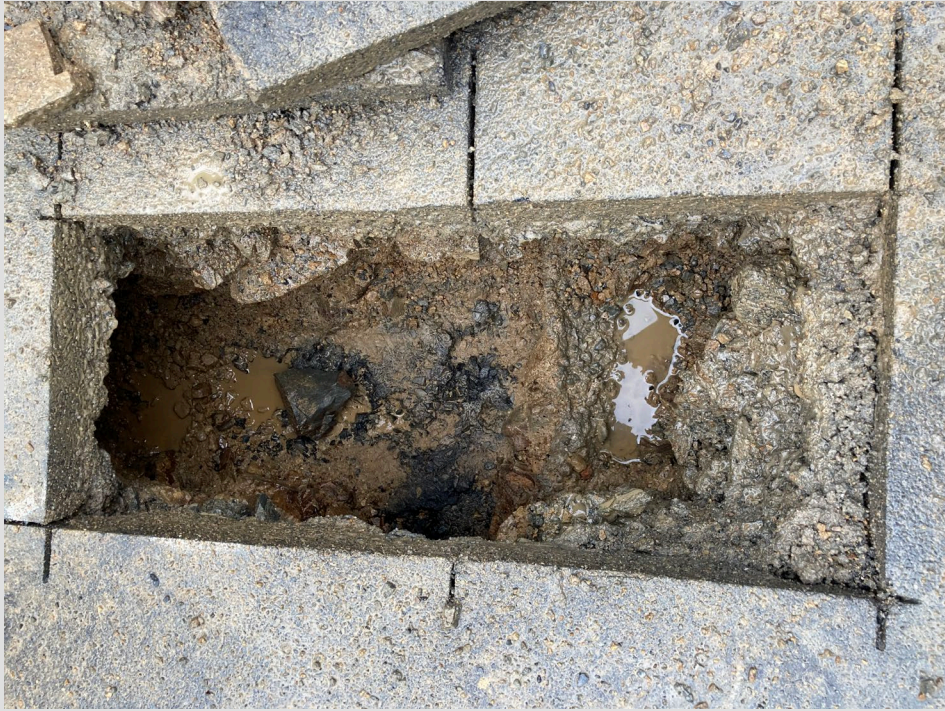
Figure 11 BH105

Due to the abandonment owing to ground conditions of BH101 and BH105 it is unconfirmed what materials are present underneath. Further, it is unconfirmed at what depth natural ground is encountered underneath the ramp to the upper carpark, although due to the close proximity of this location to other investigation locations (approximately 15 m laterally from BH101 and BH06) it is assumed to be at a similar depth or a shallower relative level than the boreholes.

The following section does not provide comment for deeper soils associated with BH101 and BH105. Due to unforeseen ground conditions at these locations they have not been characterised at depth. The material at these locations may require further sampling to confirm the suitability of material for landfill/cleanfill and/or reuse. This could occur prior to the removal of the carpark surface in the form of test pits. This would help to confirm the extent of the ground slab at BH105.
