**110 Jervois Quay**  
**DRAFT CONSTRUCTION**  
**MANAGEMENT PLAN**

# PROJECT INTRODUCTION AND CMP OBJECTIVES

An 8-level base isolated office building, sitting on the junction between Wakefield Street and Jervois Quay. This will be built on the existing carpark, where the Royal New Zealand Ballet currently occupies in a temporary building.

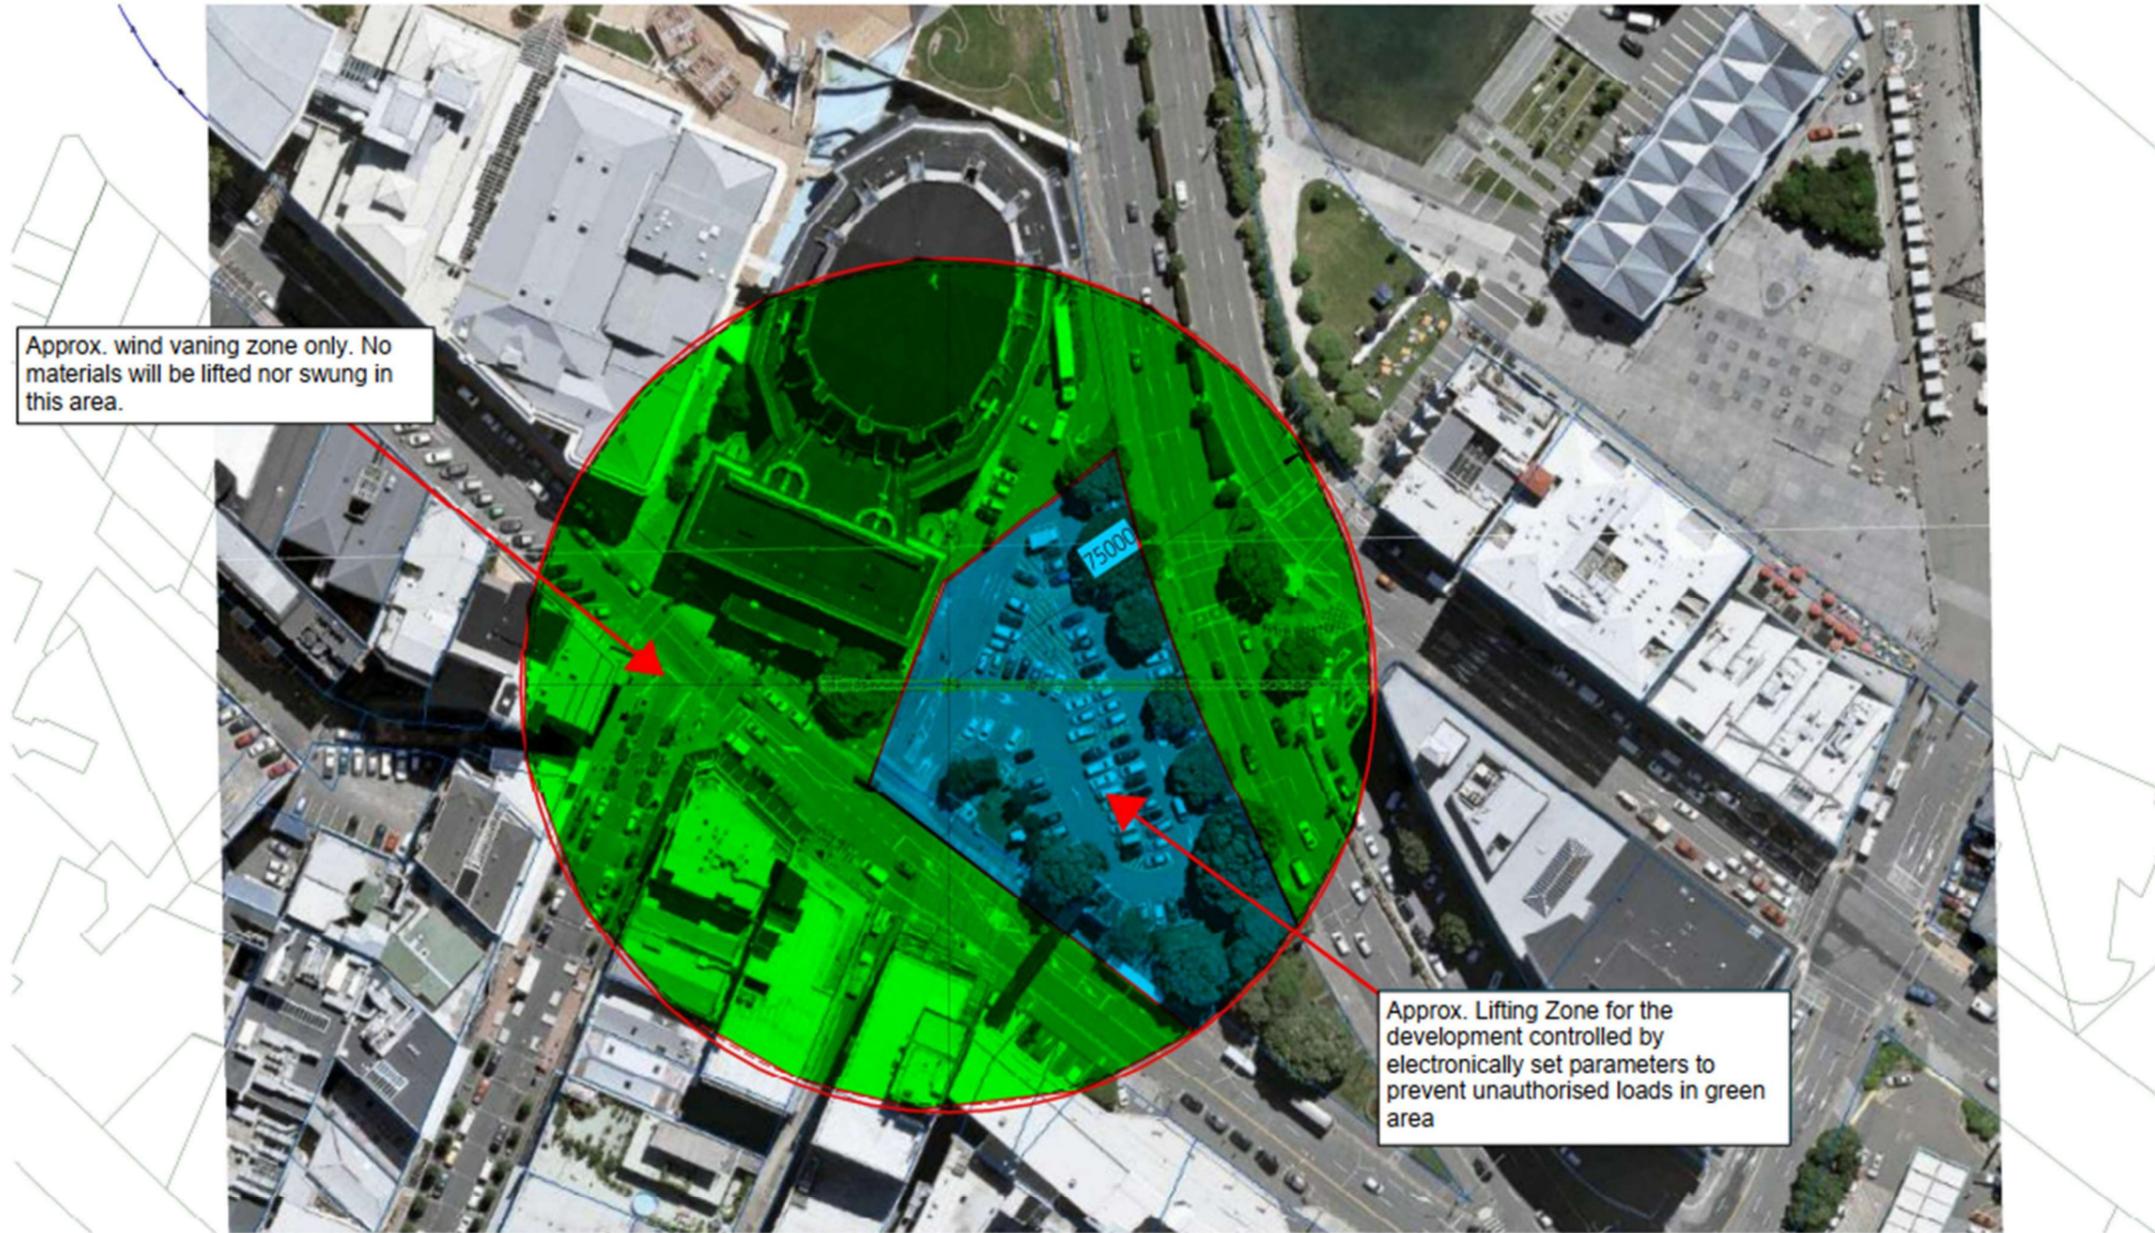
PRELIM ① CRANE A1  
1:1000

LT McGuinness proposes to erect one tower crane located as per Section 6.0 Crane Plan. These proposed locations will allow full reach over the footprint of the building and the loading bays. All necessary approvals and air space compliance from affected building and land owners will be arranged by the site owner.

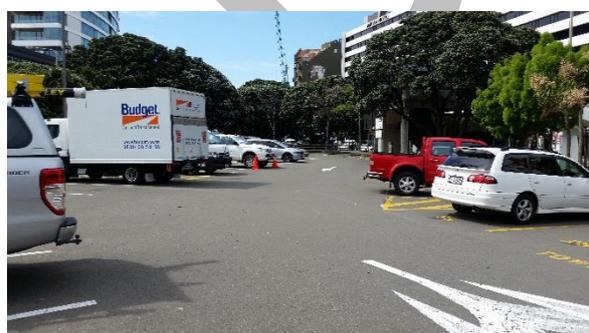
*Photograph 1: The site comprises a carpark to the Michael Fowler Centre. Photograph taken on 9 November 2016. Photograph facing southeast.*

- The site is generally flat with no major topographical features within the site.
- The site generally comprises an asphalt carpark for the Michael Fowler Centre (Photograph 1). A number of cut/ patch areas were observed on the carpark, which appear to be associated with repairs to underground services (Photograph 2).

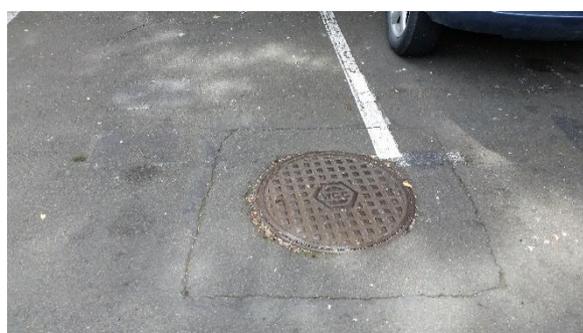
*Photograph 2: Cut/patch areas within the carpark. Photograph taken on 9 November 2016.*

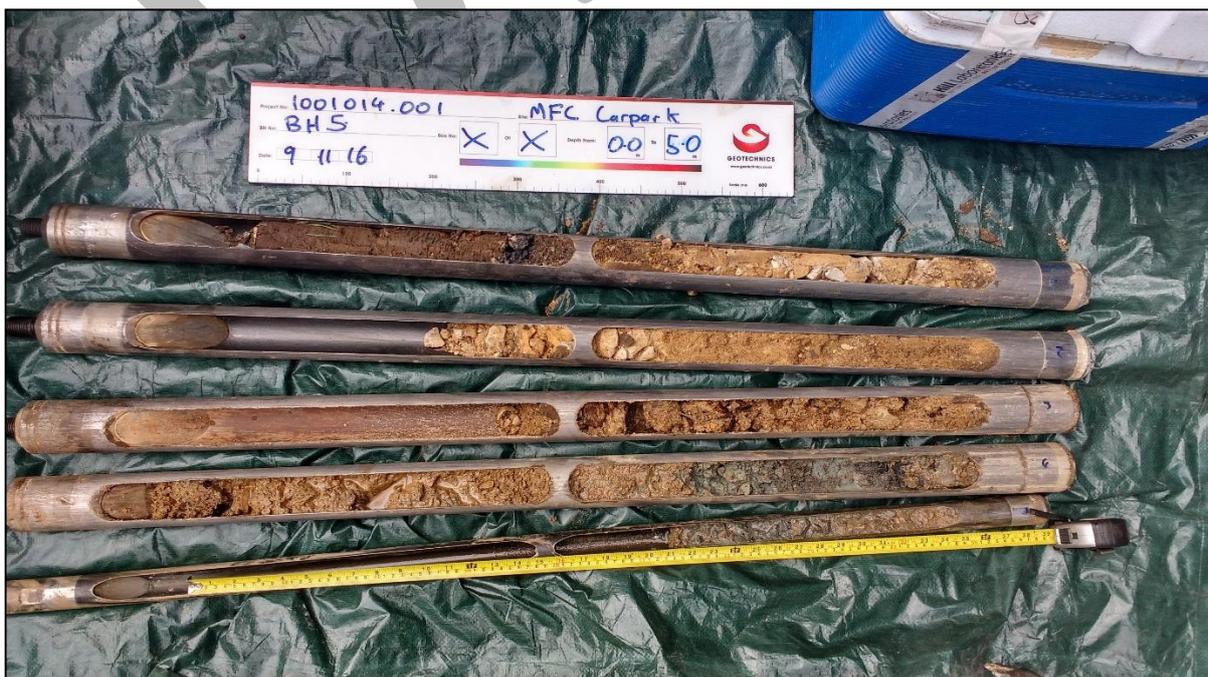
Photograph 5: Recovered core from BH5. Black gravels/slag can be observed at 0.3 m. Photo taken on 9 November 2016. Photo sourced from Geotechnics Limited.

Hydrocarbon odours (possibly petrol or oil) and black gravels/slag were observed in shallow fill materials at sample BH5 from 0.3 m to 0.5 m bgl.

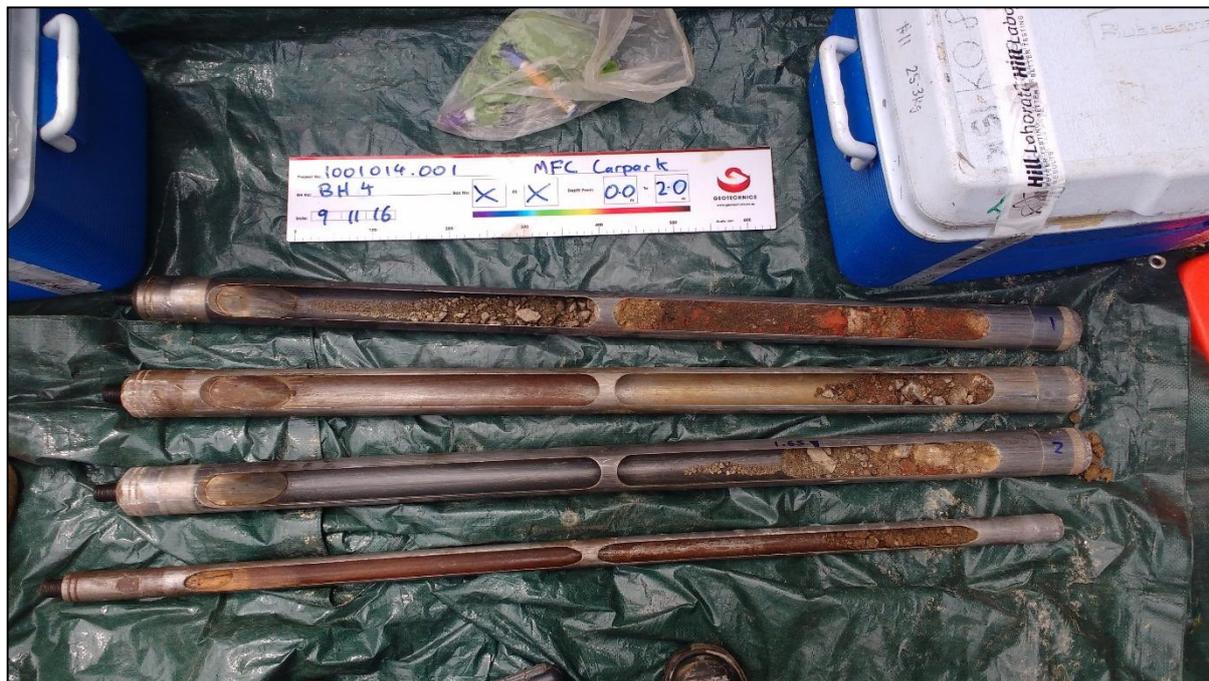
Photograph 6: Recovered core from BH4. Photo taken on 9 November 2016. Photo sourced from Geotechnics Limited.

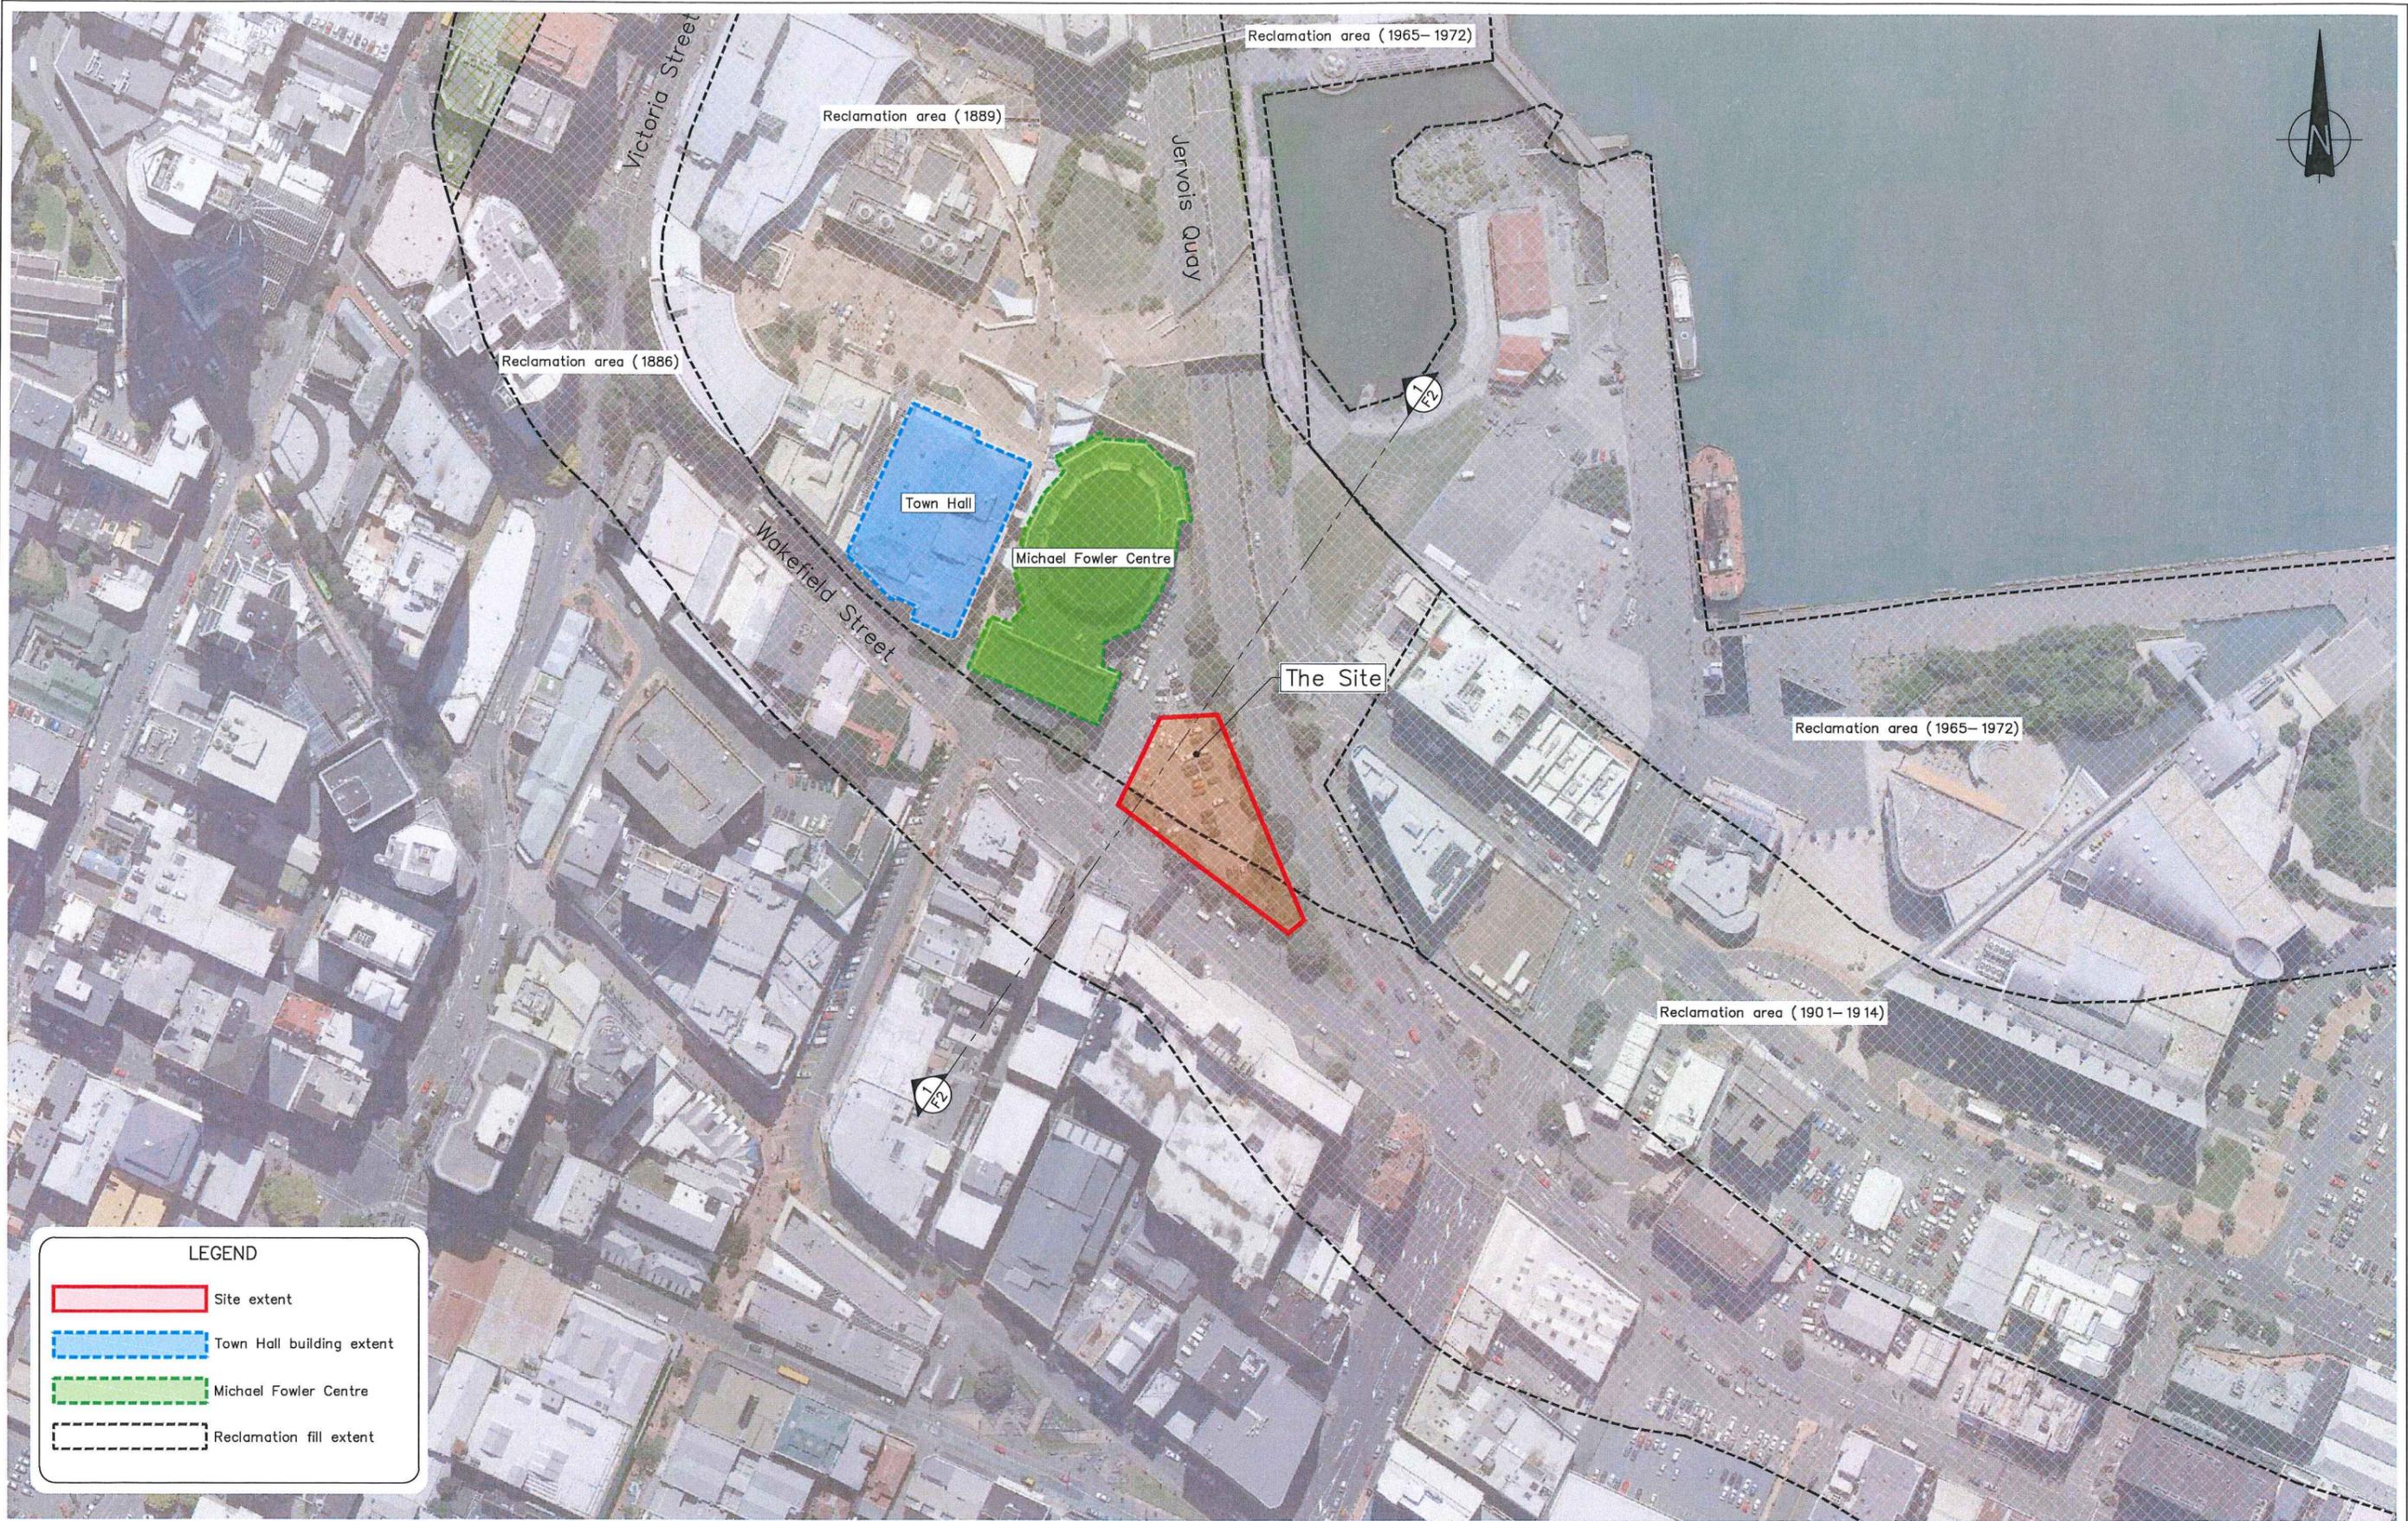
- Site extent
- Town Hall building extent
- Michael Fowler Centre
- Reclamation fill extent
