former military base
shelly bay road
shelly bay
wellington

heritage assessment and
assessment of environmental effects

the wellington company limited

may 2019

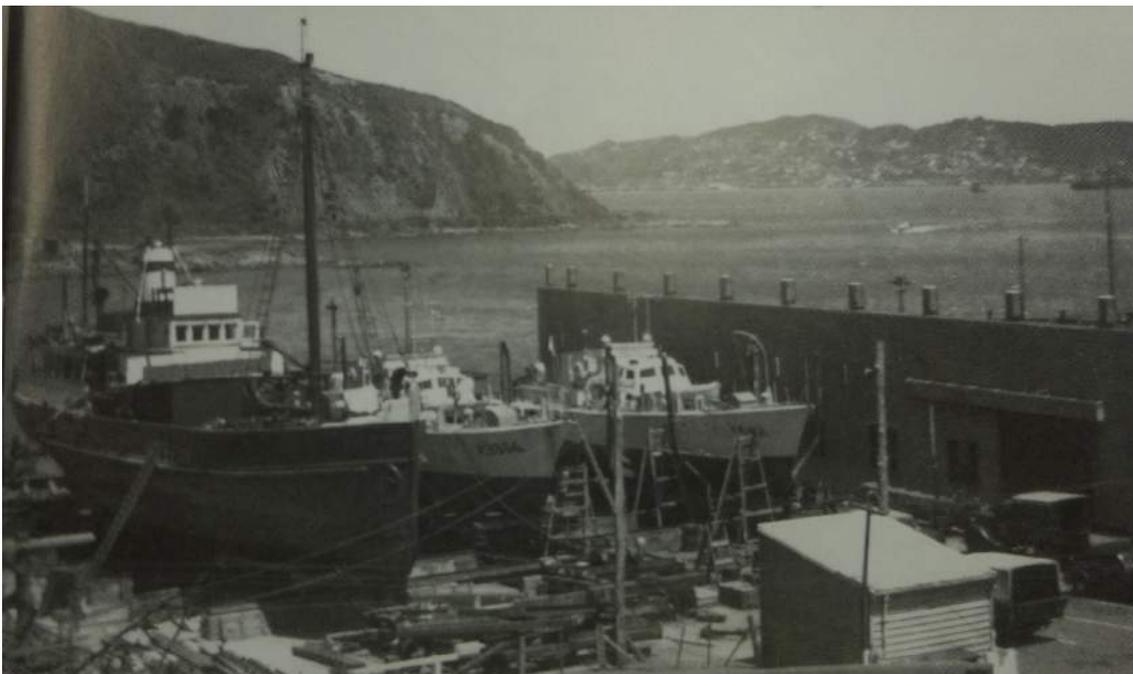
Fig. 18 Looking southwest at boats in the slipway and the Shipwright's Building on the right ca early 1953 – early 1954. (Berthold, "B.T. Daniel Ltd., Shipwrights, Boatbuilders & Marine Engineers, Shelly Bay, Wellington," *New Zealand Marine News* v.58, no.1, p7)

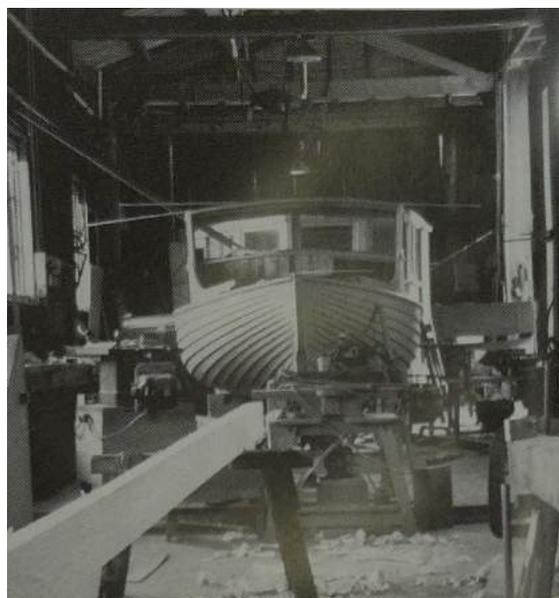
Fig. 19 Two views looking north within the Shipwright's Building in the 1950s, showing boats under construction and repair. Note the monopitched roof, with half-truss roof structure. (Berthold, "B.T. Daniel Ltd., Shipwrights, Boatbuilders & Marine Engineers, Shelly Bay, Wellington," *New Zealand Marine News* v.58, no.1, p20)

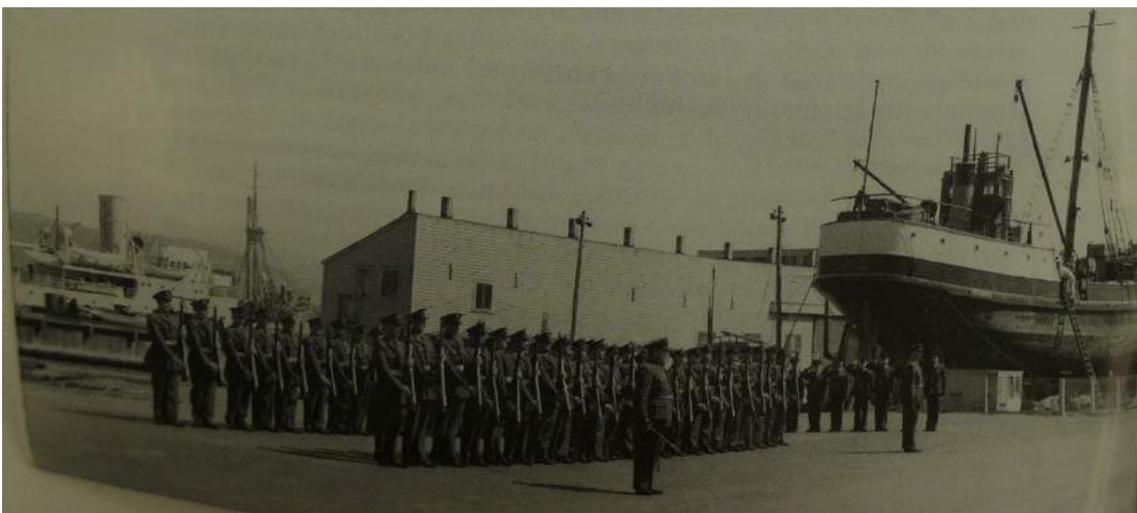
Fig. 21 Looking northwest towards the Shipwright's Building and slipway in 1957, with military forces on parade in the foreground. (Berthold, "B.T. Daniel Ltd., Shipwrights, Boatbuilders & Marine Engineers, Shelly Bay, Wellington," *New Zealand Marine News* v.58, no.1, p6)

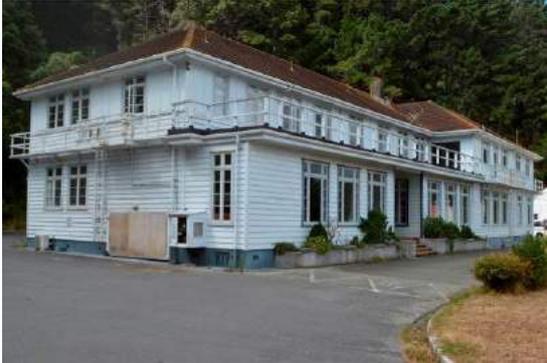
- The external fabric is generally in fair a condition but finishes are in poor condition and require immediate attention to avoid deterioration of built fabric.

Fig. 32 Looking towards the north west corner of the Officer's Quarters building.

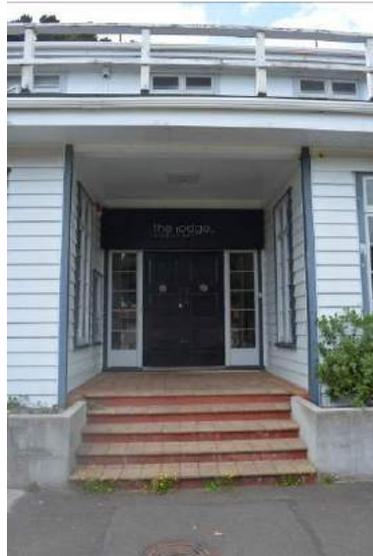
Fig. 33 Looking towards the principal entrance for the Officer's Quarters which is located on the eastern side of the building.

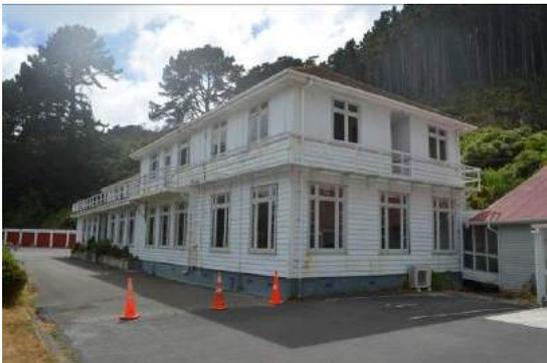
Fig. 34 Looking towards the south west corner of the Officer's Quarters building.

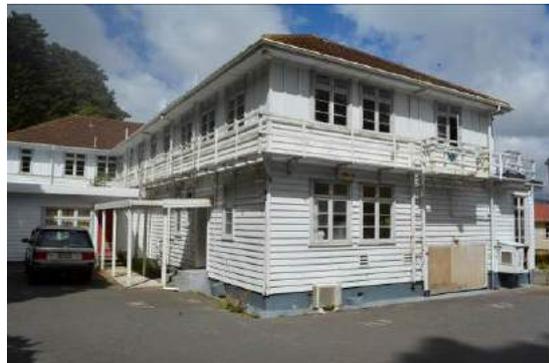
Fig. 35 Looking towards the north east corner of the Officer's Quarters building.

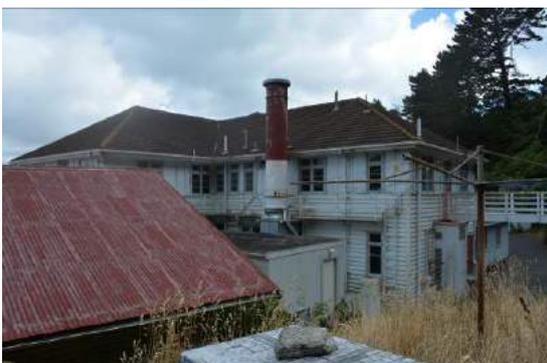
Fig. 36 Looking towards the south east corner of the Officer's Quarters building. The roof of the Officer's Mess Games Room (Building 06) is shown in the foreground.

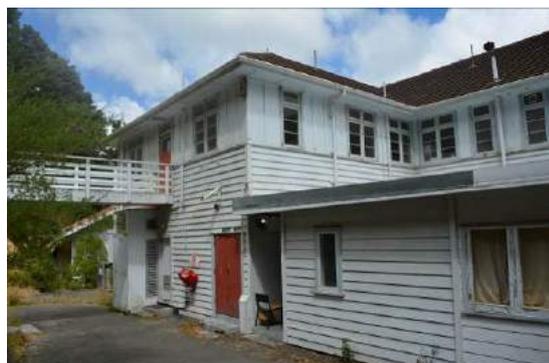
Fig. 37 Looking towards the rear projecting wing of the Officer's Quarters Building. Note the single storey, non-original addition in the foreground.

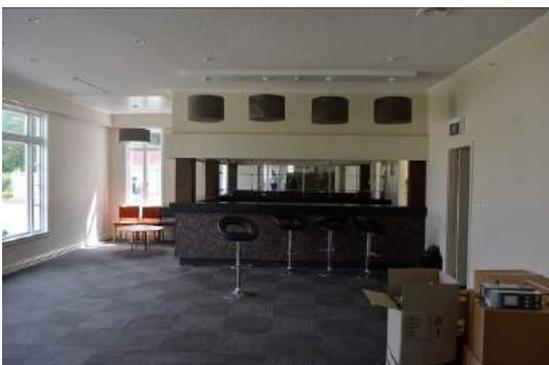
- Laundry and luggage storage facilities are provided at this level
- Walls and ceilings are finished with plain sheet material.
- Internal fabric is generally in good condition but finishes in a number of areas require upgrading.

Fig. 38 Looking north at ground floor level towards the bar area.

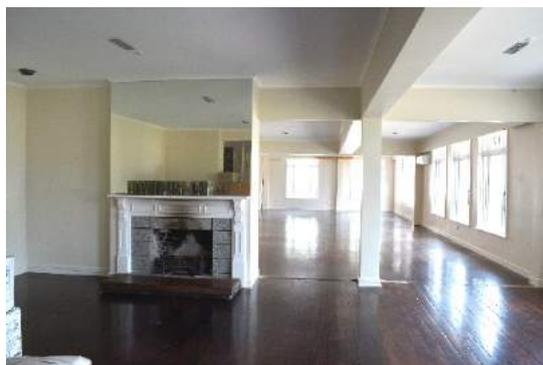
Fig. 39 Looking south at ground floor level towards the central room partition which features the fireplace mantle and hearth. Note the timber floors and window joinery.

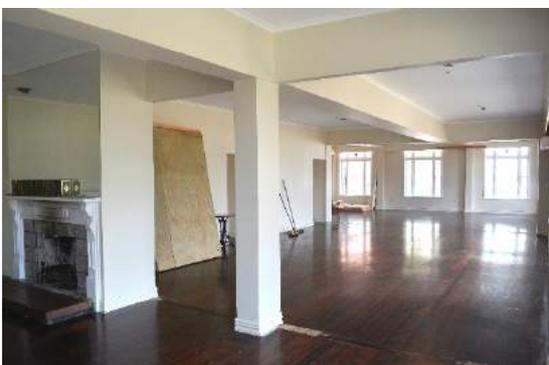
Fig. 40 Looking south east at ground floor level towards the central room partition which features the fireplace mantle and hearth. Note the timber floors and window joinery..

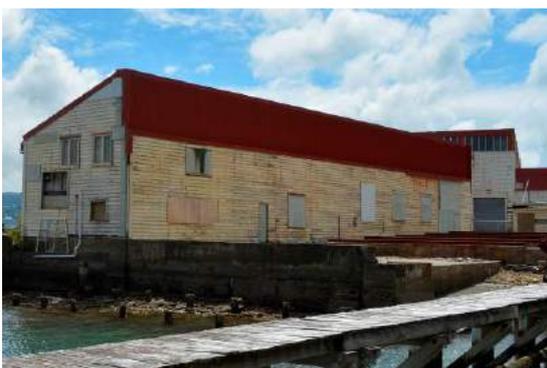
- The external fabric is generally in poor condition with missing/decayed weatherboards and rainwater goods. Immediate attention is required to avoid irrevocable deterioration of built fabric.

Fig. 56 View towards the south eastern corner of the Shipwrights' Building.

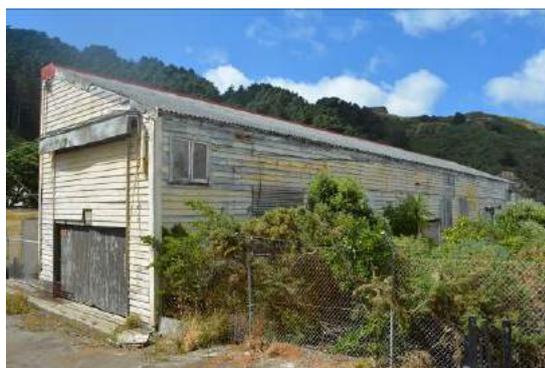
Fig. 57 View towards the north western corner of the Shipwrights' Building. Note the large timber swing doors in the north gable end.

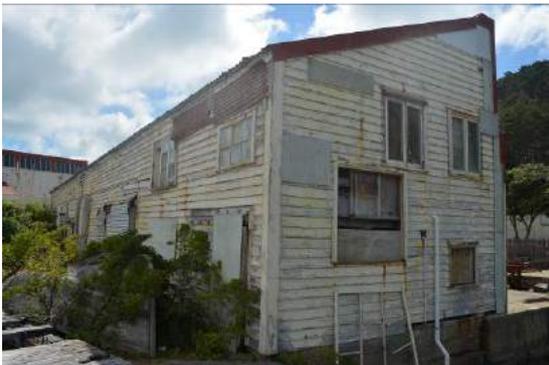
Fig. 58 View towards the south west corner of the Shipwrights' Building.

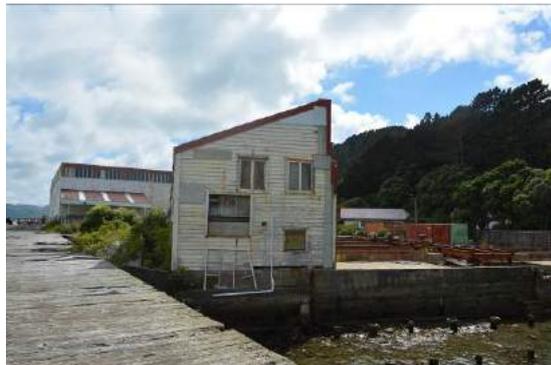
Fig. 59 Looking north towards the south gable of the Shipwrights' Building. Note the slipway infrastructure on the right of the building.

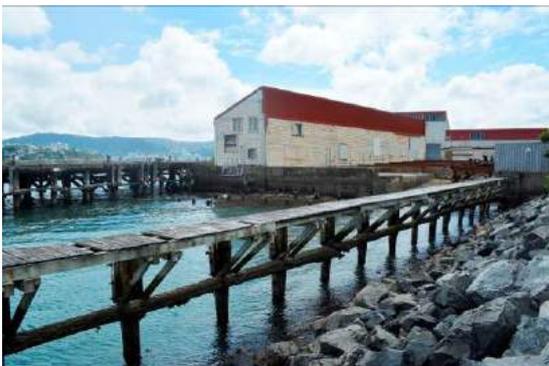
Fig. 60 View towards the south east corner of the Shipwrights' Building from Shelly Bay Road.

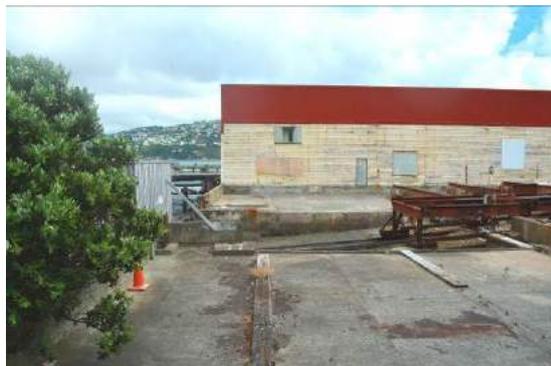
Fig. 61 View towards the eastern elevation of the Shipwrights' Building with the slipway infrastructure in the foreground.

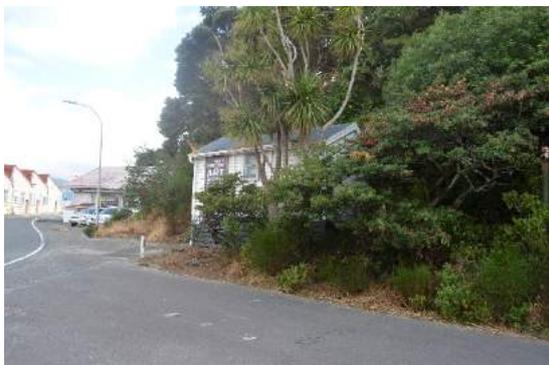
- The building is laid out over a simple rectangular plan
- It is arranged over a single storey on raised piles to accommodate for the steep topography.
- The roof is clad with corrugated metal sheeting.
- Rusticated timber weatherboard exterior cladding is evident on the north and south elevations. The west gable is clad with shiplap weatherboards. The east gable is clad with sheet material
- Timber framed casement windows are evident in the south western elevation and north western gable.
- A single timber tongue and grooved entrance door is located on the north eastern elevation.
- The external fabric is generally in good condition but finishes are degrading and general repair and maintenance is required to address vegetation growth, missing gutters.

Fig. 62 View looking from Shelly Bay Rd towards the north. Note the subject outbuilding set back into the base of the escarpment and screened by vegetation from this approach..

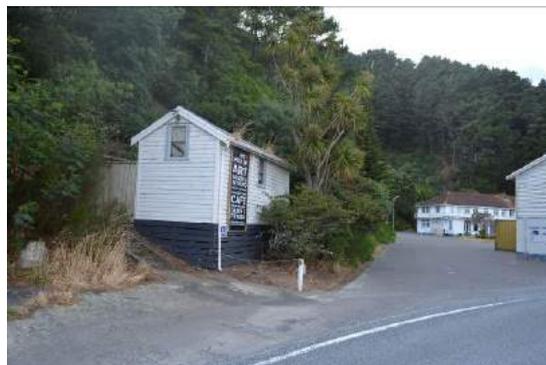
Fig. 63 View of the outbuilding looking towards the east from Shelly Bay Road.

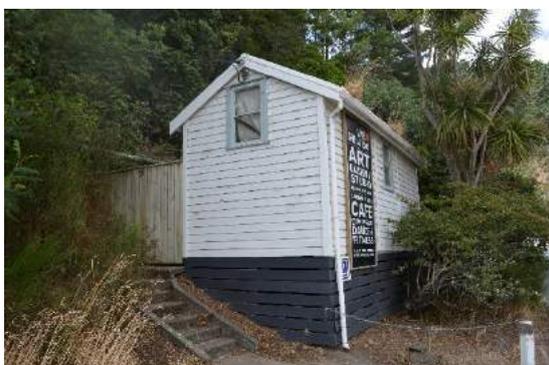
Fig. 64 View of the outbuilding looking towards the west gable. Note the concrete steps which provide access up to the main entrance and the shiplap weatherboards on this gable.

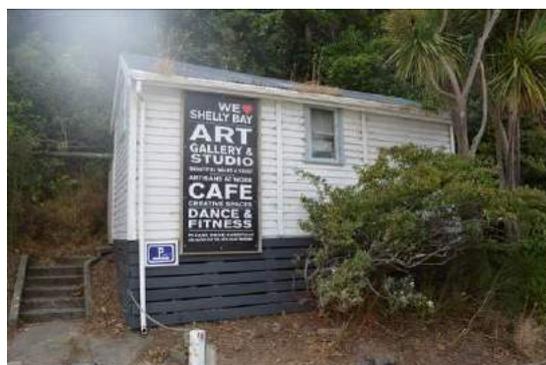
Fig. 65 View of the outbuilding looking towards the south elevation. Note the concrete steps which provide access up to the main entrance and rusticated weatherboards on this elevation.

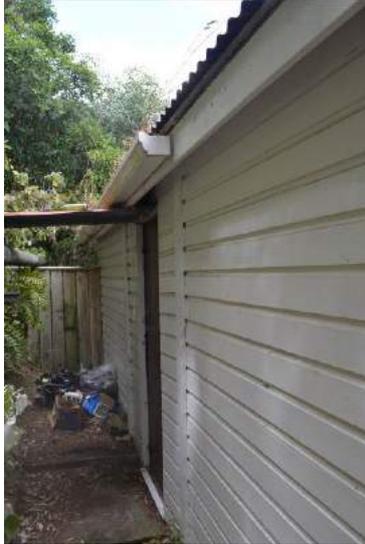
Fig. 67 View of the main entrance door in the north elevation. Note the rusticated weatherboard on this elevation.

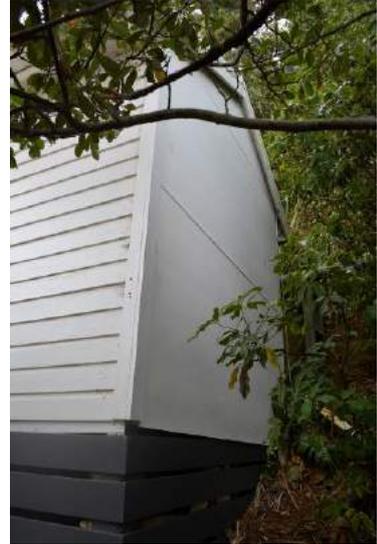
Fig. 68 View of the east gable. Note the flat sheet material used for the cladding.

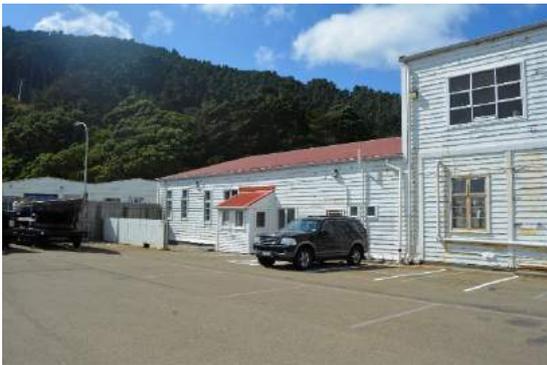
- Timber panelled or tongue and grooved external doors.
- The external fabric is generally in poor condition with delaminating finishes, missing/decayed weatherboards and rainwater goods. Immediate attention is required to avoid irrevocable deterioration of built fabric.

Fig. 69 View of Shed 8 looking towards the east corner of the north elevation. Note the single storey element fronting the service courtyard.

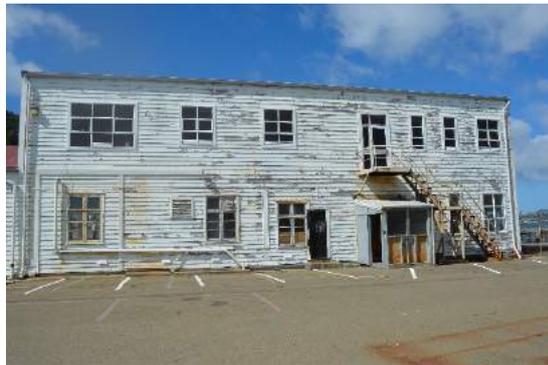
Fig. 70 View of Shed 8 looking towards the west corner of the north elevation. Note the two-storey element fronting the service courtyard used for office accommodation.

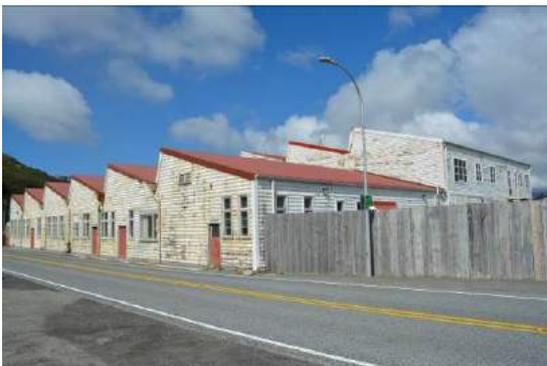
Fig. 71 View of Shed 8 looking towards the north east corner of the building and the six span, single storey element fronting Shelly Bay Road. Note the two-storey element towards the rear aspect.

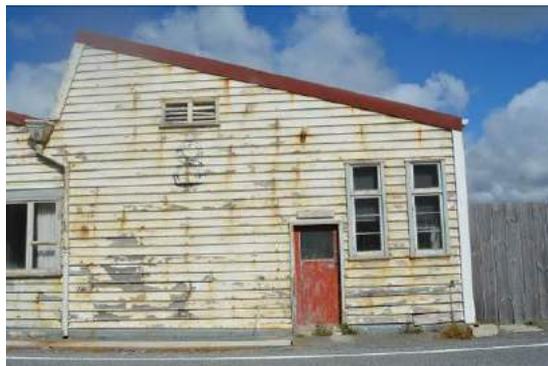
Fig. 72 View of a single span on the north east gable end. Note the 'saw-tooth' roof profile.

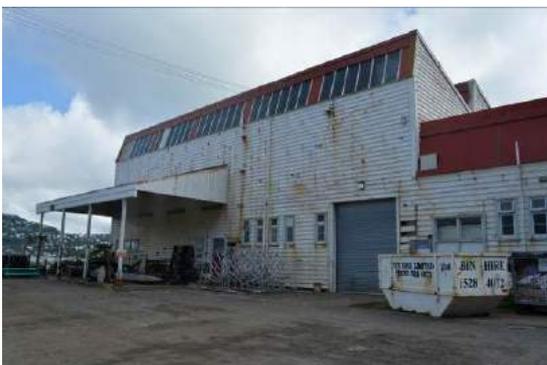
Fig. 75 View of the southern elevation and the high stud, two-storey section fronting the service yard. This section was utilised as the workshop and storage facility.

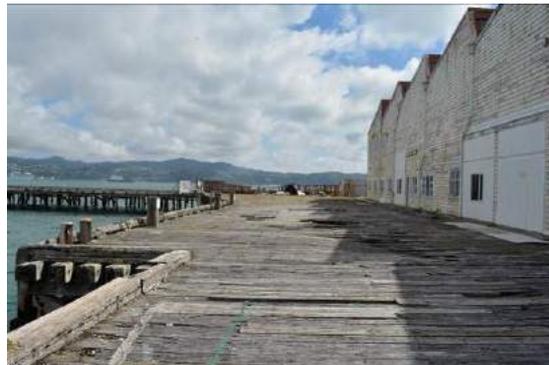
Fig. 78 Looking towards the north with the west gable, high stud portion of Shed 8 on right of image. Note this elevation directly addresses, and links to, the wharf structure.

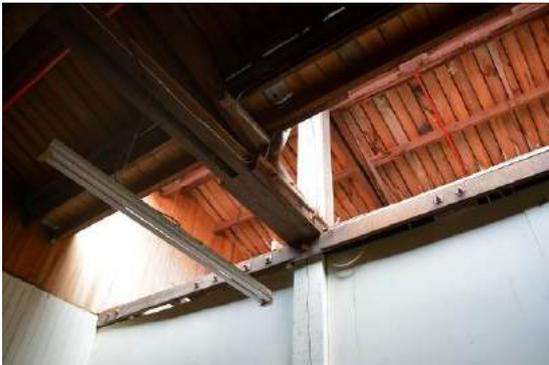
Fig. 82 Looking above internal non-structural partitioning to view the timber roof structure.

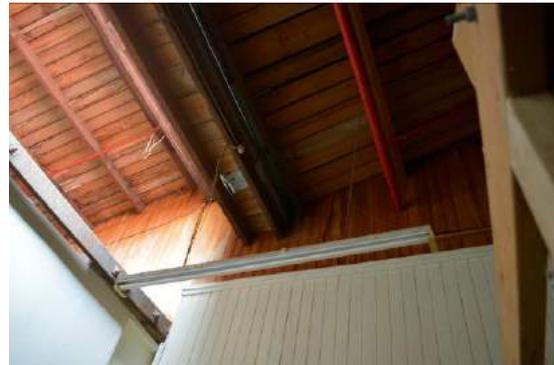
Fig. 83 Looking above internal non-structural partitioning to view the timber roof structure.

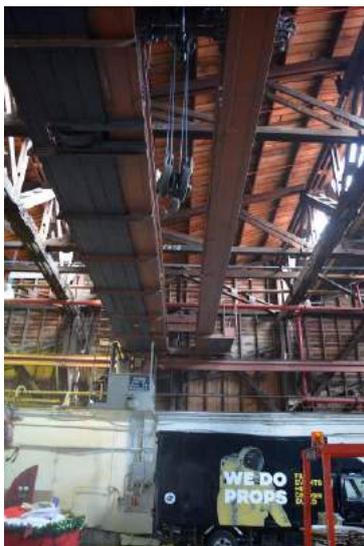
Fig. 85 Interior view looking east across the high stud double storey section of the building. Note the gantry crane remains in-situ.

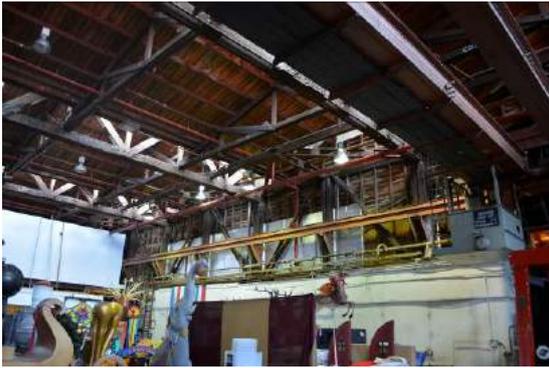
Fig. 87 View looking west across the high stud double storey section of the building. Note the timber roof structure with wide span ladder trusses, heavy gauge structural timbers, exposed purlins and sarking.

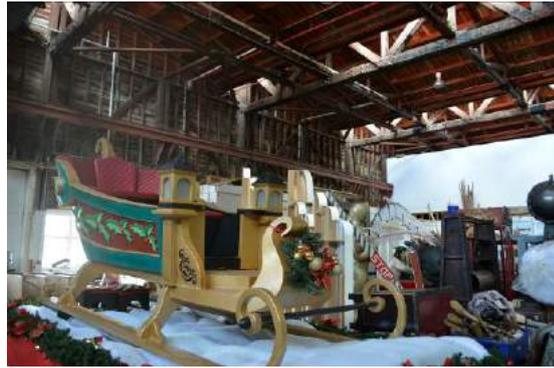
Fig. 88 View looking towards the west elevation, across the high stud double storey section of the building. Note the timber roof structure with wide span ladder trusses, heavy gauge structural timbers, exposed purlins and sarking.

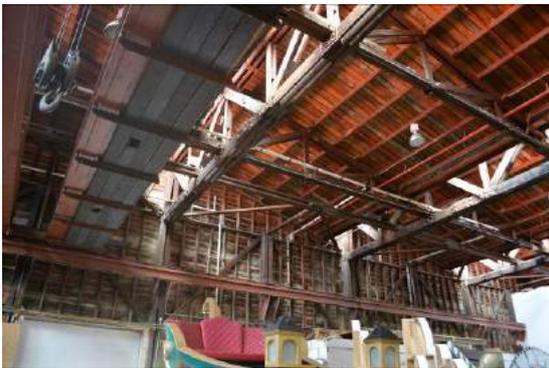
Fig. 89 Interior view looking west across the high stud double storey section of the building. Note the timber roof structure with wide span ladder trusses, heavy gauge structural timbers, exposed purlins and sarking.

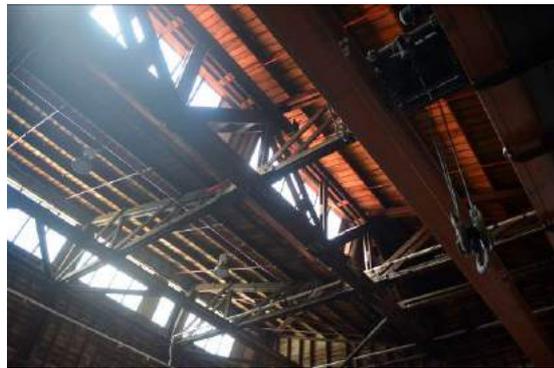
Fig. 90 Looking back towards the south aspect. Note the glazed portions of the saw-tooth roof profile.

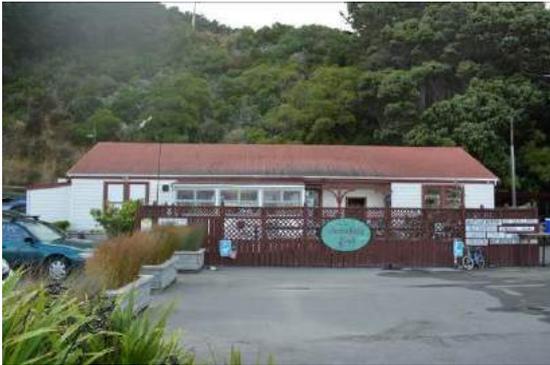
- The external fabric is generally in good condition but finishes are degrading and general repair and maintenance is required. Some splitting/checking of timber weatherboard ends is noted.

Fig. 91 Looking towards the north-west elevation of the Former Submarine-Mining Building. Note the trellis in front of the building which forms a dining courtyard for the café patrons.

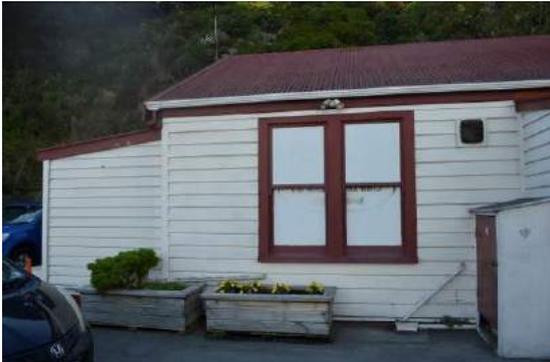
Fig. 93 View of the pair of double-hung sliding-sash windows (boarded up) in the north end of the principal elevation.

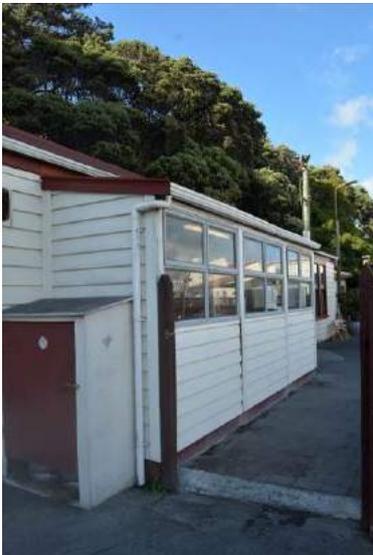
Fig. 95 View of the non-original lean-to structure constructed on the against the veranda on the north-western elevation. This forms additional kitchen facilities.

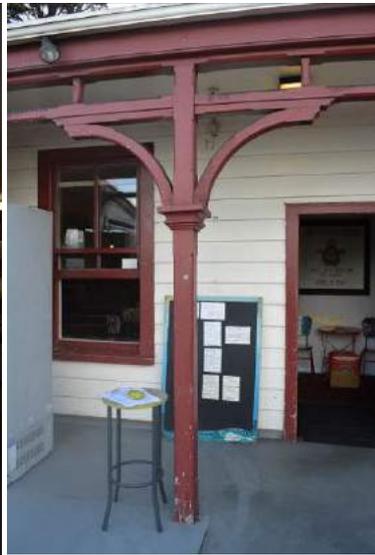
Fig. 97 Note original braced posts and timber fretwork.

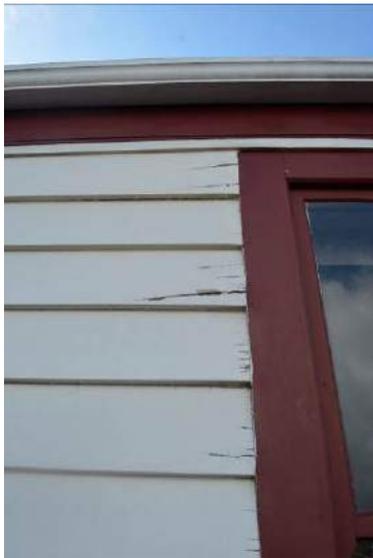
Fig. 99 Evidence of decaying weatherboards.

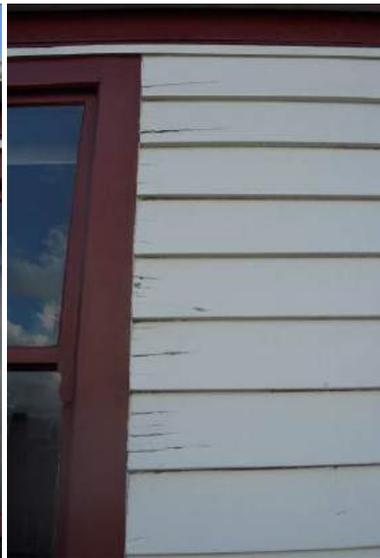
Fig. 100 Evidence of decaying weatherboards.

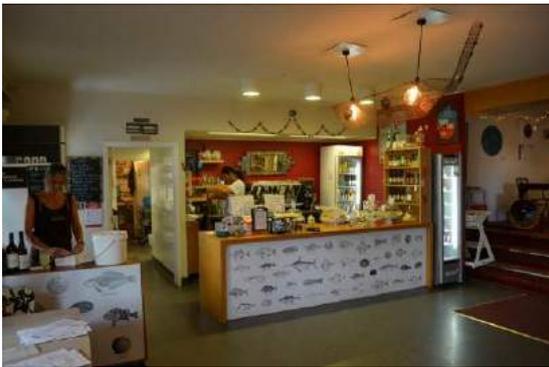
- Floors were covered with a mixture of linoleum or carpet.
- Walls and ceilings are lined with plain sheet material.
- Internal fabric is generally in good condition but finishes in a number of areas require upgrading.

Fig. 101 Looking from the entrance lobby into the main body of the building which is formed as a single open space. Note the café counter and door behind leading to kitchen preparation facilities and a rear entrance.

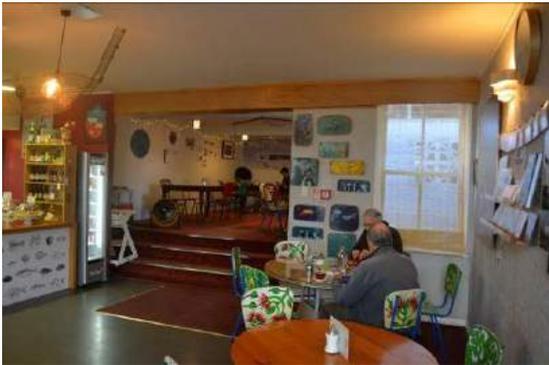
Fig. 103 View across the single large interior open space towards steps leading to the rear addition which is set on a higher level. Note the large opening to this area which would have been formed through the rear wall of the original building and resulted in the loss of historic fabric.
