Frank Kitts Carpark DSA Detailed Seismic Assessment

Frank Kitts Carpark
15 Jervois Quay
Wellington

Detailed Seismic Assessment Report

Prepared For:
Wellington City Council

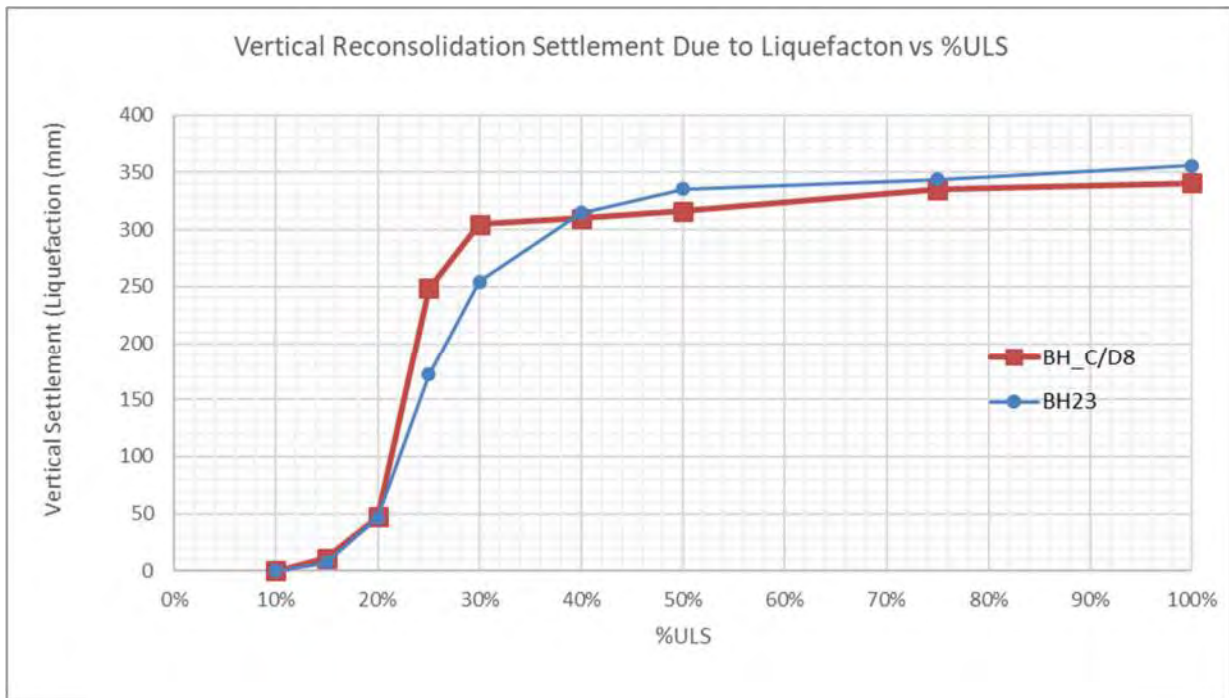
Figure 8: Plot showing relationship between vertical reconsolidation settlement and %ULS

The analyses were carried out for a range of accelerations to determine the relationship between liquefaction triggering and the ULS PGA. These results are presented in Figure 8. This plot suggests that a 'step change' in ground performance occurs between 20 – 30%ULS.

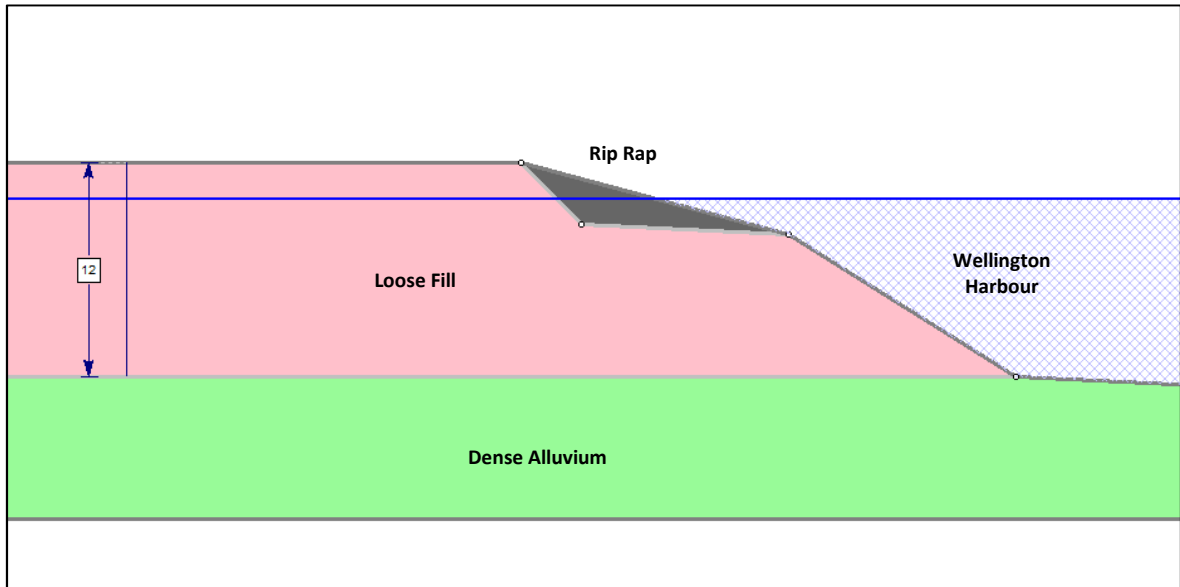
Figure 10: Ground profile used for the lateral spread analysis

We have taken $L = 75\text{m}$ which is the distance from the free face to the edge of the building furthest from the Wellington Harbour. This distance runs in a West – East direction which is the more critical case for lateral spread at the site. The height of the free face, H , was more difficult to determine given that we did not have a survey of the seabed. What we know is there is approximately 12m of fill at the site and there is riprap at the crest of the slope which we can observe. Bathymetry surveys⁶ for Wellington indicate that the seabed is approximately 5m below chart datum in area nearest to the Frank Kitts Carpark. We have therefore used the ground profile shown in Figure 10 for the lateral spread analysis.

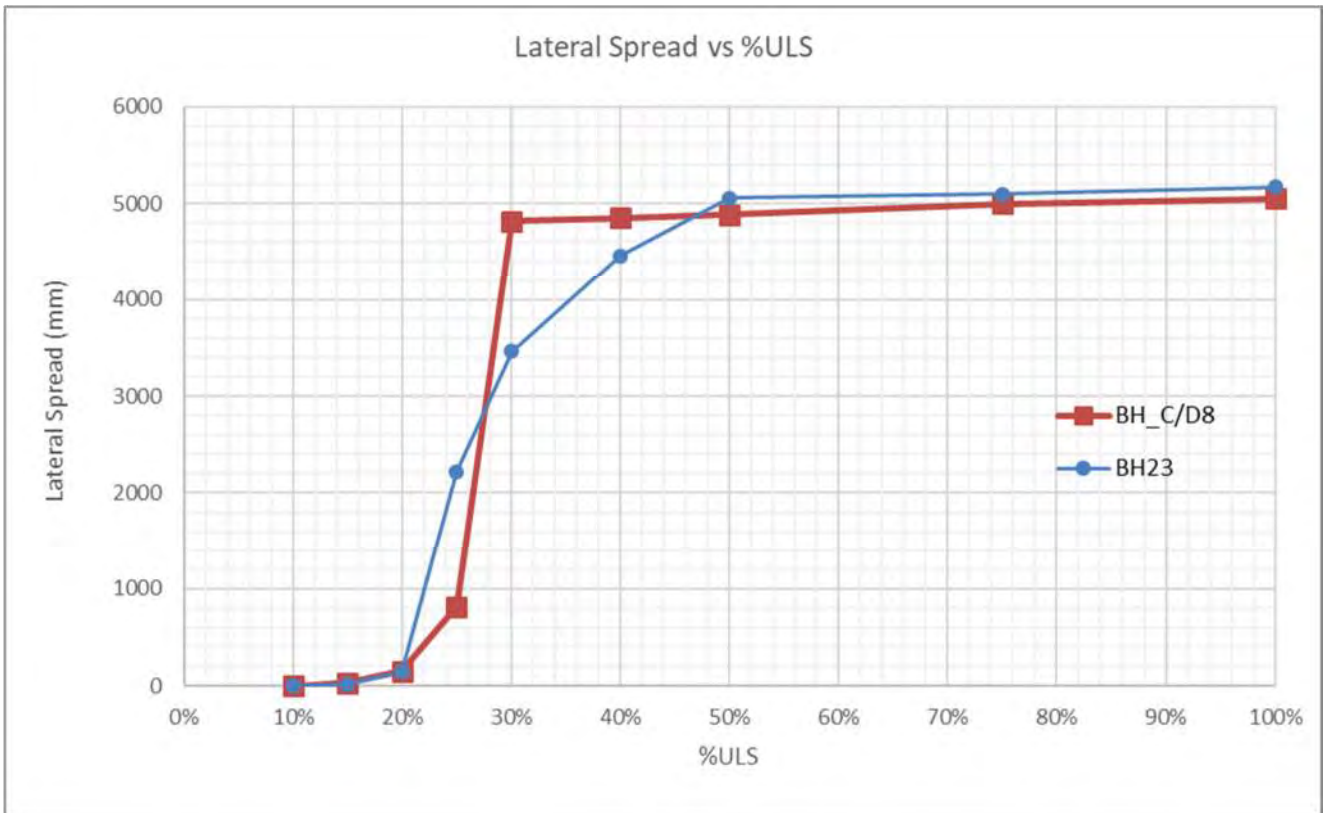
Figure 11: Plot showing the relationship between lateral spread vs %ULS

The results of the lateral spread analysis using Zhang (2004) are shown in Figure 11.

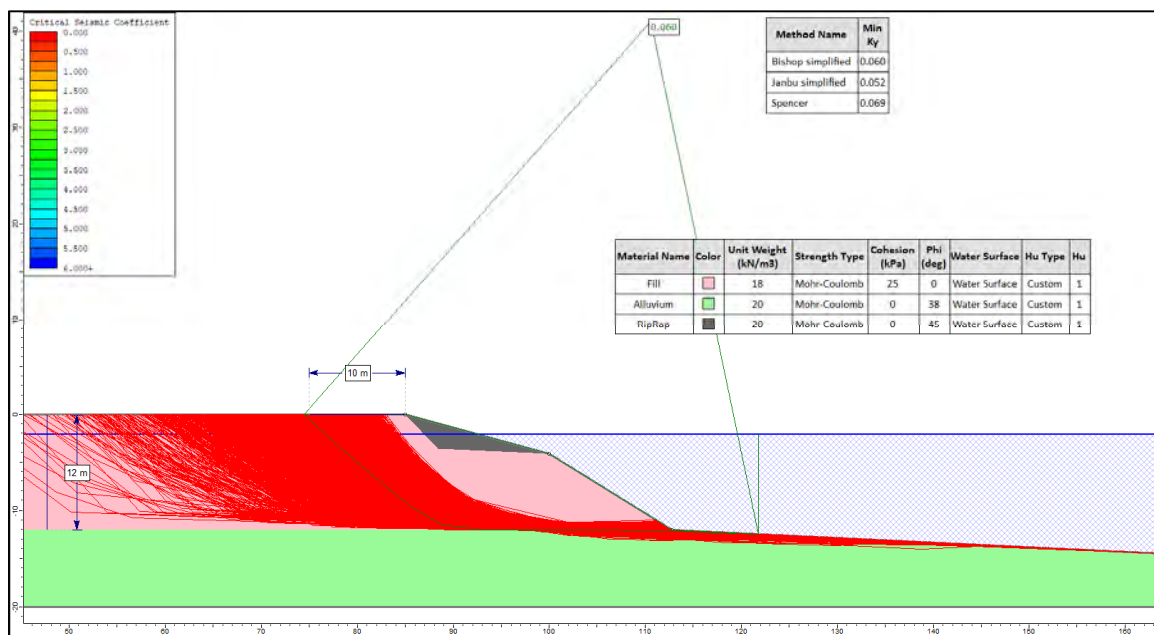
Figure 12: Results showing critical acceleration

Using the meta-analysis chart presented in Figure 24 in the paper presented by Wood 2015⁸, and taking $a_{max} = 0.585g$, the displacement was calculated to be about 1m.

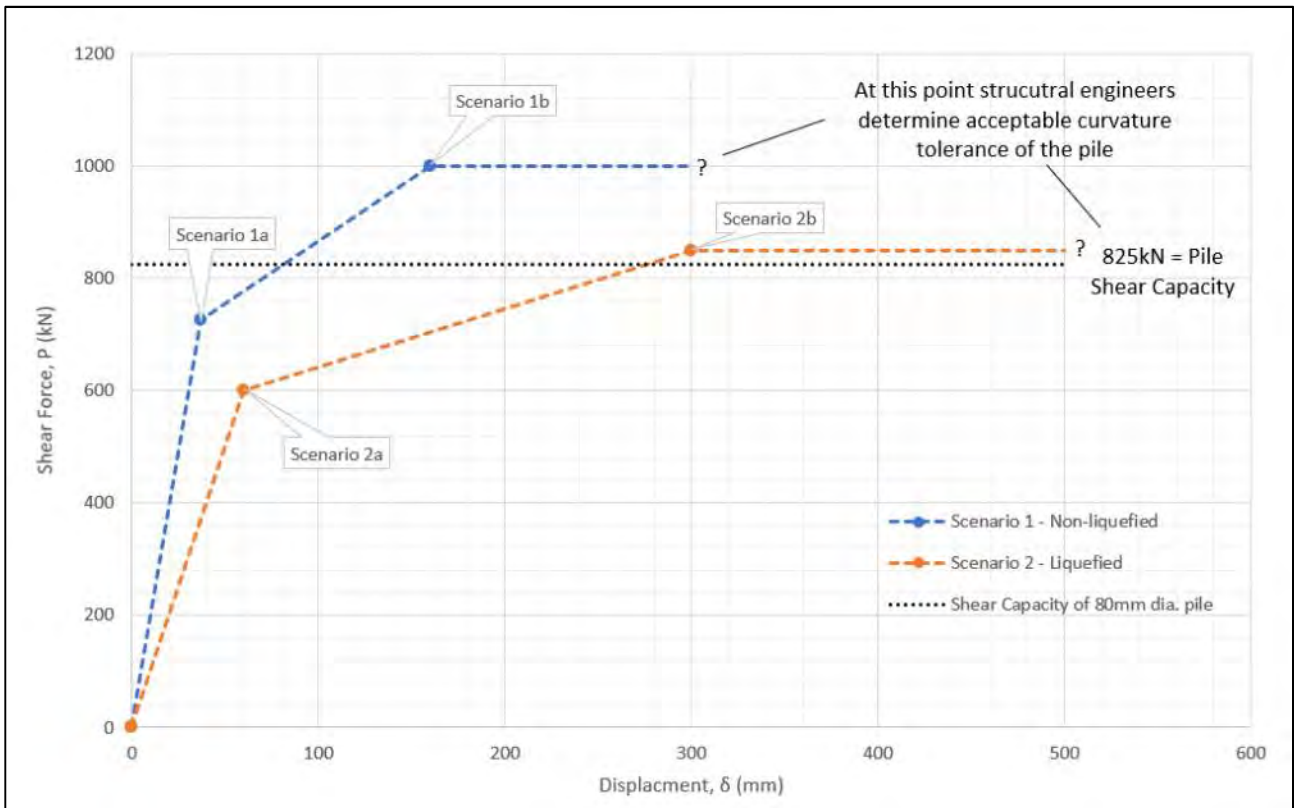
Figure 14: Plot showing load-displacement relationship for the 800mm dia. piles

The results of the pile analyses can be summarised in the plot presented in Figure 14. The structural engineers will use this (load – displacement) relationship to investigate the structural performance of the pile foundation. On this plot we have also included the shear capacity of the pile (825kN, as advised by the structural engineers). The structural limitations of pile performance are evaluated and discussed as part of the structural assessment.

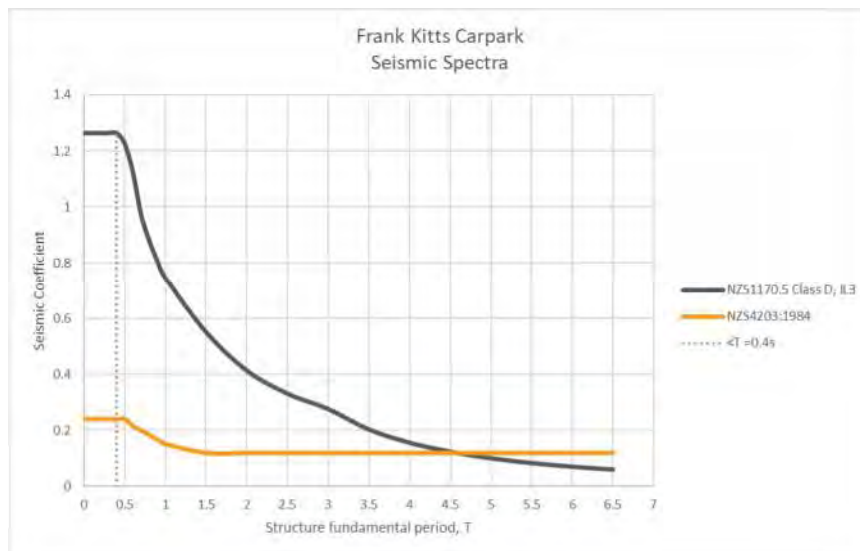
Figure 5 - Seismic spectra comparison between NZS4203:1984 and NZS1170.5:2004

The horizontal acceleration response spectra determined in accordance with NZS1170.5 and NZS4203 is shown in Figure 5.

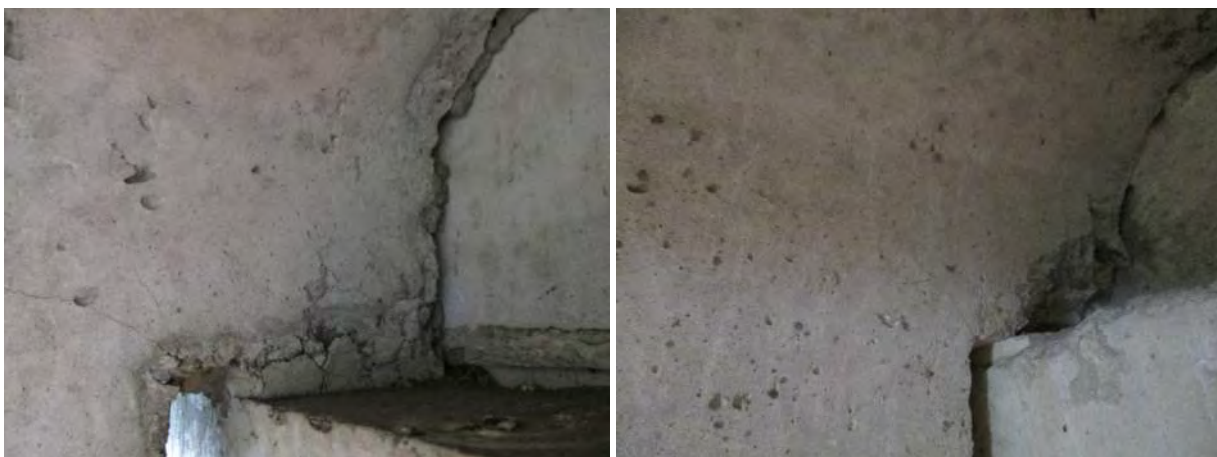
Figure 8 - Double tee support conditions - (Left) double-tee units positioned directly against the beam and (right) initial spalling at the back of the double-tee unit

However, for damaged units, where initial spalling has occurred there is limited seating length remaining. The area remaining for bearing at the ends of the double-tee units will be reduced. For the double-tee units that were found with initial spalling, the potential remaining contact length is within the concrete cover of the beams. Bearing capacities have been checked in accordance with Section 16.3 of NZS3101:2006 Amendment 3. It was found that the residual bearing area is expected to be adequate for building drifts (displacements) up to 40%NBS (IL3) level of loading.

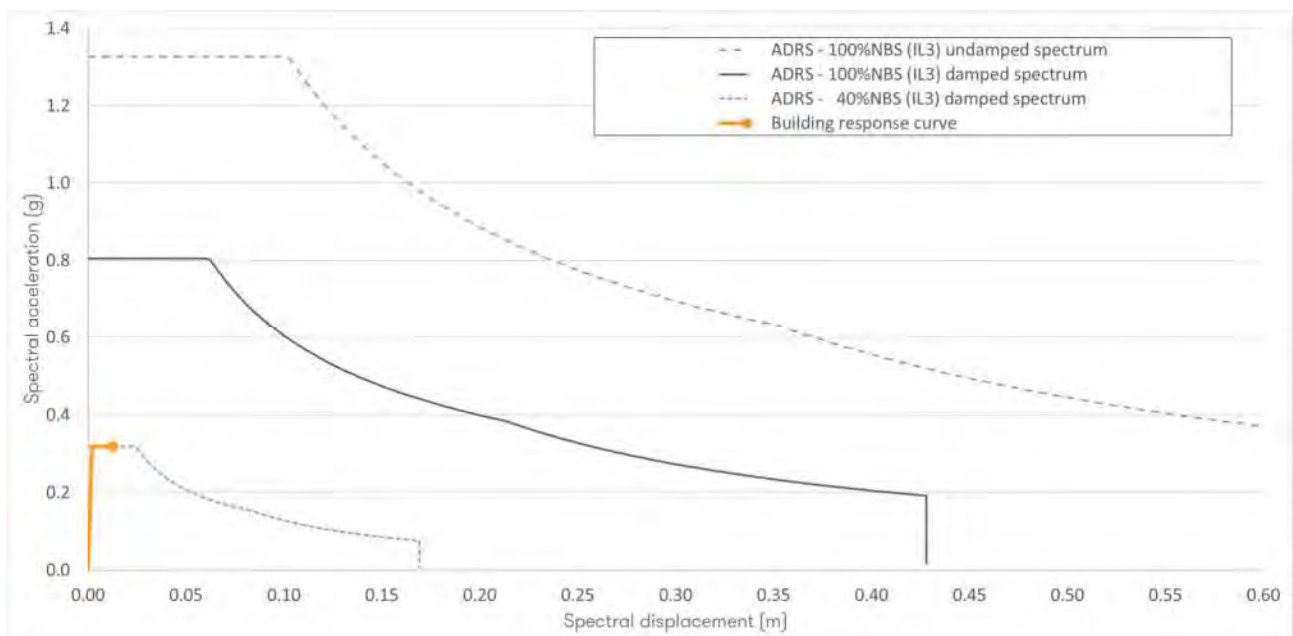
Figure 12 - Building response curve of the precast concrete walls in the East-West direction

Initiating this step in the analysis has found that the centre of stiffness, is moving approximately 15m to the North to redistribute the loads between the remaining elastic bracing lines. Upon this redistribution however, it is found that under the same level of loading (~22% of ULS seismic loading) the other primary gridlines 1 and gridline 3/4 are also initiating yielding due to the additional load on the walls from torsional demands. The total system is ultimately able to redistribute the loading to other gridlines to increase the overall shear resistance of the system and the whole system yields in the East-West direction at 24% of ULS seismic loading. The North-South direction has more walls to redistribute the forces along and initiates yielding of the precast concrete wall panels at higher seismic loading.

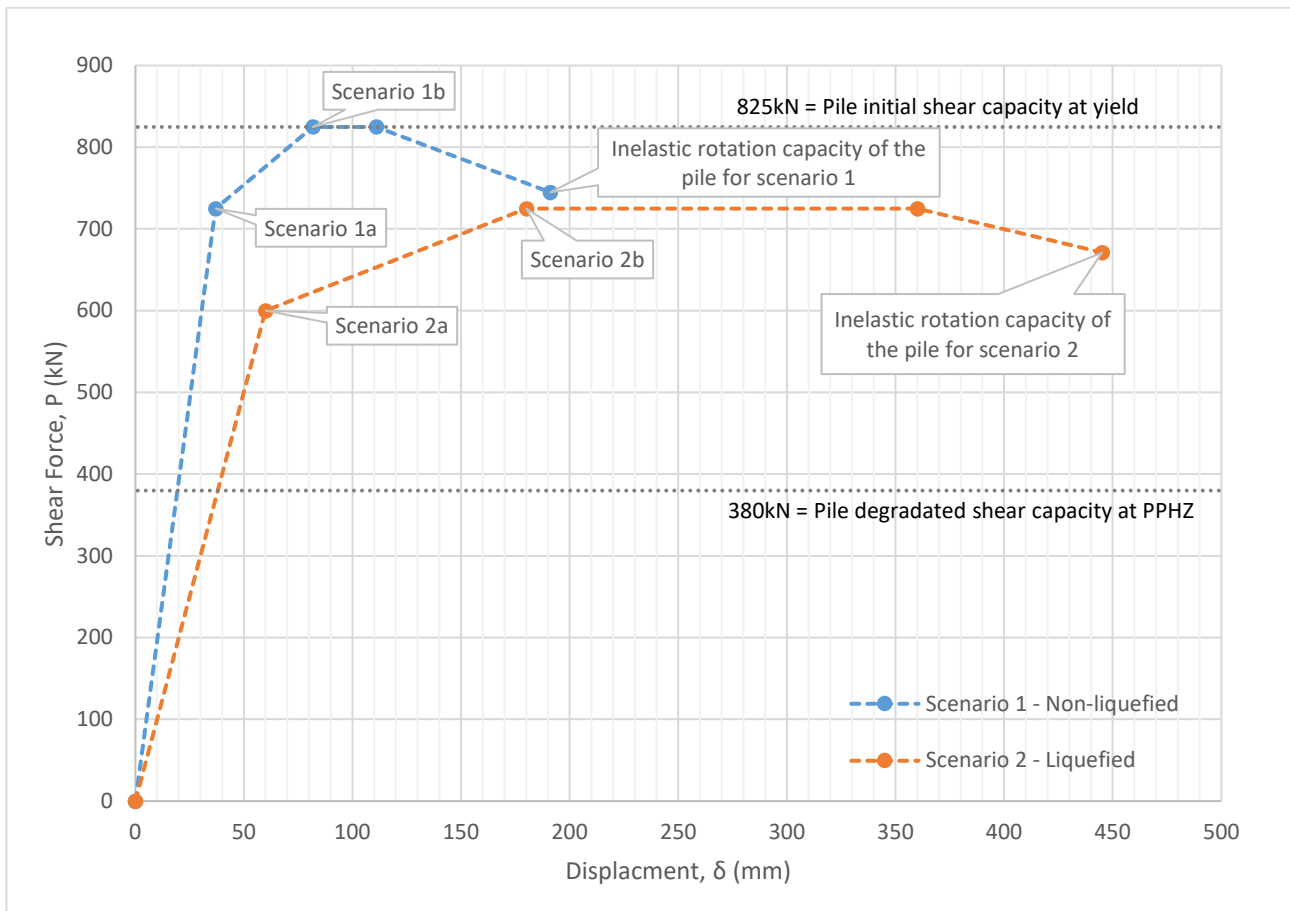
Figure 20 - Pile response curves

While the piles have got the inelastic rotation capacity to undergo these inelastic displacements there is less certainty in how much this dissipates the energy of the seismic shaking and how these large displacements may affect the superstructure. However, the piles themselves perform around the 40-50%NBS mark for scenarios 1 and 2.
