# WCC Housing Detailed Seismic Assessments

Hanson Court Block A – Detailed Seismic Assessment

**Wellington City Council**

Document control		aurecon				
Report title		Hanson Court Block A – Detailed Seismic Assessment				
Document code		523020-001-REP-SS-001	Project number		523020	
File path		<a href="#">523020 - WCC Housing DSAs - Berkeley Dallard, Etona Apartments, Hanson Court - 5 Working Files\502 Engineering\02 Structures\Reports\HC - Block 1</a>				
Client		Wellington City Council				
Client contact		Casey Zhang and Mario Venter	Client reference			
Rev	Date	Revision details/status	Author	Reviewer	Verifier (if required)	Approver
0	2023-03-09	Draft – For Client Review	s(7)(2)(a)			
1	2023-12-19	Draft – Accounting for the peer review				
2	2024-09-03	Final				
3	2025-01-29	Final				
Current revision		3

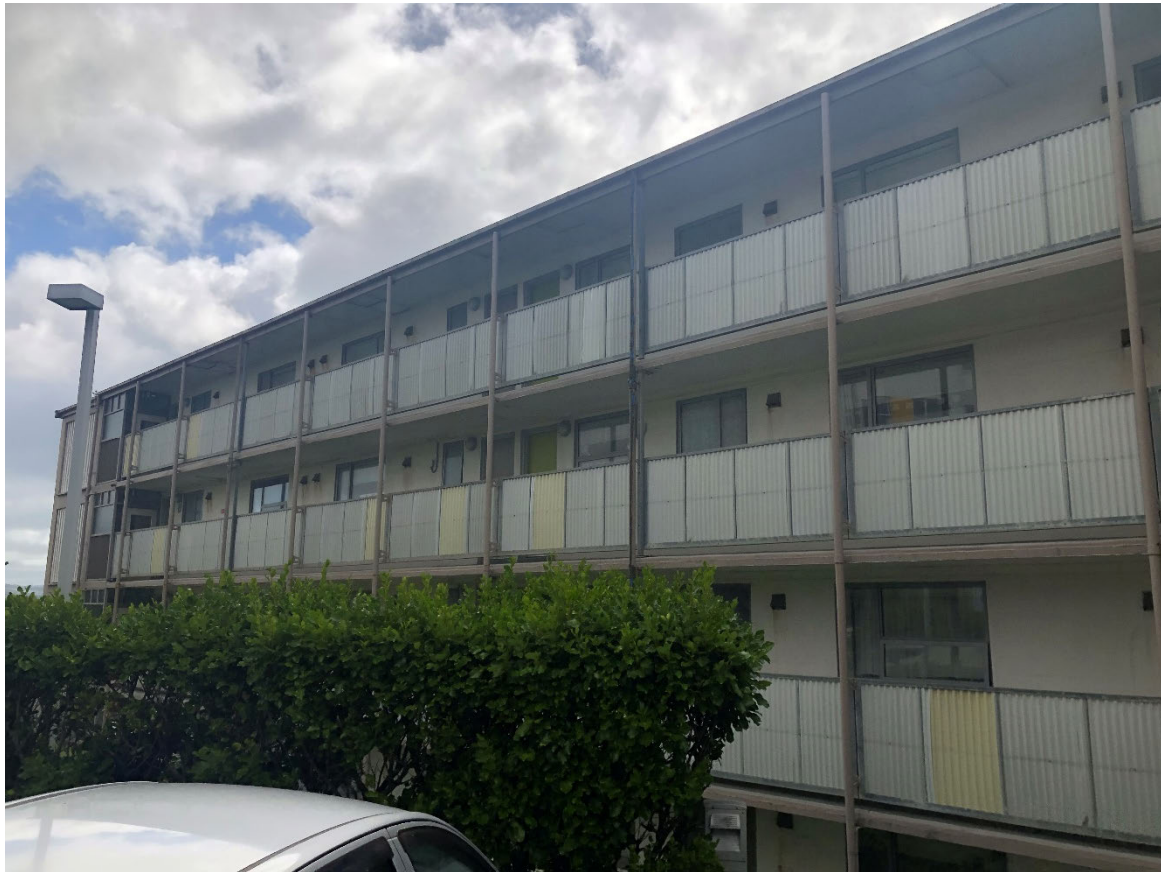
Figure 1-2 Building Site Photograph

This DSA report is for the **Hanson Court Block A Building**. **Figure 1-2** shows an elevation of the building.

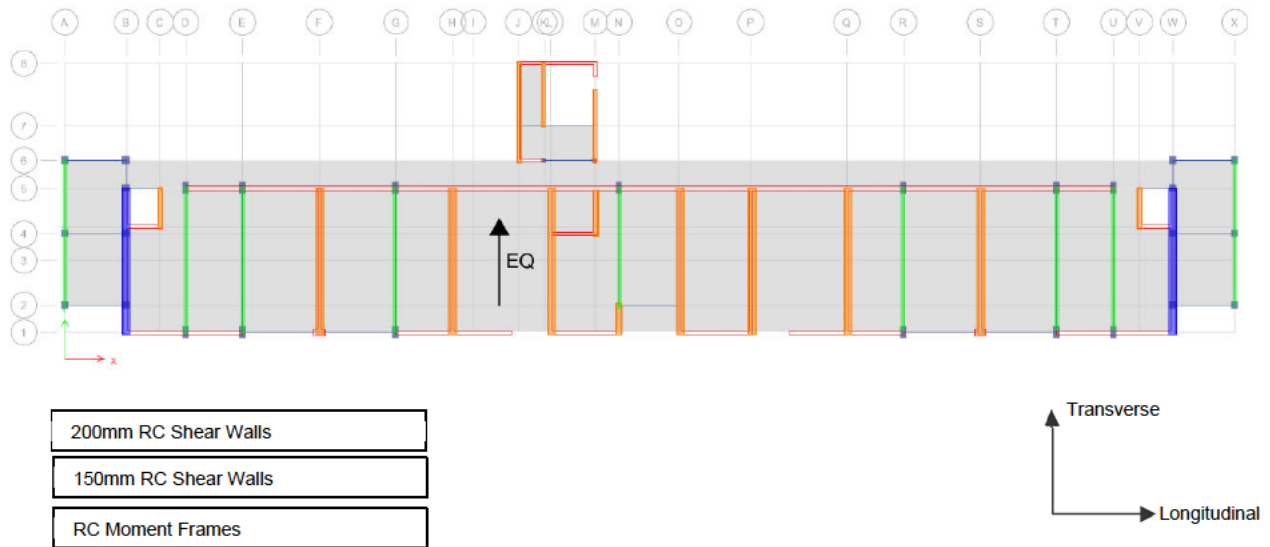
Figure 3-2 Lateral Load Resisting Elements in the Transverse Direction

The shear walls cantilever up from the 3<sup>rd</sup> floor to support the timber and aluminium roof structure. Refer to

Figure 3-2 for a plan view showing the lateral load resisting elements in the transverse direction.

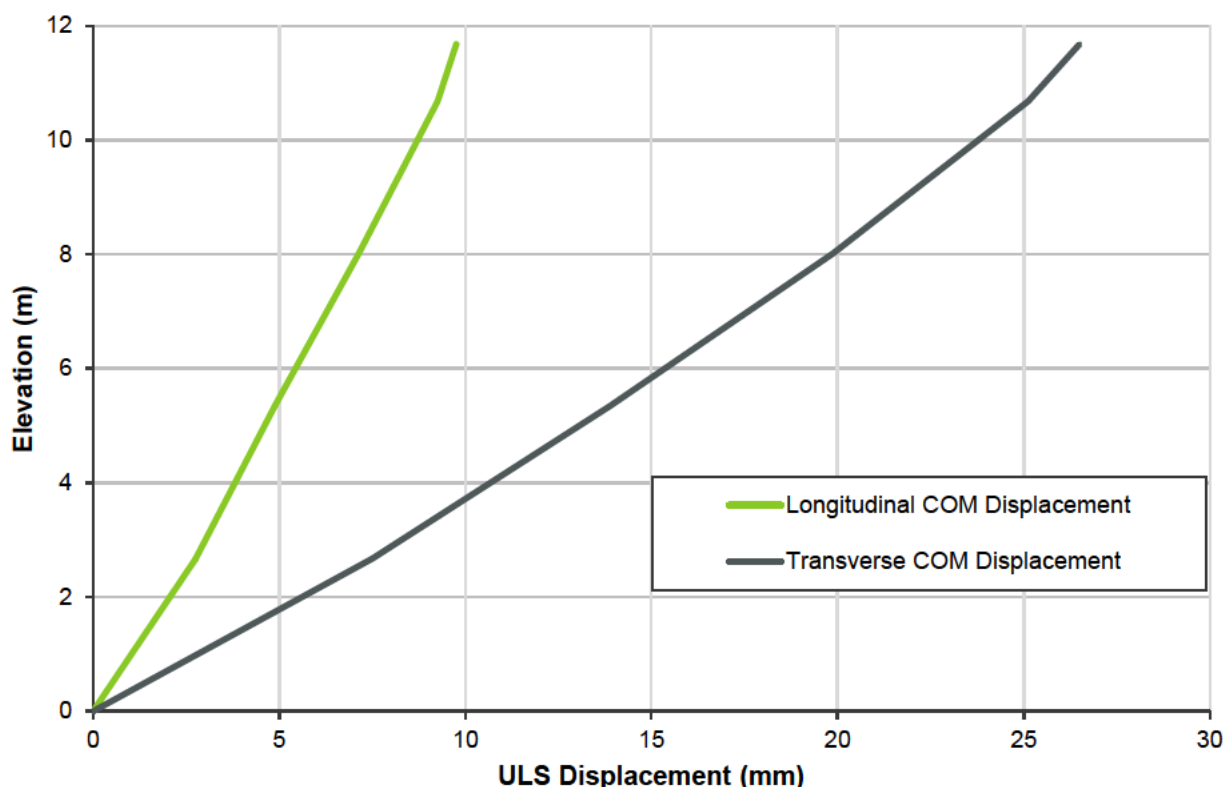
Figure 6-1 Estimated Building Displacements for 100% ULS shaking

**Table 6-2** shows the structures time periods, global ductility demand at 100%ULS and the maximum inter-storey drift under 100%ULS shaking. The storey drift allows for the kdm modification factor and P-delta effects. In both directions, the drift is less than the design code limit of 2.5%.

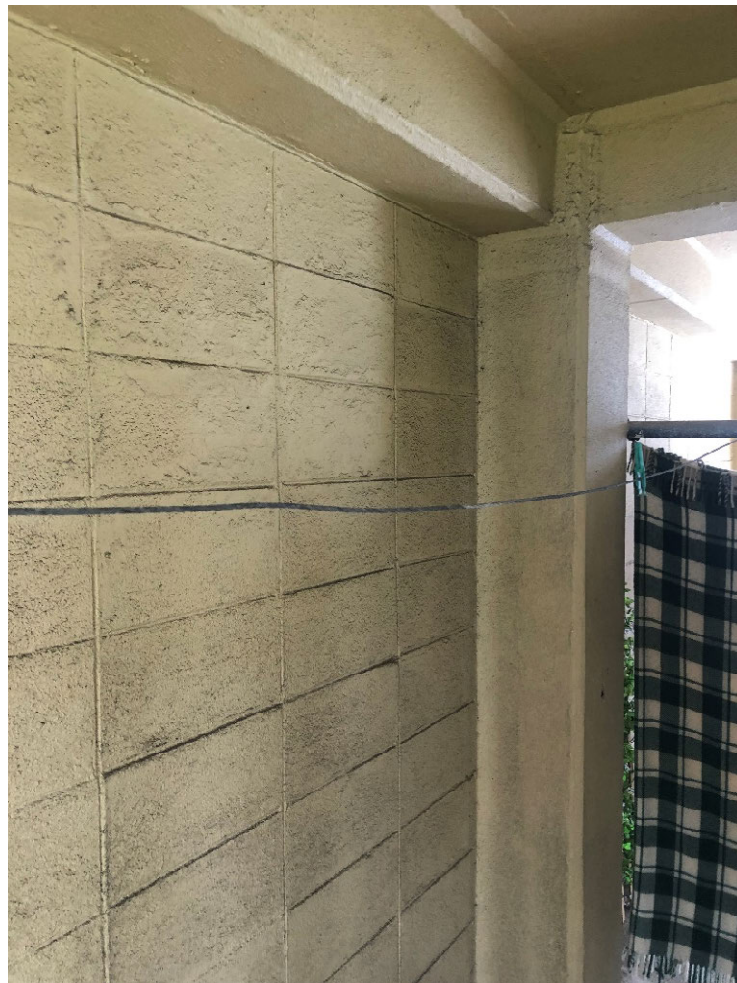
**Photograph 2: Blockwork infill wall**
