KOTC DSA Report HUP2-T0-Seismic Assessments

5 Kemp Street

Document Number:
N0541-RBG-KOTC-XX-RP-ST-00001

Prepared for Wellington City Council

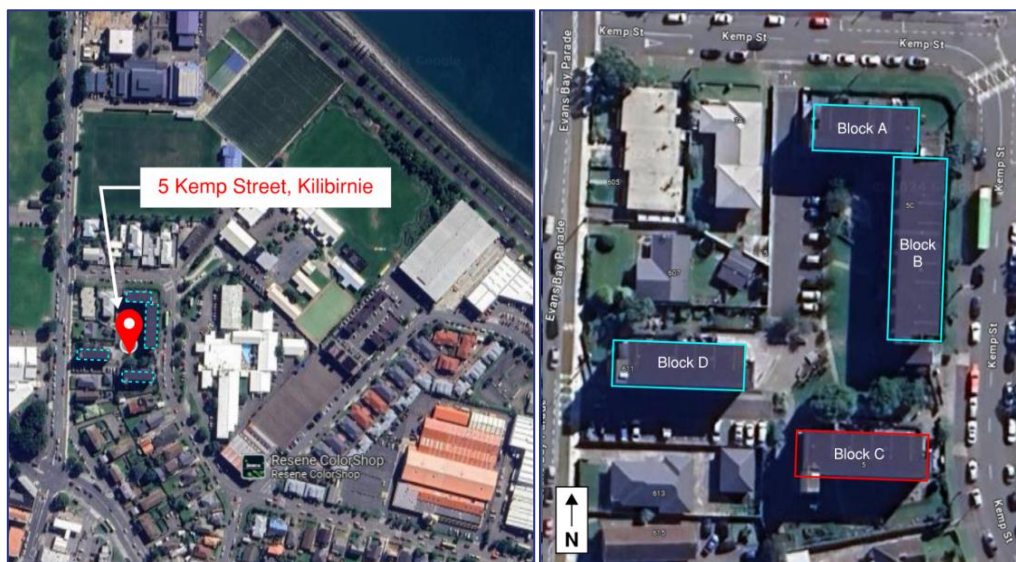
Figure 1: Kōtuku Apartments arrangement, Block C in red

As part of this programme, RBG's work scope entails completing a detailed seismic assessment (DSA) of the block of four residential buildings on 5 Kemp Street, Kilbirnie, Wellington. These buildings are collectively known as the Kōtuku Apartments, and individually as Blocks A to D. This DSA focusses on Block C, which is highlighted in Figure 1.

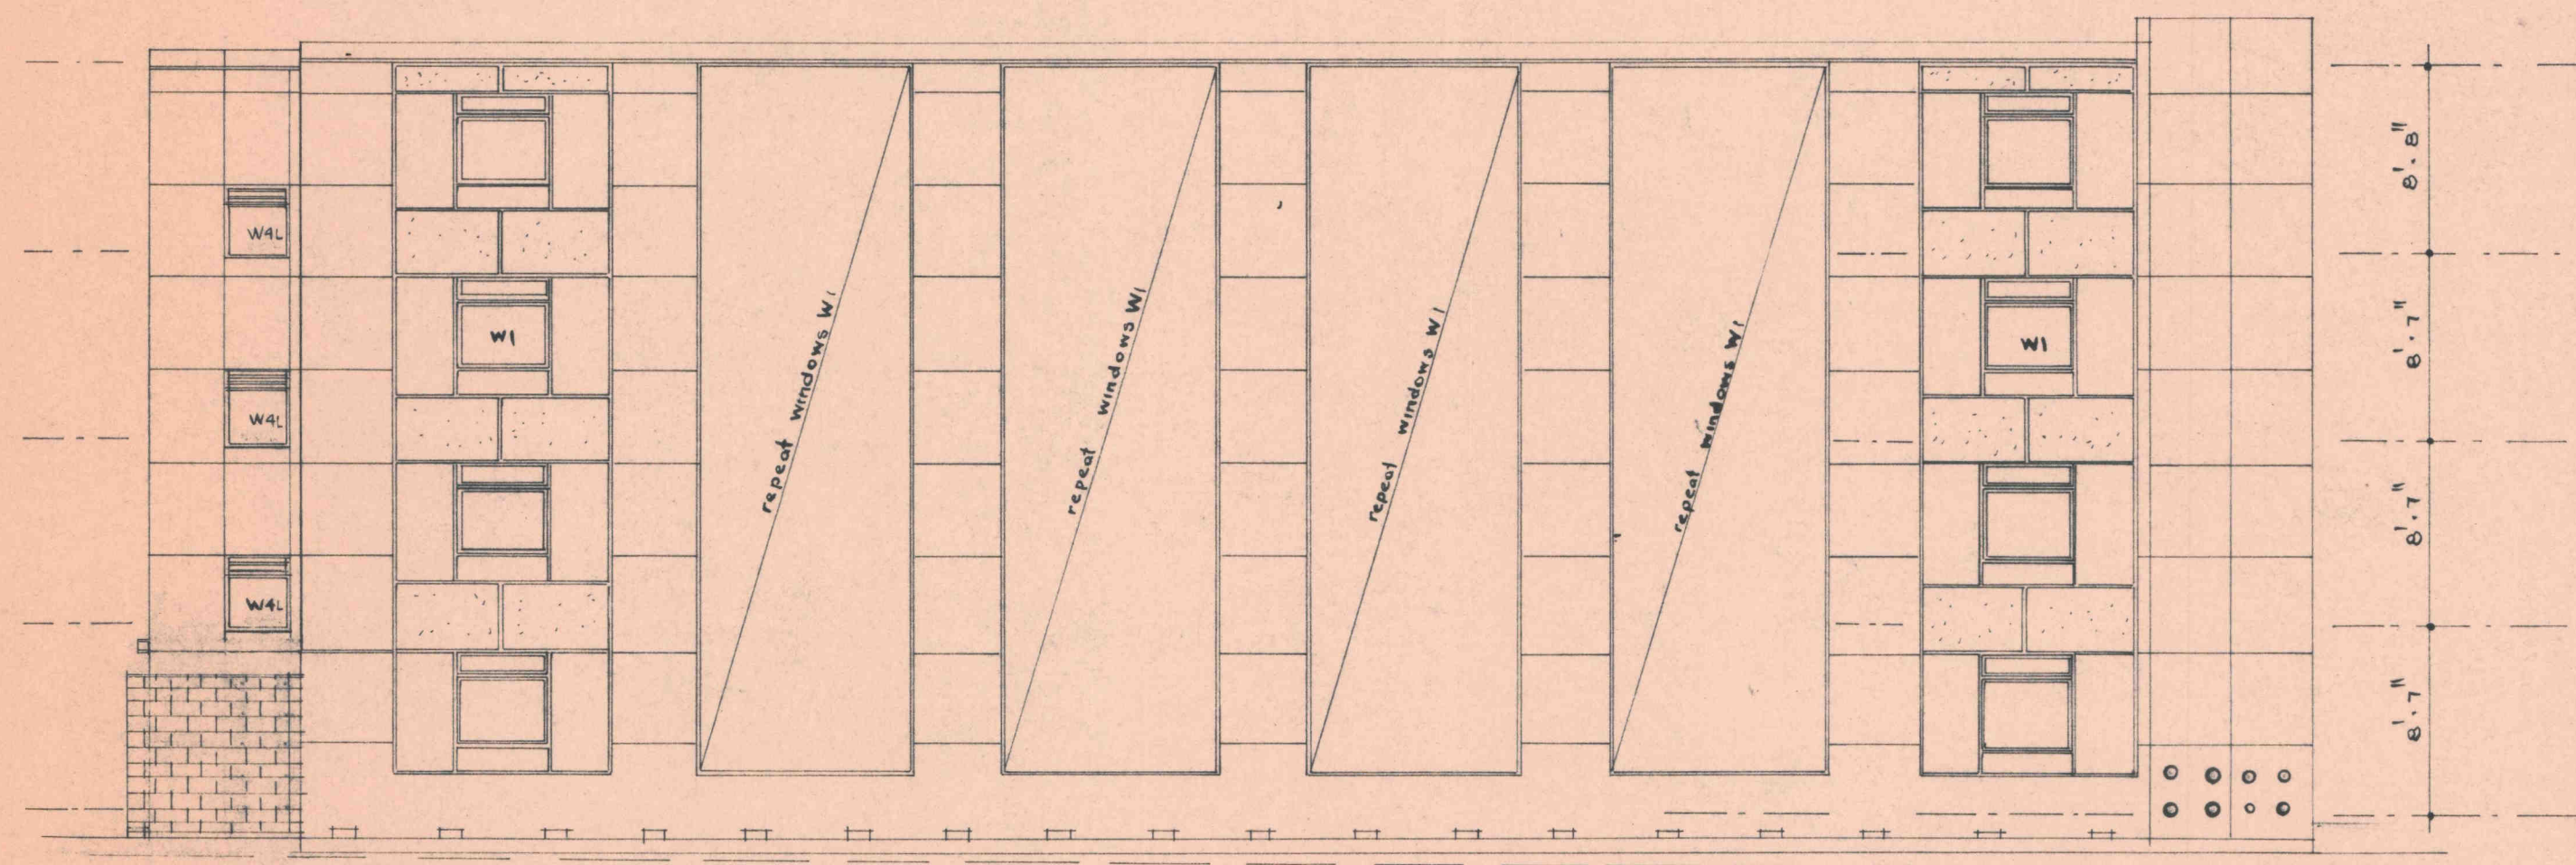
1/8" SCALE NORTH ELEVATION

KOTUKU FLATS KEMP STREET - KILBIRNIE FOR THE WELLINGTON CITY CORPORATION		CONTRACT NUMBER 2278 SCALE AS SHOWN WEST ELEVATION OF BLOCK A AND B ELEVATIONS OF BLOCK C	SHEET No. 7 IN SET OF 44
WELLINGTON CITY CORPORATION TOWN PLANNING DEPARTMENT ARCHITECTURAL DIVISION		TRACING NO. A.M. 247/7	
DESIGNED	W.J. BEECH		
DRAWN	M. COLARIC	MARCH '68	
TRACED	P. LENIHAN	JULY '68	
CHECKED	496		
APPROVED		C.M. MASON CITY ARCHITECT

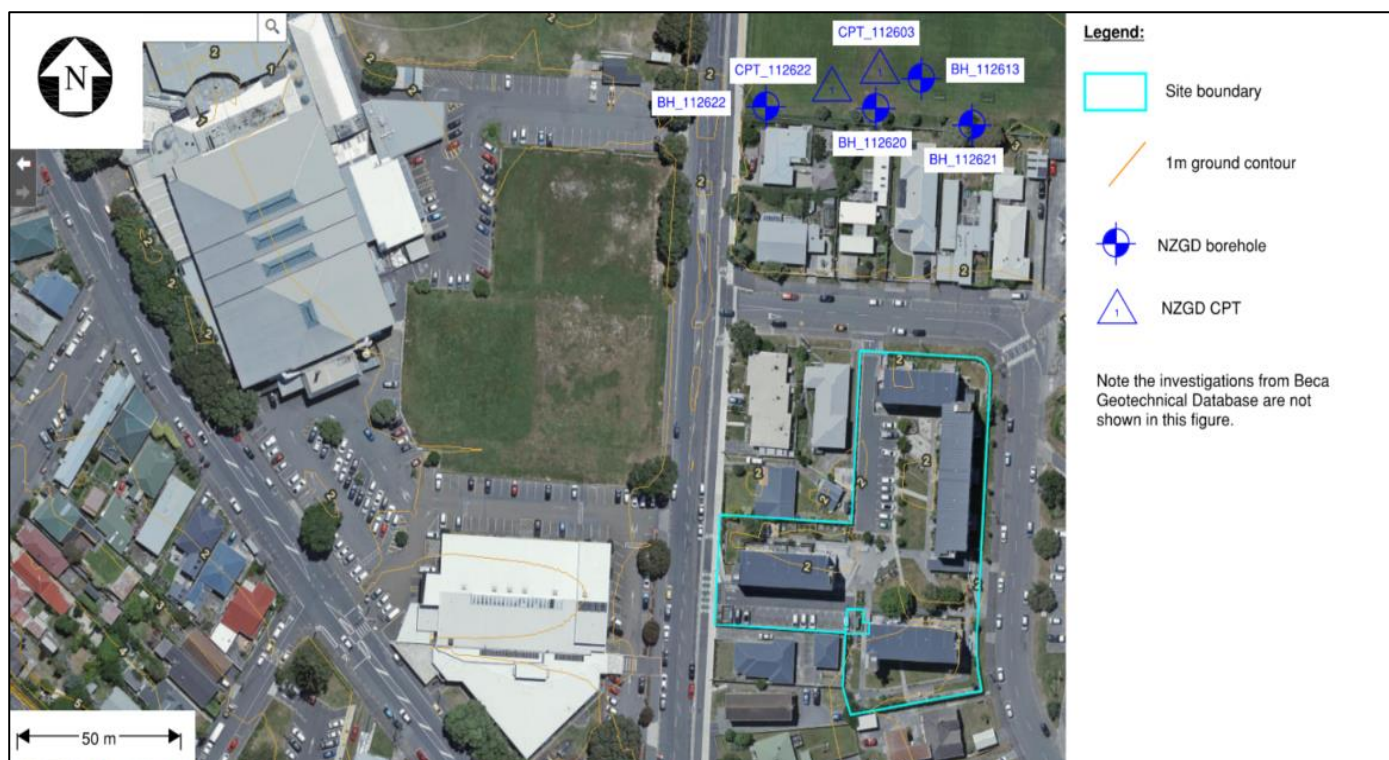
Figure 1: Locations of available historical site investigation data

Historical ground investigation data within/near to the site has been sourced from both the Beca Geotechnical Database and New Zealand Geotechnical Database (NZGD). NZGD investigation locations and topographic contours are presented in Figure 1 below. The ground investigation data from Beca Geotechnical Database were not shown in the figure due to the data not being available publicly. Copies of potentially relevant investigation logs are enclosed in Appendix A.
