Document Number: N0541-RBG-KOTD-XX-RP-ST-00001

Prepared for Wellington City Council

Robert Bird Group NZ Limited (RBG) has been engaged by Wellington City Council (WCC) to complete a detailed seismic assessment (DSA) of the block of four residential buildings on 5 Kemp Street, Kilbirnie, Wellington. **This DSA focuses on Block D** and has been undertaken as part of Phase 2 of the Housing Upgrade Programme.

The four buildings are collectively known as the Kōtuku Apartments and were designed between 1967 and 1969. These buildings are four-storey concrete structures of varying lengths but similar configurations. The buildings are founded on a relatively flat site with poor soil capacity of subsoil class D classification. Currently, all four buildings are being used for housing.

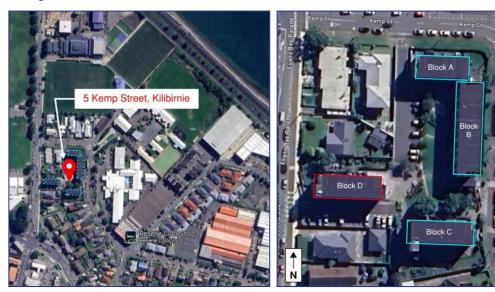
Figure 1: Kōtuku Apartments arrangement, Block D in red

As part of this programme, RBG's work scope entails completing a detailed seismic assessment (DSA) of the block of four residential buildings on 5 Kemp Street, Kilbirnie, Wellington. These buildings are collectively known as the Kōtuku Apartments, and individually as Blocks A to D. This DSA focusses on Block D, which is highlighted in Figure 1.

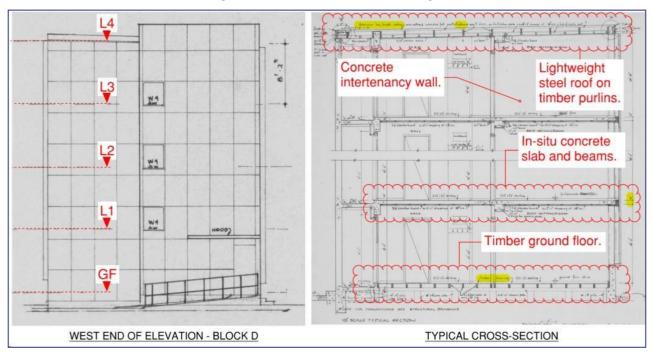
Figure 4: Block D elevation and typical cross-section

Referring to Figure 4, Block D is a four-storey building with concrete intertenancy walls. The roof is lightweight and comprises steel on timber purlins. There is a water tank on the roof. From level 1 to 3, the floor type is an in-situ concrete slab and beam. The ground floor is timber on concrete ground beams.

Block D mainly uses reinforced concrete walls to resist vertical gravity loads. These walls are generally 6 or 8 inches thick, with many of the 6-inch-thick walls acting as intertenancy walls. Gravity loads are transferred into the ground through concrete ground beams and bulb pile foundations, the former of which the walls sit on.

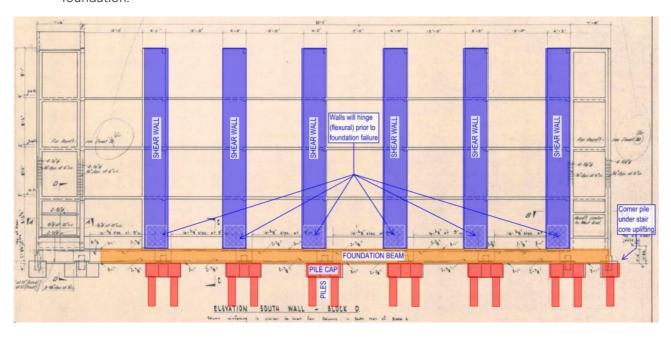
Figure 6: Typical longitudinal wall elevation

In longitudinal direction (see Figure 6):

- 1. The corner piles under the stair cores are expected to see damage first due to the limited geotechnical capacity. This is expected to be uplifting of the pile against the soil. Note that as this failure mechanism has a geotechnical nature, we expect the pile to remain structurally intact and load can be redistributed.
- 2. The primary mechanism of the longitudinal system will be the rocking of the cantilever shear walls above the foundation beam. It has been assessed that the wall will rock prior to the failure of the foundation.

While the above-mentioned item 1 could occur first during a significant earthquake, it is unlikely to lead to significant life-safety risks. The piles under the stairs would be lifted and the shear wall above would be rocking and providing gravity support, leading to redistribution of seismic loads from this wall to other shear walls. We have assessed that it is acceptable for these piles to exceed its geotechnical capacity and seismic loads redistributed; for a further discussion on load redistribution regarding the stair cores, refer to section 3.1.

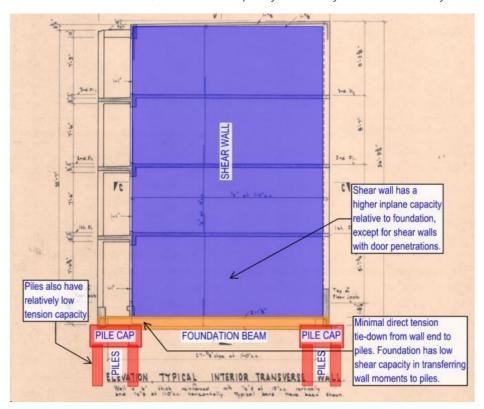
Figure 7: Typical transverse wall elevation

- 1. Similar to the seismic performance of the building in the longitudinal direction, the corner piles under the stair core are expected to see damage first due to the limited geotechnical capacity. This is expected to be uplifting of the pile against the soil.

- 2. The foundation ground beams in the transverse direction are expected to experience shear failure. There is minimal vertical wall reinforcement directly anchored to the pile cap. The in-plane moment demands from the wall will have to be transferred via shear in the foundation beam to the piles. This beam's shear failure limits the overall capacity.

- 3. The bulb pile foundations under the middle walls have a geotechnical tension capacity that is only marginally higher than the foundation beam. It is possible that the mechanism is a combination of pile tension and beam shear failure, with overall capacity limited by the foundation system.

As discussed earlier, the failure of the stair piles is unlikely to lead to significant life-safety risks during an earthquake event and is considered acceptable; the seismic loads can be redistributed.

The damage in ground beams raised in above item 2 is a brittle failure and has no other load path to support the wall. Once the beam under the transverse wall fails, the shear wall above would lose lateral and gravity resistance and progressively tilt in one direction. As this failure mechanism occurs, the transverse walls may also push the pile caps outwards and drop off from the pile cap. This would lead to excessive vertical settlement, significant structural damage and floors losing gravity support.

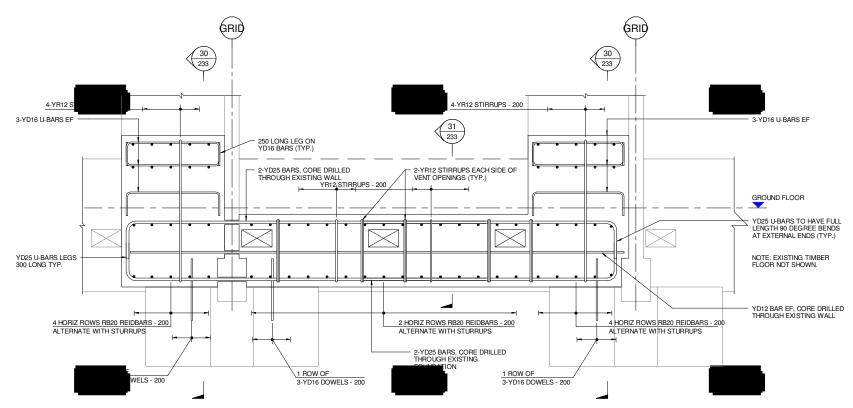
FT1 EXTERNAL ELEVATION - REINFORCEMENT

REINFORCEMENT DETAILS FOR BOTH EXTERNAL AND INTERNAL 2 BAY FT2 TYPE FOUNDATION THICKENING IS SIMILAR TO THAT SHOWN HERE FOR THE SINGLE BAY FT1 TYPE FOUNDATION THICKENING. ALLOW FOR THE YD25 BARS TO EXTEND OVER THE ENTIRE LENGTH OF THE FT2.

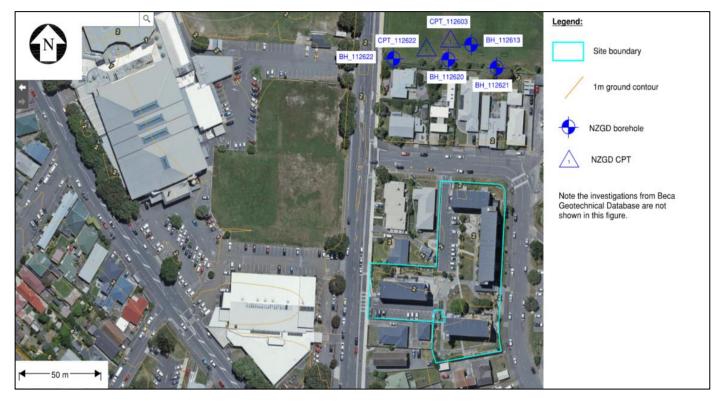
Figure 1: Locations of available historical site investigation data

Historical ground investigation data within/near to the site has been sourced from both the Beca Geotechnical Database and New Zealand Geotechnical Database (NZGD). NZGD investigation locations and topographic contours are presented in Figure 1 below. The ground investigation data from Beca Geotechnical Database were not shown in the figure due to the data not being available publicly. Copies of potentially relevant investigation logs are enclosed in Appendix A.

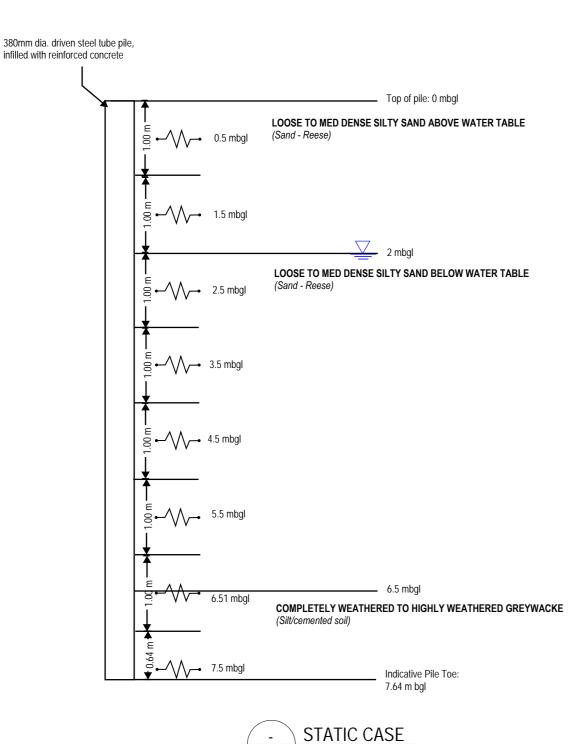
380mm dia. driven steel tube pile, infilled with reinforced concrete Top of pile: 0 mbgl LOOSE TO MED DENSE SILTY SAND ABOVE WATER TABLE (Sand - Reese) •**-**∕√√ 0.5 mbgl LOOSE TO MED DENSE SILTY SAND BELOW WATER TABLE (Liquefied Sand - Rollins) 6.5 mbgl 6.51 mbgl COMPLETELY WEATHERED TO HIGHLY WEATHERED GREYWACKE (Silt/cemented soil) Indicative Pile Toe: 7.64 m bgl
