WCC Accessibility Audits Tawa Community Centre

703771/01

1.1 Tawa Community Centre

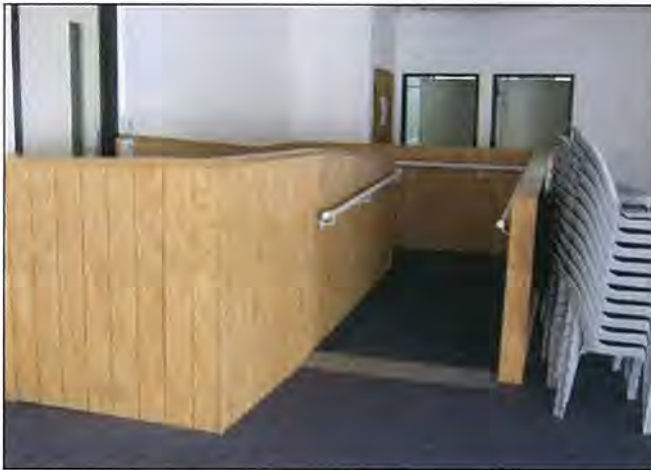
Ramp handrail projects into accessible route

- Install wheel stops along the eastern carparks to prevent vehicles from parking too close to the kerb and causing a projection onto the accessible route. Example of wheel stops in effect is pictured below.
- Widen ramp so that handrails do not project into the accessible route

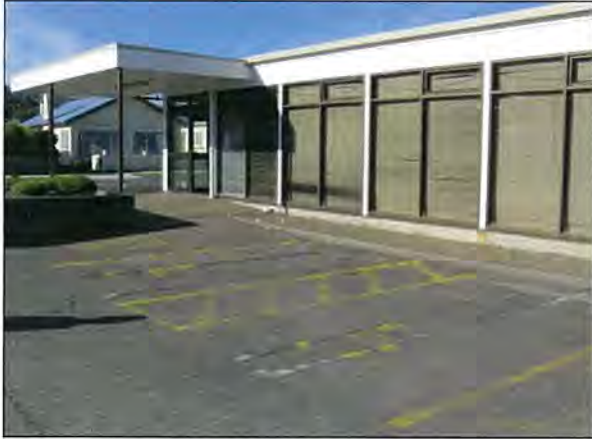
Existing accessible carparks (east)

- That the southern accessible carpark space be abandoned and that the 2 carparks on the eastern side be upgraded to replace this park.
- Upgrade existing eastern accessible carpark spaces to have compliant dimensions, repaint markings, install kerb ramps and signage.

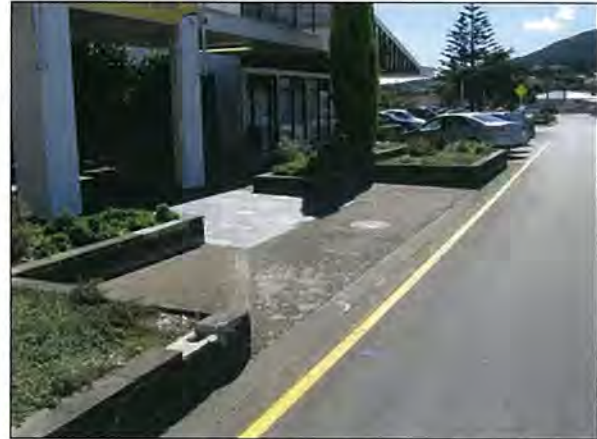
**Non-compliant Southern Accessible Carpark
(in front of council chambers)**

- The southern “accessible” carpark has signage located at a height well above the recommended positioning of 750 - 1200mm from ground level.
- The painted markings on all accessible carparks are very worn and faded, which makes them difficult to see at a distance.

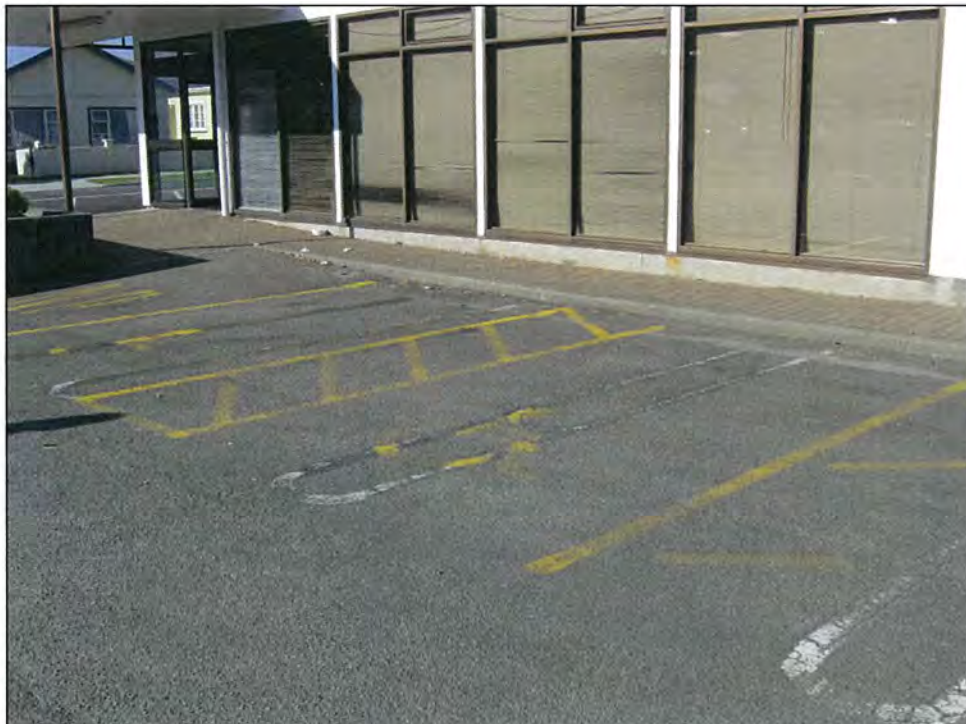
Existing Eastern accessible parking

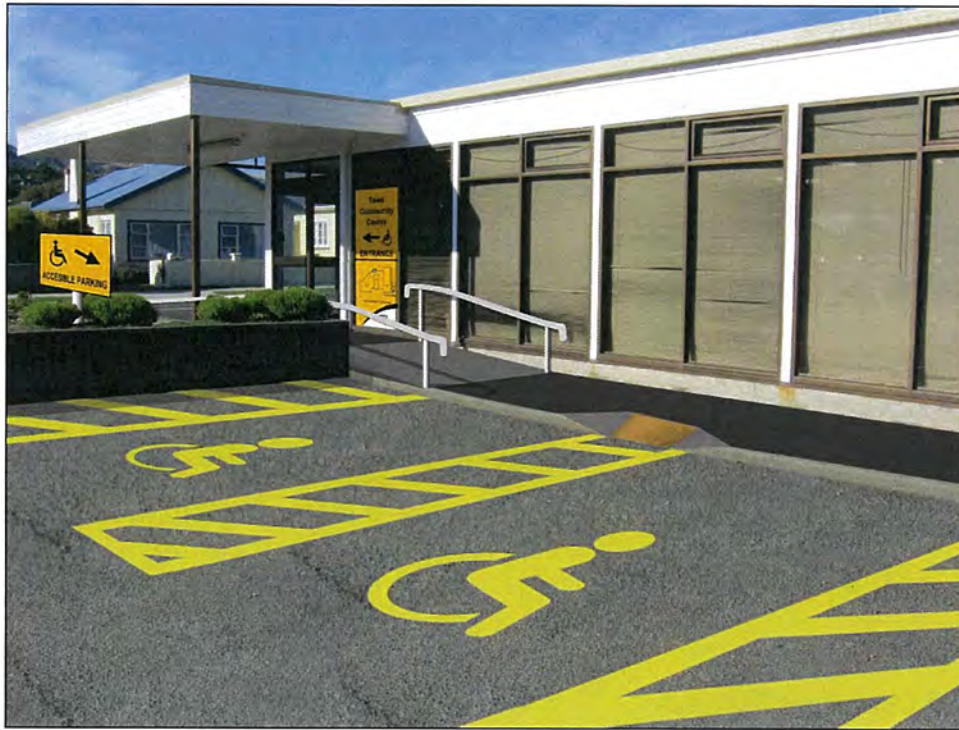
Artist's impression - Upgraded eastern accessible parking

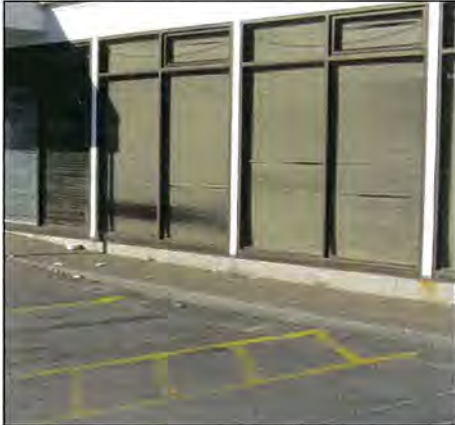
No kerb ramps present, East Side

- Install kerb ramps with tactile indicators between the two accessible carparks in the eastern carpark which meet the requirements of either NZBC section D1/AS1 3.4 fig.10, or NZS4121 section 13.4.3 fig.46. Tactile indicators help maintain independence, wayfinding and the safety of visually impaired and blind people.

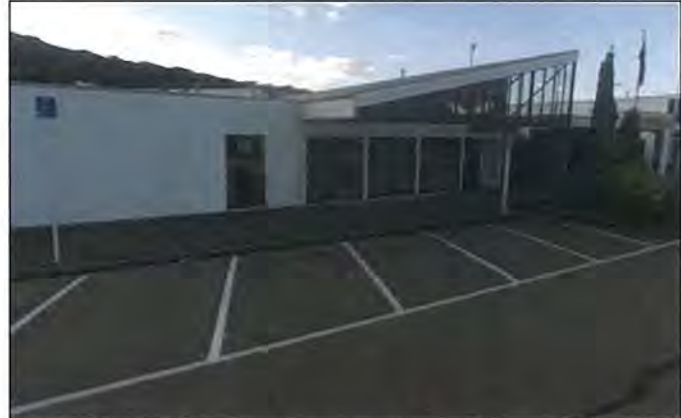
No kerb ramps present, Southern Side

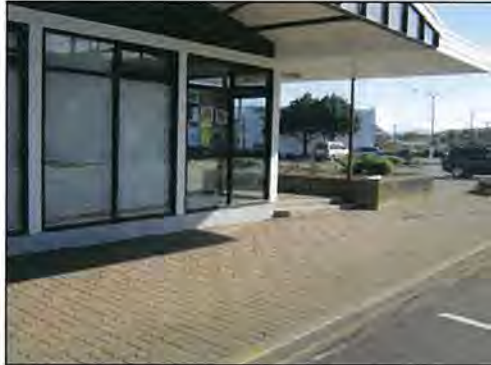
South footpath

- Replace all the chamfered zigzag brick pavers with asphalt, concrete or compliant style paving. This will make the Community Centre more attractive to users sensitive to uneven surfaces.

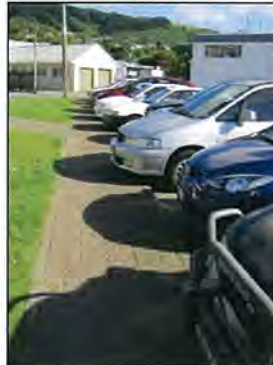
East footpath

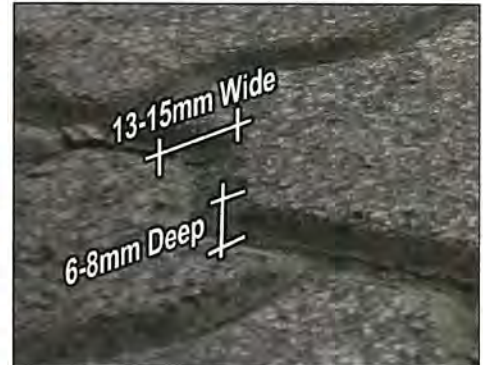
Zigzag brick pavers

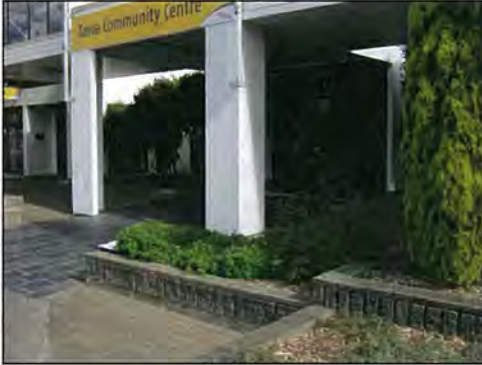
Council Chambers ramp

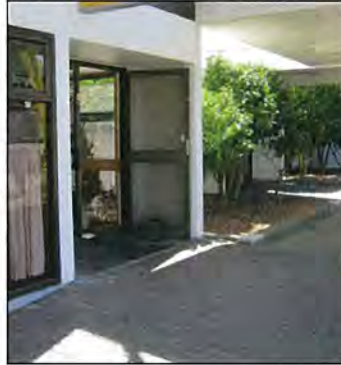
Community Centre ramp

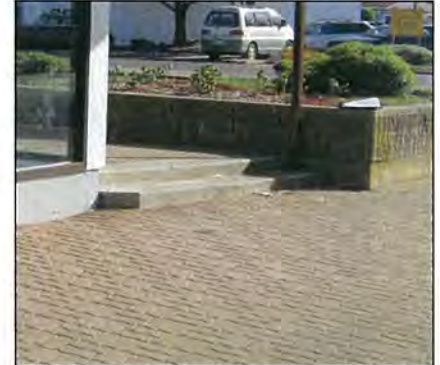
Community Hall - no ramp

- Install an accessible ramp beside stairs in front of the Community Hall. It is recommended that this ramp is designed by a person who is experienced in accessible design and that it is done in accordance with NZS4121.

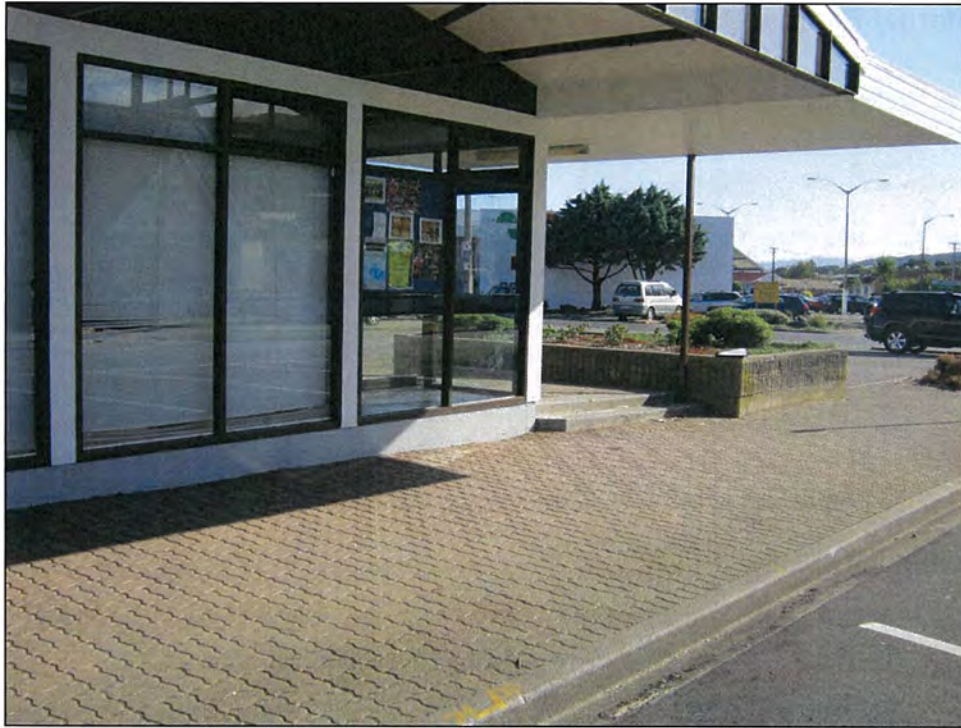
Existing steps in front of community hall entrance

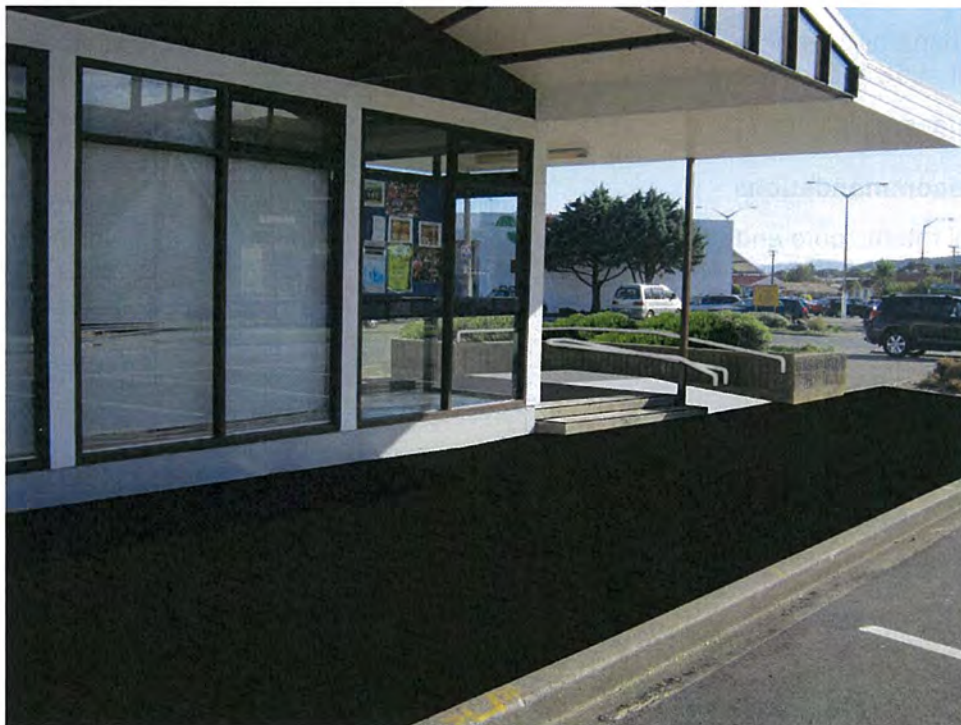
Artist's impression - Possible ramp beside steps in front of community hall entrance

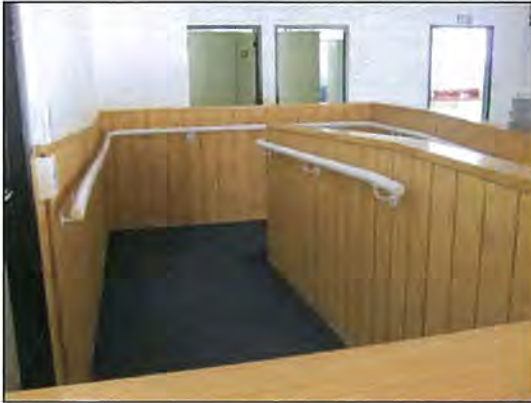
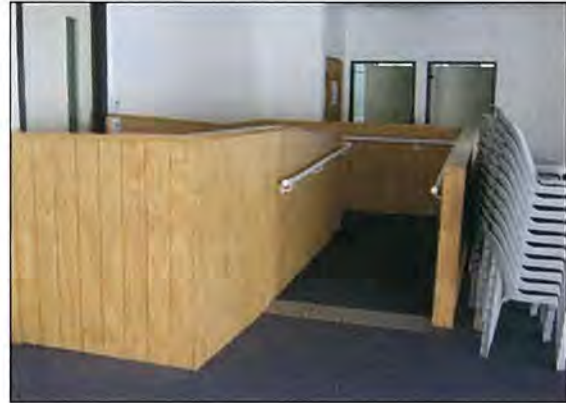
Community Hall and Community Centre connection ramp

- Install returns onto end of handrails or have them returning into the wall. Installing a domed button 150mm from the end of the handrail indicating its imminent termination while not fully compliant may be an easier way to lessen non-compliance.
- Widen ramp so that clear width is 1200mm

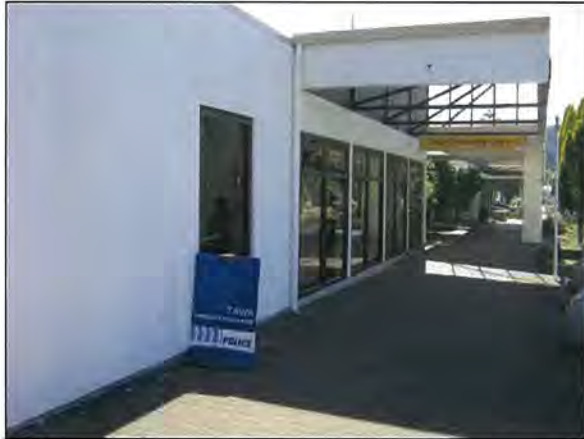
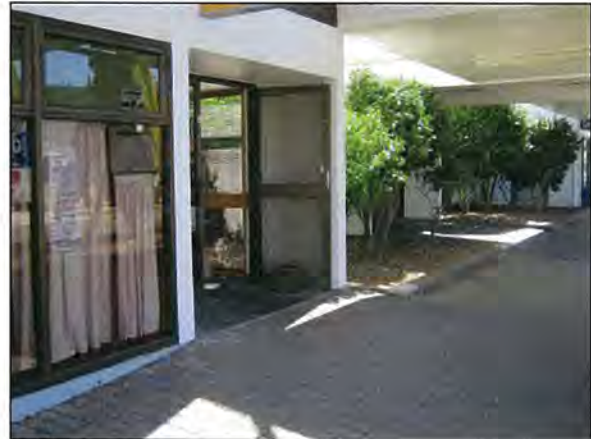
Poorly signed front entrance

- The front entrance is not located on an accessible route from the eastern carpark area. Currently users from the eastern accessible car parking must travel out onto the road to access the front of the Centre.
- No signage is present to indicate that this is an entry point to the Community Centre (a sandwich board sign was placed in the lobby but this is of little use to people outside the building).
- No signage is present at the entrance to clearly indicate where any of the facilities are.
- The dimensions of the landing in front of the entrance doors are inadequate and would require a chair user to back off the level to open the door fully.

- Informative and directional signage should also be installed as close to the entrance as possible. The signage should indicate: accessible carparks, accessible routes through the building, accessible entrances, services available in the building, accessible ramp locations and the location of accessible toilet facilities.

- Widening of the landing area to ensure 1,200mm of clear space in front of the opened door. This makes opening the door much easier for a chair user.
- Installing hooks for the doors to remove the need to hold doors open with objects that cause obstructions.

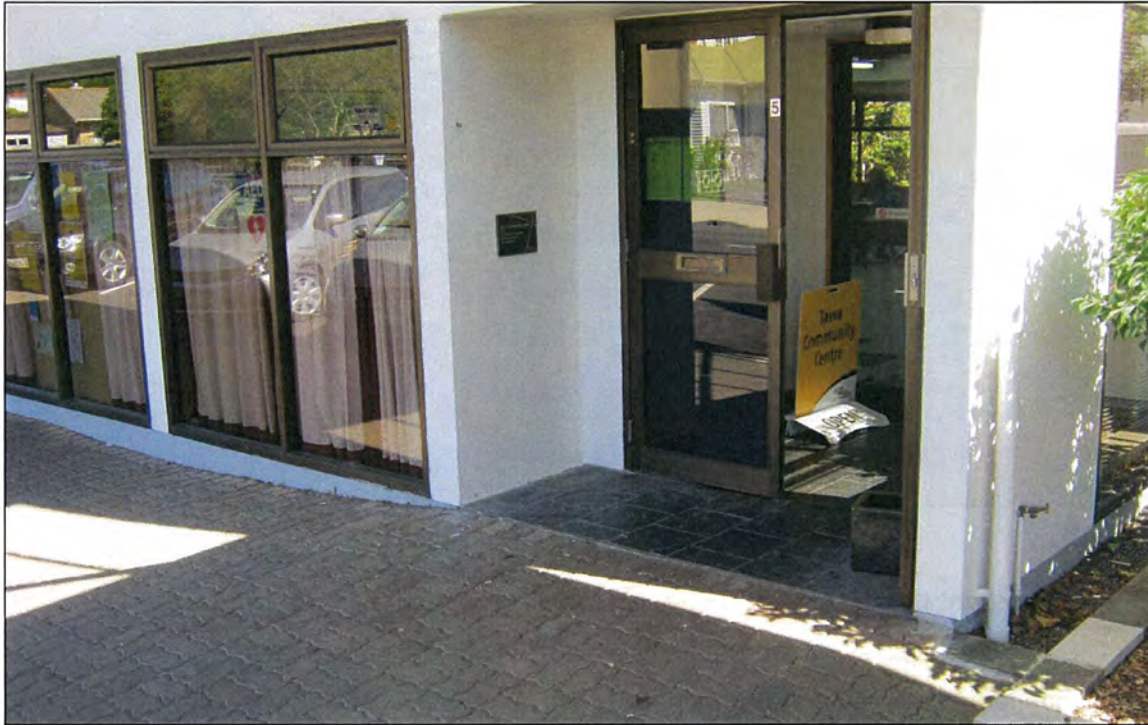
Existing Entrance

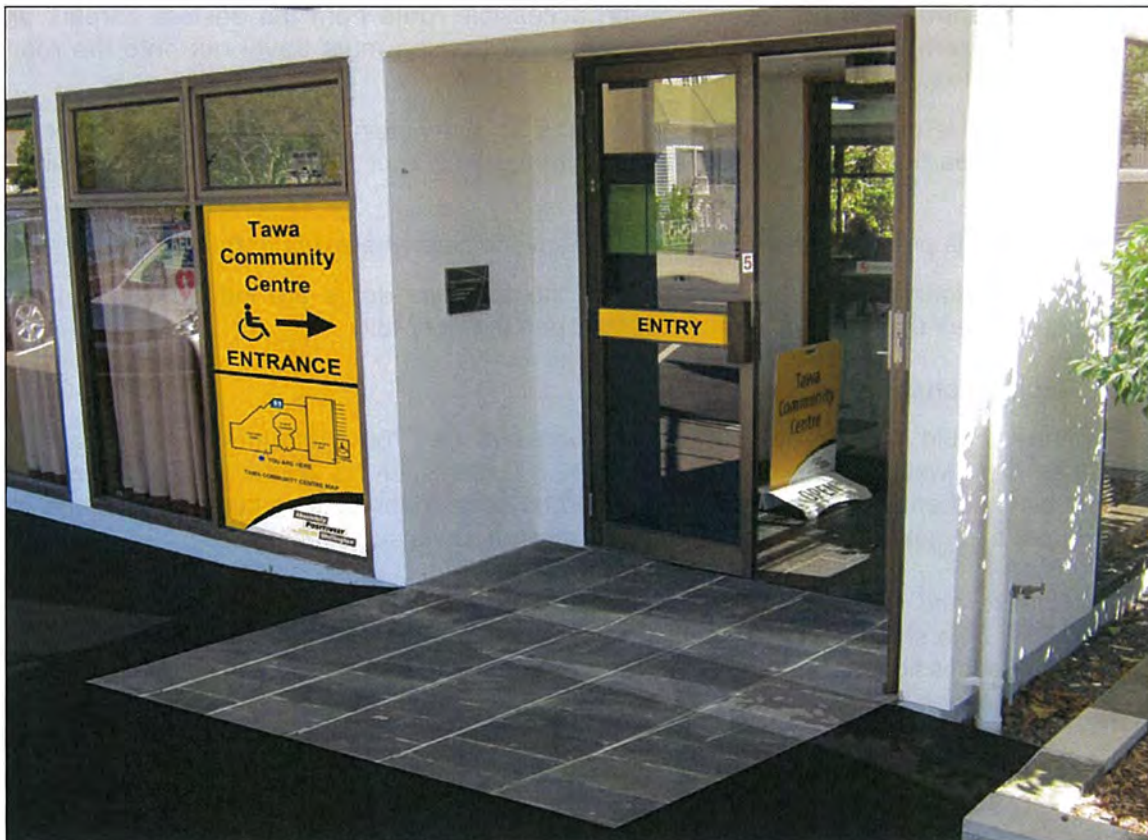
Artist's impression - Showing possible signage and landing extension

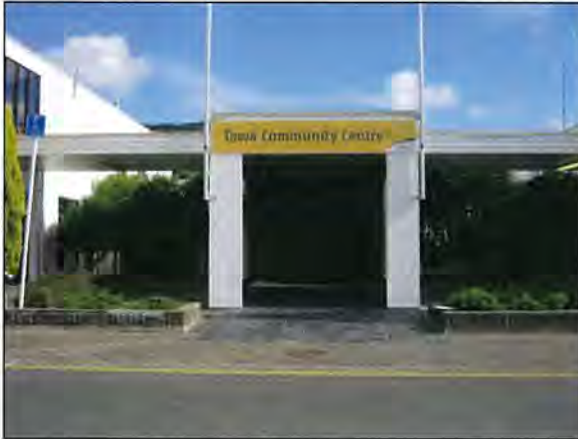
Poorly signed front entrance

- Signage should be installed on the entry doors between 700 - 1000mm from the floor level. These signs would ideally be in a contrasting colour such as yellow and be 50mm deep with black lettering to read "ENTRY" placed on each manifestation strip, giving good clear contrast and making the door easy to distinguish from its surroundings.
- Informative and directional signage should be installed as close to the entrance as possible. The signage should indicate: accessible carparks, accessible routes through the building, accessible entrances, services available in the building, accessible ramp locations and the location of accessible toilet facilities.

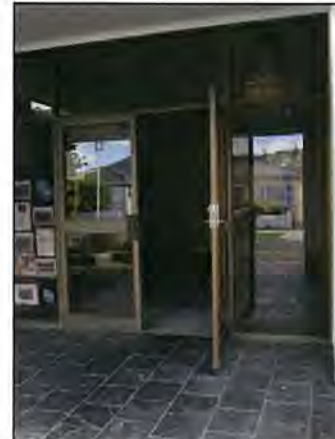
Front entrance doors

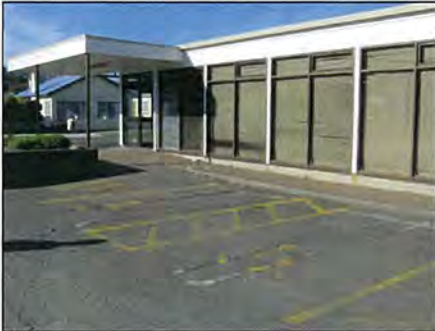
Overview from carpark

- No signage is present to indicate that this is an entry point to the Community Hall.
- No signage is present at the entrance to clearly indicate where the accessible carparks, accessible routes through the building, accessible entrances, services available in the building, accessible ramp locations and the location of accessible toilet facilities.
- The entrance door side panels and glass panels along the hall have no manifestations, and could be mistaken as a path of travel.

Informative and directional signage should be installed as close to the entrance as possible. The signage should indicate: accessible carparks, accessible routes through the building, accessible entrances, services available in the building, accessible ramp locations and the location of accessible toilet facilities.

Signage should be installed on the entry door between 700 - 1000mm from the floor level. This sign would ideally be in a contrasting colour such as yellow and be 50mm deep with black lettering

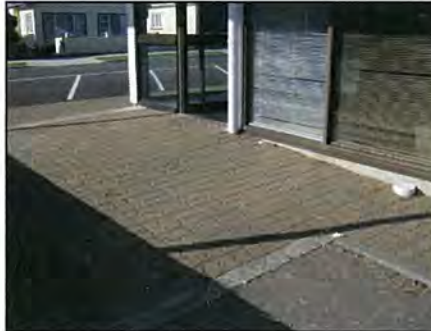
Landing in front of entrance

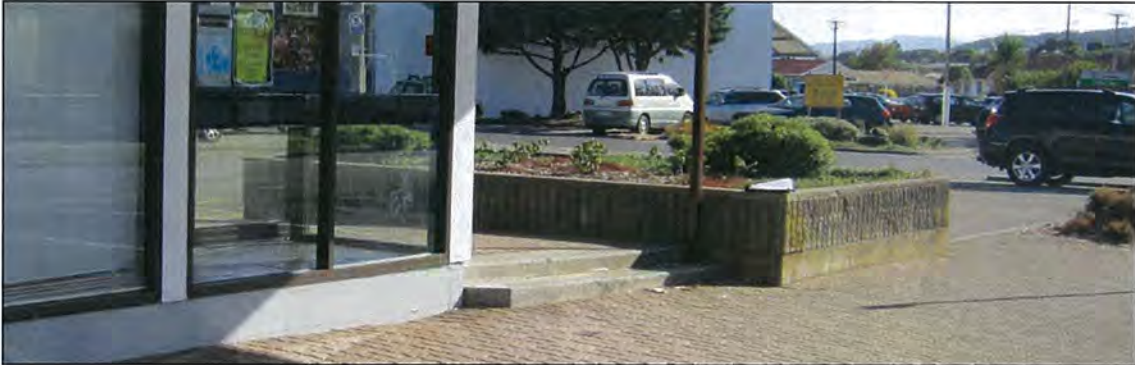
Stairs in front of Community Hall entrance

- The stair riser heights are not uniform which may lead to misjudgement of stepping, and consequently falls.
- No contrasting nosings are present which is a trip hazard to the vision impaired.
- No handrails were present on stairs. Handrails assist with navigation of the stairs and also offer support.

- Accept the stairs as non-accessible stairs, install an accessible ramp opposite as pictured below.

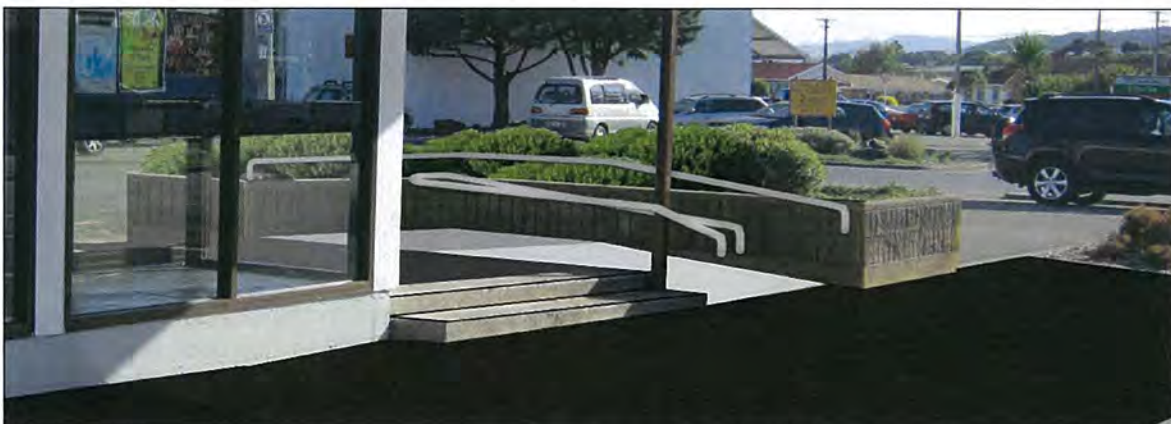
Artist's Impression of ramp installation beside stairs

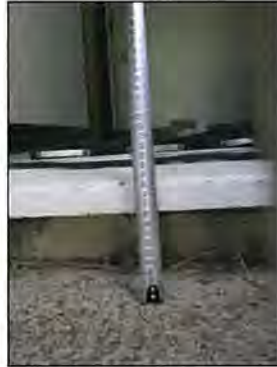
Fire exit step

- Install a landing and ramp outside the northern exit fire door so that manoeuvring the escape route could be done safely while unattended.
- Provide directional and informative signage indicating access to the police office is via the community centre main entrance or provide a compliant ramp to the door complete with handrails.

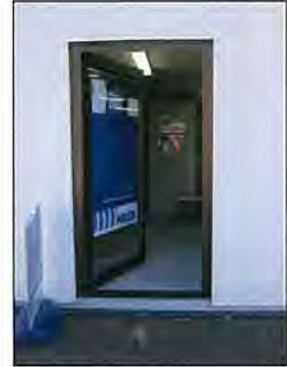
Police office

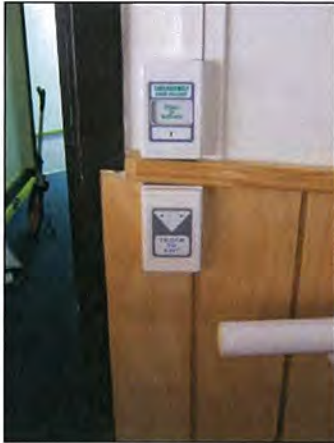
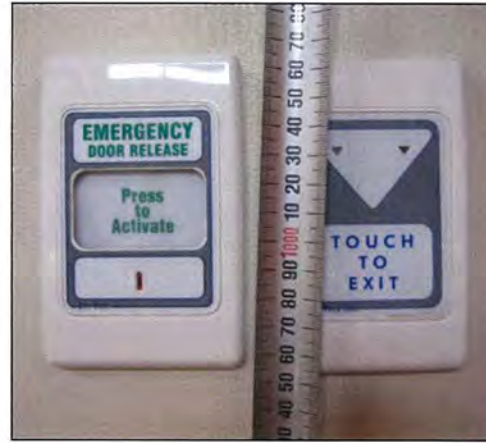
Example controls

- Lights and windows are manually operated.
- Door control buttons are generally positioned at a height within the recommended 1310mm above the floor.

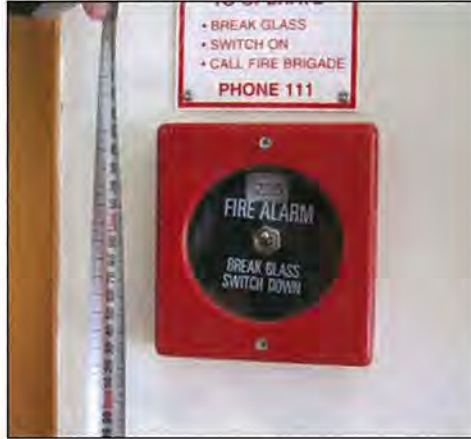
Callpoint

- Alerting devices have been installed on the accessible route in the form of manual callpoints and sirens.
- The fire callpoints are correctly signed, although the signage is at the upper limits of the preferred visual zone.
- Callpoints are positioned at a height typically within the recommended 1,310mm above the floor.

- Install visual alerting devices along the accessible route of the Community Centre and in the toilets. Should an opportunity arise to lower or relocate the callpoint signage to below or beside the callpoint it should be done.

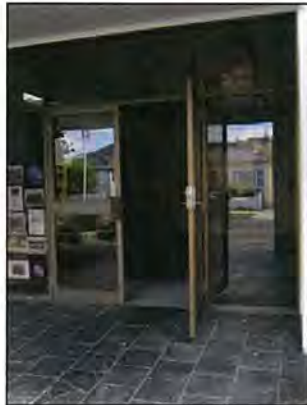
Chambers entry

- Install manifestations on all full height glass panels located by entry doors, all the southern and eastern perimeter glass panels in the town hall/community centre areas areas.
- Install more directional and informative signage or relocate existing signage to a height within the recommended range below.

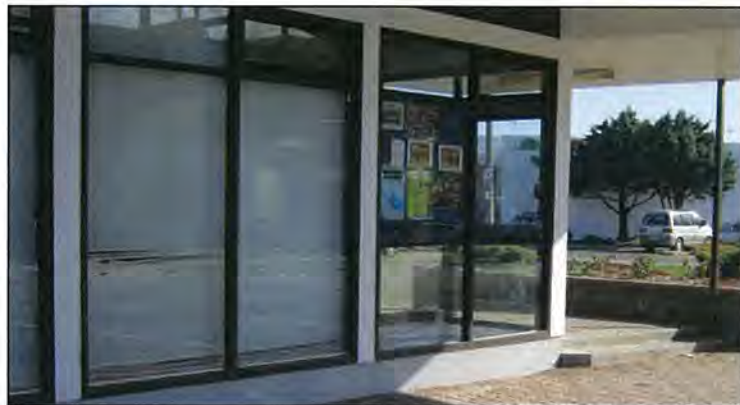
Hall entry

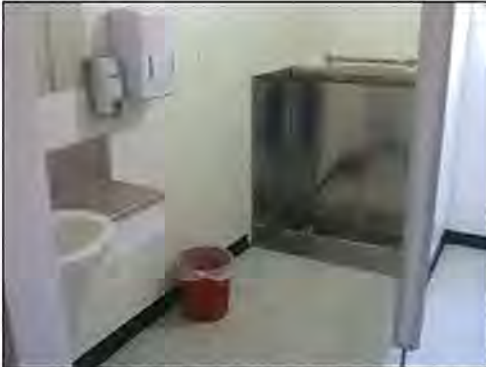
Male accessible toilets

- Lower hooks in main toilet area to be 1200mm from floor level so that they are easily reachable.
- Install hooks within the accessible toilet cubicles at 1200mm from floor level.
- Consider installation of accessible facilities for the community hall area as part of future developments that may be planned.
- Install a compliant basin and mirror within the toilet cubicle as per the below details from NZS4121.

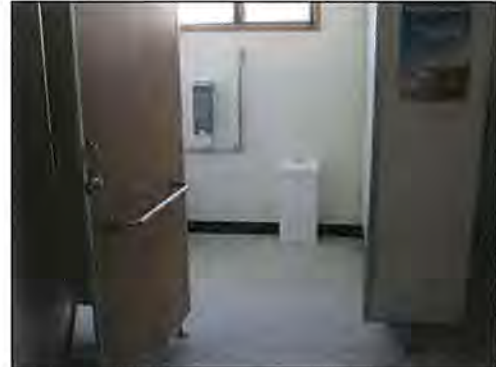
Female accessible toilets

- No washbasin has been provided within the toilet cubicles.
- The door latch on the female facility was difficult to lock in place with one hand.
- Hooks for hanging items on have been installed well above the recommended accessible height of 1200mm from floor level, and are therefore unusable to persons with mobility impairments.
- The accessible toilet within the cubicle has no signage
- Directional signage to the facility is inadequate.
- Entry doors to the toilets do not have a horizontal grab rail to the back of the door. A grab rail assists users with pulling open the door.
- Due to the angled arrangement of the toilet cubicles, they do not meet the minimum dimensions of 1600 x 1900mm required for an accessible cubicle. See sketch below.

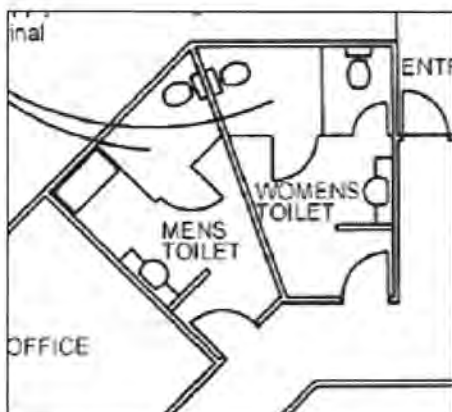
Plan Layout of accessible toilets

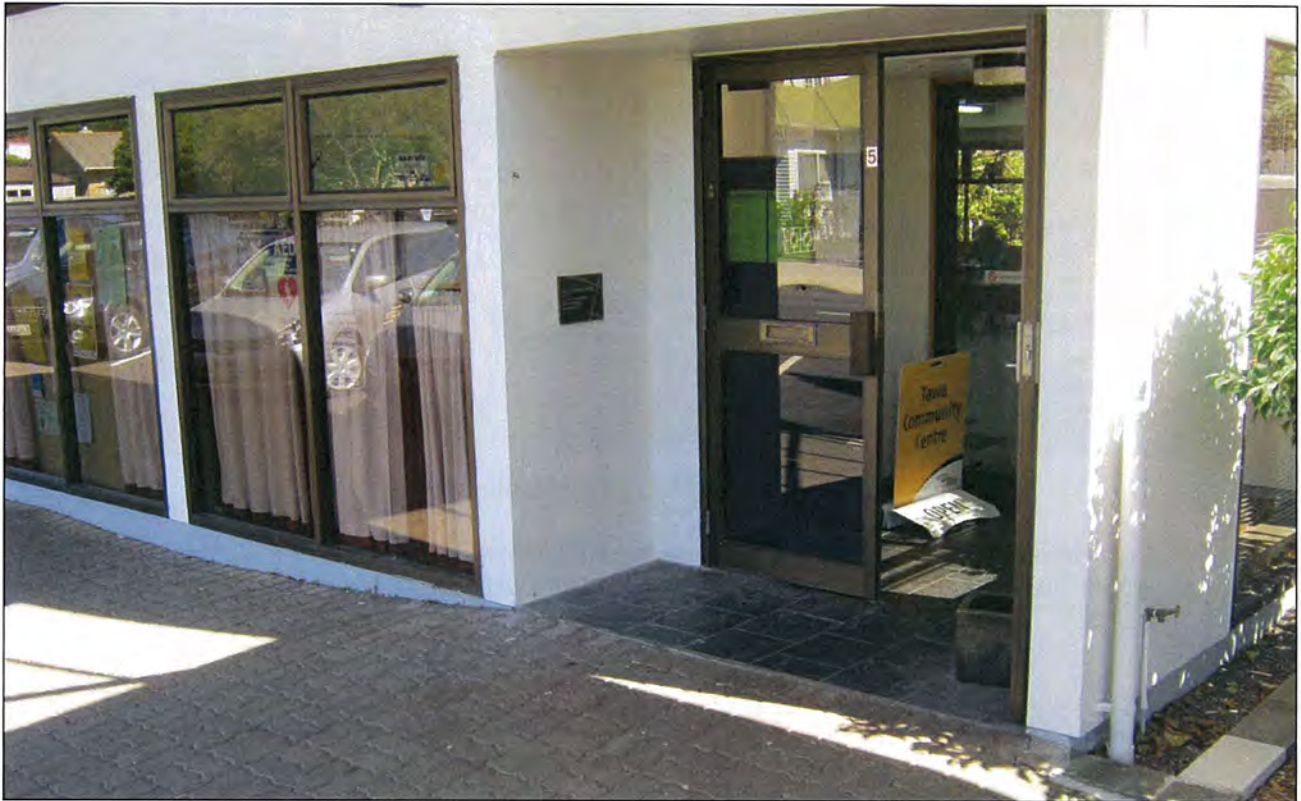
Front entrance to the Community Centre

- The signage is typically in inconsistent locations and positions, making it difficult to navigate the building.
- Signs are generally outside of the recommended height zone of 730mm - 1700mm.
- Accessible facilities such as the ground floor toilets have no compliant informative, directional or locational signage.

- Installation of better directional signage both within and outside the Community Centre would greatly enhance the experience of a visitor with impairments and also non-impaired users.
- New signage should be installed within the recommended height zone of 730mm-1700mm. These signs are to be placed consistently in locations which are easily visible from the accessible route.
- The colour scheme of this signage should be high contrast (*eg: black text on a yellow background as pictured above*). Consideration should also be given to providing low or non-reflective backgrounds to signage.

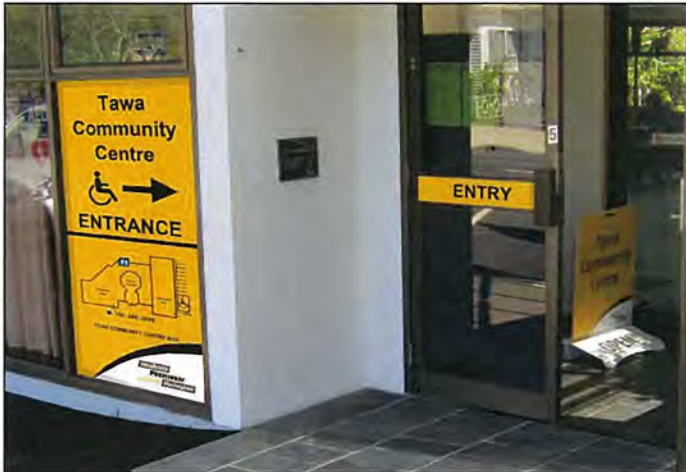
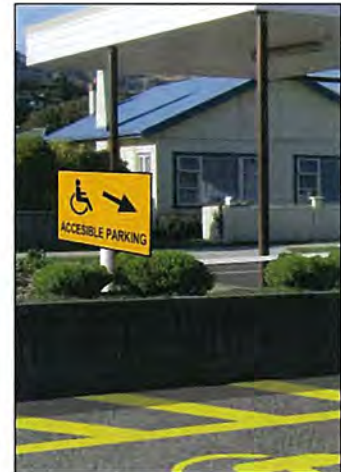
Artist's impression of possible signage
