# Historic Heritage Evaluation

## Emeny House

1 Ranfurly Terrace, Mount Cook, Wellington

March 2022

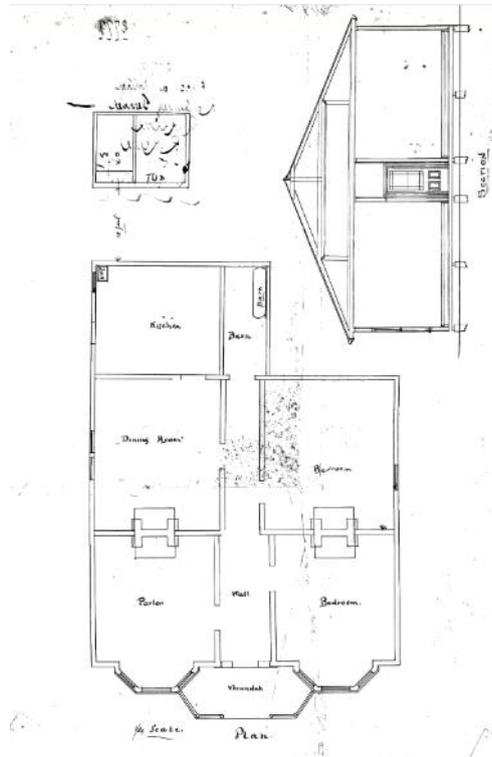
Image: Original house plans (1898). Wellington City Archives 00053:43:2779

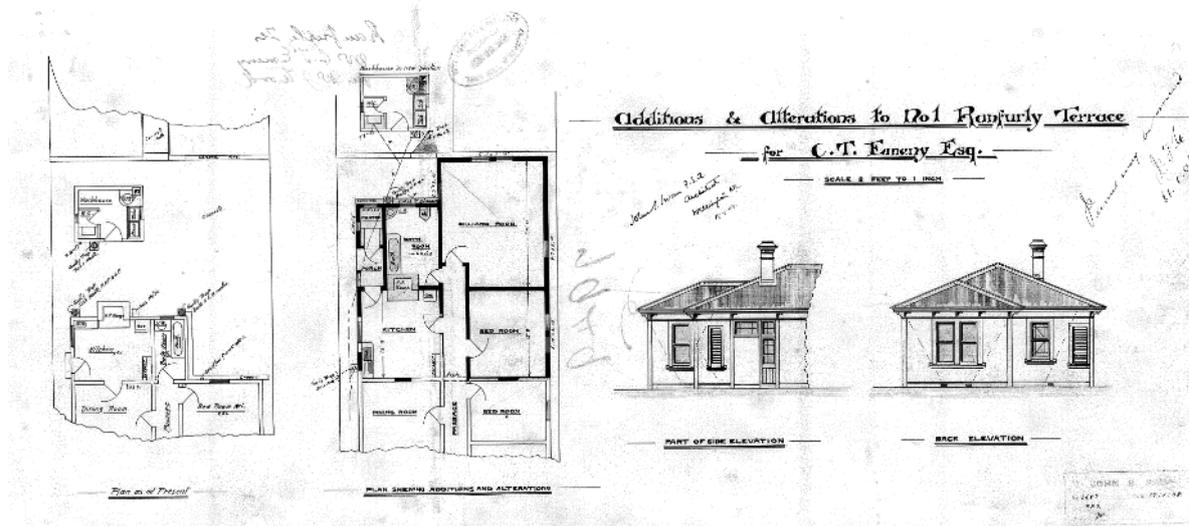
Image: Additions and alterations (1908). Wellington City Archives 00053:143:7949

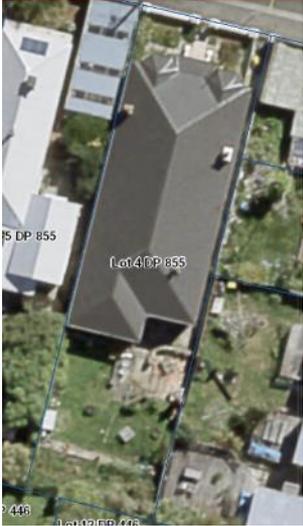
ROOF		Heritage value - B

Additional items in current Schedule		Proposed amendments
<p>History – The billiards room roof was added in 1908 and is an early addition. The three brick chimneys were removed when the house was re-piled in c.2008, and replaced with lightweight replicas. The roof was re-clad in corrugated mild steel long-run roofing.</p>		
Element	Description of the roof components	Value
<b>Structure and profile</b>	Overall form and profile of roof	A
<b>Cladding</b>	Roof cladding is long run corrugated mild steel that dates from after 2007. It replaces an earlier corrugated iron roof.	B
<b>Chimneys</b>	The brickwork to the chimneys was removed when the house was re-piled. The chimneys have been rebuilt as lightweight replicas after 2007. The two north chimneys are rendered, the rear chimney is clad with brick “slips”. The chimneys support the original chimney pots.	C
<b>Chimney pots</b>	The chimney pots are early or original.	A

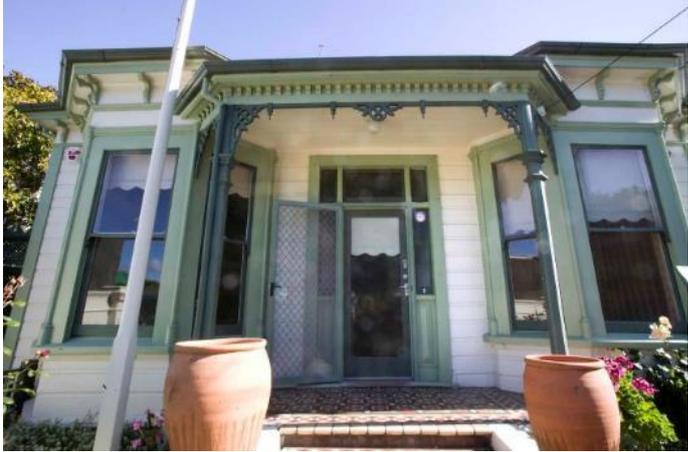
<b>FRONT ELEVATION</b>	<b>Heritage value - A</b>

**History** - The front elevation has had few changes and is substantially intact. It has a new replica front door, and the decorative planters, urn, or “pineapples” on the front plinths are moveable objects and are not included in this assessment.

<b>Elements</b>	<b>Description of the front façade</b>	<b>Value</b>
<b>Bay windows</b>	Two bays with sliding sash windows.	A
<b>Cladding</b>	Timber rusticated weatherboard cladding and trim.	A
<b>Eaves</b>	Timber soffits and eaves brackets	A
<b>Front porch</b>	Tiled floor to the front porch.	A
	Front steps with cement rendered plinths, and tiled treads	A
	Front porch includes posts, fretwork, ornamentation, and timber soffit.	A
	Front entrance door – including door frame, top-lights, side-lights, panelling, sill, coverboards and glazing.	A
	Partly glazed four-panel front door is a modern replica (after 2007).	B
<b>Services</b>	Any rainwater pipes, soil waste pipes, and soil vent pipes.	NIL

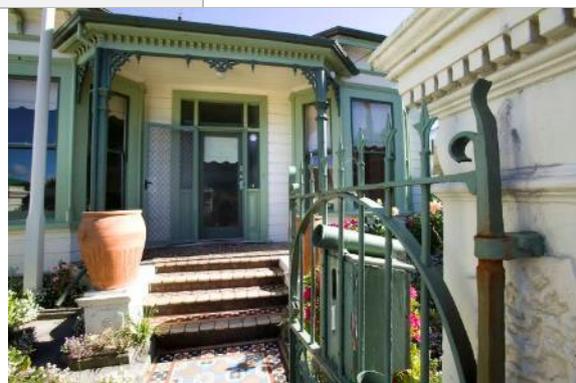
Tiled front porch floor, steps, and plinth.

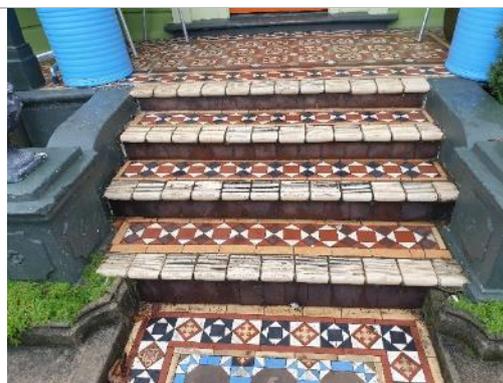
Tiled porch floor, steps, and path. (Moirá Smith, 2022).

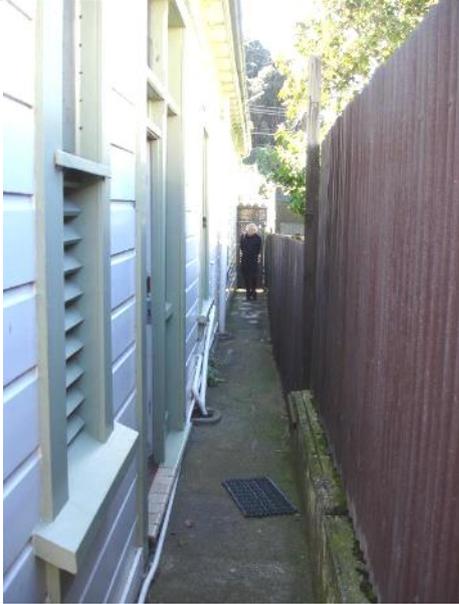
EAST ELEVATION	Heritage value - B

History – The east elevation has had few changes and is substantially intact.

Element	Description of the east façade	Value
<b>Cladding</b>	Timber rusticated weatherboards and trim.	A
<b>Eaves</b>	Timber eaves brackets and soffit.	A
<b>Windows</b>	Windows including sliding sash windows, and laundry window which has a timber louvre.	A
<b>Door</b>	Timber four panelled door with glazed lights. This appears to have been altered or replaced since 2007.	B
	Timber door surround including - coloured fixed glazing to side lights and top-lights. Timber panelling to base of side lights.	A
<b>Services</b>	Any rainwater pipes, sanitary drainage pipes, and soil vent pipes	NIL

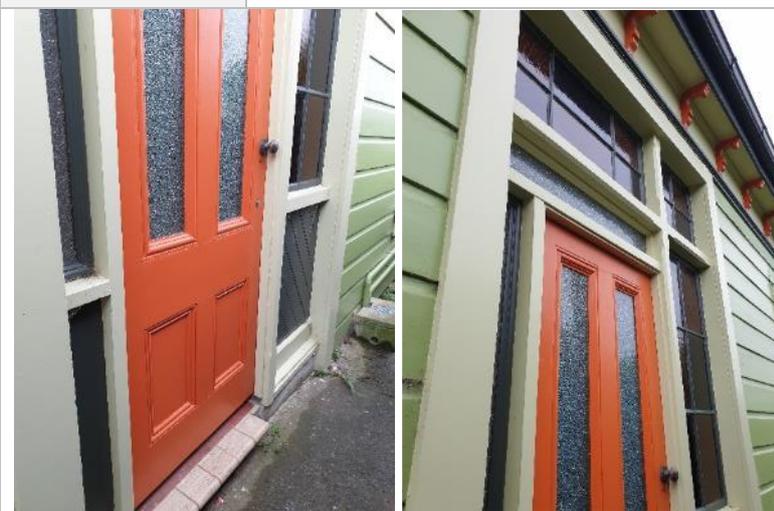
The side entrance porch door including side-lights and top-lights. (Moira Smith, 2022).

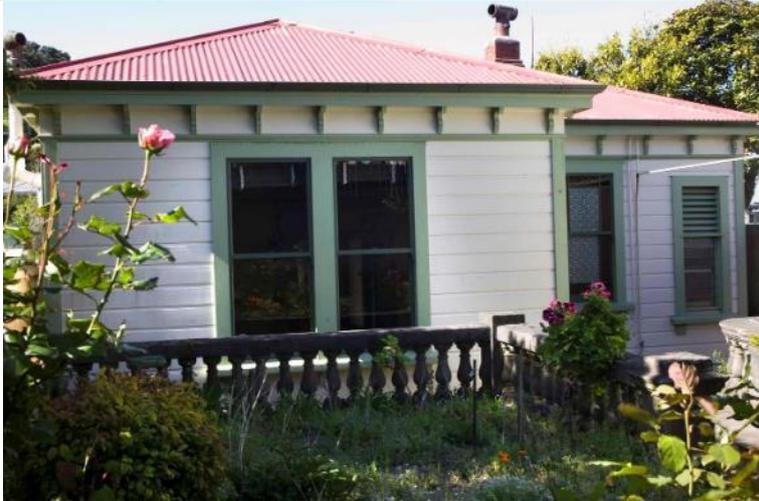
**SOUTH ELEVATION** **Heritage value - A**

History – the billiards room was added in 1908 and is an early addition. The east billiards room window was replaced with a door after 2007. The rear chimney is a lightweight replica and is clad in brick “slips”, the pots are original.

Element	Description of the south façade	Value
<b>Cladding</b>	Rusticated timber weatherboards and trim.	A
<b>Eaves</b>	Timber eaves brackets and soffit.	A
<b>Windows</b>	Sliding sash windows.	A
	The laundry window has a timber louvre.	A
	The bathroom window has decorative glass to the larger panes and coloured glass to the large central panes of each sash.	A
<b>Door</b>	The door to the billiards room added after 2007 and replaces a window.	C
<b>Services</b>	Any rainwater pipes, sanitary waste pipes, and soil vent pipes.	NIL

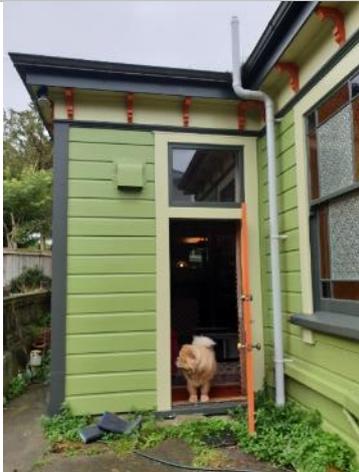
East elevation to Billiards Room including the new (after 2007) door. (Moirá Smith, 2022).

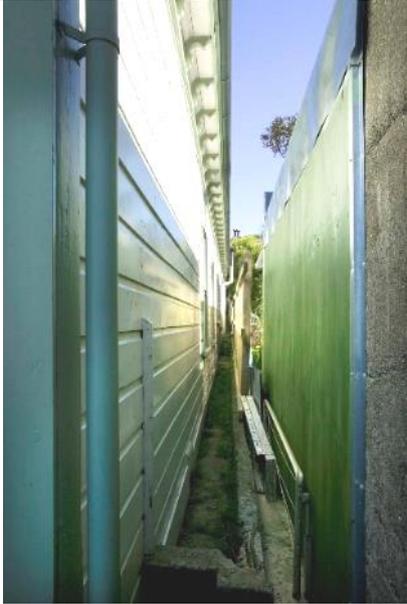
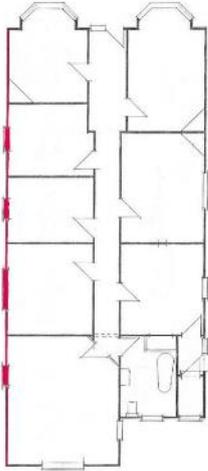
WEST ELEVATION	Heritage value - B

History – The west elevation has had few changes and is substantially intact. It was built close to the boundary and is difficult to see from the front or rear gardens, or from the street.

Element	Description of the west façade	Value
<b>Cladding</b>	Timber rusticated weatherboards and trim.	A
<b>Eaves</b>	Timber eaves brackets and soffit.	A
<b>Windows</b>	Sliding sash windows.	A
<b>Services</b>	Any rainwater pipes, sanitary drainage pipes, and soil vent pipes	NIL

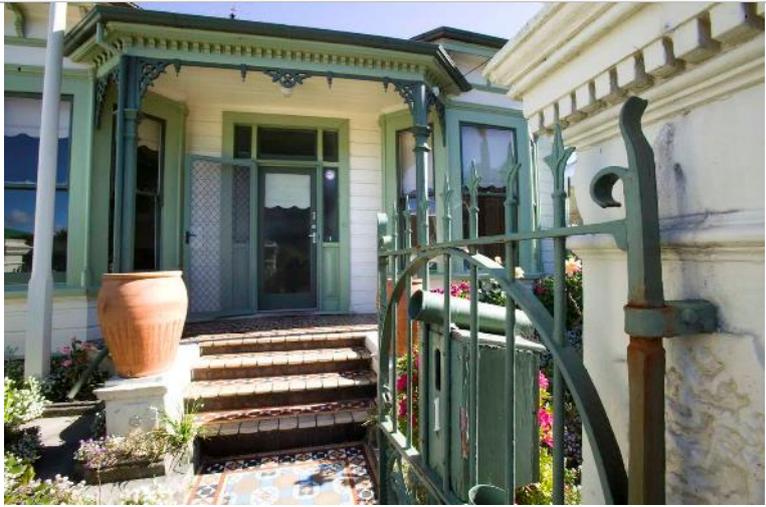
<b>FRONT GARDEN</b>	<b>Heritage value - A</b>

History – the front garden has had few changes and is substantially intact. The front fence is likely to have been designed and constructed by Charles Emeny. The house has had a flagpole since at least the 1930s.

Element	Description of the front garden components	Value
<b>Fence</b>	Front masonry fence with rendered or painted piers, gateposts, bottle balusters, plinths, and rails.	A
<b>Gates</b>	Two x metal gates. Assumed to be cast or wrought iron.	A
	Letter box and milk bottle holder	C
<b>Garden layout</b>	Formal layout of the front garden beds and paths.	A
	Concrete garden paths.	C
	Concrete edging to front garden beds	A
	Front steps with cement rendered plinths, and tiled treads. Porch floor with tiled surface.	A
<b>Flagpole</b>	Timber flagpole.	B

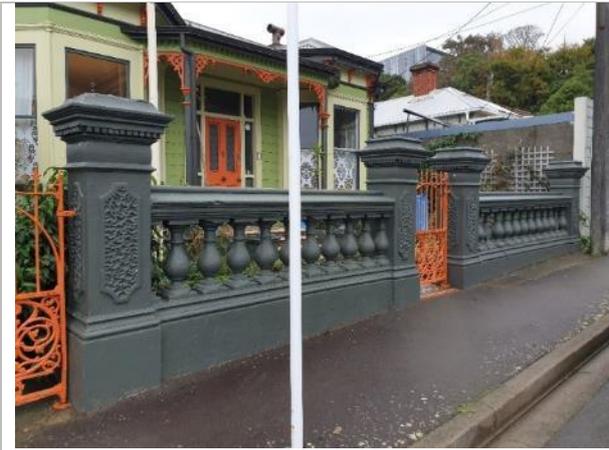
Front garden, masonry fence and gates. (Moira Smith, 2022).

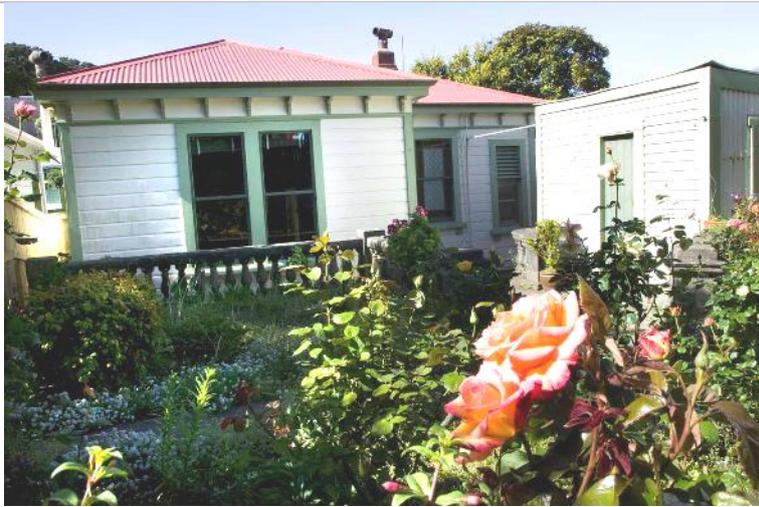
**REAR GARDEN**

History – the rear garden once included a washhouse complete with “copper”, wringer, and chimney. The washhouse was relocated when the house was extended in 1908. The washhouse was demolished after 2007, and the remaining chimney was demolished in 2017.

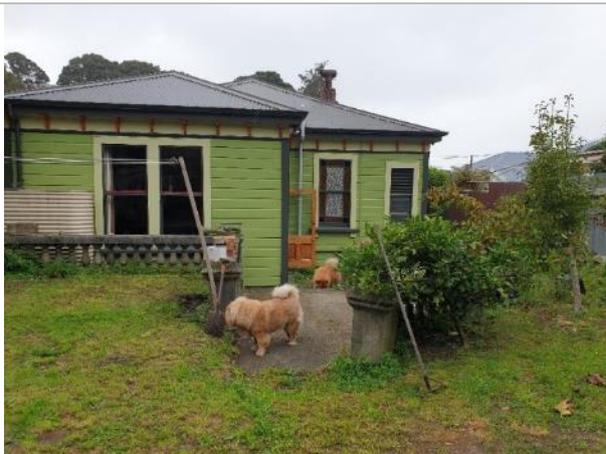
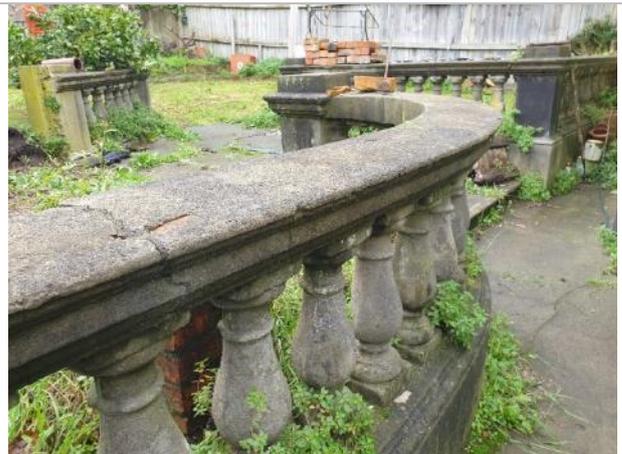
Masonry terrace “fence” – noted as “1” on sketch above. (Moira Smith, 2022).

Masonry terrace “fences”. The curved fence in the foreground is noted as “2” on sketch above. (Moira Smith, 2022).

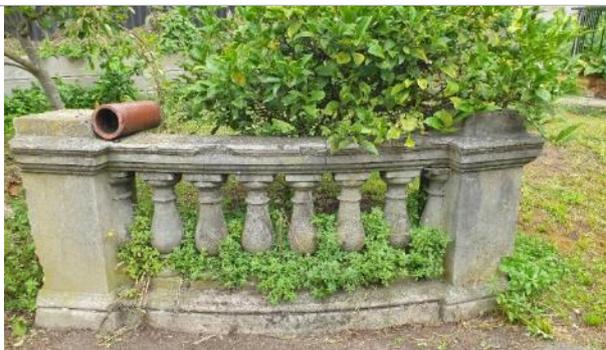
Masonry terrace “fence” – noted as “3” on sketch above. (Moira Smith, 2022).

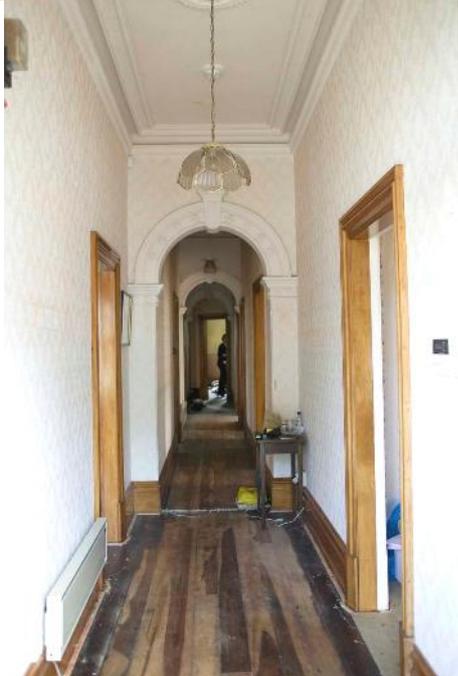
<b>HALL</b>	<b>Overall value - A</b>

History – the hall was extended in 1908 when the new bedroom and billiards room were added.

<b>Element</b>	<b>Description of components</b>	<b>Value</b>
<b>Floor</b>	Timber floorboards.	B
<b>Plaster</b>	Lath and plaster ceilings and walls.	A
	Decorative plaster including ceiling roses, cornices, and mouldings.	A
	Decorative plaster arches.	A
<b>Doors</b>	Timber four-panelled doors and door hardware.	A
<b>Joinery</b>	Timber joinery including skirting boards and architraves.	A

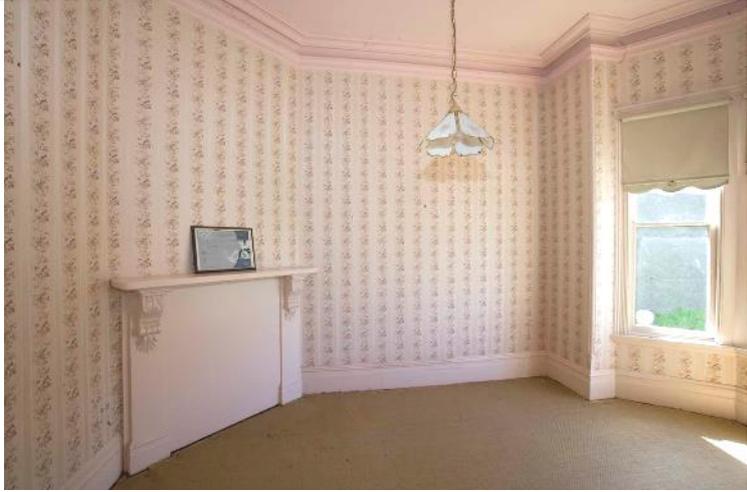
BEDROOM 1	Overall value - B

History – A new concealed door was added between bedroom 1 and the adjacent ensuite bathroom after 2007.

Element	Description of components	Value
<b>Floor</b>	Timber floorboards – may be under carpet.	B
<b>Plaster</b>	Lath and plaster ceilings and walls.	A
	Decorative plaster including ceiling rose and cornice.	A
<b>Doors (see also hall)</b>	Concealed door to ensuite and dressing room	NIL
<b>Joinery</b>	Timber joinery including skirting boards and architraves	A
	Timber fire surround	A

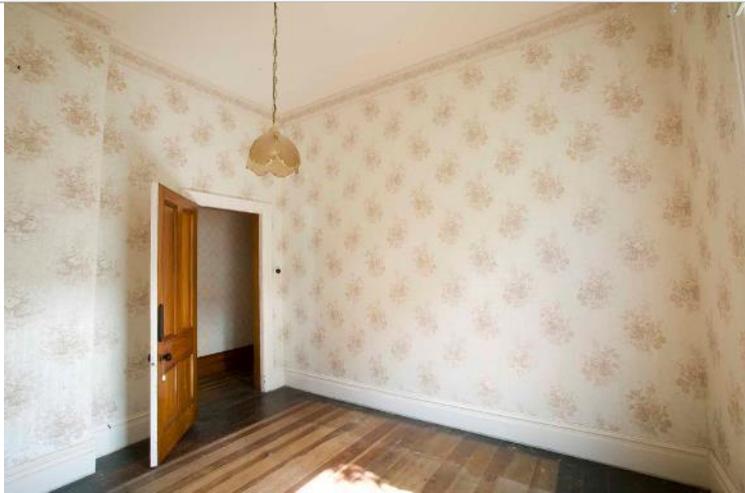
BEDROOM 2	Overall value - C

History - Bedroom 2 was adapted to form a dressing room and bathroom after 2007. The door to the hall has been fixed shut. The room has always had little decorative plasterwork.

Element	Description of components	Value
<b>Doors (see also hall)</b>	Concealed door to ensuite and dressing room.	NIL
<b>Joinery</b>	Timber joinery including skirting boards and architraves	A
	New partitions and fittings to bathroom and dressing room (c.2007)	NIL

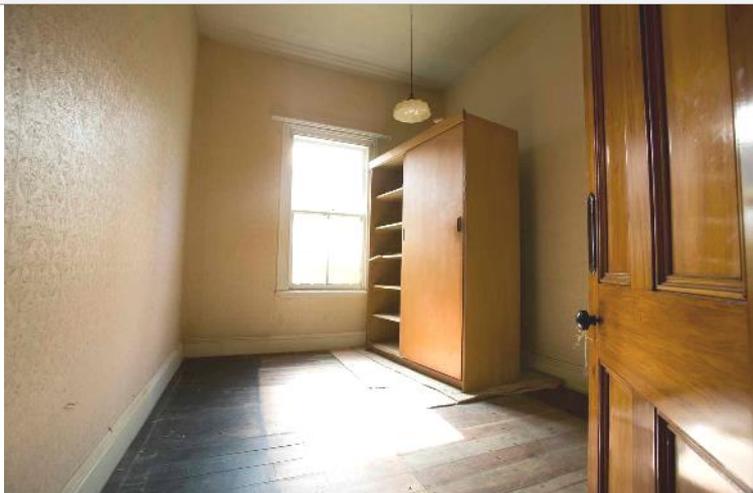
BEDROOM 3	Overall value - C

History – Bedroom 3 has had few changes since it was constructed. It has very little decorative plasterwork.

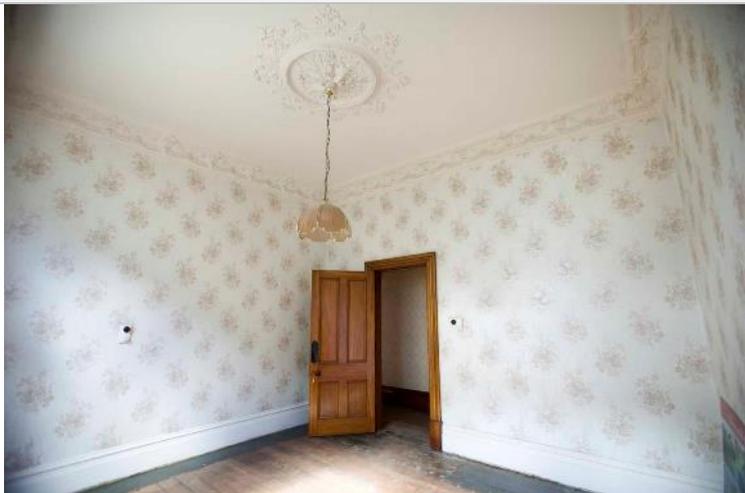
BEDROOM 4	Overall value - C

History – Bedroom 4 has had few changes since it was added in 1908. It has more decorative plasterwork than bedrooms 2 and 3.

Element	Description of components	Value
Floor	Timber floorboards.	B
Plaster	Lath and plaster ceilings and walls.	A
	Decorative plaster cornice and ceiling rose.	A
Doors	See hall	
Joinery	Timber joinery including skirting boards and architraves.	A

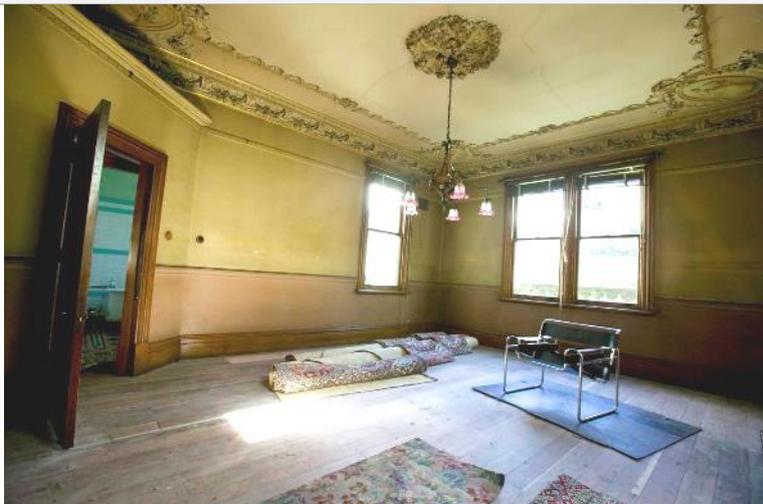
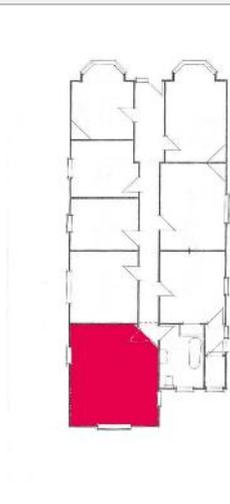
<b>BILLIARD ROOM</b>	<b>Overall value - A</b>

History – the billiards room was added in 1908. It includes painted cameos on the ceiling that are thought to be of Mary Emeny and her daughters Mabel, Rene, and Ophir. The door to the back garden replaces a sash window and was installed after 2007. The fireplace was originally designed for a gas fire, which was later removed. The tiles have been repaired.

Element	Description of components	Value
<b>Floor</b>	Timber floorboards.	B
<b>Plaster</b>	Lath and plaster ceilings and walls.	A
	Decorative plaster cornice and ceiling rose.	A
	Dado rail and timber picture rail	A
<b>Doors</b>	See hall	
<b>Joinery</b>	Timber joinery including skirting boards and architraves.	A
	Timber fire surround with ceramic tiled insert	A
<b>Other</b>	Pendant light fitting at centre of room	B
	Painted cameos on ceiling.	A

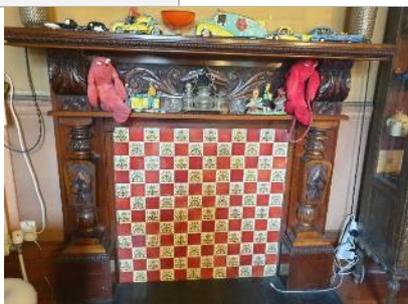
Timber fire surround with tiled insert. Note that this was originally for a gas fire and there is no fire insert. (Moira Smith, 2022).

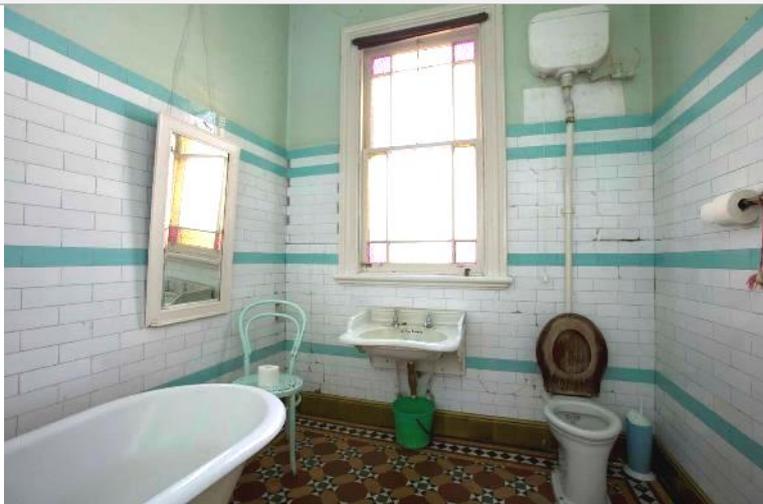
<b>BATHROOM 1</b>	<b>Overall value - B</b>

History – the WC was added in 1908. The glass wall tiles, skirting tiles, and some of the fittings were replaced in c.2017 when the bathroom was refurbished.

Element	Description of components	Value
<b>Floor</b>	Tiled floor	A
<b>Walls</b>	Ceramic wall tiles and skirting tiles were replaced / installed in c.2017	C
	There is a small remnant of original glass tiles preserved behind the north bathroom cupboard	B
<b>Doors</b>	See hall	
<b>Joinery</b>	Timber joinery including architraves	A
<b>Fittings</b>	Bath	A
	Ceramic basin was replaced in c.2017	C
	Basin brackets are probably original	B
	WC pan	B
	WC cistern, chrome pipes, and seat were all replaced in c.2017.	C

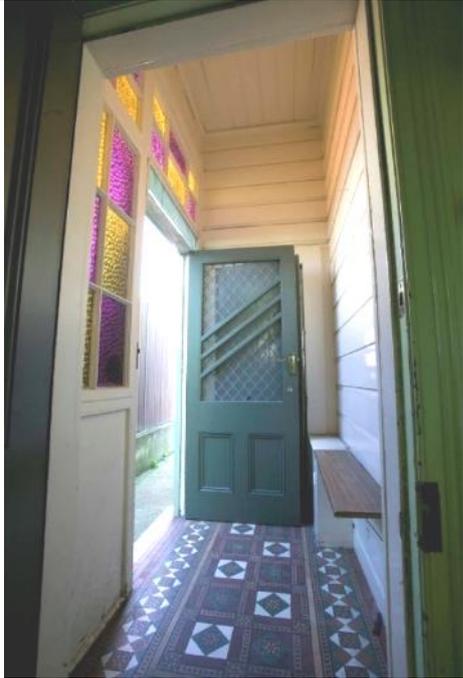
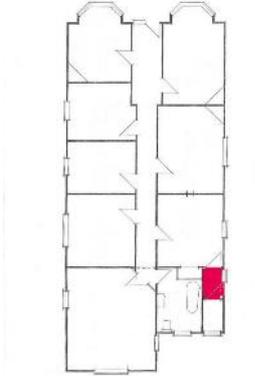
SIDE ENTRANCE PORCH	Overall value - A

History – there have been few changes to the side entrance porch. The external door was altered or replaced after 2007.

Element	Description of components	Value
Floor	Tiled floor	A
Walls	Timber rusticated weatherboards	A
Ceiling	Timber match-lining	A
Joinery	Timber joinery including architraves	A
Doors	External door – is part of the east façade	
	Ledged and battened door to pantry	A
	Four panelled door to kitchen	A

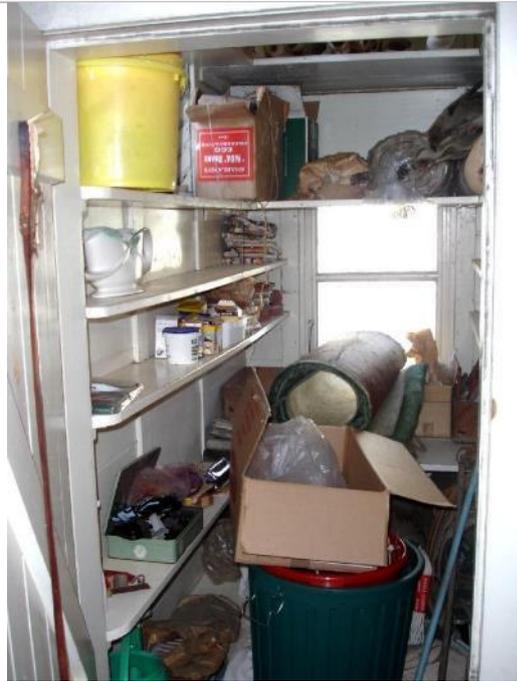
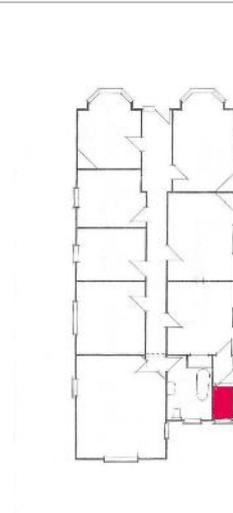
**PANTRY**

History - The pantry was converted to a laundry after 2007.

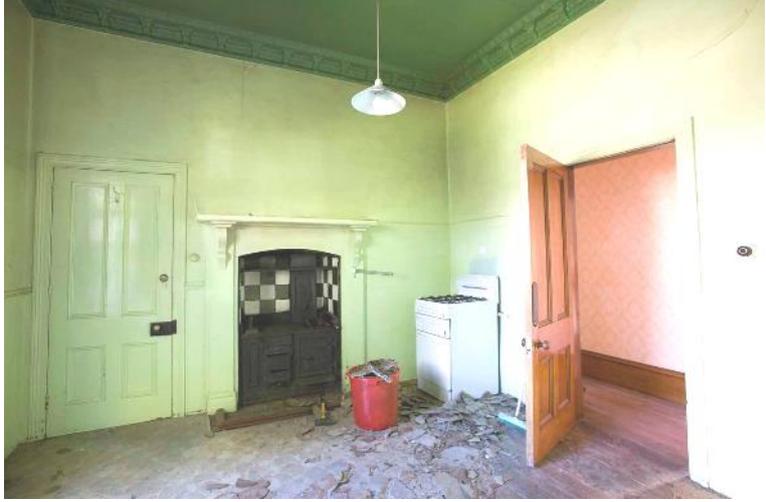
KITCHEN AND DINING	Overall value - B

History – The kitchen and dining room have been updated since 2007. The kitchen floor is covered with ceramic tiles. There are fixed units to the east and west walls. The plaster and lath has been replaced on the walls. There is a new opening between the kitchen and dining room. The kitchen hutch dresser and dining room hatch were relocated to the dining room.

Element	Description of components	Value
Floor	Tiled kitchen floor was installed after 2007.	C
	There is a small area of tiling under the southwest kitchen cabinet.	B
Walls	New plaster or plasterboard linings to the kitchen and dining room walls.	C
Ceiling	Plaster on lath ceiling with plaster cornices and ceiling rose.	A
Doors	Four panelled timber doors and door hardware.	A
Joinery	Timber joinery including architraves and skirtings.	B
	Timber surround to coal range.	A
	Coal range.	A
	Tiled surround to coal range – the tiling was replaced to match the original tiles after 2007.	B
	The 1950s tiled dining room fireplace was replaced after 2007.	B
	Kitchen hutch dresser was relocated to the dining room after 2007.	A
	Dining room hatch was relocated to north wall after 2007.	A

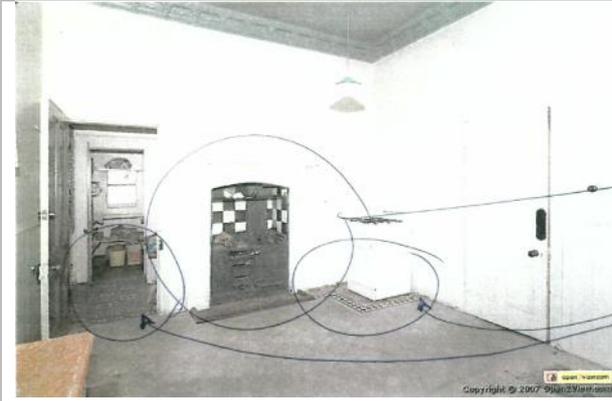
The kitchen floor tiles are located under a c.2007 kitchen unit. (SR 171210 Resource Consent application.)

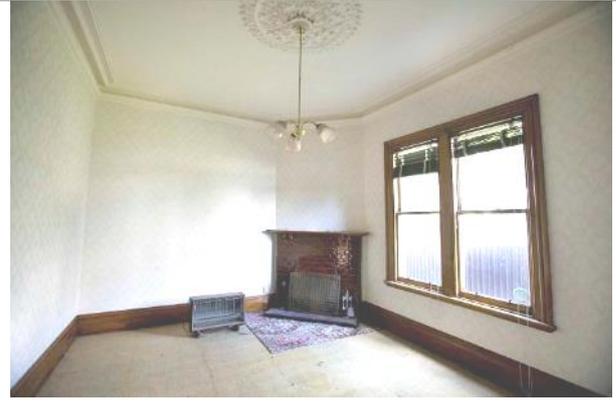
The dining room fireplace has been replaced with a timber surround and the dining room hatch has been moved to the north wall of the room.

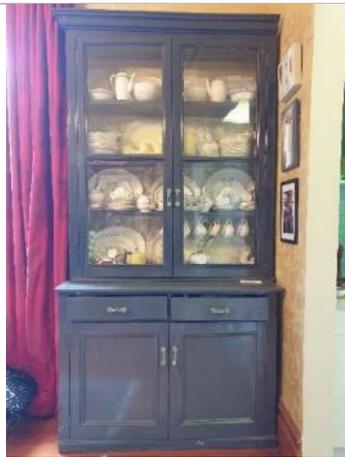
Kitchen hutch dresser has been relocated to the dining room.

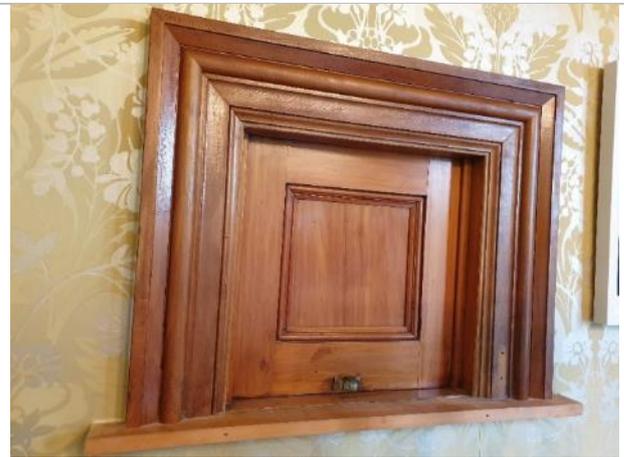
The kitchen to dining room hatch has been relocated to the north wall of the dining room

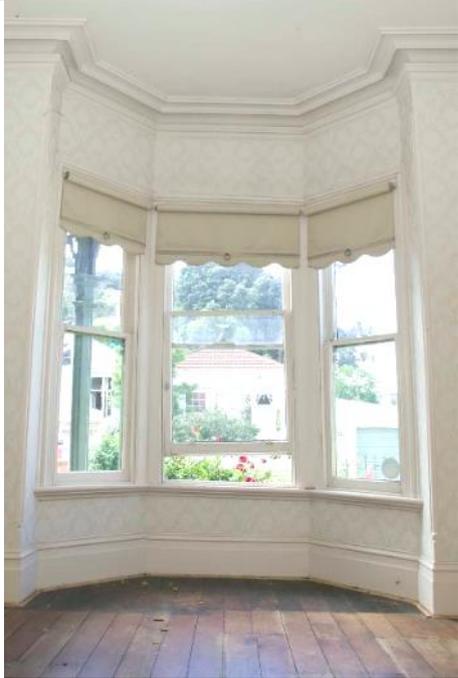
LOUNGE	Overall value - A

History – The lounge has had few changes since it was constructed.

Element	Description of components	Value
<b>Floor</b>	Timber floorboards	B
<b>Plaster</b>	Lath and plaster ceilings and walls.	A
	Decorative plaster including ceiling rose and cornice.	A
<b>Doors</b>	See hall	
<b>Joinery</b>	Timber joinery including skirting boards and architraves	A
	c.1950s Tiled fireplace and surround was replaced after 2007 with a timber surround.	B
