Richard Murcott

Independent Commissioners' Panel  
for the Wellington City Proposed District Plan

Hearing Stream 3 – **Heritage**

## **Principal Submission on the PDP Relief sought**

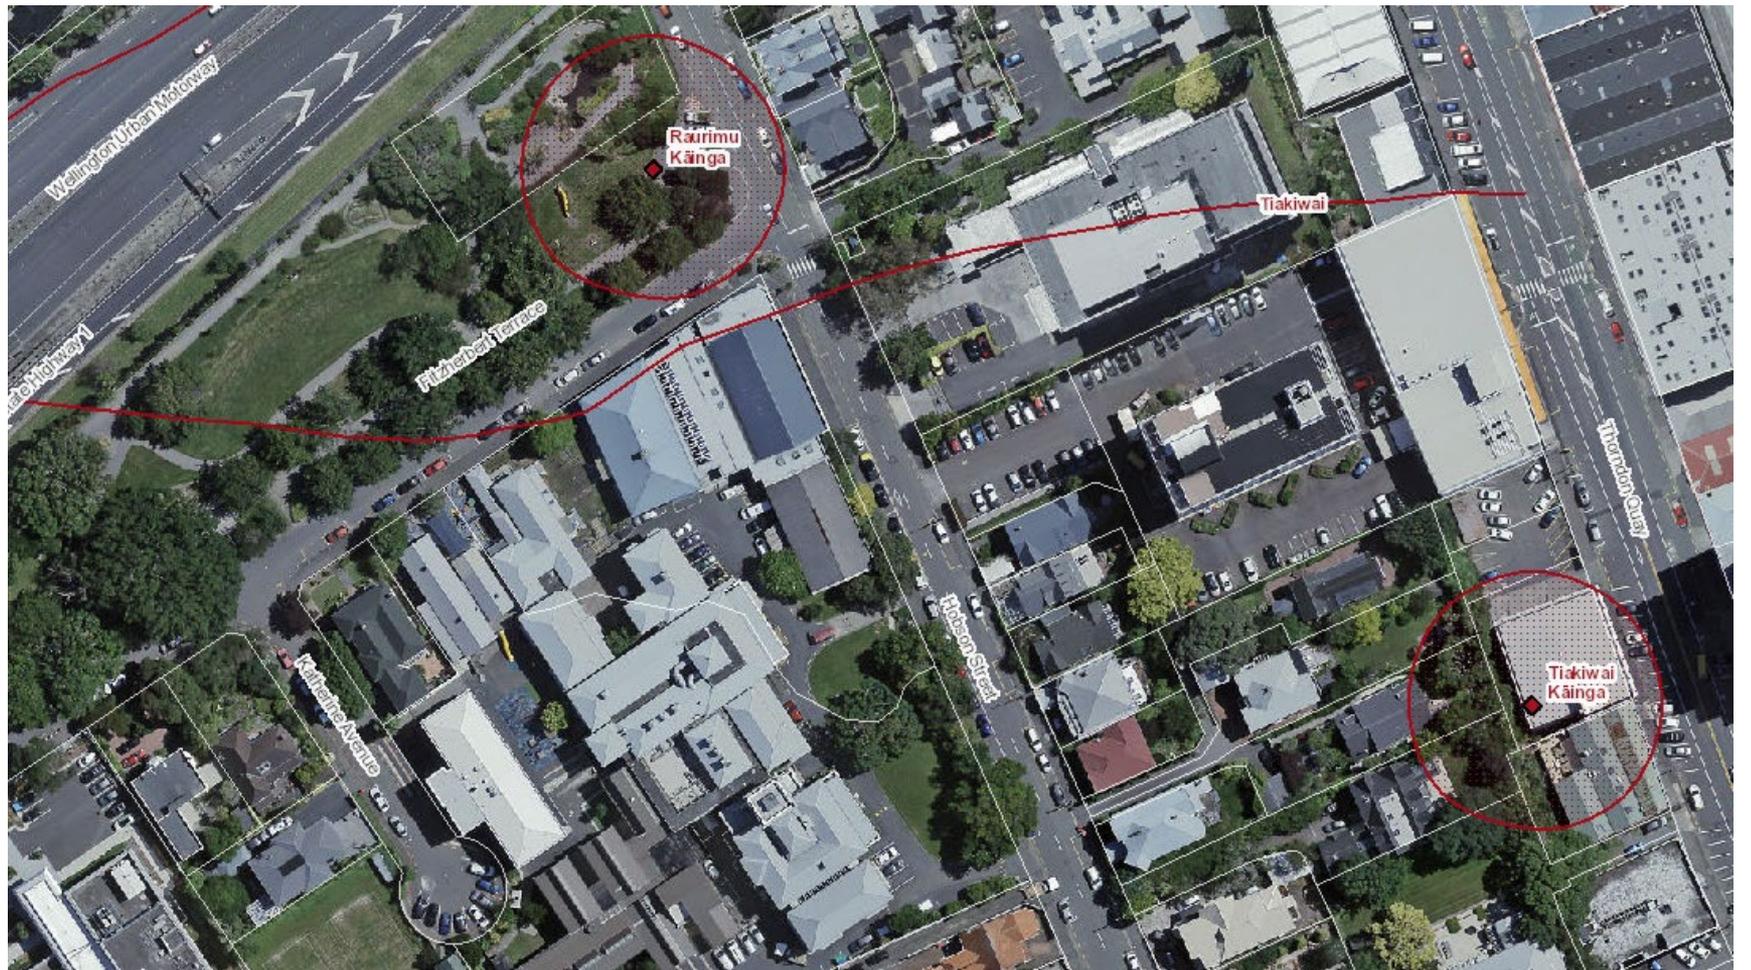
At Hobson St, Tiakiwai is mapped ~70m north of it's actual position

| <p>3</p> | <p>An image from the PDP</p> <p>The line of the stream is currently plotted across <b>Katherine Mansfield Memorial Park</b>, then generally running parallel to <b>Fitzherbert Tce</b> and across the intersection with Hobson St, then through the property of the <b>Australian High Commission to Thorndon Quay</b>.</p> <p>Note where it crosses Hobson St.</p> |

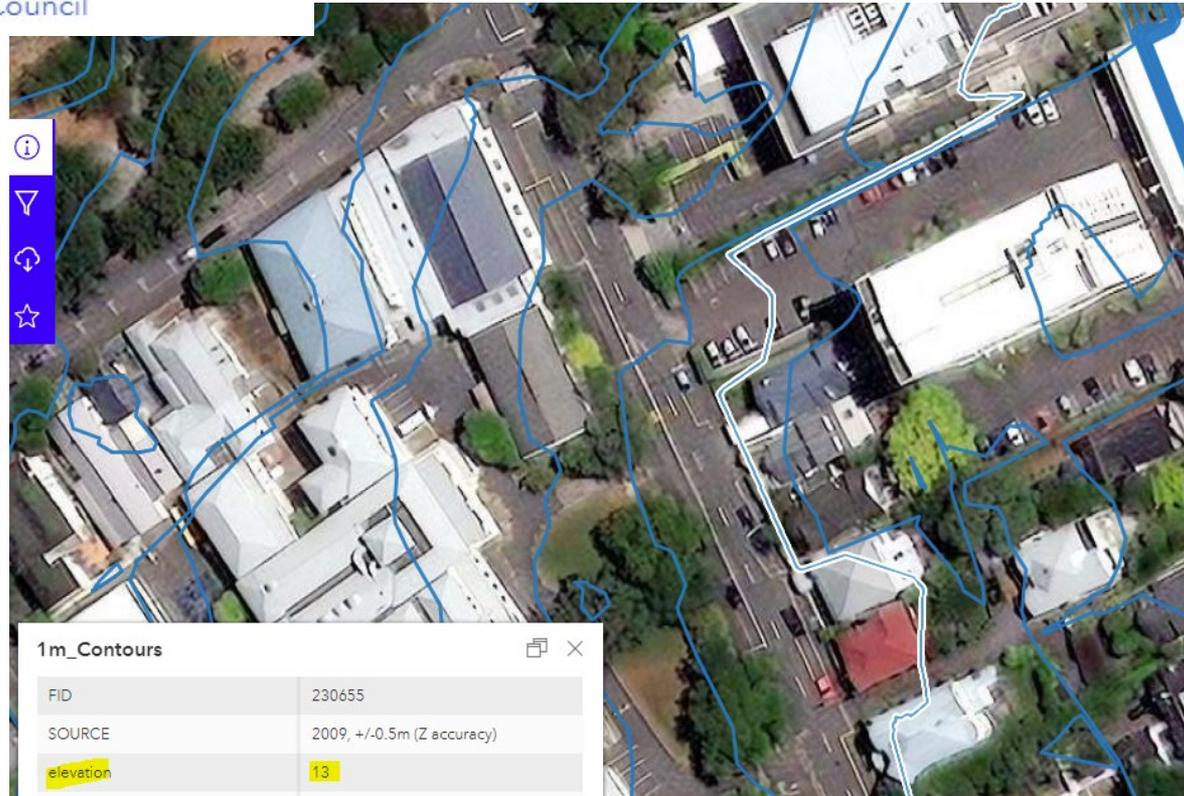
# Wellington CC 1m Contours 2017

Where Tiakiwai has been incorrectly plotted in the PDP it is crossing Hobson St on a contour that is ~3m above the lowest point along this segment of the street.

| <p>4</p> | <p>Here's an extract from WCC's Open Data Portal.</p> <p>The contour near where the line of the stream crossed Hobson St is 3m higher than the lower point in the street, being the likely position for a stream, which is 70m down the road.</p> <p>But we don't need contour maps to alert us where the gully and historic stream used to be. <b>Papatūānuku</b> (mother earth) has her own way of speaking to us.</p> |

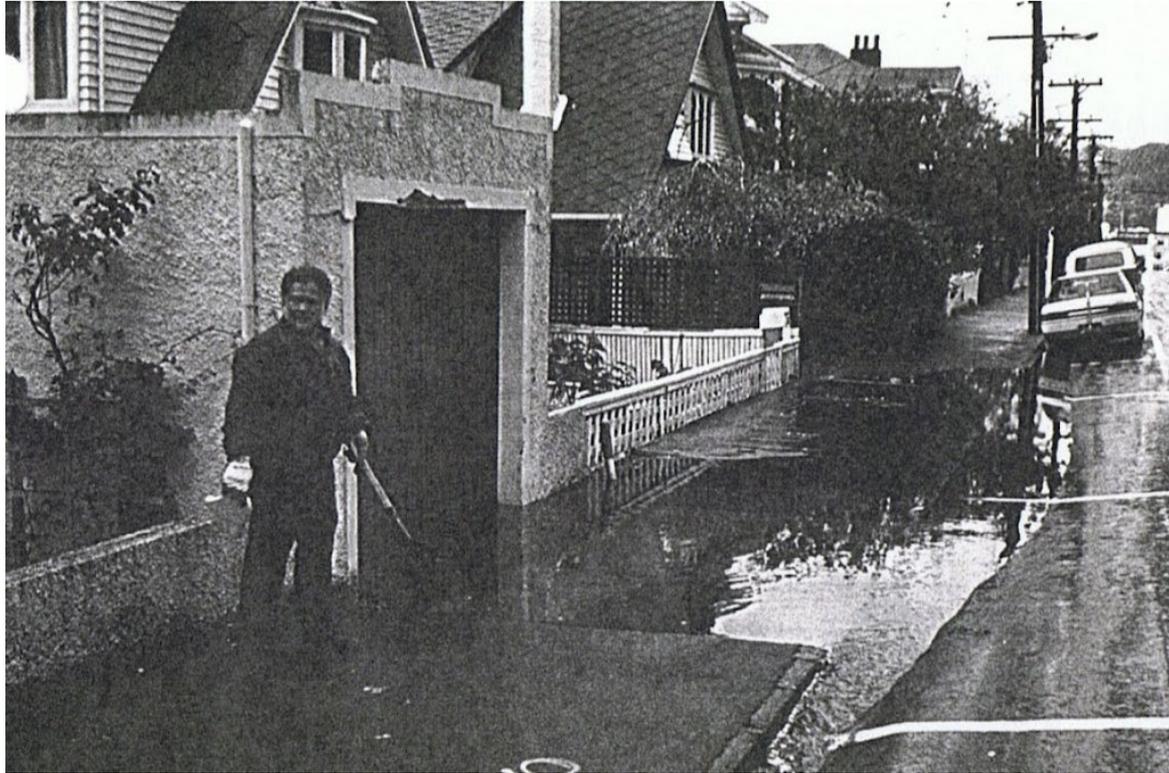
Nature disclosing Tiakiwai's location in this flood in 1993

| <p>5</p> | <p>Here's Tiakiwai attempting to daylight itself after a downpour in 1993. Clearly, the stormwater system failed.</p> <p>Not the first time it'd failed. 40 years earlier, in 1953 the property <i>opposite the white car in the photo</i> suffered flooding and stormwater damage originating from the street. There have been other examples in living memory.</p> <p>On all these occasion's WCC has paid <b>compensation</b> for the damage caused and various mitigations.<br/>Ref. Wellington City Archives</p> |

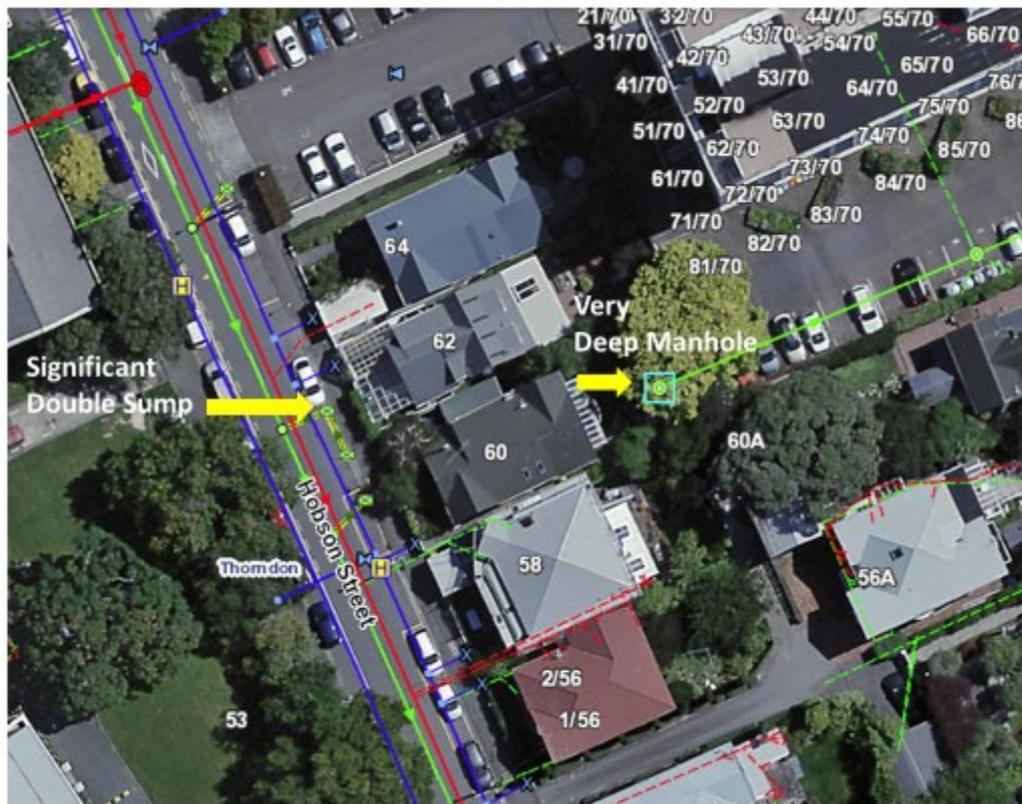
Stormwater Node: WCC\_SW026488

| Type | Manhole |
| Chamber Material | Reinforced Concrete In-Situ |

| <p>6</p> | <p>An example mitigation</p> <p>A significant double sump was installed.<br/>Wellington Water knows it needs regular cleaning.<br/>'Solutions' like these in our suburb will be tested when Wellington is visited by an atmospheric river.</p> |

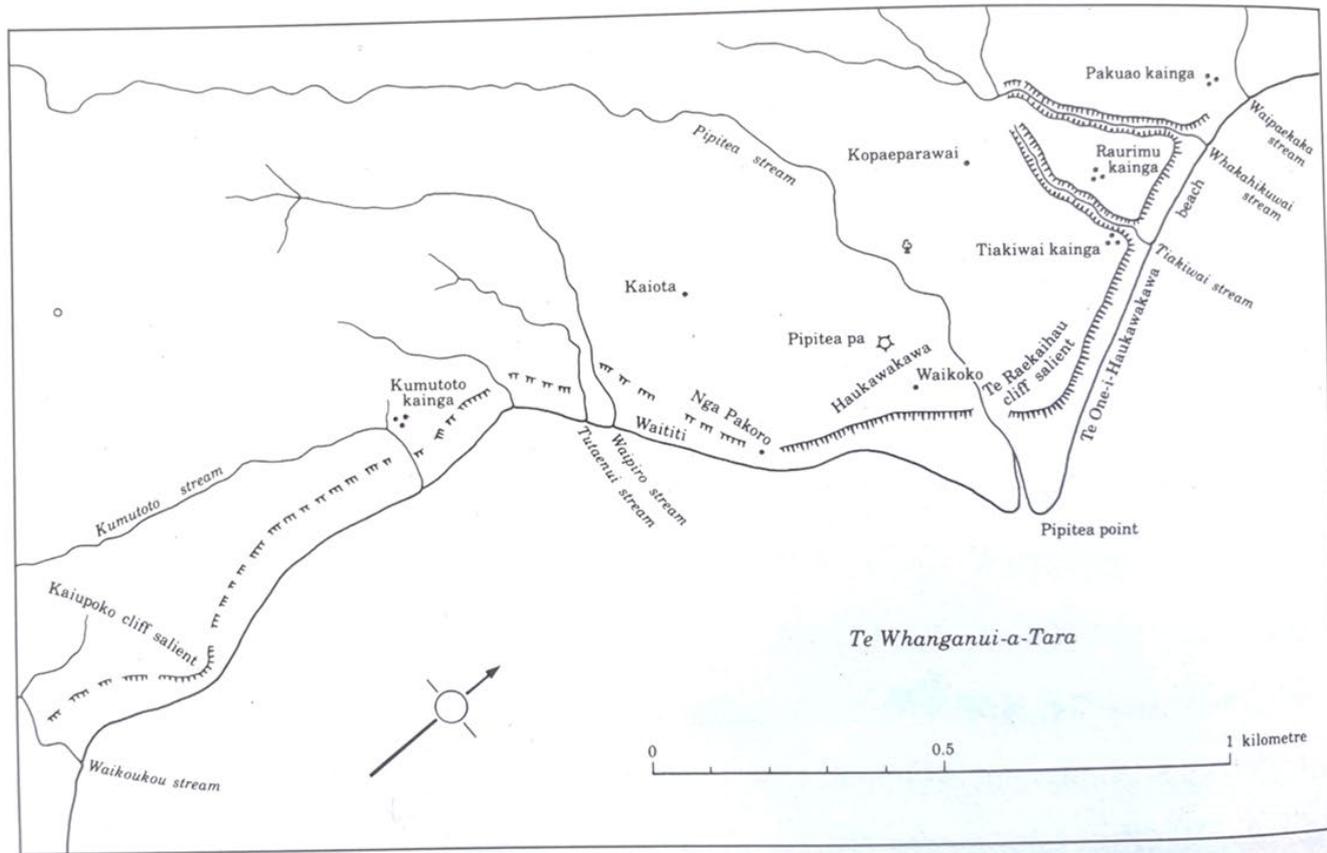
Maori Thorndon about the time that William Wakefield decided to move the settlement from Petone to the Lambton Harbour side of the harbour.

| <p>9</p> | <p>This illustrates the lay of the land nearer 200yrs ago.</p> |

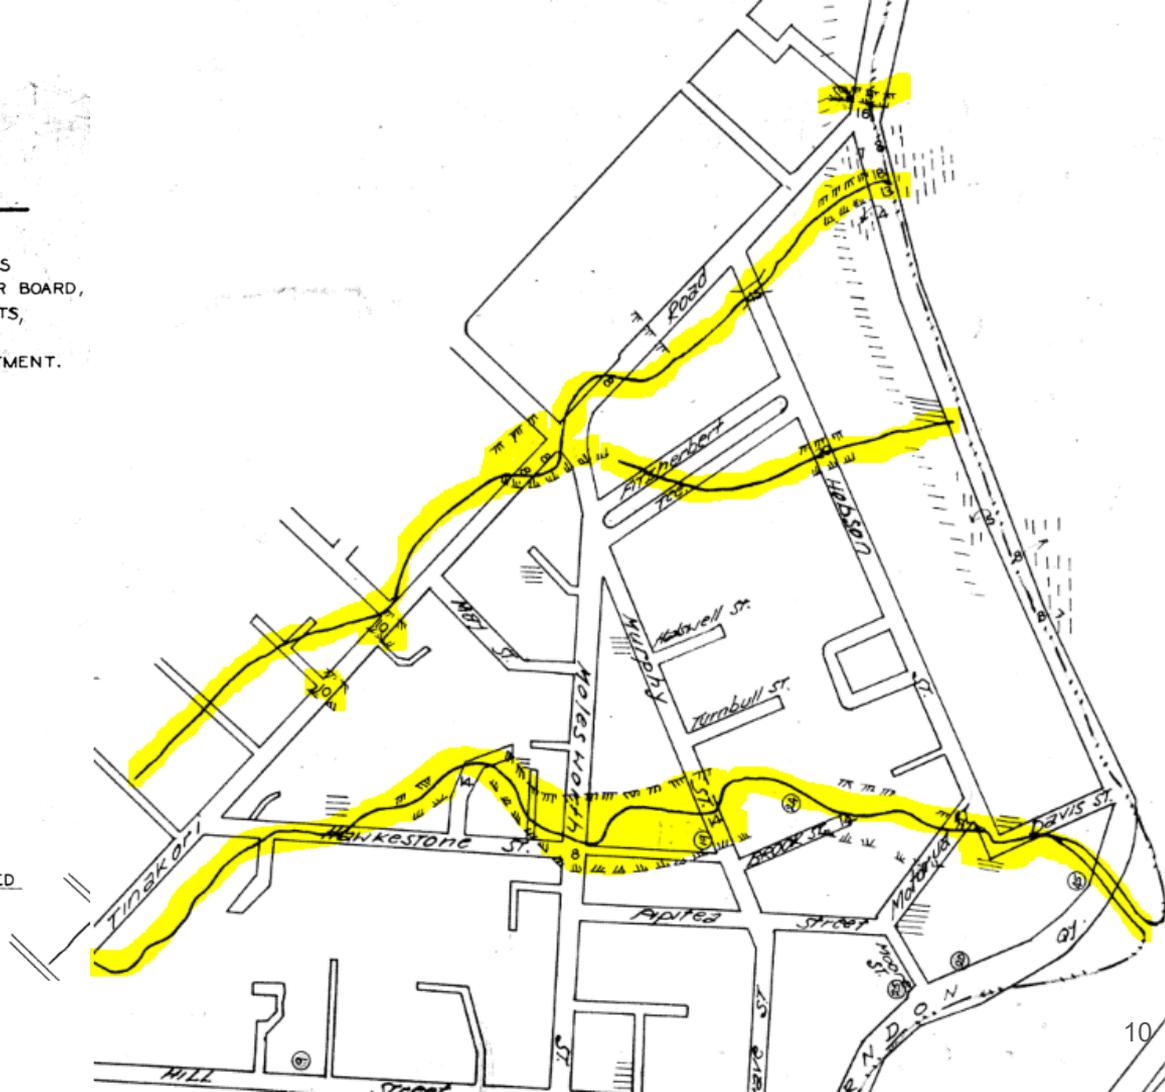
# SUBSOIL SURVEY OF CENTRAL WELLINGTON CITY

PREPARED  
FROM INFORMATION COLLECTED FROM THE RECORDS  
OF THE CITY COUNCIL, THE PUBLIC WORKS DEPT, THE HARBOUR BOARD,  
THE TURNBULL LIBRARY, OR SUPPLIED BY ARCHITECTS,  
BUILDERS, CONTRACTORS, ETC.  
ADAPTED FROM THE 5CHAIN MAP OF N.Z. LANDS & SURVEY DEPARTMENT.

**FIGURES DENOTE DEPTH OF FILLING IN FEET**

| <p>10</p> | <p>More base data; a City Council subsoil survey from <b>1936</b>. (<i>highlighting added by me</i>).</p> <p>Tiakiwai is the small stream in the middle.</p> <p>Of interest are the extra insights we obtain from such records e.g. the <b>depth of fill</b> under Hobson St; <b>20 feet ( +6m )</b> – <i>that's about two storeys high</i></p> |

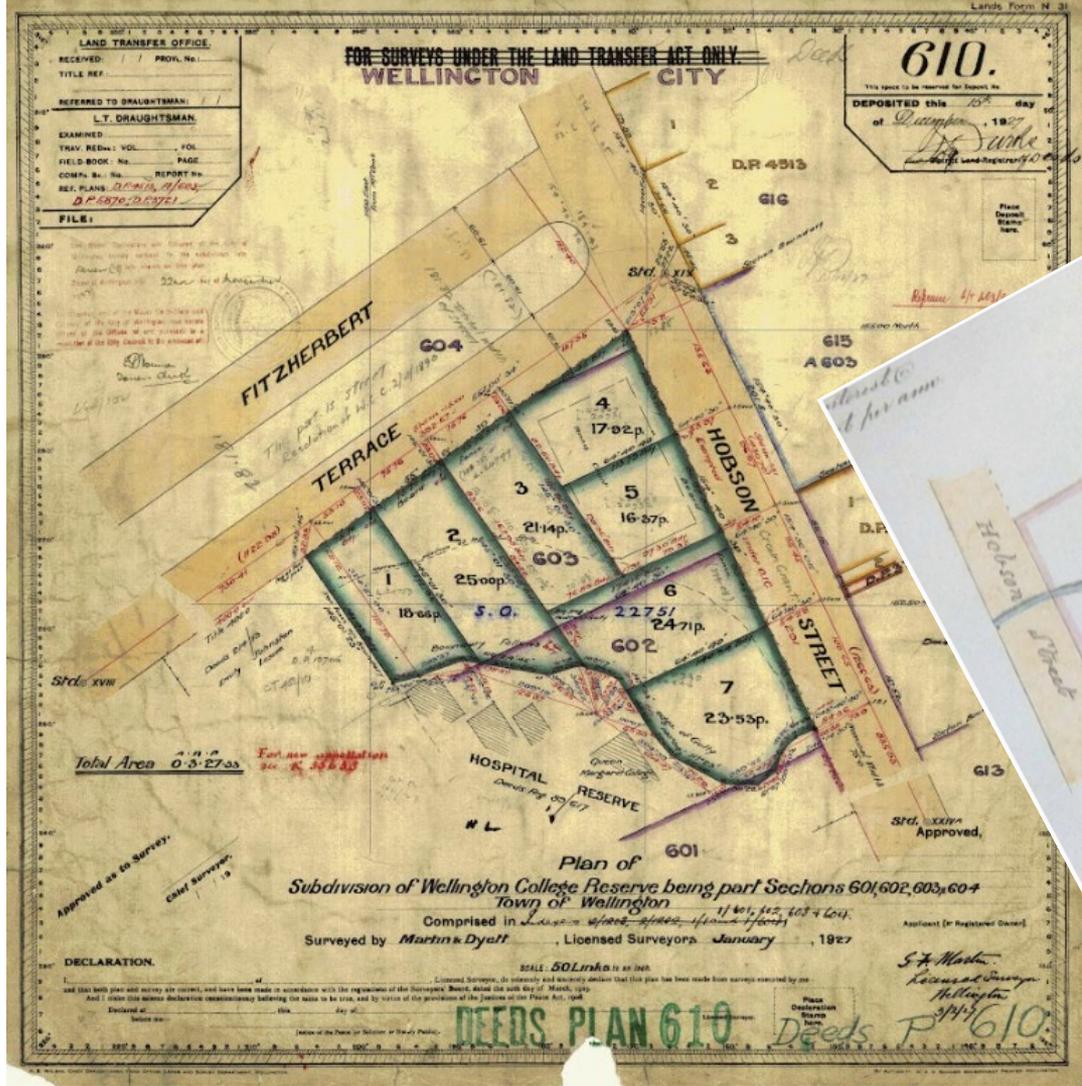
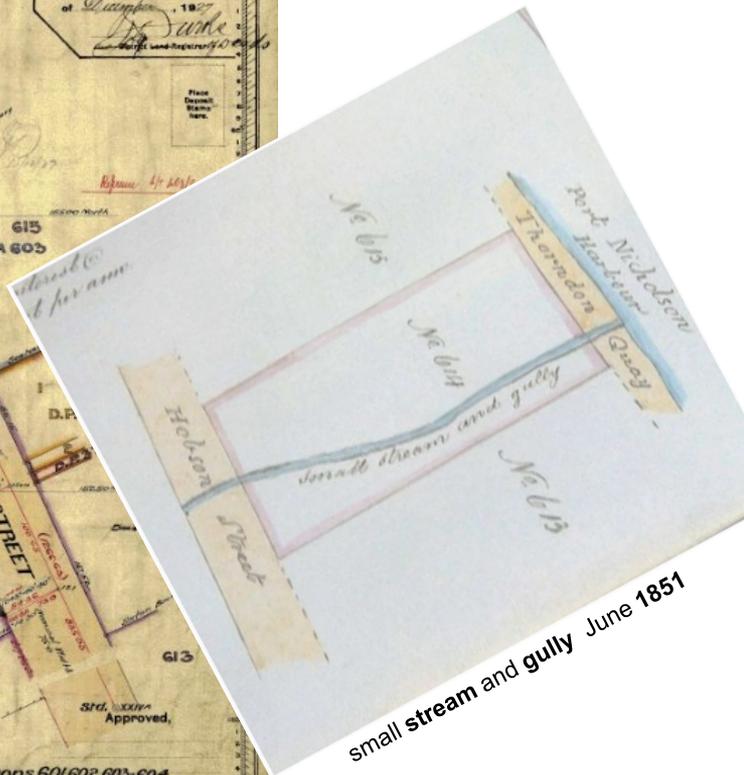
# Surveying the Tiakiwai stream

Boundary follows edge of Gully  
January 1927

| <p>12</p> | <p>To nail down the location even more precisely this cadastral survey from 1927 fixes the edge of the right bank of the gully.</p> <p>On this slide I've attempted an illustrative overlay of a <b>1851</b> sketch (not to scale), which was contained in a letter sent by Charles Von Alzdorf (land agent) to Robert Wainhouse in England, being the owner of Town Acre 614 at the time.</p> <p>Something else from the archives:<br/> On <b>31 May 1879</b> the then owner of Town Acre 614 sent a letter to the <b>Wellington City Engineer</b> complaining about a culvert and stream that traversed under Hobson Street carrying the Tiakiwai stream towards Town Acre 614 and to the beach. It was causing erosion every time there was heavy rain.</p> <p>Part of this gully remains evident under the residences at No's 60 and 62 Hobson St. These houses were constructed in 1915 and 1916.</p> <p>Re the translations on this slide are summarised from a Stuff article written by Rachel Buchanan published 15 September 2012.</p> |
