Island Bay town centre Audit

The CPTED audit of Island Bay was carried out throughout March 2022 – the area looked at was around the central shopping area, including the New World car park, it extended down the parade to include the library and further on south to the Empire cinema. It also included the walkway between The Parade and Clyde Street.

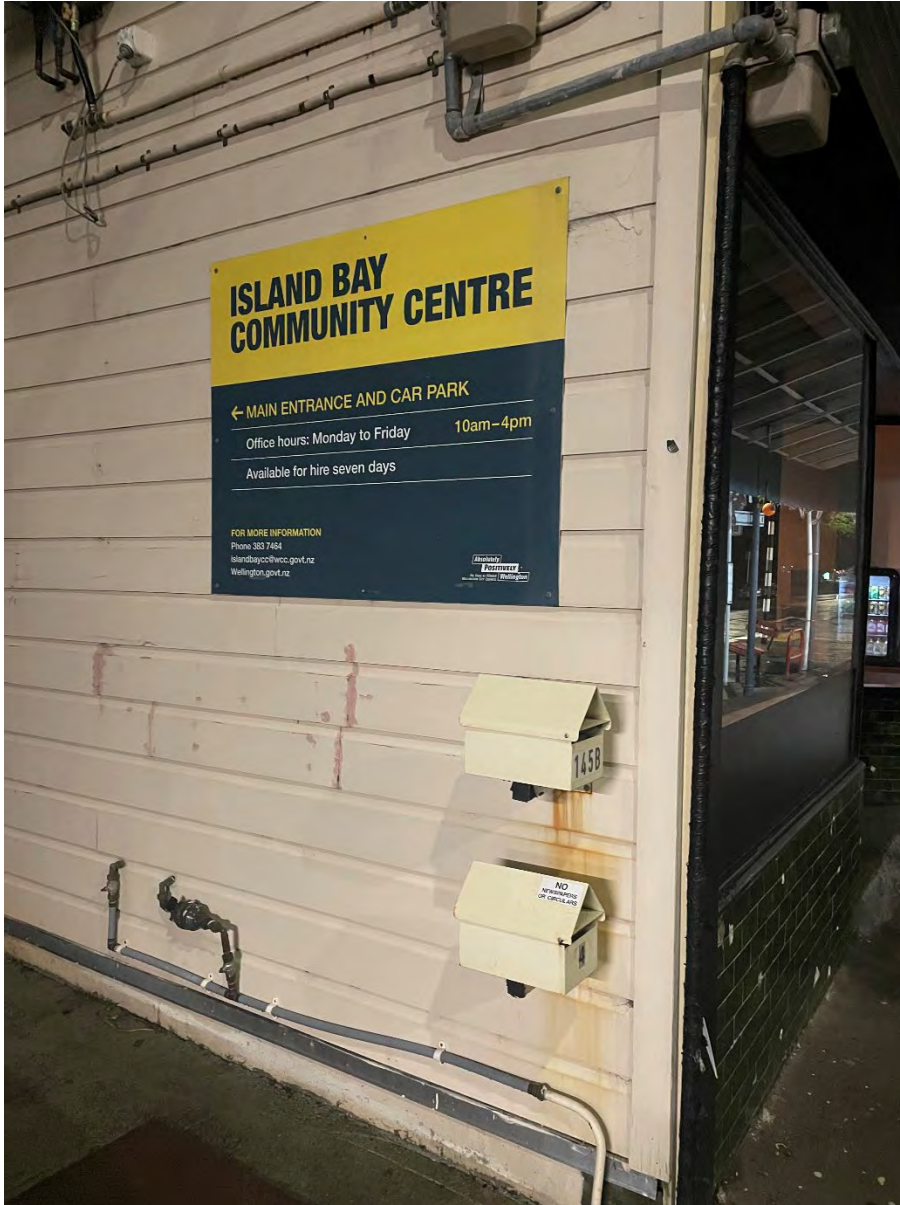
The walkway between the Parade and Clyde Street presents its own specific safety issues. It is narrow and confined and has insufficient lighting. While it feels safe to use during the day, at night it loses that feeling of safety and it appears little used.

Clyde Street Walkway from The Parade at night

- Improve lighting in Clyde Street pathway
- Improve under canopy lighting or encourage its use by business to create consistency.
- Improve lighting in and around the Community Centre and Library – and Toilets if they're accessible at night.
- Consider pedestrian lighting between the Town Centre and Cinema
- Improve lighting between the Parade and New World

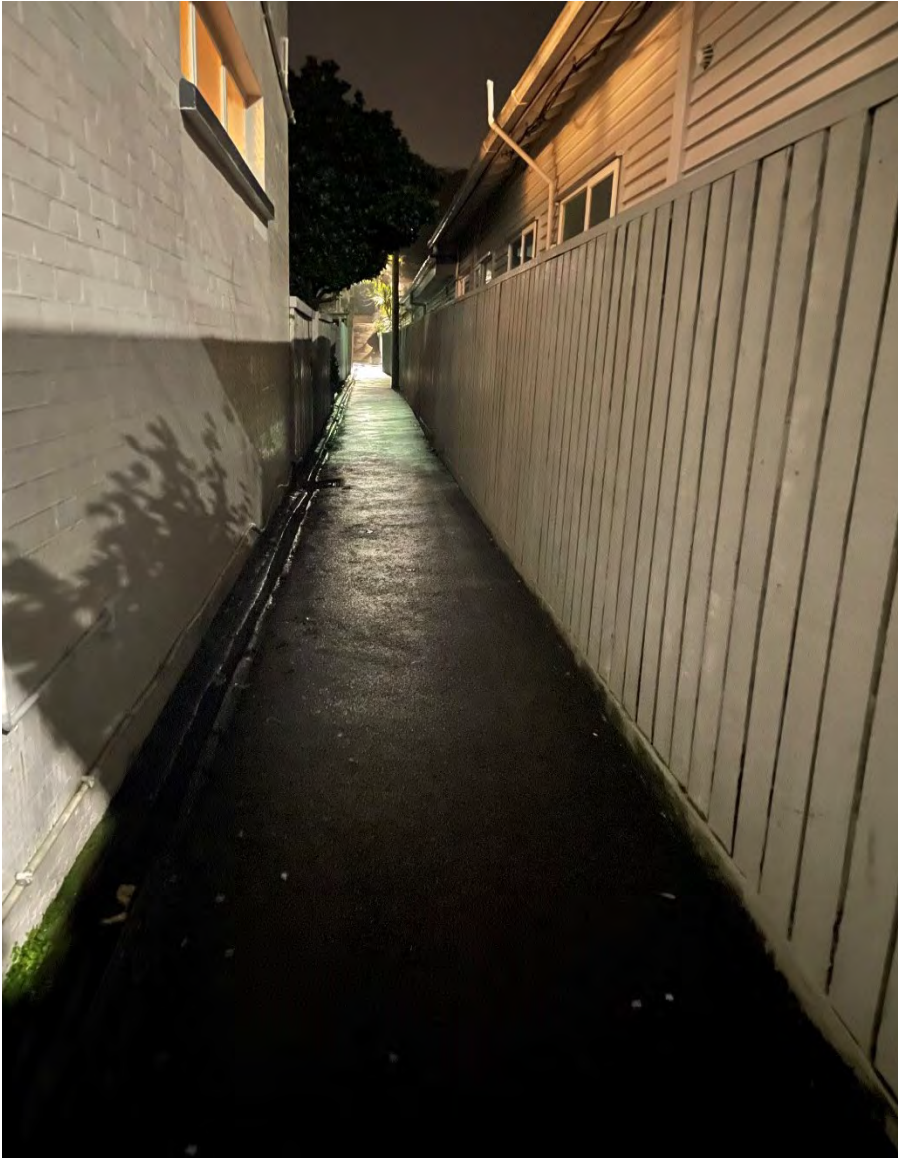
There are 2 lights along the path, one of which has light partially blocked by a large tree. The lighting is not sufficient as a night time pedestrian route. Light measurements are only 1.5 lux at the start at the Parade end (with Street light spill), it then drops to 0.1 and the 0.9lux when moving closer to the light. The lights are poorly spaced which in turn gives poor coverage, and leaves dark spots.

- Trim or remove overhanging tree
- Increase lighting – number of poles as well as lumens – Aim for 7-10 lux and consider various lighting height to help decrease impact on neighbouring property
- In the absence of being able to improve sightlines due to residential fencing consider CCTV coverage to be the “eyes”
- Improve directional signage

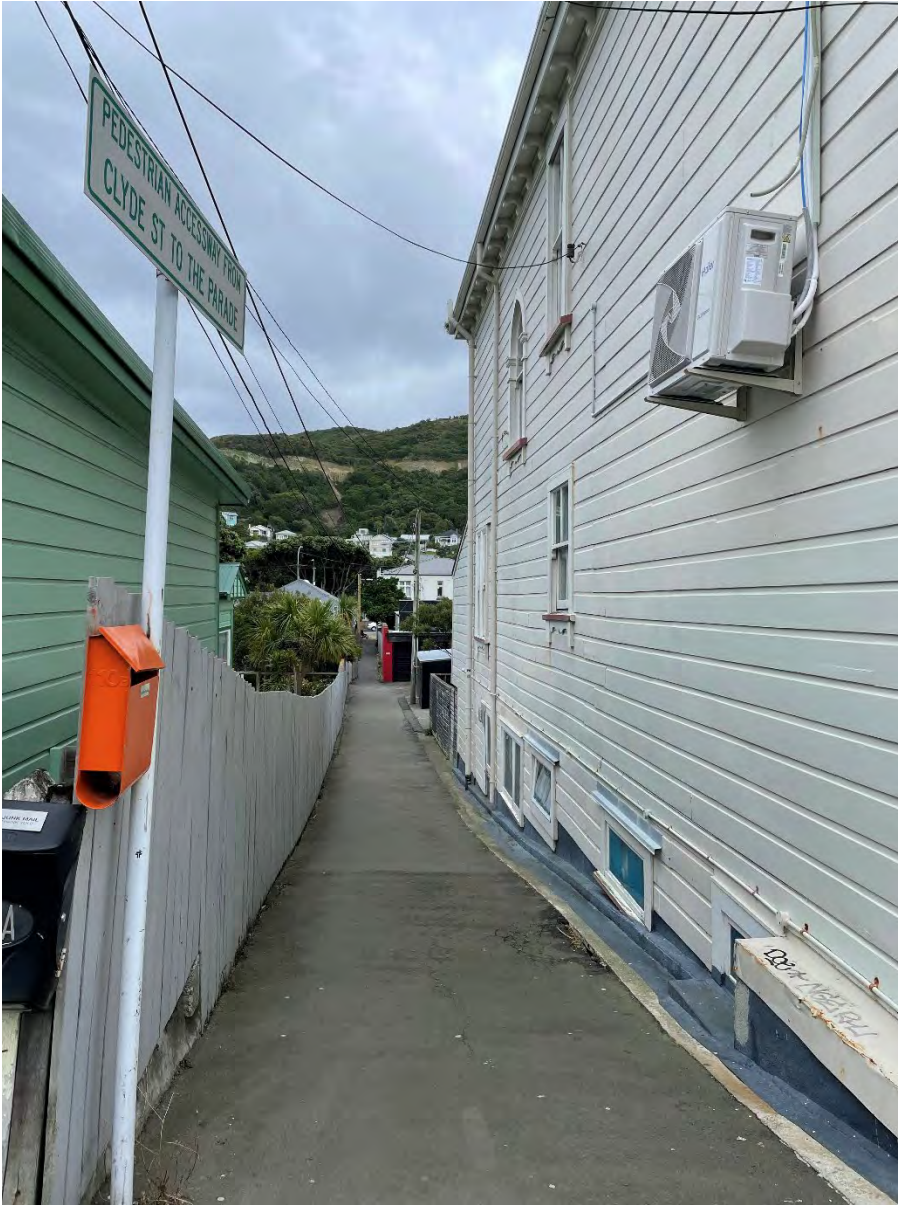
The walkway from The Parade through to Clyde Street is approximately 200m long, narrow at the Parade end it widens to allow for vehicles at the Clyde Street end.

While during the day it is used regularly by pedestrians at night it is used far less often (but worth noting it IS still used). The residential properties that form the boundaries for the length of the path are both a help and a hindrance. Their need for privacy has led to high fences on both sides that make the space (at the parade end) confined and removes any lines of sight from residents to the path users. There are no exit points along the path and little lighting. At the top end the fences give way on one side to housing and garaging, however there is still little lines of sight out to the path, with either garaging, small or frosted windows dominating the side of buildings facing the path.

Clyde Street walkway from Clyde Street end

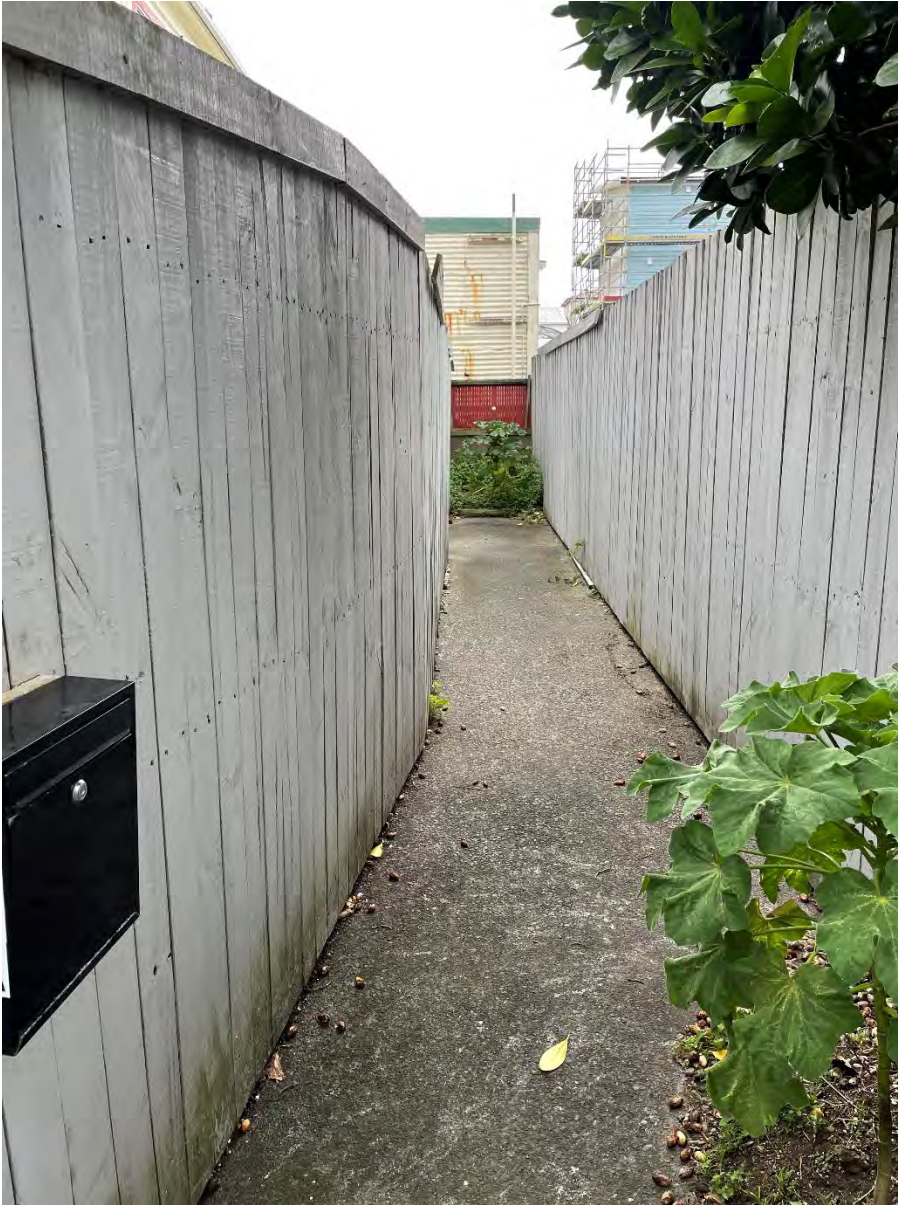
There are both entrapment and concealment spots on the lower end where there is an alcove and then a path that allows access to a rear property. This, along with the narrowness and poor lighting adds to the unsafe feeling when using the path at night.

Entrapment spot of walkway

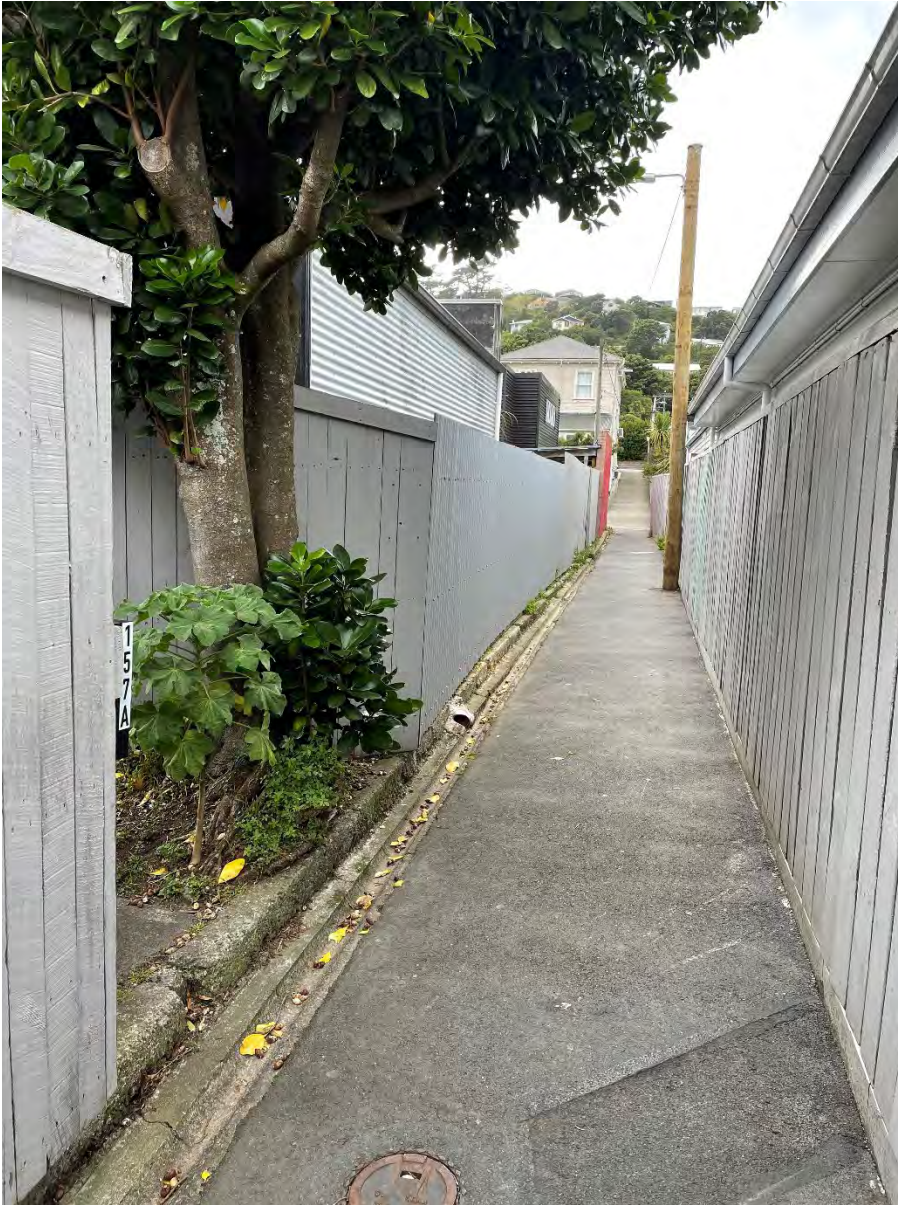
Rear of Bluebird Café and Post shop

- Some territorial reinforcement via painting on the ground, bollards etc to show private space at the rear of the shops backing onto the carpark
- Improved lighting at rear of café and postshop
- Improve community noticeboard area to be more user friendly and noticeable
- Its recommended the "picnic" area possibly be relocated or improved to make it more attractive for appropriate use.

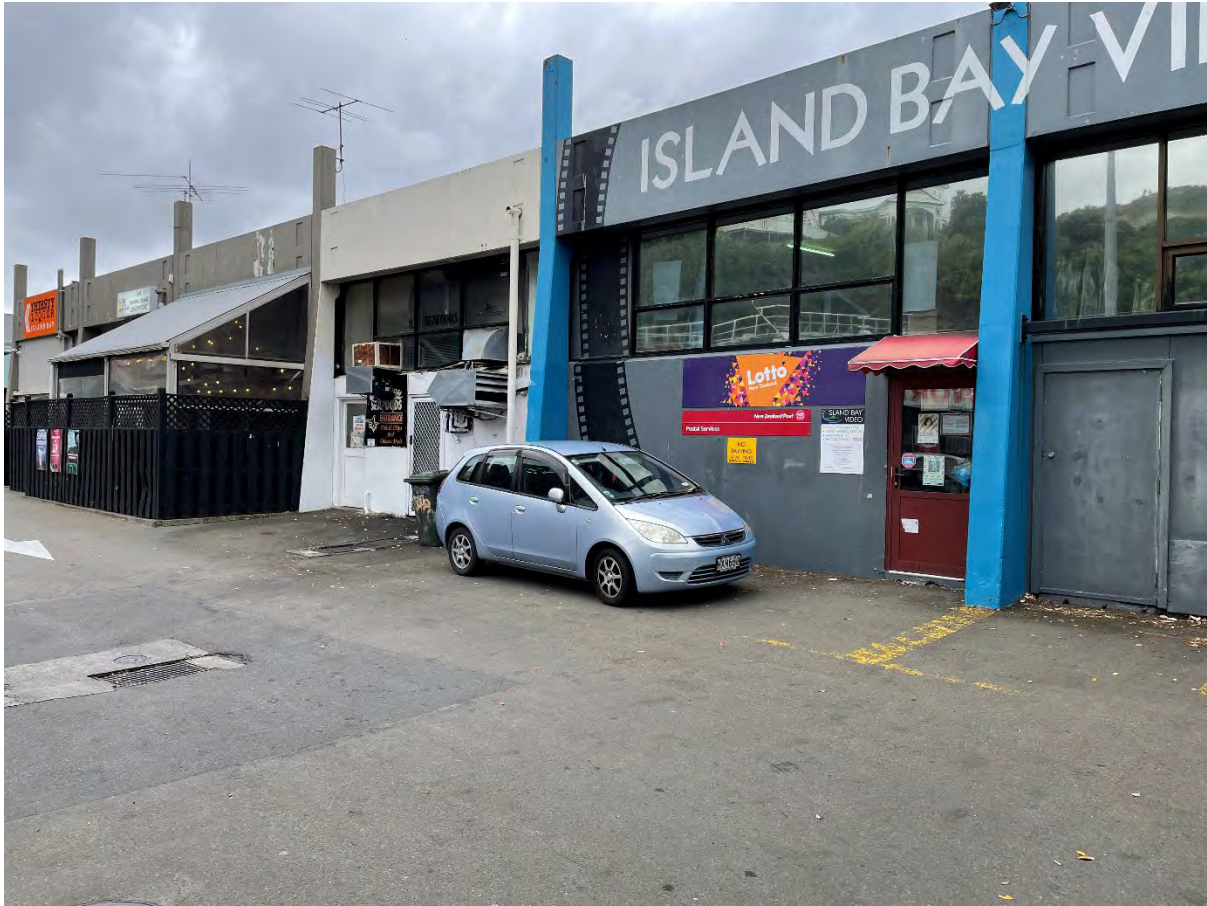
The rear of the retail and cafes open directly into carpark space, and there is little to delineate between semi-public to private ownership of space and nothing to stop anyone physically or symbolically from walking up to the rear doors and attempting entry. The lighting from the carpark does light the area somewhat but is dependent on New World using their lighting overnight.

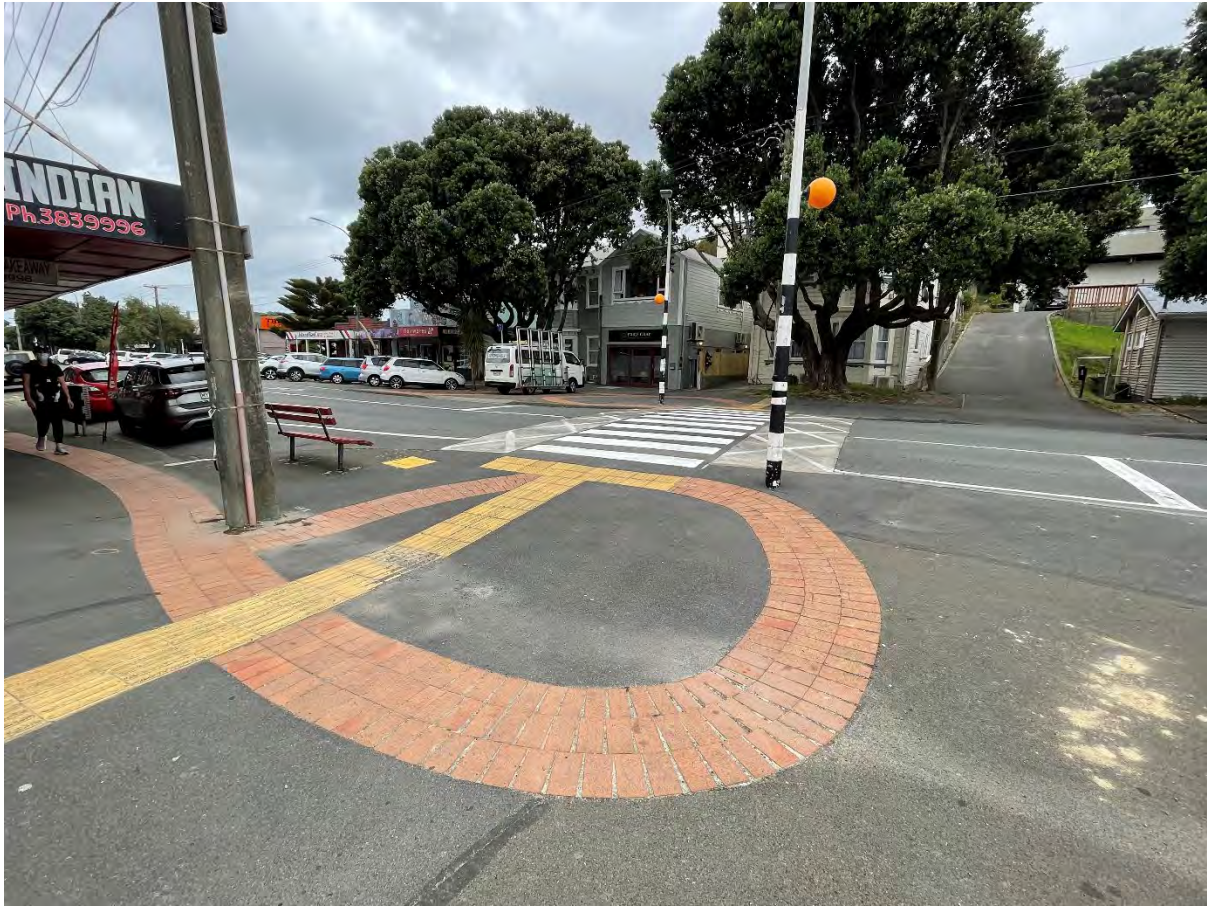
A good example of territorial reinforcement

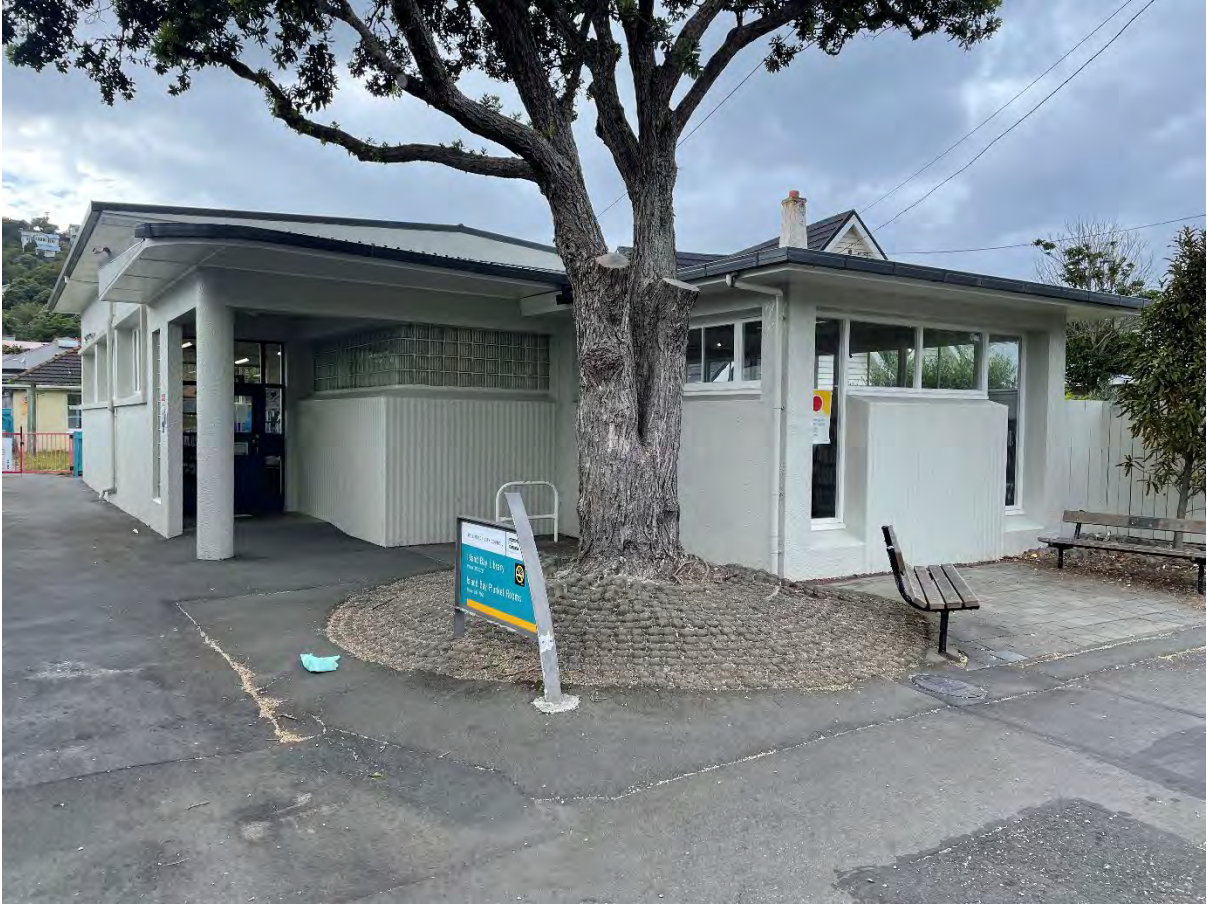
The Community centre is tucked back off the road with no frontage – there is some signage at the end of two separate driveways but generally it does not invite you up and into the space. The library has a solid front – there is no line of sight between the footpath and the interior of the library, and it is not inviting at all. There are several park benches out the front, and while there is no indication these are used for antisocial behaviour there are improvements that can be made to make the area a more attractive meeting place during the day and would encourage appropriate use. (See photos – Appendix A)

Front of library

- Consider how to improve the entry to the community centre – joining it into the main shopping area so it feels included (murals, driveway markings, paving etc).
- Re imagine the front of the library area, to also include it as part of the main “village area”, Open up the front to encourage oversight of the outside space and vice versa, improve signage.
- Improve signage on the public toilets, and directional signage in the area noting their availability.

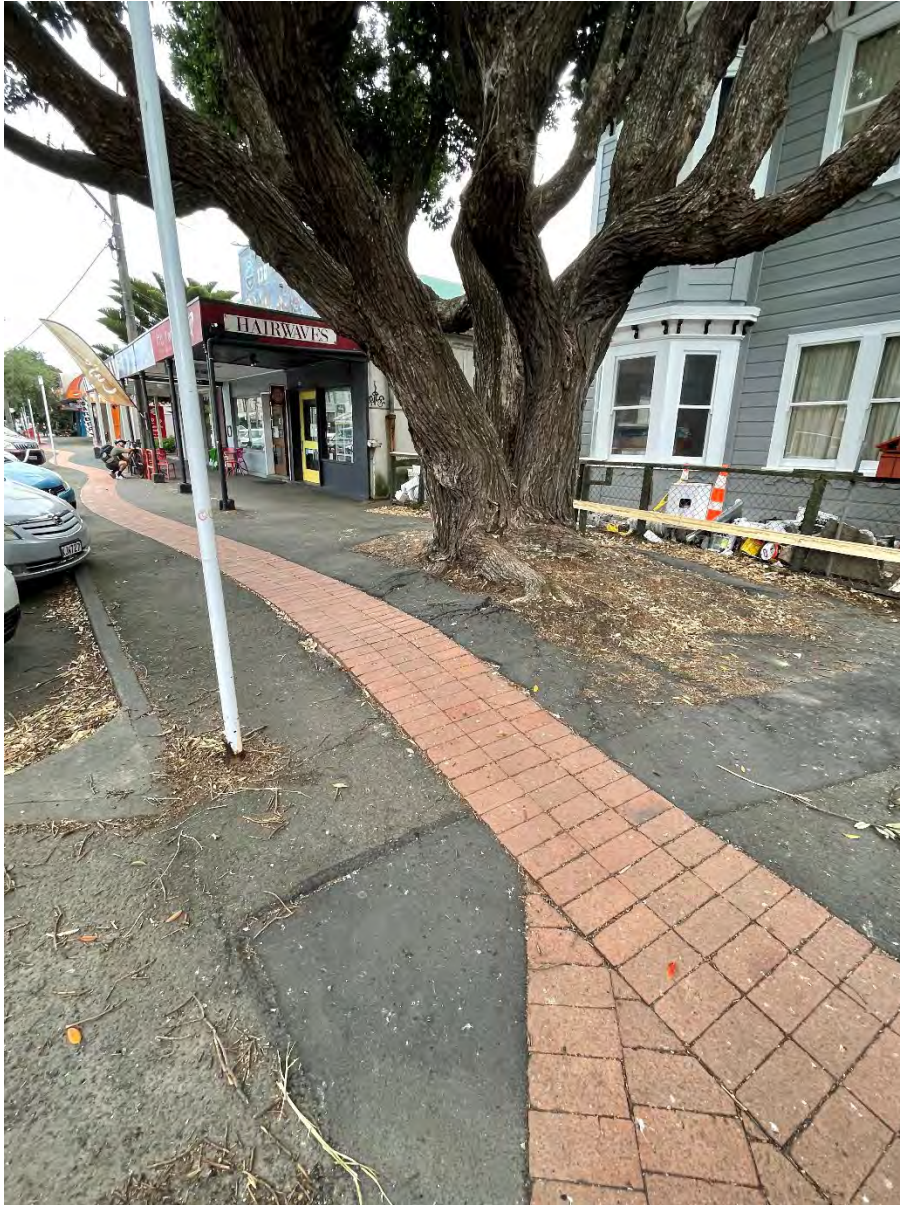
The brick paving is a good guide for pedestrians, guiding them up past the shops to the crossing area, it is a good example of layout and orientation as well as access control. Footpaths are a good width but could be extended to allow for more outside seating to premises which allow that. There is an issue with the footpath being cracked and broken by tree roots, this is particularly evident between the crossing and Thirsty liquor, it would be almost inaccessible for those with mobility issues.

Poor accessibility with path at an angle and cracked

- Fixed raised paving
- Increase mixed use of space (e.g. More public/footpath dining)
- Encourage use of under canopy lighting at night by retailers
- Consider some sort of “link” down to the empire, signage, footpath art etc

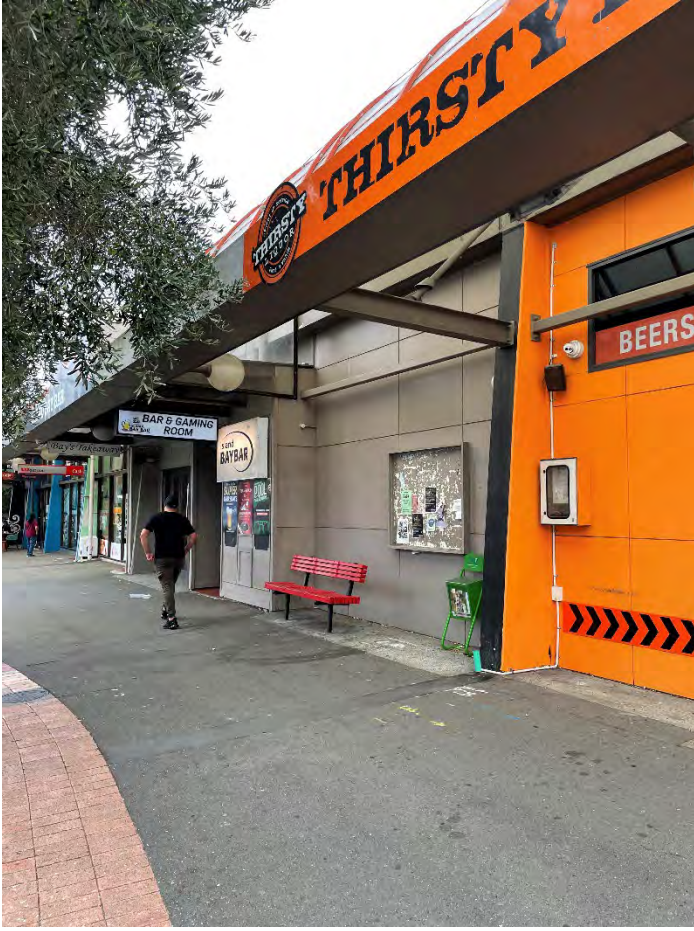
The area around the “community noticeboard” is dirty, uncared for, unused and not signposted.

Community notice board area

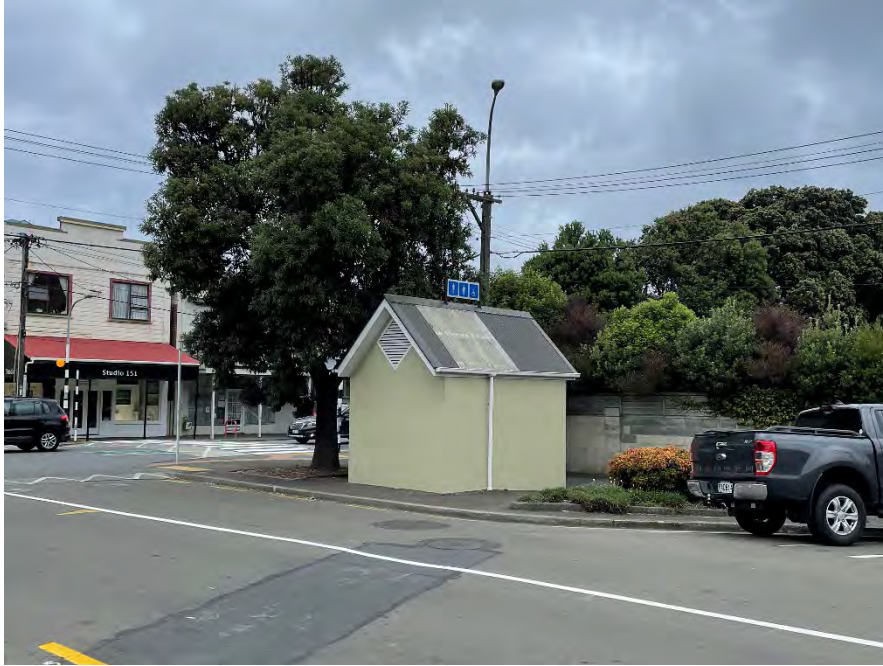
Public Toilets

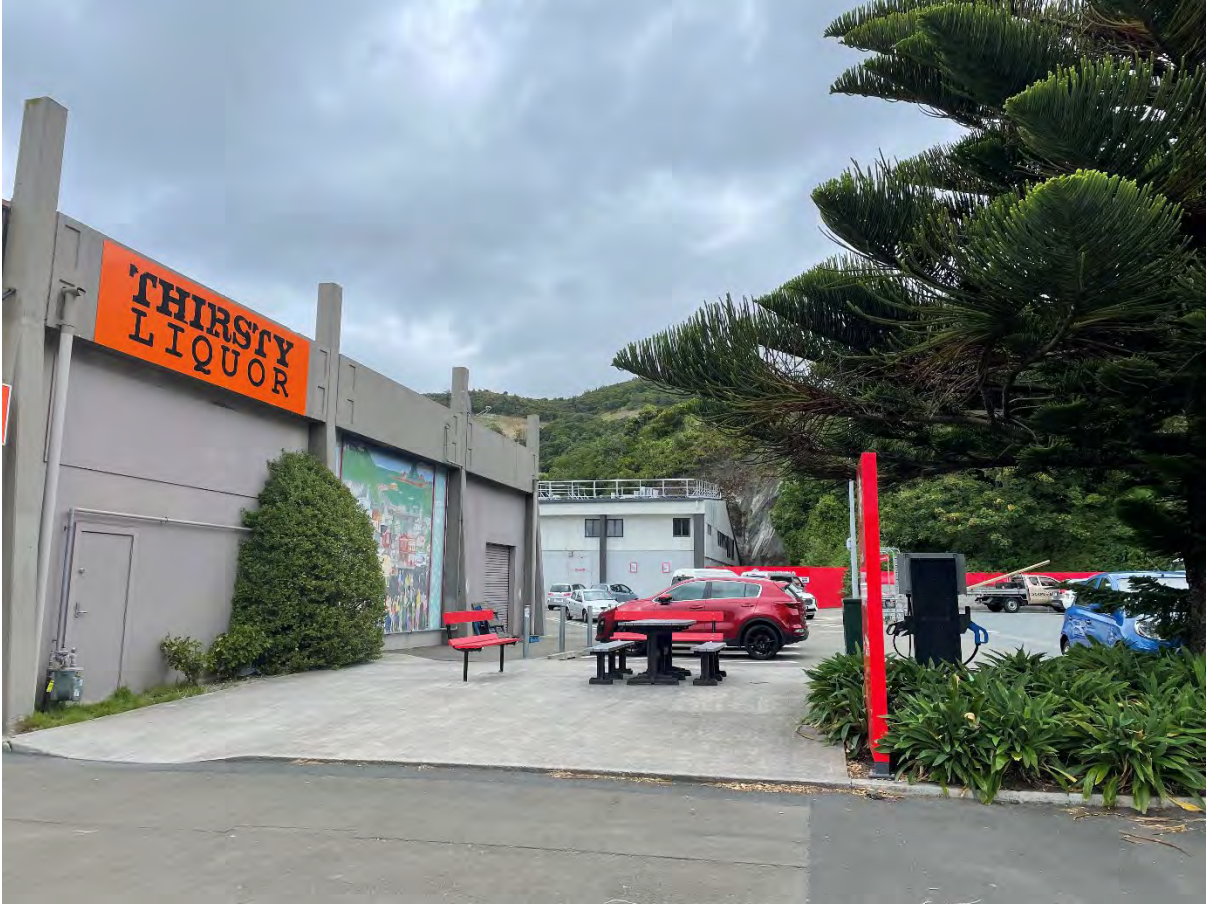
The Picnic table in an area next to thirsty liquor, while no antisocial behaviour was seen here while I visited, it is an interesting choice of location. Being next to a bottle

shop lends itself to becoming a drinking location, there is also little reason for normal use, it's not a desirable location to sit considering it backs onto a busy carpark and looks out to a bus stop.

“picnic” area

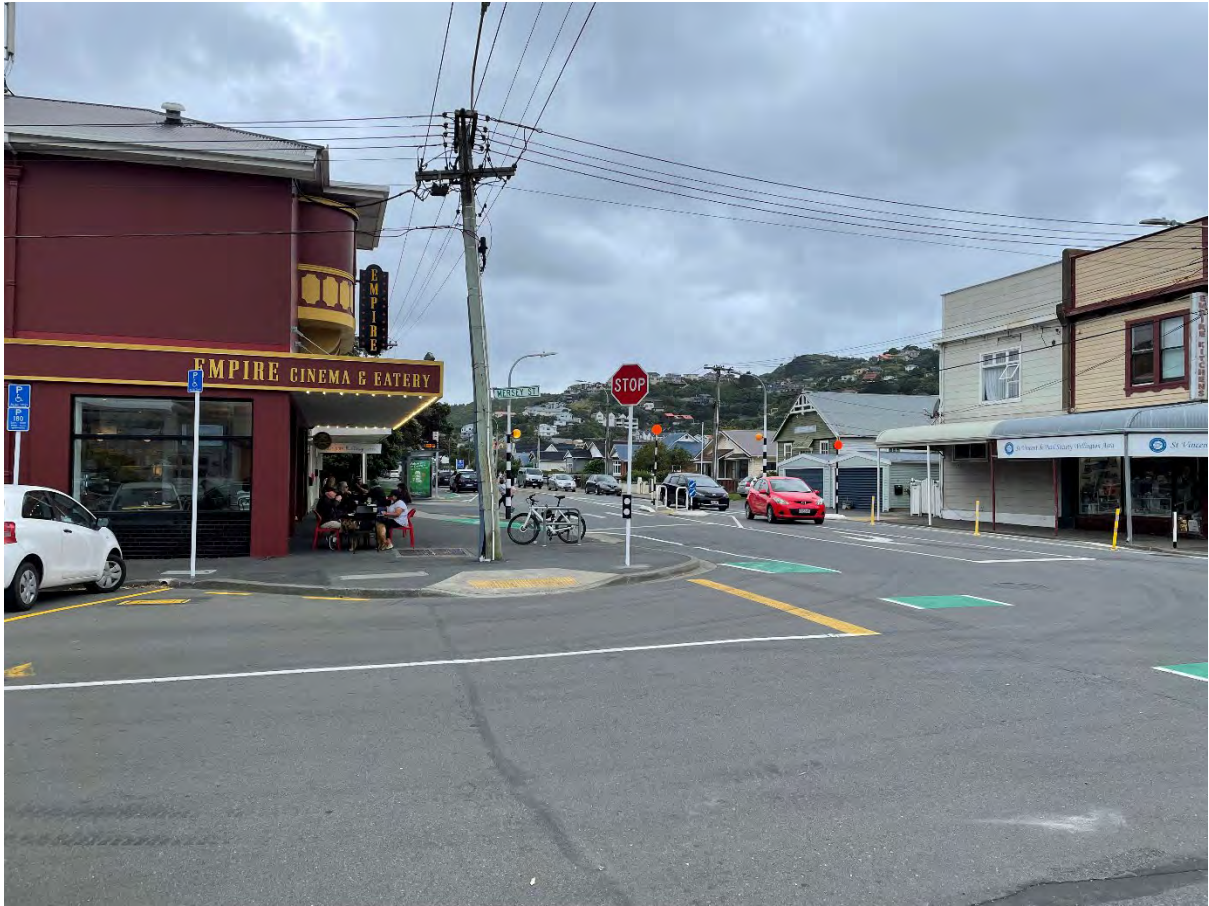
The empire theatre – is a tidy building with outdoor seating – it does however have poor links to the shop/s in the same area and also poor links back up the road to the main shopping area; meaning there is nothing to guide or encourage patrons towards the shops or to encourage walking.

Good example of mixed use outside the Empire cinema

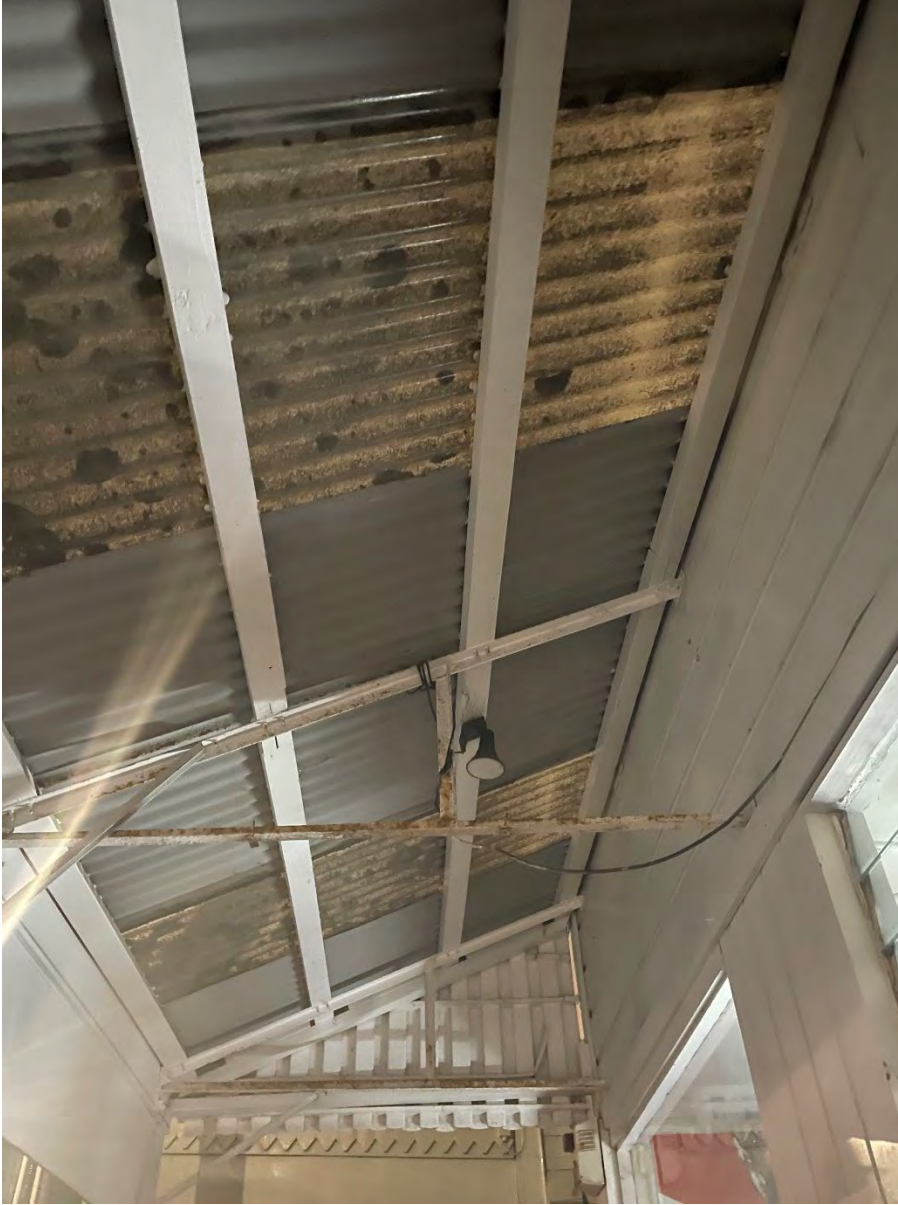
While there were various different types of lighting located under the canopy's of shops none were in use during night audits. All lighting came from within premises lit at night with window displays. Lux levels ranged from 0.4 outside the Postshop and Bluebelle café to 123 lux outside the well lit gallery across the road. On average the level along the shopping strip was 1.1 lux. This inconsistent lighting creates dark patches and leads to a feeling that darker areas feel unsafe compared to those areas that are well lit.

An example of under canopy lighting not in use

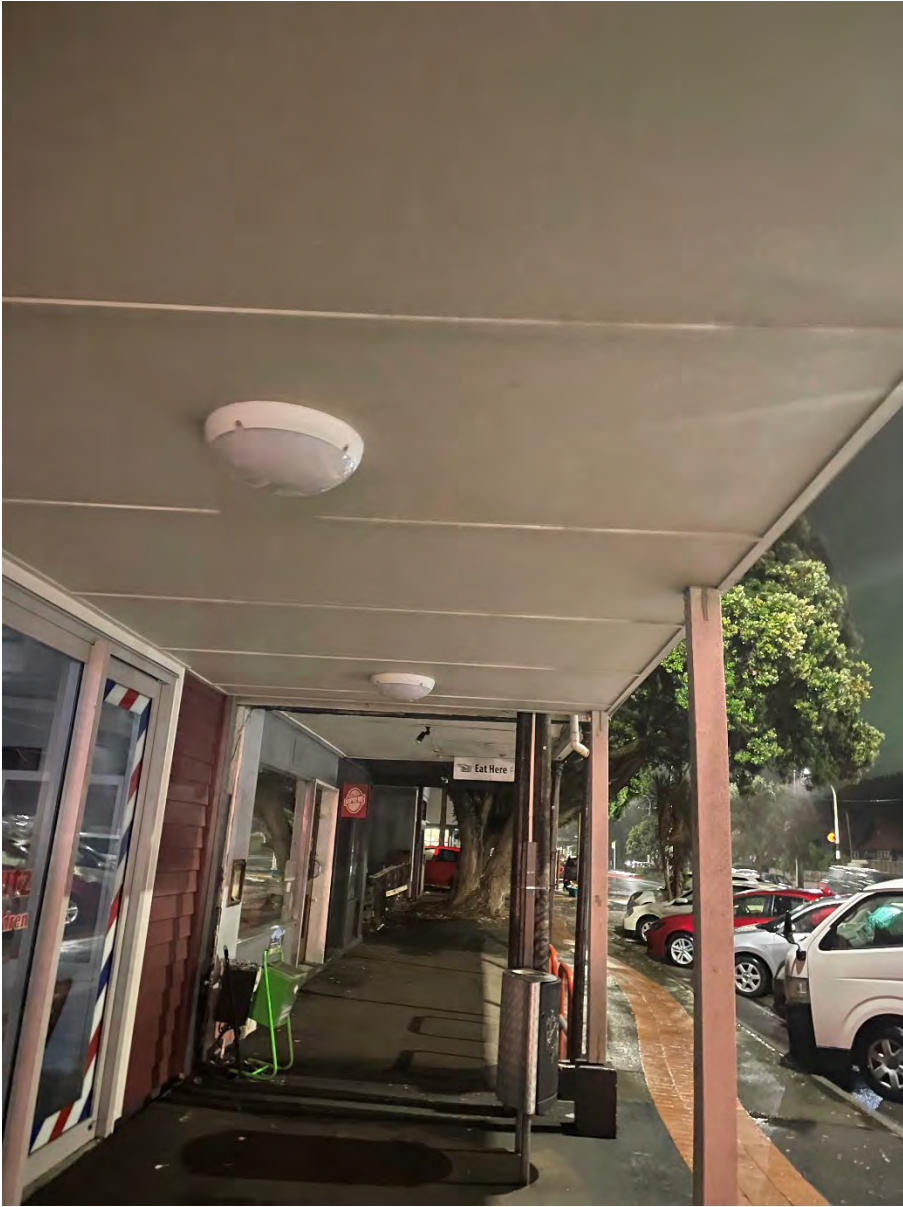
Good use of canopy lights after closing

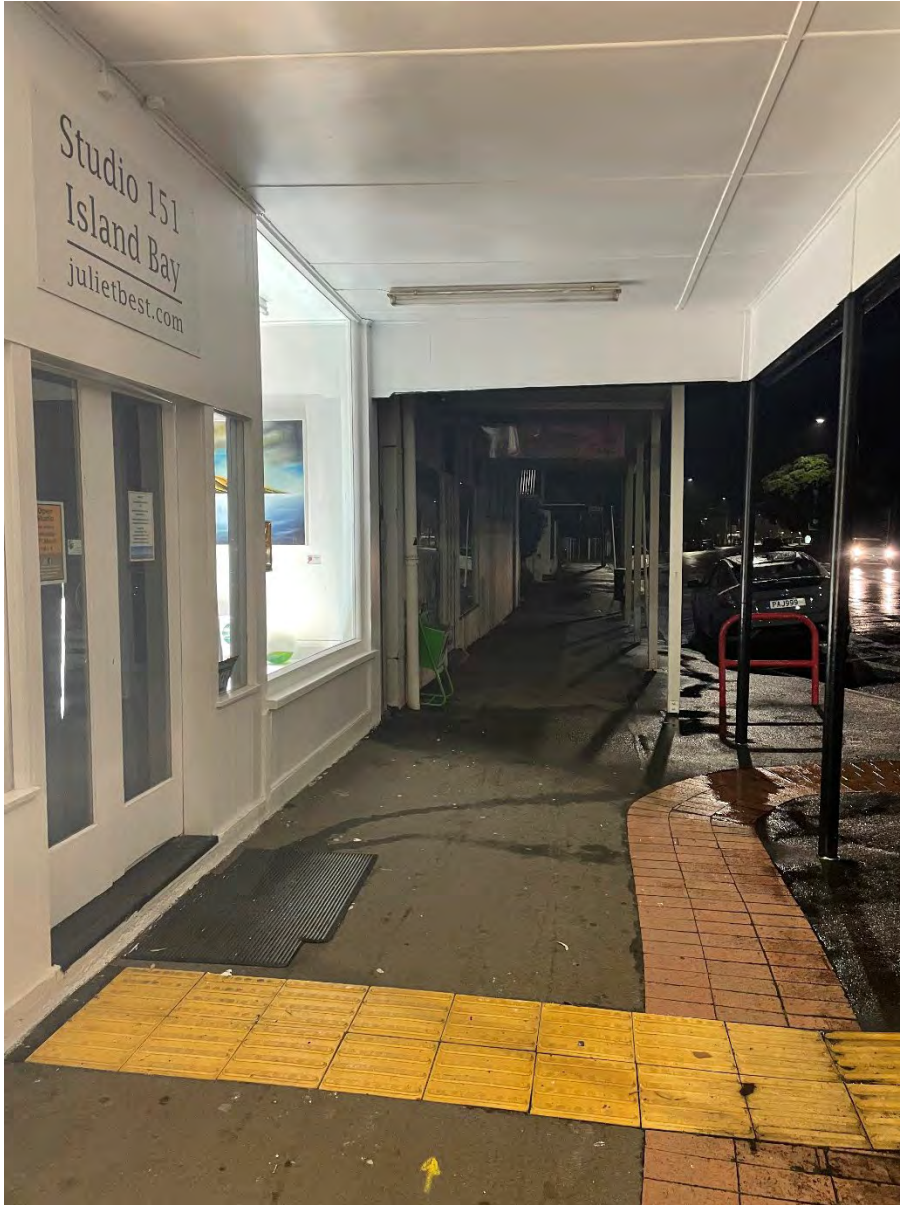
An example of inconsistent lighting
