# REPORT

Wellington City Council

Island Bay Seawall Alternatives  
Analysis  
Coastal Processes Assessment

May 2014

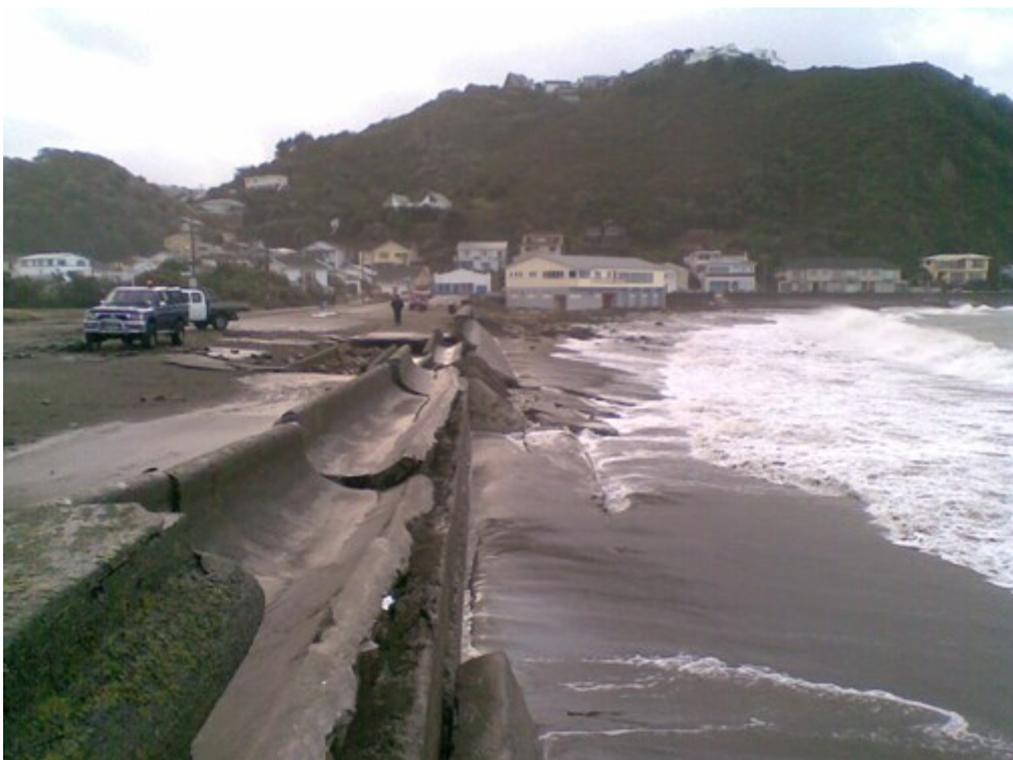
*Figure 2 Damage to the Island Bay seawall following the June 2013 Storm Event (image: WCC)*

A large storm event on 22-23 June 2013 caused widespread damage along Wellington's South Coast, which included the seawall at Island Bay. The damage caused to the wall included a 35m section of wall rotating and a further 50m section completely failed.

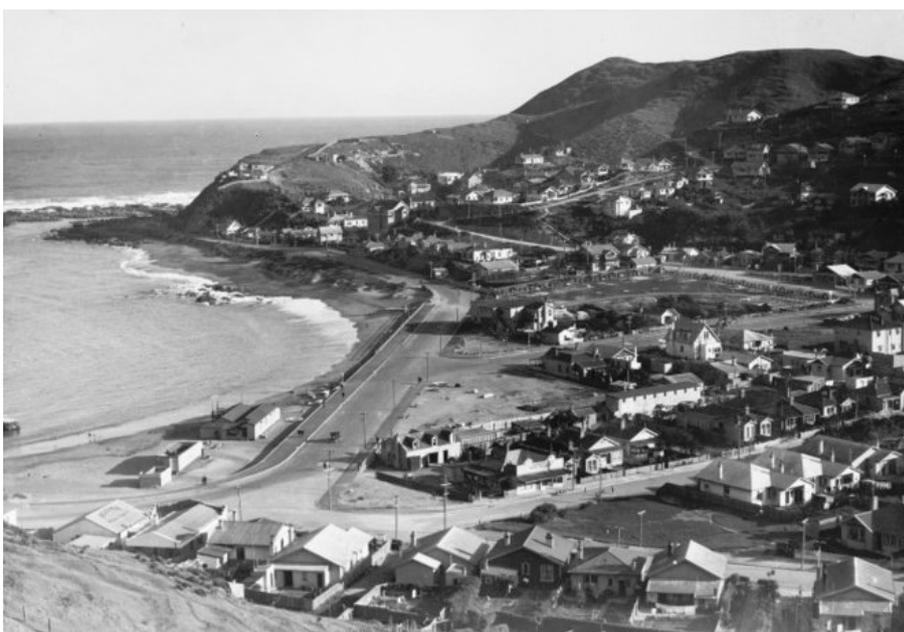
*Figure 5 Island Bay, Wellington, circa 1930, photographed by Robson & Boyer. PAColl-7081-06 Alexander Turnbull Library, Wellington, New Zealand.*

Island Bay is a heavily modified urban beach with development beginning in the early 1900's with a roadway constructed along the foredune crest in approximately 1906 (Figure 4). The road was formalised by the 1930s (Figure 5) with a seawall constructed in two stages. The first stage was a sloped concrete revetment (Figure 6), presumably to protect the road from wave erosion and/or overtopping. A recurved upstand wall was added later (Figure 2), presumably to decrease the occurrence of wind-blown sand and periodic wave overtopping.

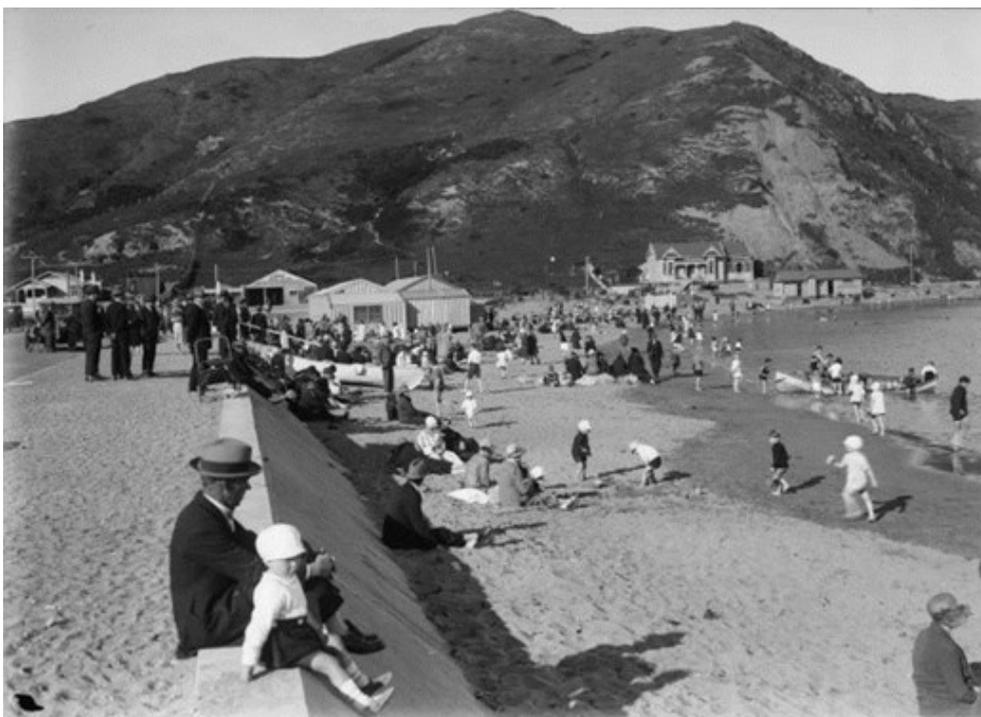
*Figure 6 Historic view of the Island Bay Seawall, circa 1930. Smith, Sydney Charles, 1888-1972: Photographs of New Zealand. Ref: 1/2-045879-G. Alexander Turnbull Library, Wellington, New Zealand.*

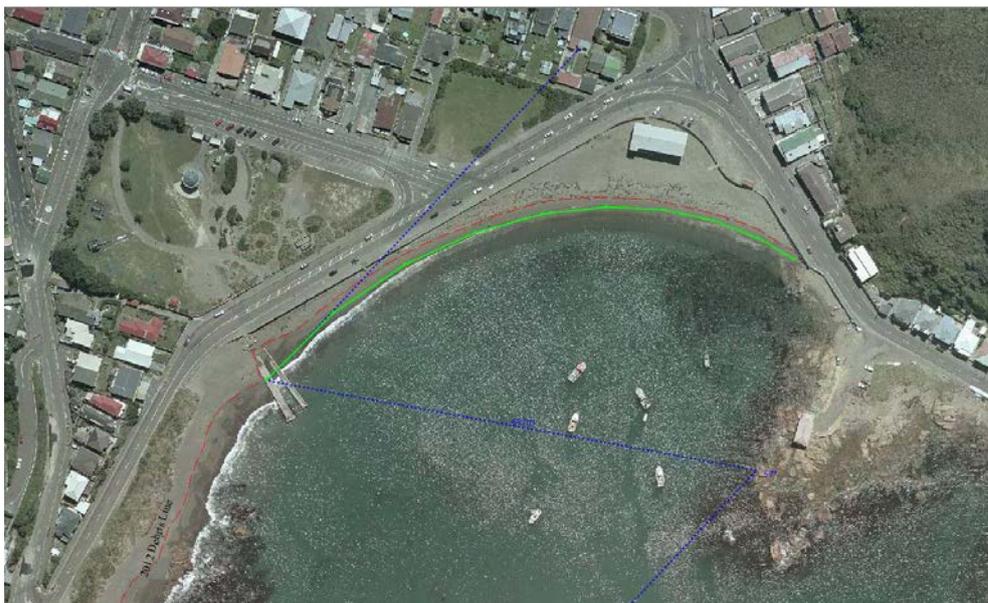
Figure 8 Current MHW line (---) compared to the predicted equilibrium planform (---)

The equilibrium curve for the present beach configuration was modelled using the software Mepbay (Klein et al., 2003) based on the parabolic bay model of Hsu and Evans (1989). Incoming wave angle is aligned between the eastern headland and Taputeranga Island and the southerly beach control point is assumed at the outfalls. Results (Figure 8) show that the existing beach planform (MHWs shown in red) is in very close agreement with the predicted equilibrium curve (shown in green) and is therefore expected to be relatively stable.

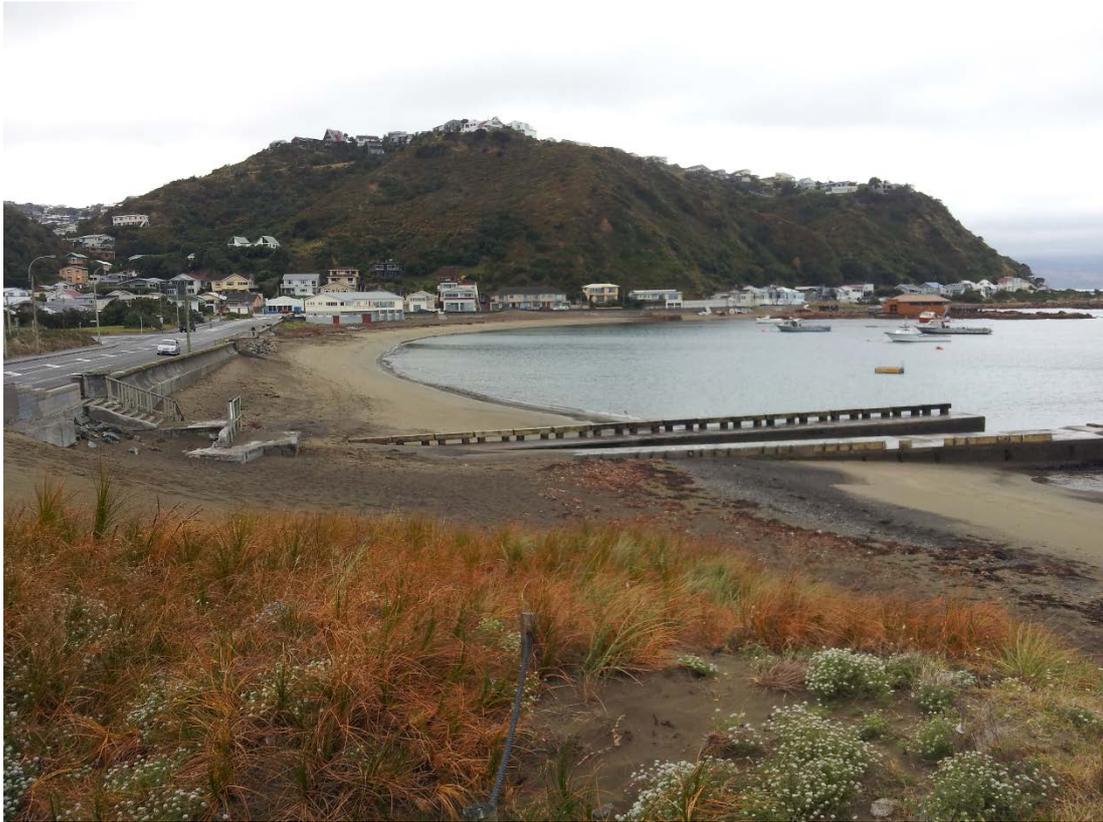
*A-1 Island Bay overview showing crescentic beach plan from backed by straight seawall*

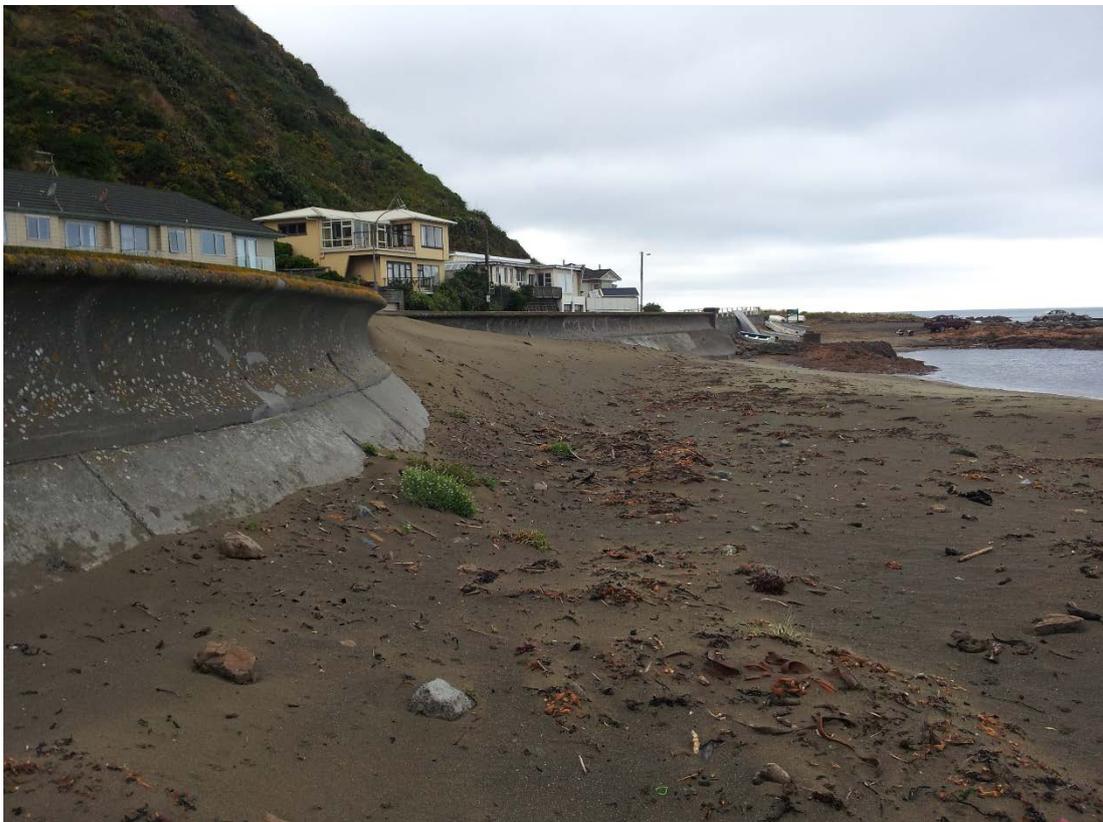
*A-2 Wind-blown sand accumulating against the existing seawall on eastern side of bay*

The road and seawall are constructed near the back of the active beach and so are not frequently exposed to coastal processes (wave impact, overtopping and erosion), however, the straight seawall alignment differs to the naturally crescentic beach (Photograph A-1) and the central portion of wall is located further into the active beach (5 to 10 m behind the high water line) and more frequently affected by coastal processes (wave impact and erosion). A large storm event in June 2013 damaged the central portion of the seawall and requires repair (Photograph A-4). Wind blown sand accumulates against the wall at the eastern (Photograph A-2) and southwestern (Photograph A-6) sides of the bay.

Wind blown sand is typically an annoyance rather than a hazard of high consequence but regular maintenance is required to remove accumulated sediment. Solutions are generally to establish vegetated dunes or utilise permeable wind fencing which reduces velocities to allow sediment to be deposited rather than inducing scour. Mobile sediments may be accumulate against hard structures such as seawalls but if the sediment supply is sufficient, the sediment will gradually build until the structure is overtopped. This is evidenced at Island Bay (Photographs A-2, A-6).

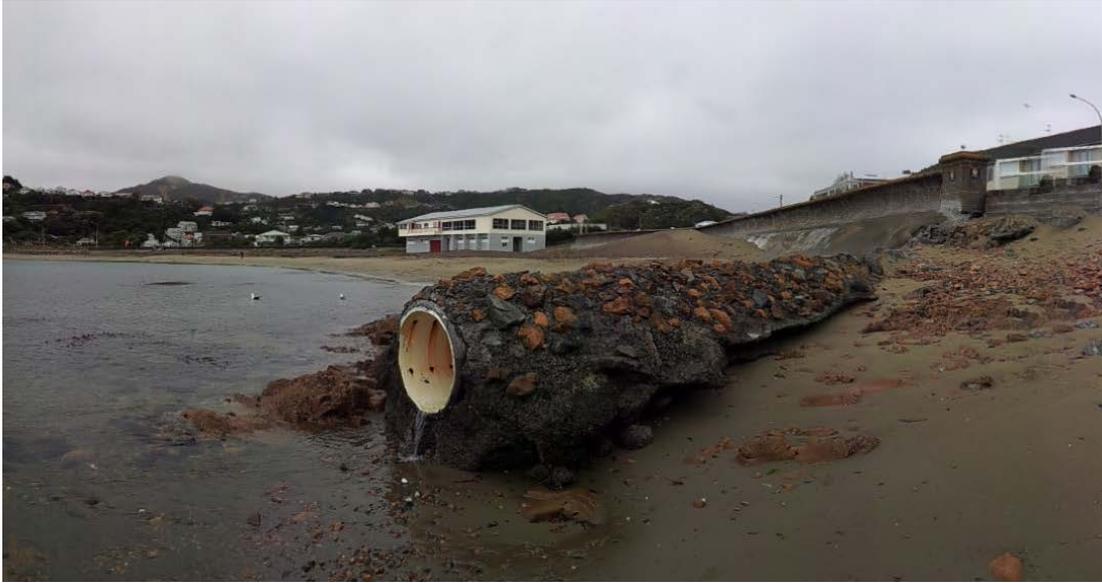
*A-3 Grouted rock and concrete outfall on eastern side of bay*

A number of stormwater outfalls discharge into Island Bay, most notably the twin outlets at the western side the crescentic beach (Photograph A-5). These outlets have replaced the natural stream which likely historically outlet in the northern corner of the beach where the surf club is now located. The first outfall was in place by 1938 and the second constructed between 1989 and 2002. A grouted rock encased outfall discharges to the east of the crescentic beach (Photograph A-3) and a number of smaller outlets discharge along the backshore.

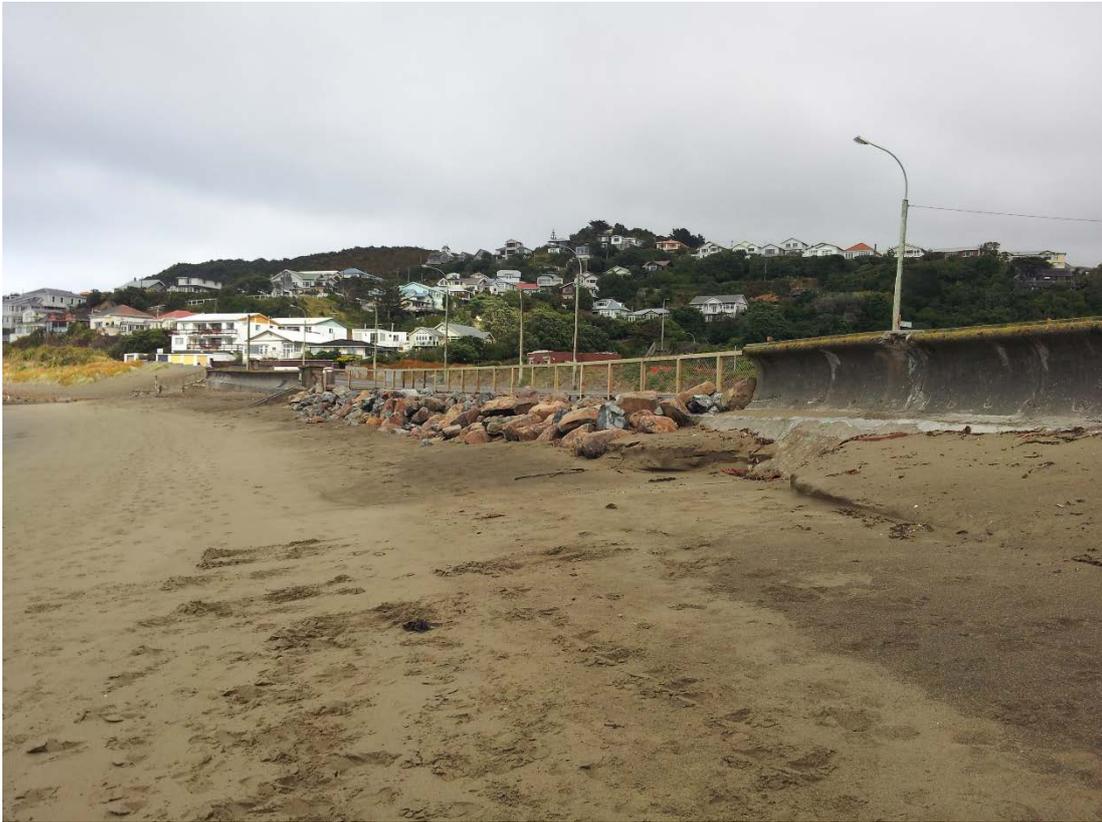
*A-4 Failed section of seawall with temporary rock repair*

While repairs to this section of seawall are presently underway, a range of longer-term management options are being assessed for the Island Bay Beach to improve resilience.

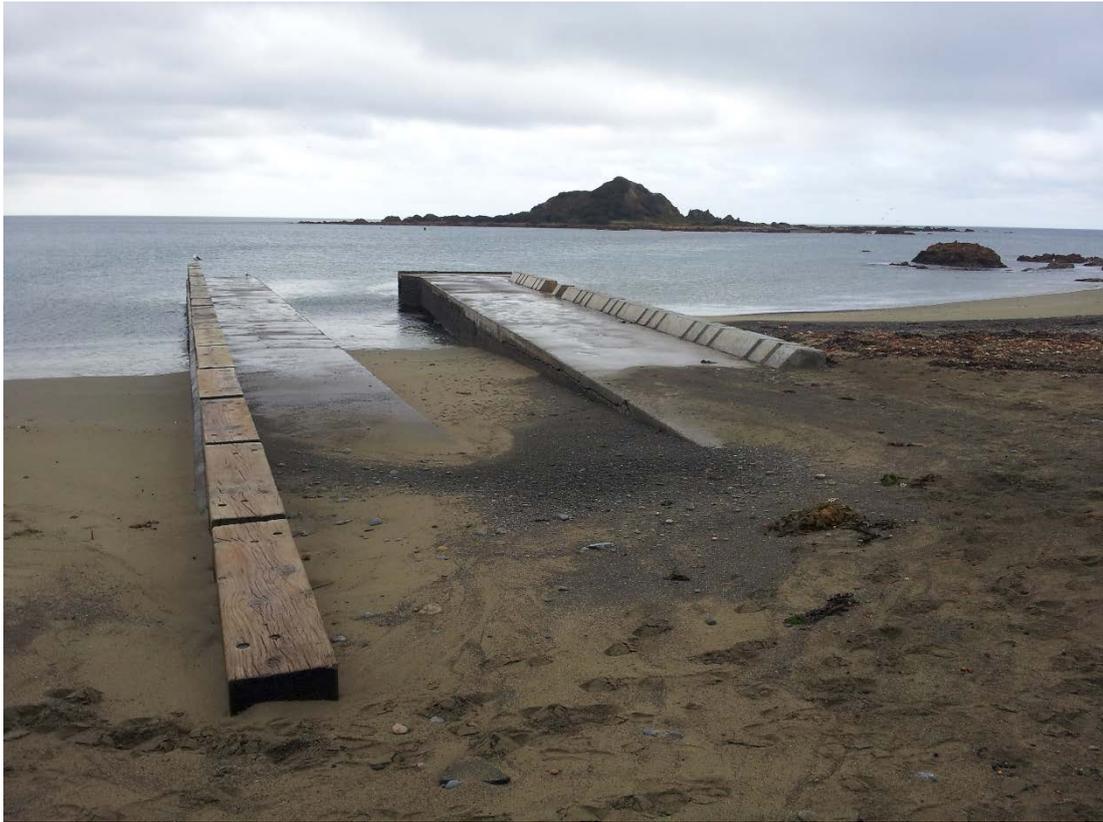
*A-5 Stormwater outfalls at southwestern end of bay*

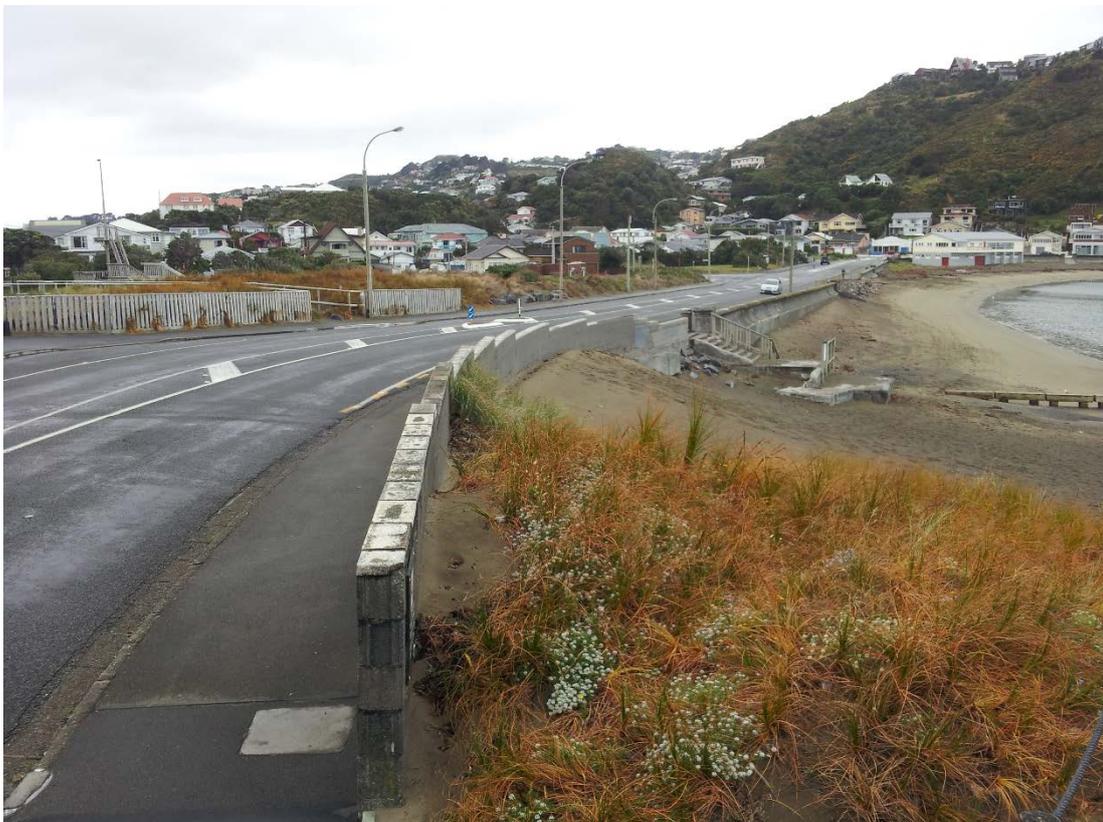
*A-6 Wind-blown sand accumulating against seawall and detached dune system evident across road in Shorland Park*
